Pit or Below-Grade Tank Registration or Closure

Re: Drilling Pit Closure of EOG Resources – Crusoe BKO Fed Com #1  
UL ‘A’ Sec. 24 T16S R24E Eddy County  
API # 30-015-34729

# **Closure Report**

**Crusoe BKO Fed Com #1**  
**API # 30-015-34729**  
**Eddy County, NM**

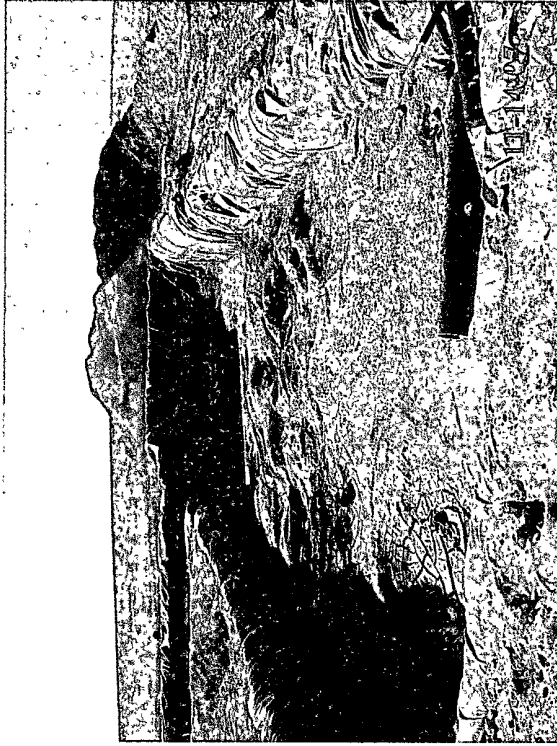
Drilling pit before closure.

Additional Comments: A burial pit was constructed and lined with a 12mil impervious liner. The drilling pit contents were stiffened with dry soil then placed in the burial pit. The burial pit was capped with a 20 mil liner. 5 bottom sample points were analyzed and met NMOCD standards. The burial pit and drilling pit were backfilled with clean native soil and contoured to the surrounding area.

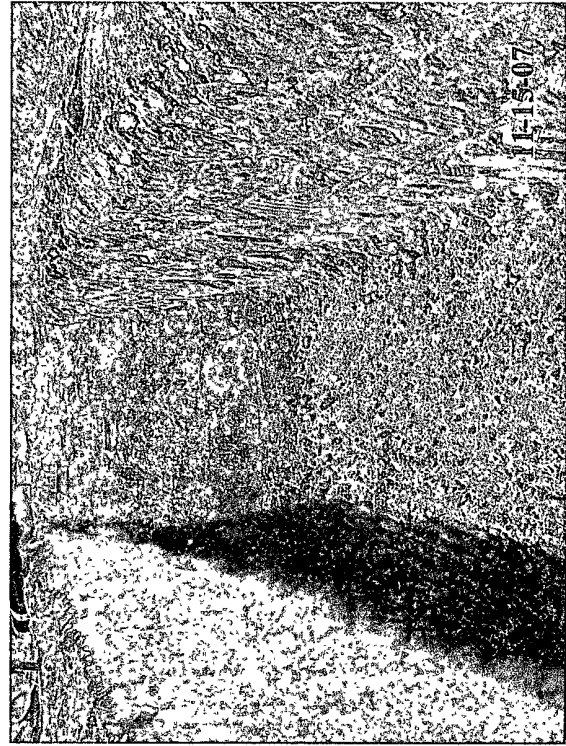
Burial pit before 12 mil impervious liner installation.

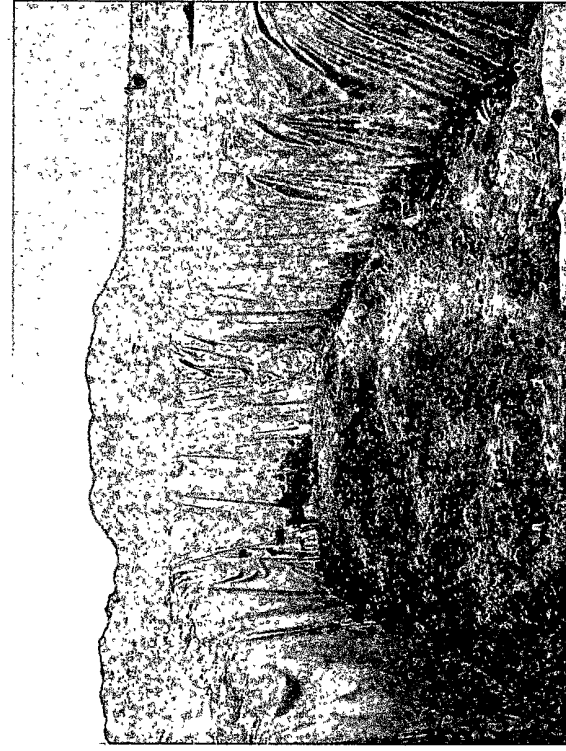
Stiffened drilling mud placed in burial pit.

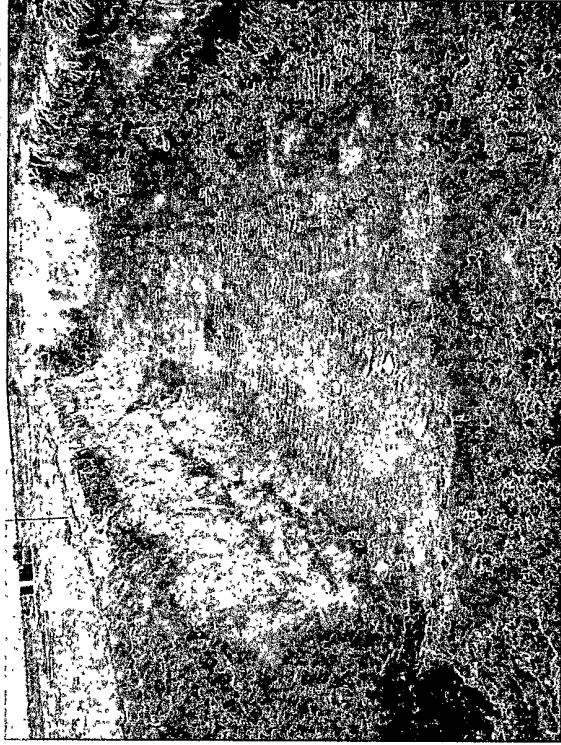
Drilling pit after mud is removed.

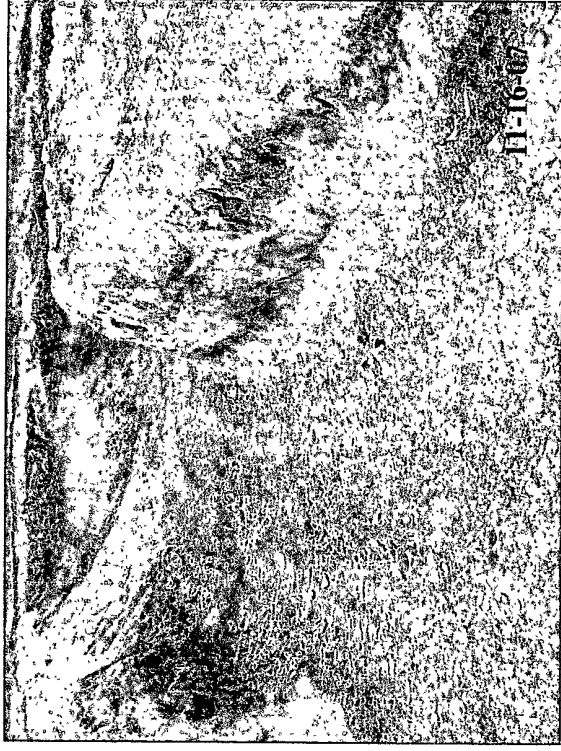
Drilling pit after mud is removed.

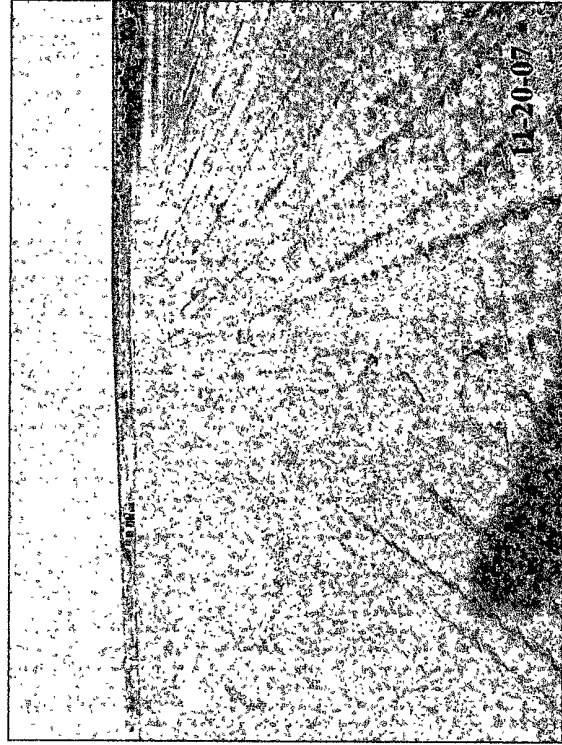
Drilling pit and burial pit after backfill and contouring.

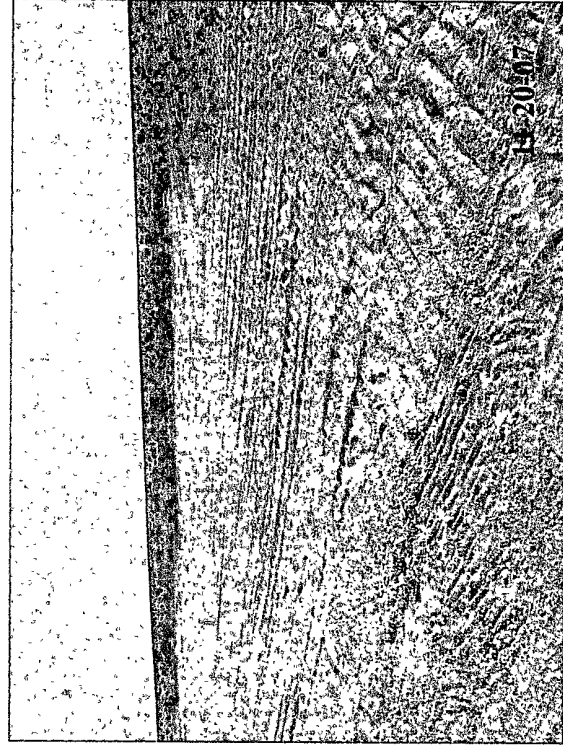
Drilling pit and burial pit after backfill and contouring.
