Pit or Below-Grade Tank Registration or Closure

Re: Drilling Pit Closure of EOG Resources – Crusoe BKO Fed Com #1
UL 'A' Sec. 24 T16S R24E Eddy County
API # 30-015-34729

Closure Report

Crusoe BKO Fed Com #1
API # 30-015-34729
Eddy County, NM

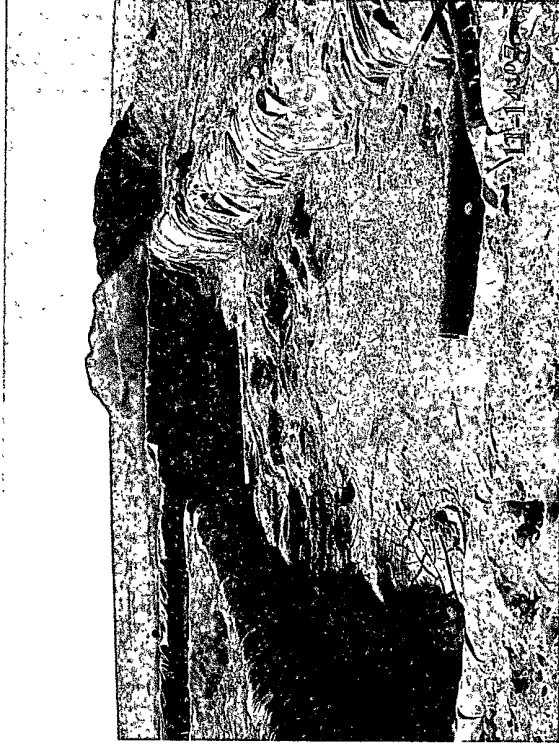
Drilling pit before closure.

Additional Comments: A burial pit was constructed and lined with a 12mil impervious liner. The drilling pit contents were stiffened with dry soil then placed in the burial pit. The burial pit was capped with a 20 mil liner. 5 bottom sample points were analyzed and met NMOCD standards. The burial pit and drilling pit were backfilled with clean native soil and contoured to the surrounding area.

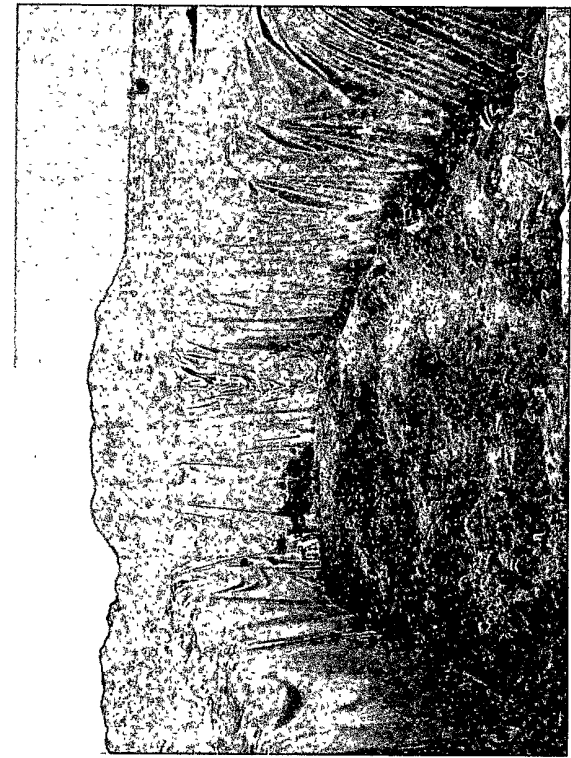
Stiffened drilling mud placed in burial pit.

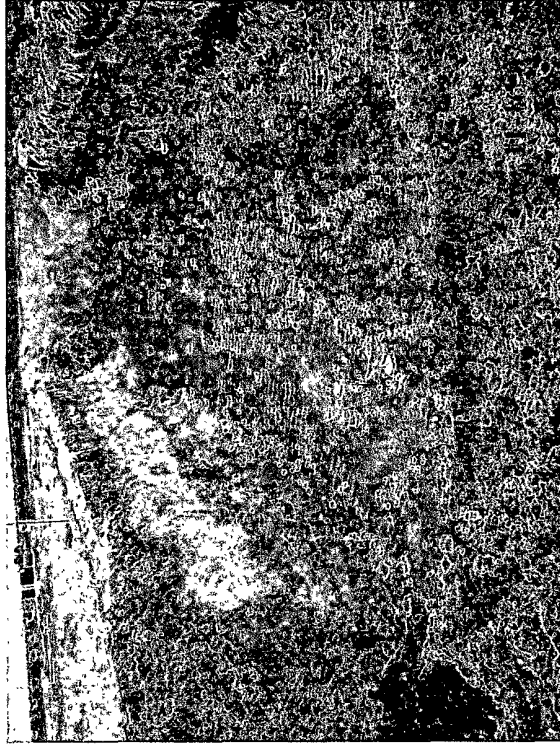
Drilling pit after mud is removed.

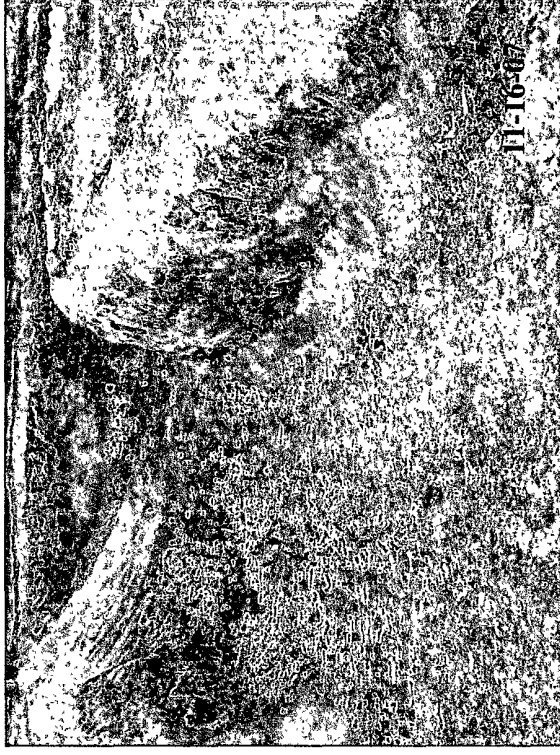
Drilling pit after mud is removed.
