Closure Report

Robinson HW Fed Com #3H API # 30-015-35812 **Eddy County, NM**

Re: Drilling Pit Closure of EOG Resources – Robinson HW Fed Com #3H

UL 'I' Sec. 24 T16S R24E Eddy County, NM

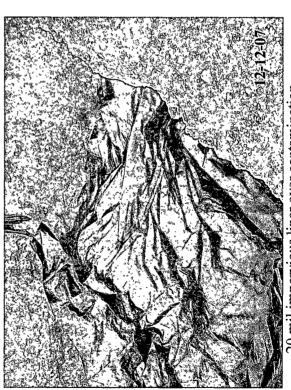
20 mil impervious liner over contamination.
