Pit, Closed-Loop System, Below-Grade Tank, or
Proposed Alternative Method Permit or Closure Plan Application

Waste Excavation and Removal Closure Plan

BEPCO, L.P.
dba Bass Enterprises Production Co.
Poker Lake Unit #290
Section 19, T-24-S, R-30-E
Eddy County, New Mexico

**SITE PLAN DENOTING
PIT CLOSURE SAMPLING LOCATIONS**
Poker Lake Unit #290

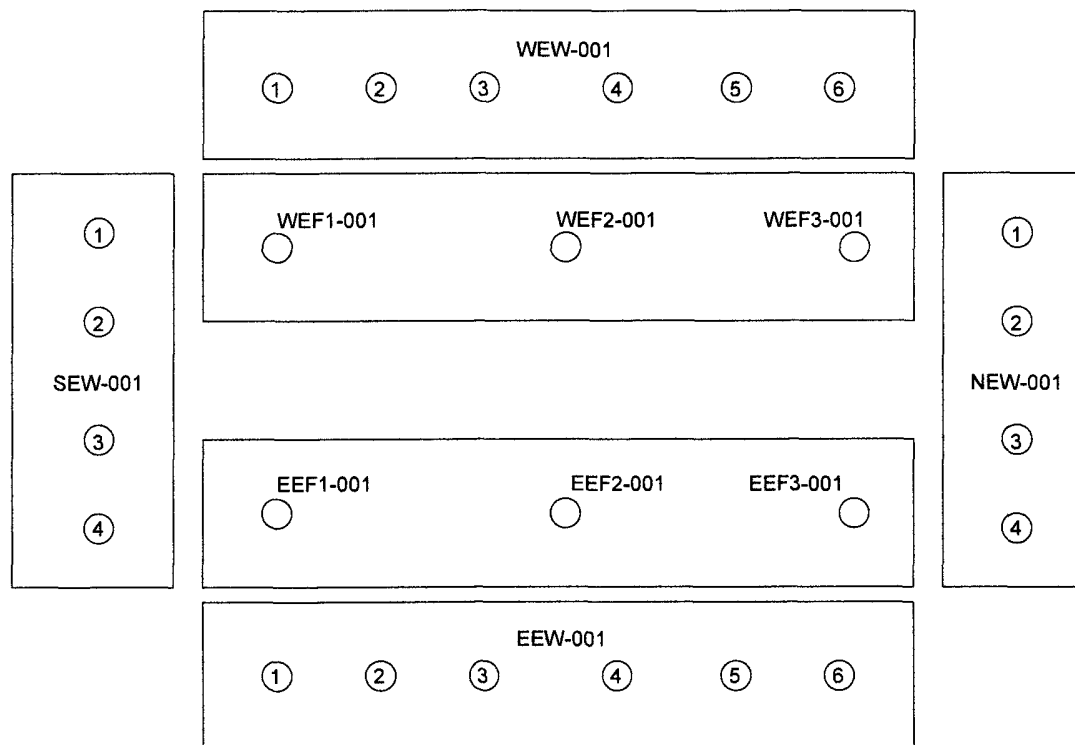
Note All wall samples were composite samples Initial round of sampling methods SW8015 Mod and EPA 418 1 for TPH, EPA 300/300 1 for chlorides and 8021B/5030 for BTEX were run during the analysis Chlorides were the only ones that came back above the required limits All analysis shown were mg/Kg Chlorides

Round One Samples - 10-27-08
Round Two Samples - 10-31-08
Round Three Samples - 11-07-08
Round Four Samples - 11-13-08
Round Five Samples - 11-20-08
