Pit, Closed-Loop System, Below-Grade Tank, or
Proposed Alternative Method Permit or Closure Plan Application

1.
Operator: BOPCO, L.P. OGRID #: 001801
Address: P.O. Box 2760 Midland, TX 79702
Facility or well name: Poker Lake Unit #162
API Number: 30-015-35522 OCD Permit Number: 208256
U/L or Qtr/Qtr C Section 6 Township 24S Range 30E County: EDDY
Center of Proposed Design: Latitude N 32.252028 Longitude W 103.923389 NAD: ☐ 1927 ☒ 1983
Surface Owner: ☒ Federal ☐ State ☐ Private ☐ Tribal Trust or Indian Allotment

Waste Excavation and Removal Closure Plan

BEPCO, L.P.
dba Bass Enterprises Production Co.
Poker Lake Unit #162
Section 6, T-24-S, R-30-E
Eddy County, New Mexico

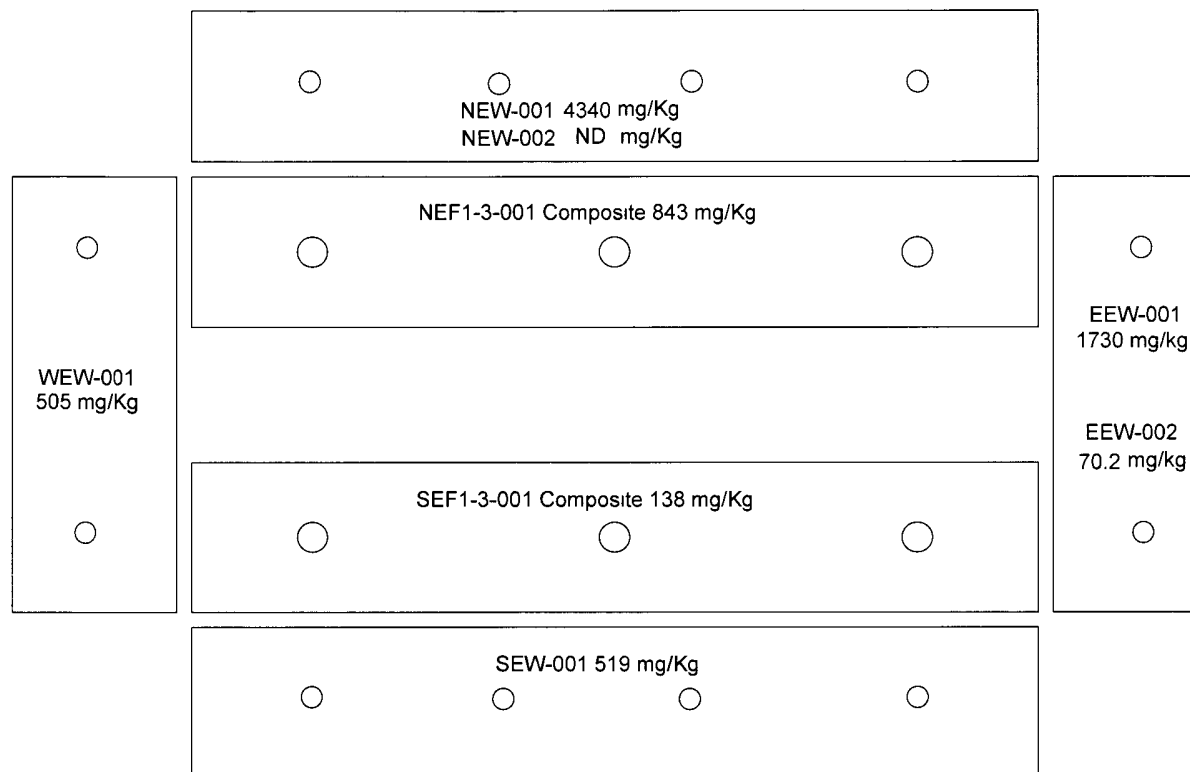
Delineation Sampling Plan

Note All wall samples were composite samples. Initial round of sampling methods SW8015 Mod and EPA 418.1 for TPH, EPA 300/300.1 for chlorides and 8021B/5030 for BTEX were run during the analysis. Chlorides were the only ones that came back above the required limits. All analysis shown were mg/Kg Chlorides.

Round One Samples - 08-14-08
Round Two Samples - 08-20-08
10-16-08
