Proposed Drilling Location Background Sampling

BOPCO, L.P.
James Ranch Unit #104H
Section 36, T-22-S, R-30-E
Eddy County, New Mexico

Re: **Proposed Drilling Location Background Sampling Report**
James Ranch Unit #104H
Section 36, T-22-S, R-30-E
Eddy County, New Mexico

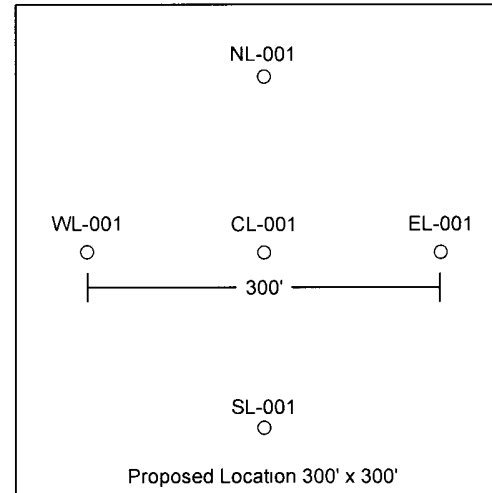
Background Soil Investigation
Site Plan

Attached please find a site plan denoting sample locations at the site displayed in a five-point arrangement plus a sixth background sample. One (1) sample was collected from each soil boring utilizing the direct push technique with a Geoprobe. Samples were collected at a depth of four feet (4'). As requested, shallow soil borings were utilized to reflect representative shallow site characteristics. This method of sampling was determined to be most effective due to the use of a closed-loop system at the site. Each soil sample was analyzed for **Total Petroleum Hydrocarbons** (C₆-C₁₂ Gasoline Range Hydrocarbons; C₁₂-C₁₈ Diesel Range Hydrocarbons; C₂₈-C₃₅ Oil Range Hydrocarbons; and Total TPH), **Chlorides (Cl)** and **BTEX** (Benzene; Toluene; Ethylbenzene; m,p-Xylene; o-Xylene; Total Xylenes; and Total BTEX) content.

James Ranch Unit #104H		
CL-001	32°21' 01"	-103°50' 14"
NL-001	32°21' 02"	-103°50' 14"
SL-001	32°21' 00"	-103°50' 14"
EL-001	32°21' 01"	-103°50' 12"
WL-001	32°21' 01"	-103°50' 16"
BACK-001	32°21' 02"	-103°50' 17"

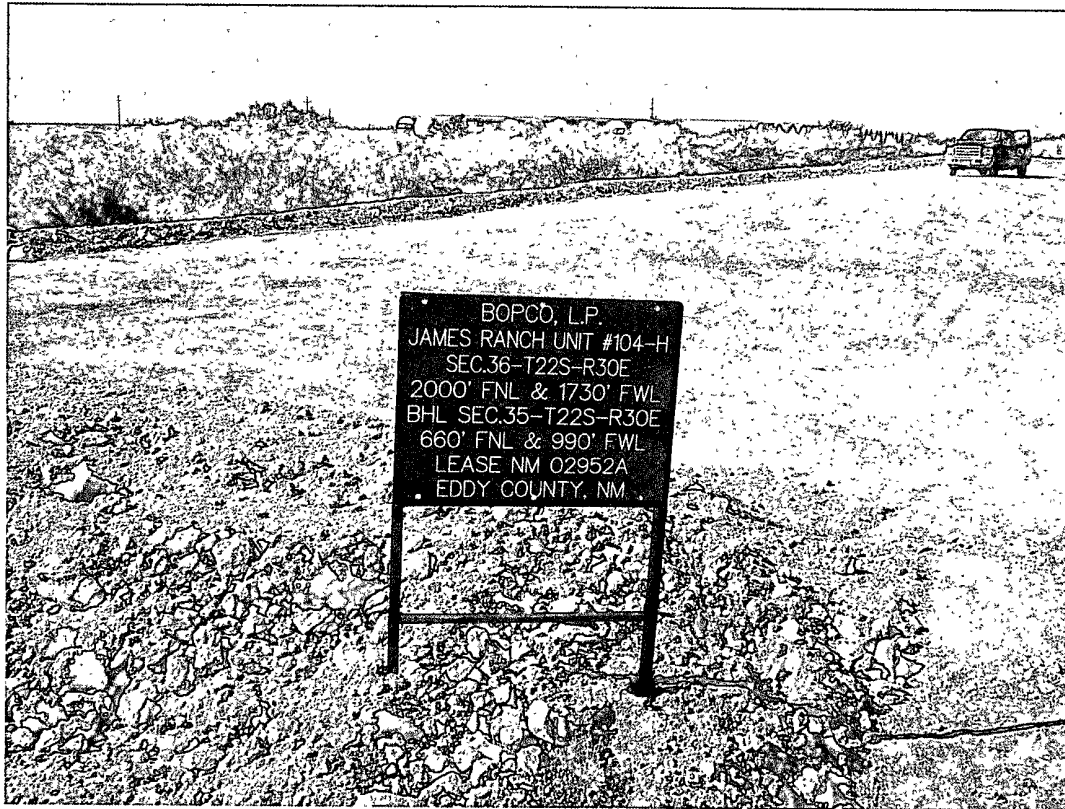
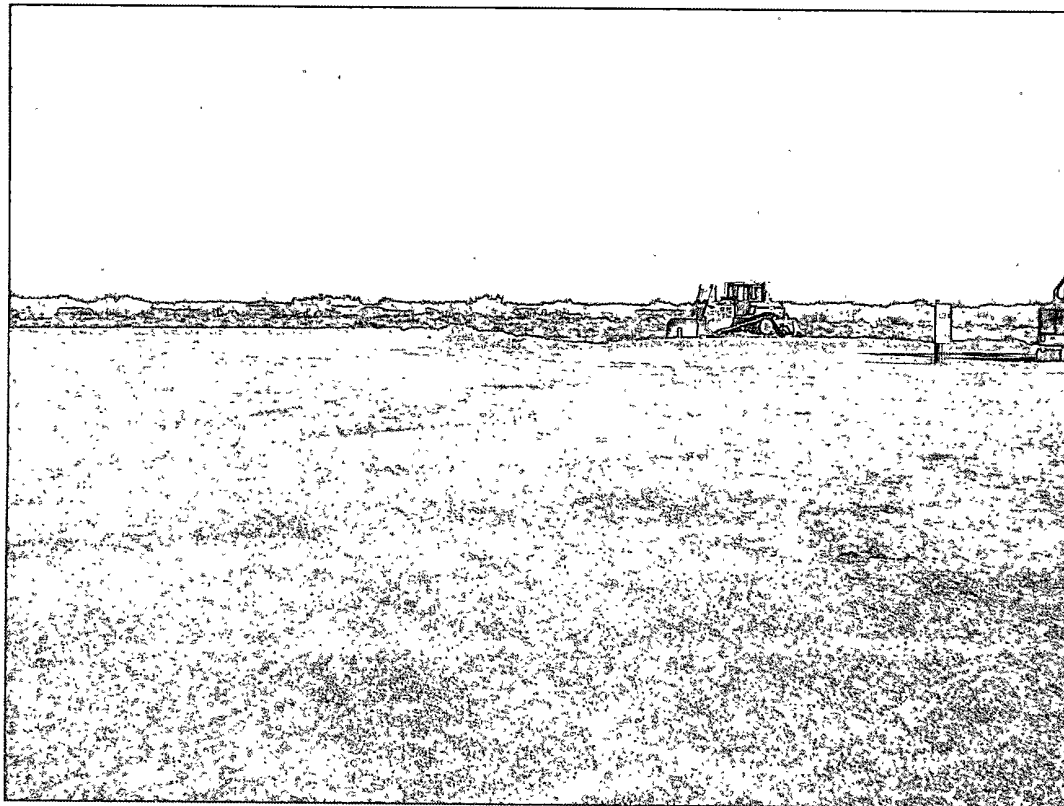
BOPCO, LP – James Ranch Unit #104H
Site Photographs taken October 19, 2009
(p. 1 of 1)

In addition to the laboratory analytical results, please find enclosed photos taken October 19, 2009, at the subject proposed drilling location. Documentation of vegetation present will assist in the future determination that the 70% seed regrowth requirement has been met.
