**RE: Spill Site Closure Reports
Duke Energy Field Services, LP
Lea County, NM**

DEFS REF: C-23-9 012403

Project Summary

1.0 Introduction & Background

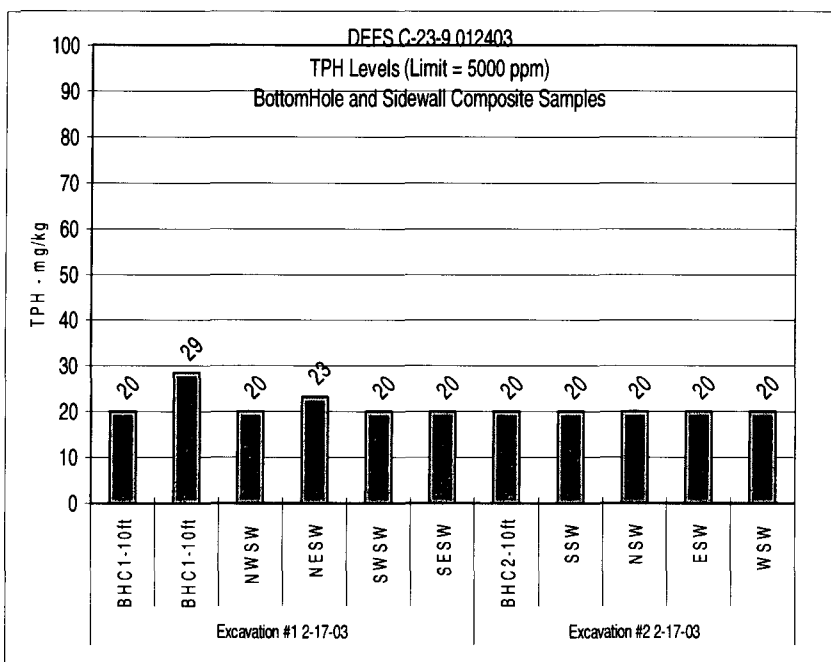
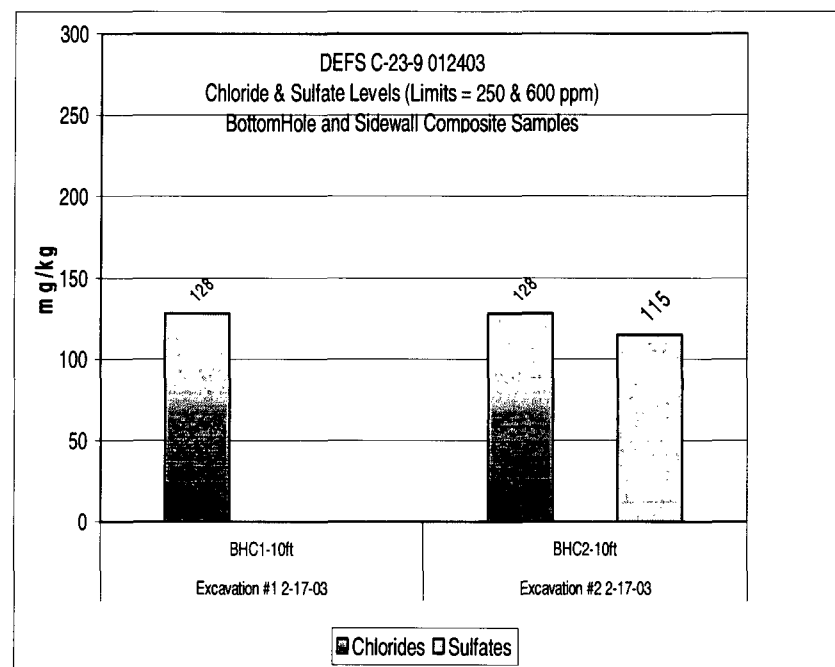
Plate 4: Soil Analytical Data Table and Charts

Duke Energy Field Services - C-23-9 012403 - Excavations 1 & 2 Sampling Results

Bold highlighted cells indicate values in excess of the NMOCD remedial action guideline thresholds: TPH = 5000 mg/Kg; Benzene = 10 mg/Kg; BTEX = 50 mg/Kg; Cl = 250 mg/Kg; SO4 = 600 mg/Kg

The excavations (*#1 and #2 - Plate 3, Attachments*) were composite sampled on February 17-19. Results of the analyses (*Plates 4, Attachments*) indicate that remedial goals have been achieved in all areas of the excavations (*#1 and #2*).

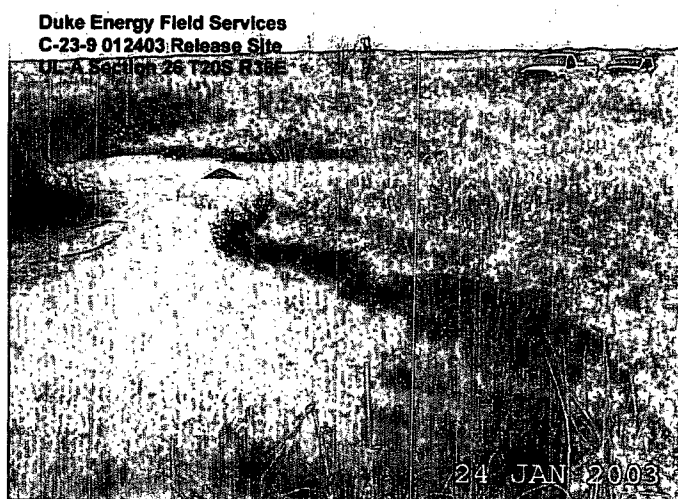
Site #1 Initial Response

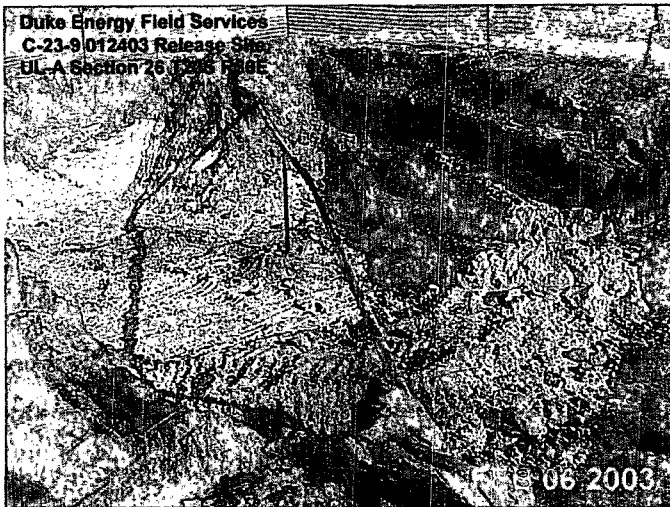
Day 14: Site #1 10-ft excavation

The initial excavation (Site-1) was extended to a depth of 10-ft bgs within the area displaying visual or VOC indications of contamination. On January 31, 2003, a composite bottom-hole soil sample was obtained and analyzed for hydrocarbons and chlorides. At the time the sample was taken, it was noted that the sidewalls of the southern portion of the excavation remained contaminated down to approximately 8-ft, although the bottom of that sidewall appeared clean. The analyses results of the 1-31-03 composite sample indicated that the 10-ft bottom of the excavation was essentially free of hydrocarbon contaminant (29 ppm TPH) and had a chloride level of 128 ppm. The excavation was extended in a southerly direction until the sidewall(s) appeared free of contamination. The bottom-hole (10-ft) and all sidewalls of the Excavation #1 were sampled on February 17, 2003. Lab analyses indicated that this first excavation (#1) was free of contamination.

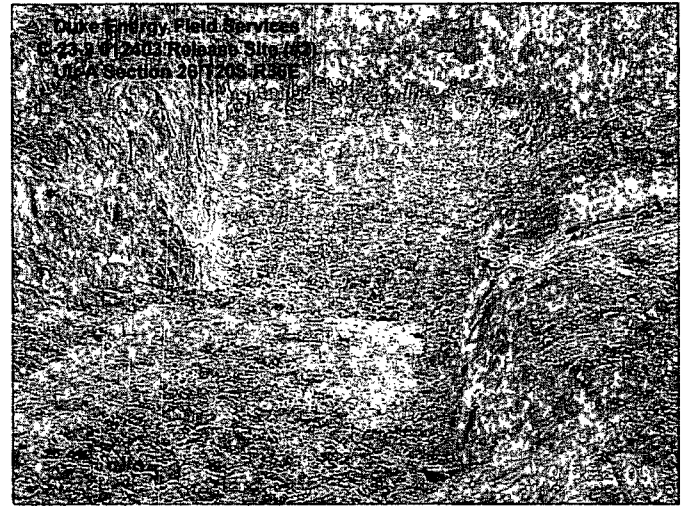
Day 27: Site #2 10-ft excavation

The #2 site, 300-ft northeast of #1, was excavated to 10-ft bgs and sampled (composite bottom-hole and sidewall) on February 19, 2003. Lab analyses of these soil samples indicated that the excavation (#2) was free of contamination. (*Plate 4, Attachments, contains a data table and charts of laboratory results for this project. BTEX and Benzene were never above detection level, thus no charting for these constituents is presented*).

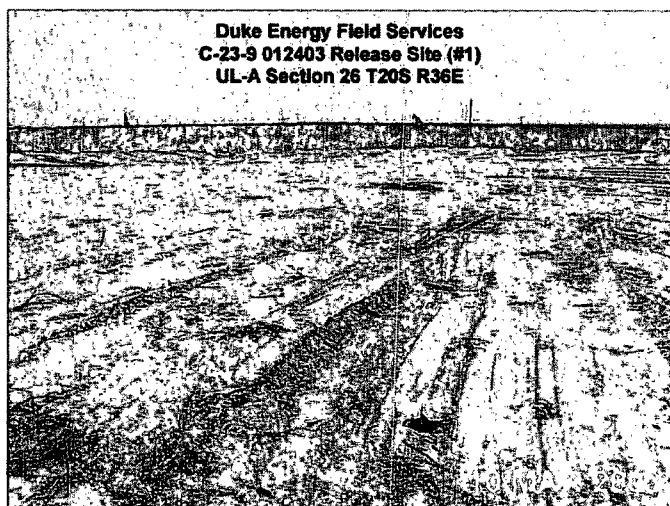
Site #1 Closed; east to west

The excavation was backfilled with clean caliche and topsoil obtained from the property owner. Based on the removal the Constituents of Concern and adequate depth to ground water, there will be no need for further ground water investigation at this site.
