**Clay Cooper #14 Closure Report
Duke Energy Field Services
Lea County, New Mexico**

CLAY COOPER #14 (CC#14)

T20S, R36 E, SECTION 25, UNIT D

Re: Removal of Hydrocarbon-Impacted Soils from the CC #14 site
Township 20 South, Range 36 East, Section 25, Unit D

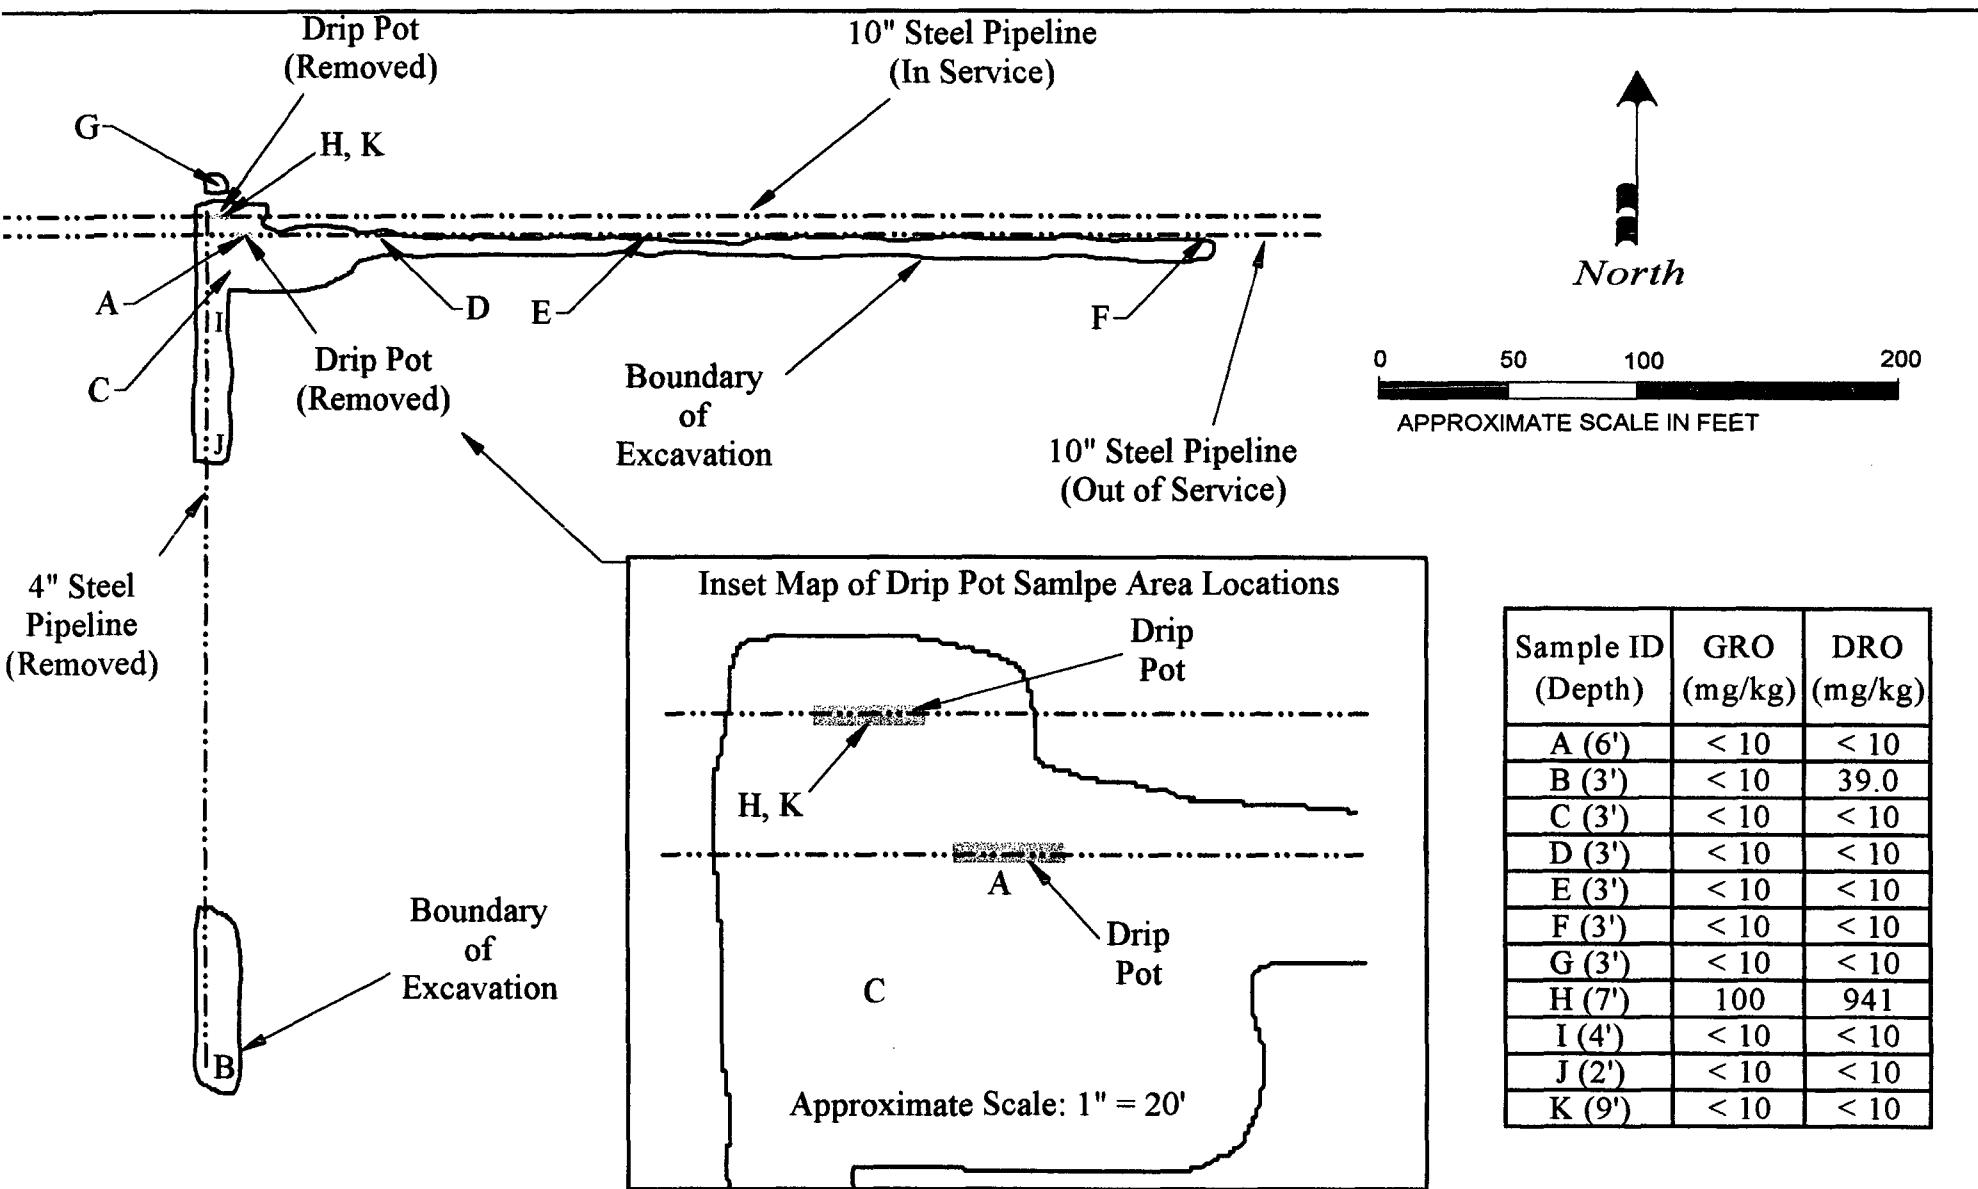
SITE MAP

At the completion of excavation activities all areas had petroleum hydrocarbon concentrations below the OCD standards listed above. Soil sample locations are depicted on the Site Map in Attachment A. A summary of the analytical results and photo documentation are also provided in Attachment A. Laboratory analytical reports, and chain-of-custody documentation for the samples collected are provided in Attachment B. Copies of the field logbook are in Attachment C.

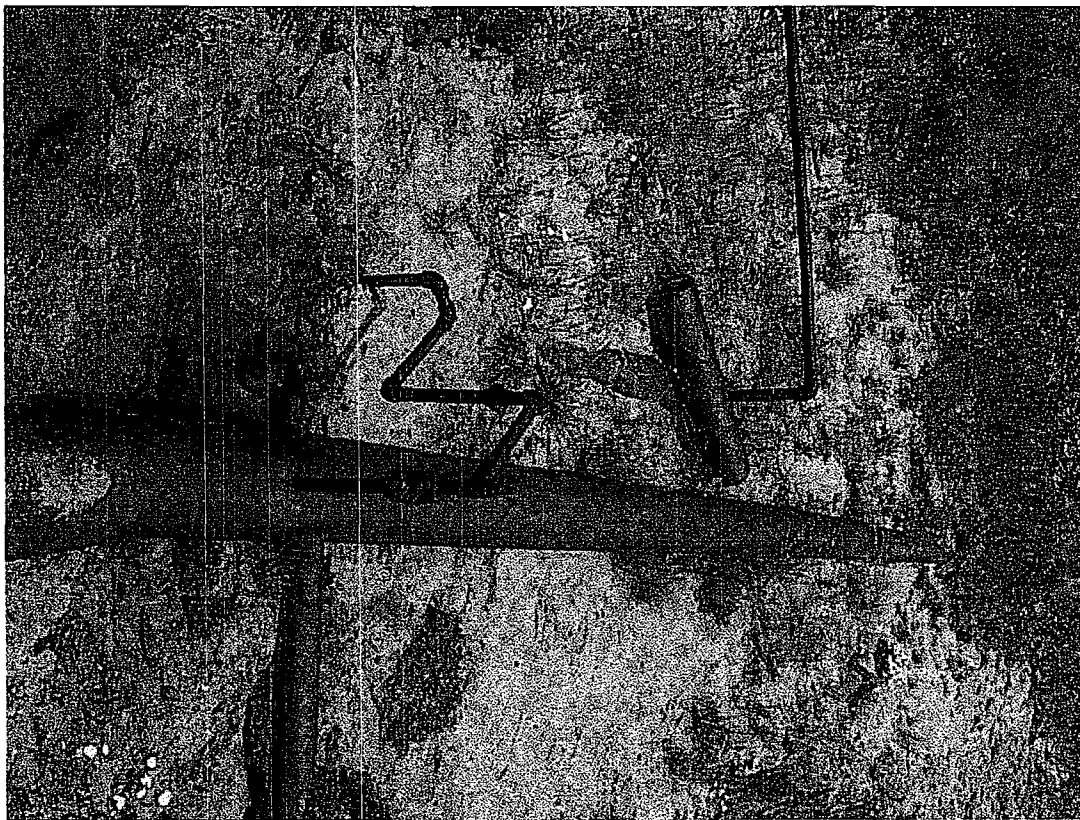
- 1 View showing hydrocarbon-stained soil and drip pot location beneath active pipeline (left center). The 4-inch pipeline is shown at bottom of photo. The drip pot and 4-inch line were removed.

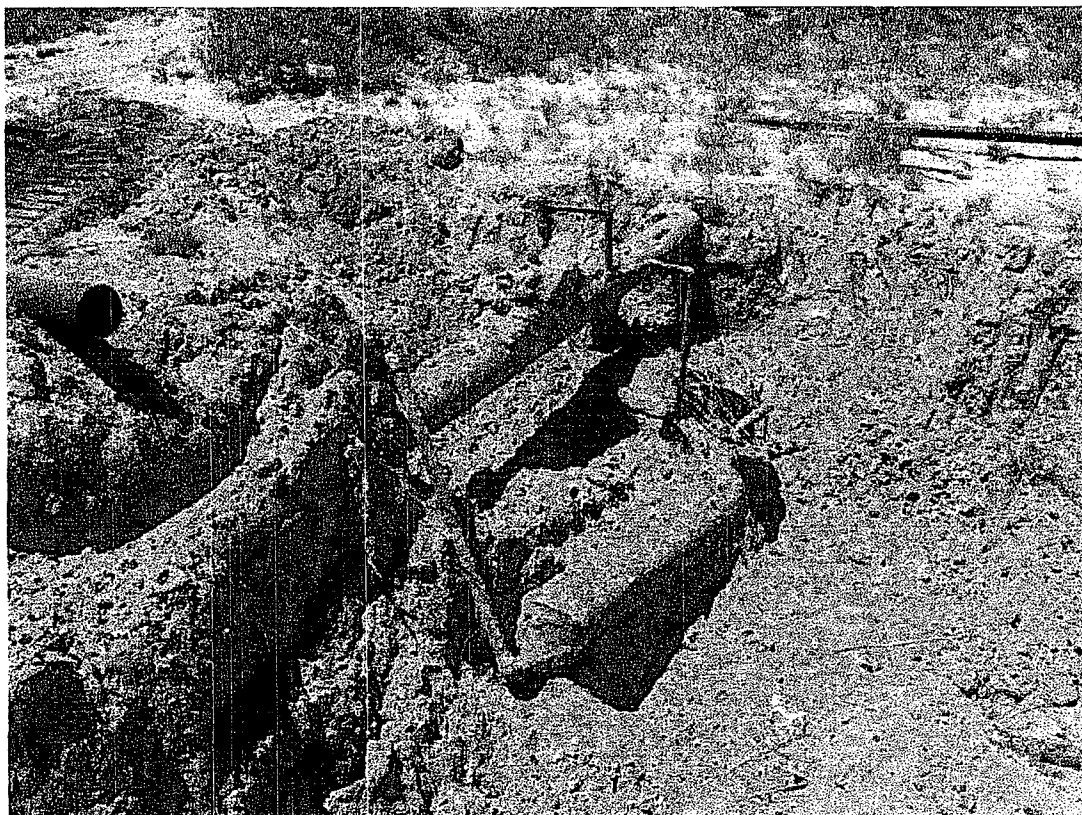
- 2 View facing southwest showing old drip pot beneath out of service pipeline prior to removal and over-excavation activities (07-31-02).

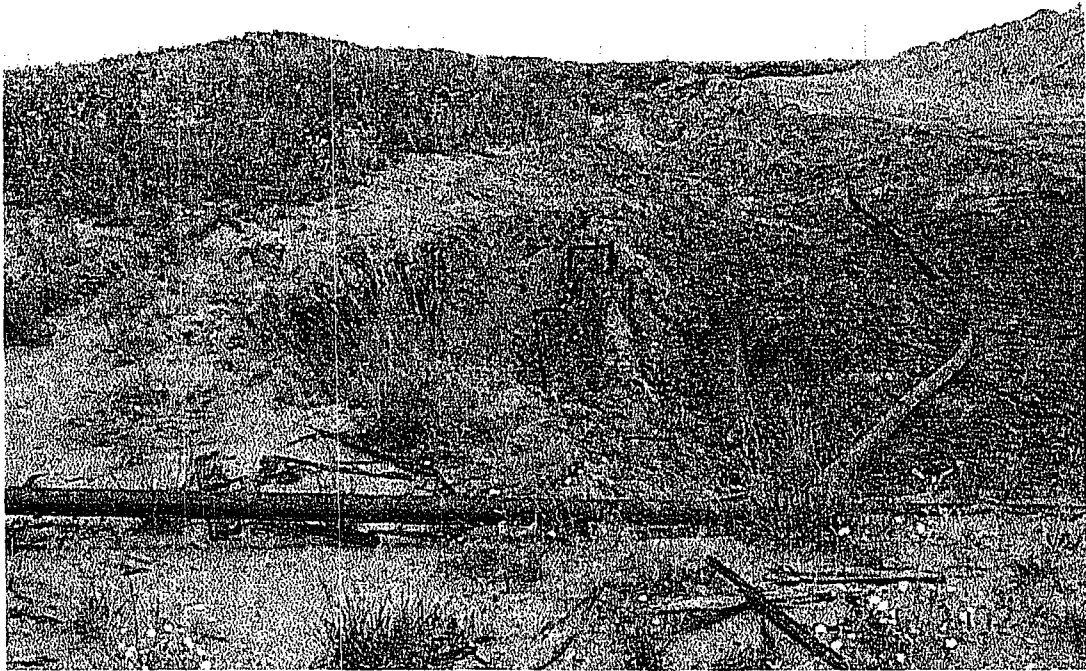
3 View showing early stage of excavation that extends approximately 400 feet east along the 10-inch steel pipeline (out of service). The 10-inch active pipeline (left center) and 4-inch line (foreground) are shown prior to excavation activity beneath them.

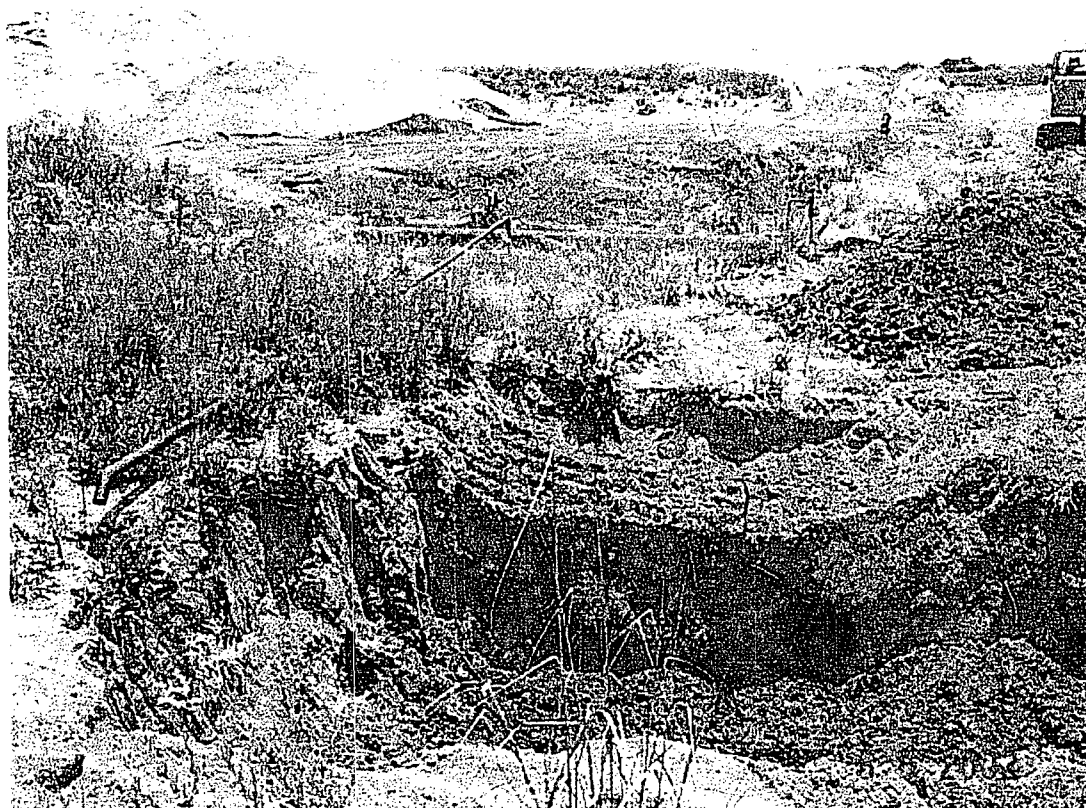
4 View facing south showing excavation beneath blowdown line (foreground) located north of the active pipeline (background).

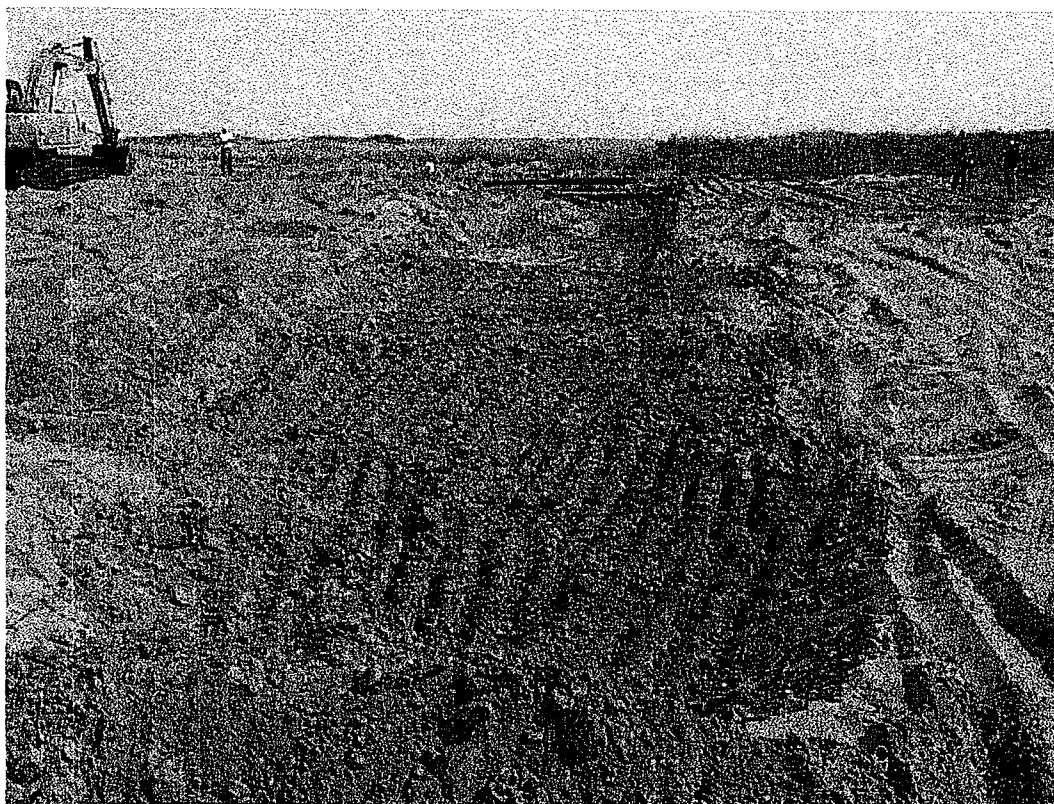
- 5 View facing north showing shallow excavation directly beneath 4-inch pipeline, which was removed. Excavation extends approx. 140 ft. north to both 10-inch pipelines (background).

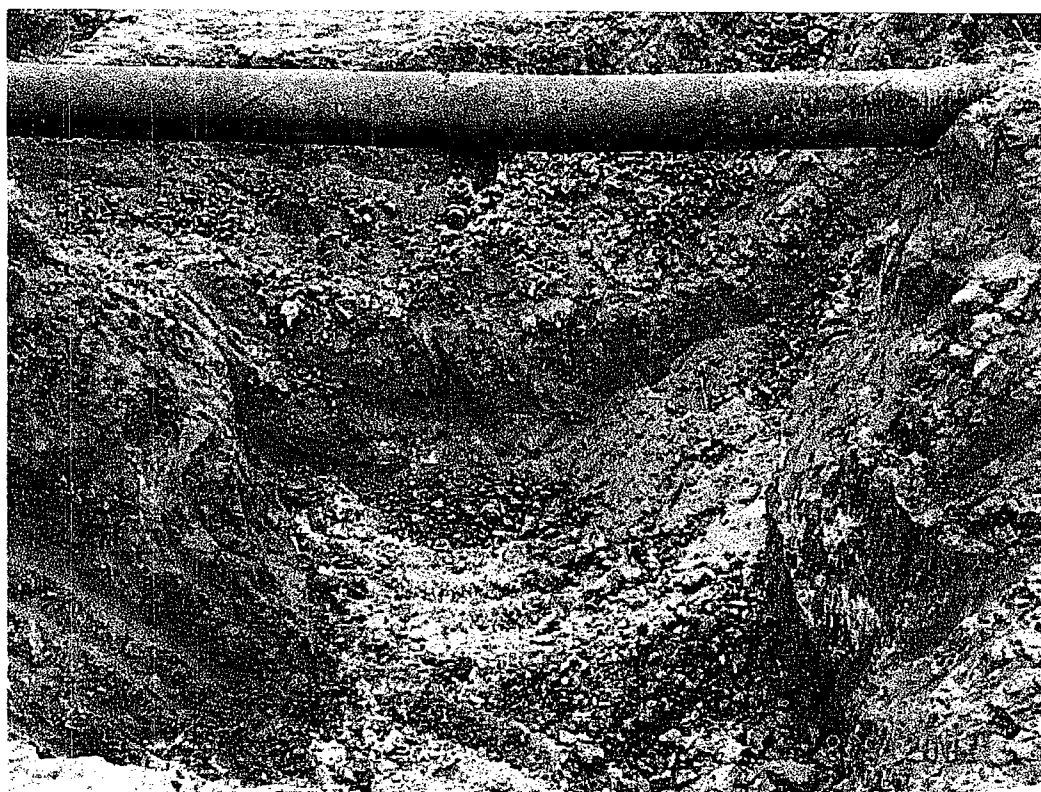
- 6 View showing floor of excavation (9' depth) directly beneath 10-inch steel active pipeline where drip pot was removed at completion of excavation activities.

Note: The area below sample "H" (7' directly below drip pot that was removed from active 10" steel pipeline) was excavated further until concentrations were below OCD guidelines as confirmed by subsequent sample K(9').
