Highlander Environmental Corp.

RE: Assessment and Closure Report for the Spill at the Pogo Producing Company, Secton Tank Battery #1, Section 21, T-23-S, R-37-E, Lea County, New Mexico

Pogo Producing Co./ Secton TB #1

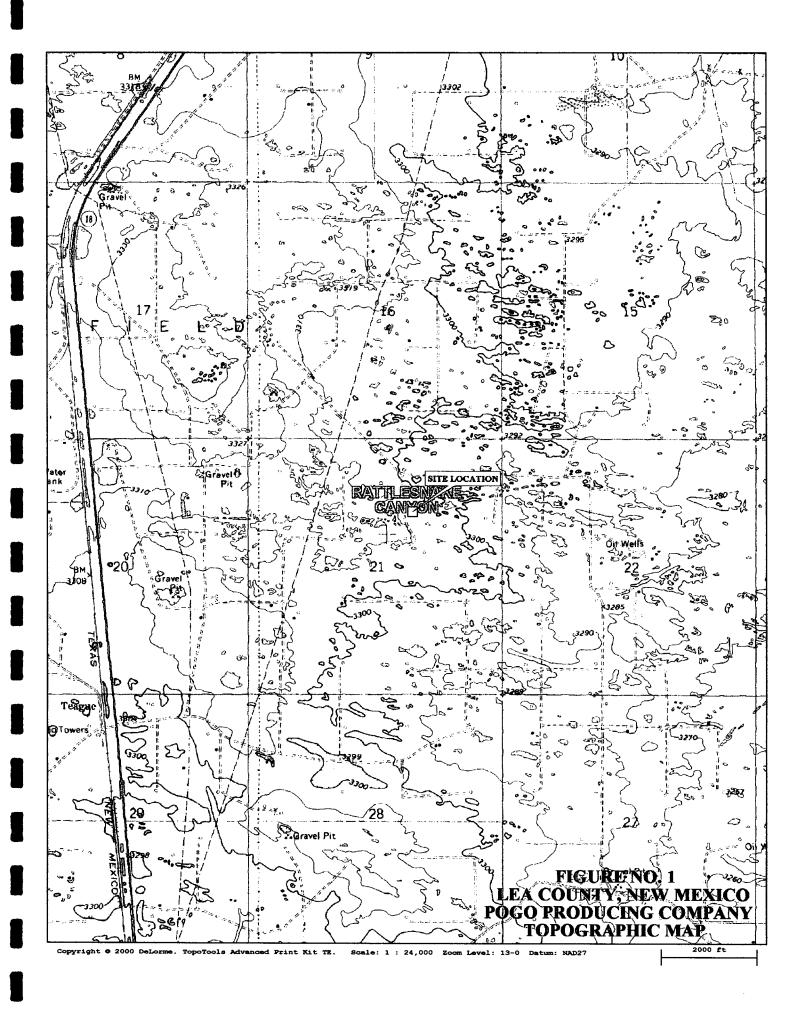
Highlander Environmental Corp. (Highlander) was contacted by Pogo Producing Company (Pogo) to assess a spill, which occurred at the Pogo Seeton Tank Battery #1 location in Lea County, New Mexico (Site). The Site is located in Section 21, Township 23 South, Range 37 East, Unit Letter G. The State of New Mexico C-141 (Initial) is shown in Appendix A. The Site is shown in Figure 1.

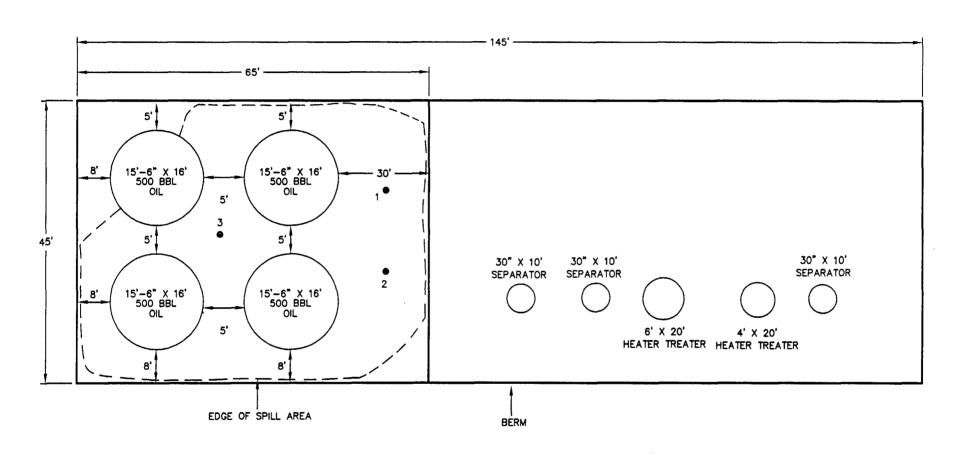
AUGER HOLE LOCATION

On September 23, 2002, a spill occurred when the transfer pump failed and the water tank ran over. The spill area was contained inside the tank battery dike. A small amount of fluids spilled over onto the lease road. The overall dimensions of the spill area measured approximately 45' x 65'. An unknown volume of produced water was released and 60 barrels recovered. The spill area is shown in Figure 2.

On September 24, 2002, Highlander personnel collected soil samples from the spill area using a stainless steel, bucket type hand auger. A total of three (3) auger holes (AH) were installed to define the extent of the impact. All of the auger holes were installed inside the tank battery dike area. The spill area and auger hole locations are shown in Figure 2. Soil samples were collected at selected depth to a total depth of 3.0' below surface. Soil samples collected from the spill area were evaluated for Total Petroleum Hydrocarbon (TPH) by method 8015M, BTEX by method 8015B/5030 and chloride by method SW 846-9252. The soil samples results are shown in Table 1. The laboratory reports and the chain of custody documentation are included in Appendix C.

Based on the results, the impact at the Site appears to be shallow and confined to a depth of 1.0' below surface. The soil samples at 1-2' below surface showed TPH levels decreasing below RRAL, except for AH-3 (1-2'), which showed a total TPH of 1,116 mg/kg. The deeper sample at 2-2.5' dropped to 510 mg/kg. One sample, AH-3 (1'-2'), was selected for an additional BTEX analysis and showed levels below the RRAL. The chloride detected showed a decreasing levels with depth. AH-1 (2'-3'), AH-2 (2'-3') and AH-3 (2'-3') bottom hole samples showed chloride levels 1,560 mg/kg, 886 mg/kg and 408 mg/kg, respectively.

Based upon the results of the sampling, it was decided to begin excavation of the impacted soils inside the bermed tank battery. The small spill area on the lease road was scraped and back dragged with the backhoe. From October 15 to 17, 2002, Key Energy Services excavated the impacted soil from the tank battery and hauled the soil to Sundance Services, Inc. in Eunice, New Mexico. The soil was excavated by hand to a depth 1.0' below surface. Approximately 108 cubic yards was removed and disposed of at Sundance. The excavated area is shown in Figure 2.

On October 24, 2002, Highlander personnel applied a treatment of Micro-Blaze to the bottom of the excavation to remediate and aid in the degradation of any hydrocarbon residue inside the tank battery dike. The excavation had been backfilled with clean fill material.
