SITE INVESTIGATION, REMEDIATION, AND FINAL C-141 CLOSURE DOCUMENTATION

G-28 LOOP-2 RELEASE SITE

DEFS REF: G-28 LOOP-2 112002

LEA COUNTY, NEW MEXICO

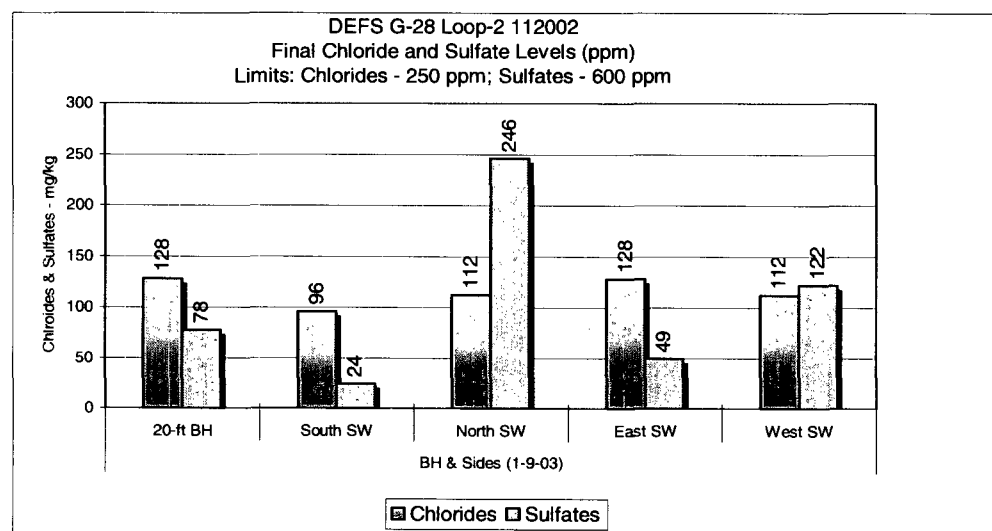
Plate 5: Soil Analytical Data Bar Charts

The projected depth to ground water at this site is 165-ft bgs. Excavation of the site was to a maximum depth of 20-ft. Final CoC levels of the bottom-hole of the excavation were confirmed to be below detection levels for Benzene and BTEX. The TPH concentrations in the 20-ft bottom-hole and in the north, south and east sidewalls were all <100 ppm. The west sidewall retained a TPH

concentration of 275 ppm, still considerably less than the 5000 ppm remedial goal (*Plates 5 and 6, Attachments*). Chlorides and sulfates were below the respective 250 mg/kg and 600 mg/kg ground water standards throughout the site.

The excavations (POR and/or Flow Path) were composite sampled (bottom-hole and sidewalls) on December 10, 2002 and January 9, 2003. Results of the analyses (*Plates 5 and 6, Attachments*) indicate that remedial goals have been achieved in all areas of the excavation.

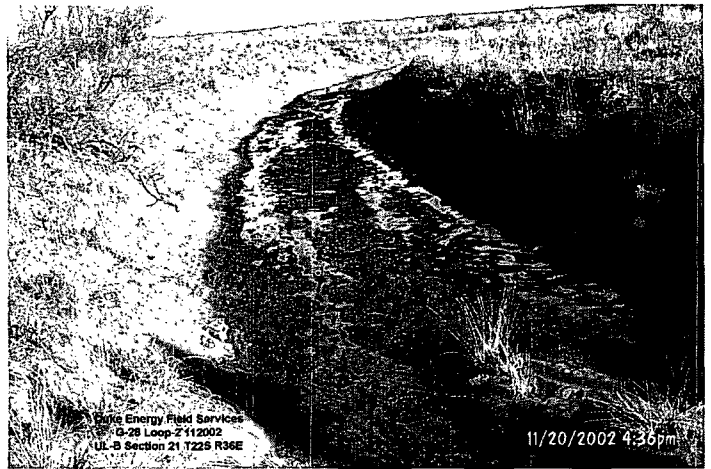
Initial Response: east extent of flow path, W to E

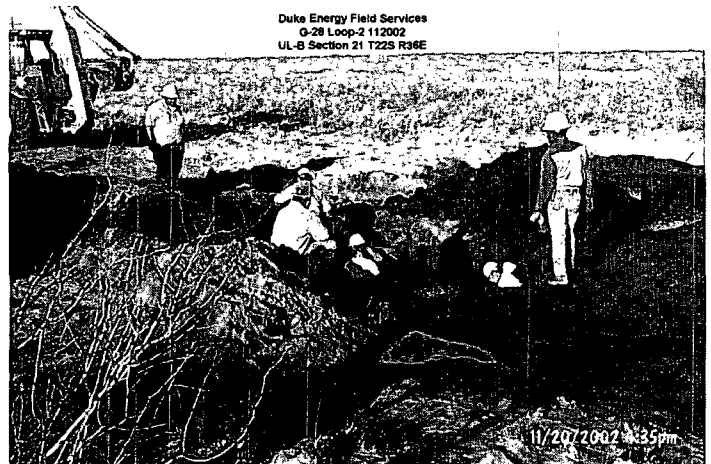
The natural gas and associated NGL release at this site was discovered and reported on November 20, 2002. The Initial NMOCD C-141 Form was submitted on November 22, 2002. The leak was the result of internal pipe corrosion. The pipeline was clamped and eventually replaced by DEFS personnel.

Initial Response: Clamping POR

Corroded pipeline, initially repaired with clamp then section replaced
