Rhombus Operating Company Northwest Eumont Unit Section 27 & 34, T-19-S R-36-E

Closure Report

RHOMBUS OPERATING NORTHWEST EUMONT UNIT SECTION 34 T19S R36E & SECTION 27 T19S R36E

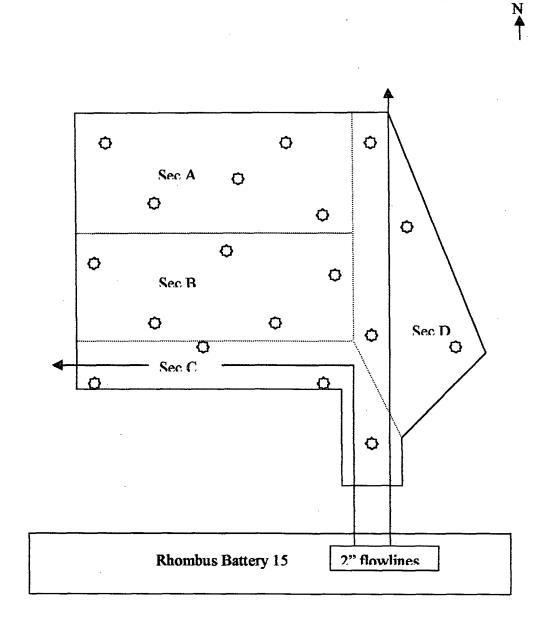
Rhombus Operating Northwest Eumont Unit Site One: Sample Map

- Site One: Approximate size 90' X 100' X 3' (area inside site one; 35' X 20' X 4') The excavated area on this site was sloped from surface to bottom hole, thereby negating the need for sidewall samples. All analytical and maps are indexed in the appendix.

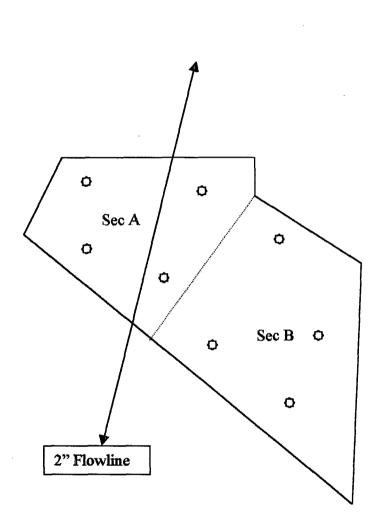
Rhombus Operating Co. Northwest Eumont Unit Site Two: Sample Map

- Site Two: Approximate size 45' X 75' X 4' The excavated area of this site was sloped from surface to bottom hole, thereby negating the need for sidewall samples. All analytical and maps are indexed in the appendix.

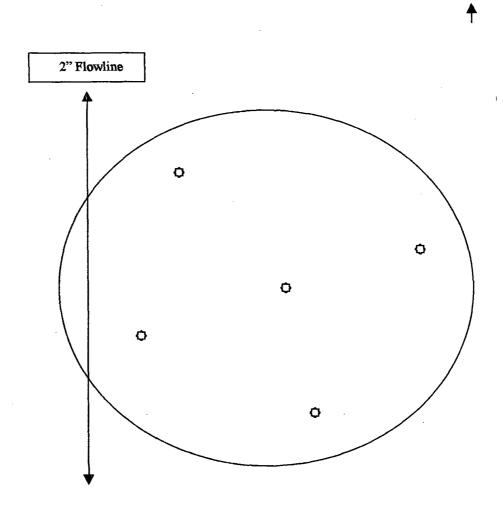
- Site Three: Approximate size 18' X 24' X 4.5' The excavated area for this site was sloped from surface to bottom hole, thereby negating the need for sidewall samples. Based on the site assessment, this site was excavated for chloride contamination only. All analytical and maps are indexed in the appendix.

Approximate Size – 50' N/S X 45' E/W Approximate Depth - Sec A = 3', Sec B = 2' Composite Sample Locations – \bigcirc Rhombus Operating Co. Northwest Eumont Unit Site Three: Sample Map

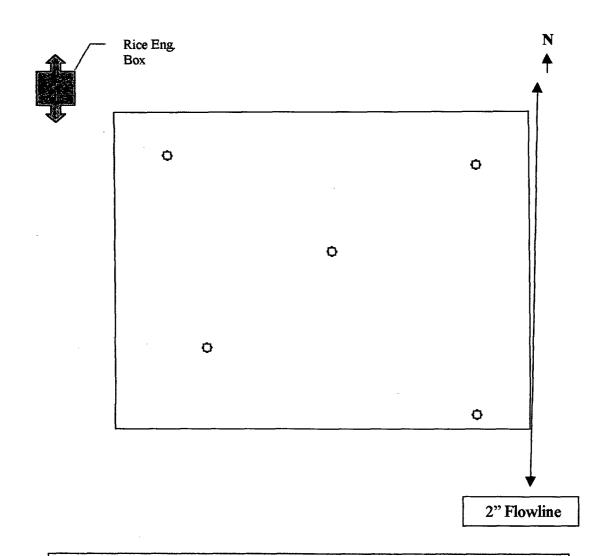
Rhombus Operating Co. Northwest Eumont Unit Sit Four: Sample Map

- Site Four: Approximate size 40° X 50° X 4.5° The excavated area for this site was sloped from surface to bottom hole, thereby negating the need for sidewall samples. All analytical and maps are indexed in the appendix.

Legend

Approximate Size - 43' N/S X 36' E/W

Approximate Depth - 2' 6"

Composite Sample Locations - O
