**INVESTIGATION & CHARACTERIZATION PLAN
– AMENDMENT**

BD A-27 Release Site
T22S, R37E, Section 27, Unit Letter A
Lea County, New Mexico

RE: **INVESTIGATION & CHARACTERIZATION PLAN - AMENDMENT**
BD A-27 Release Site
T22S-R37E-Section 27, Unit Letter A

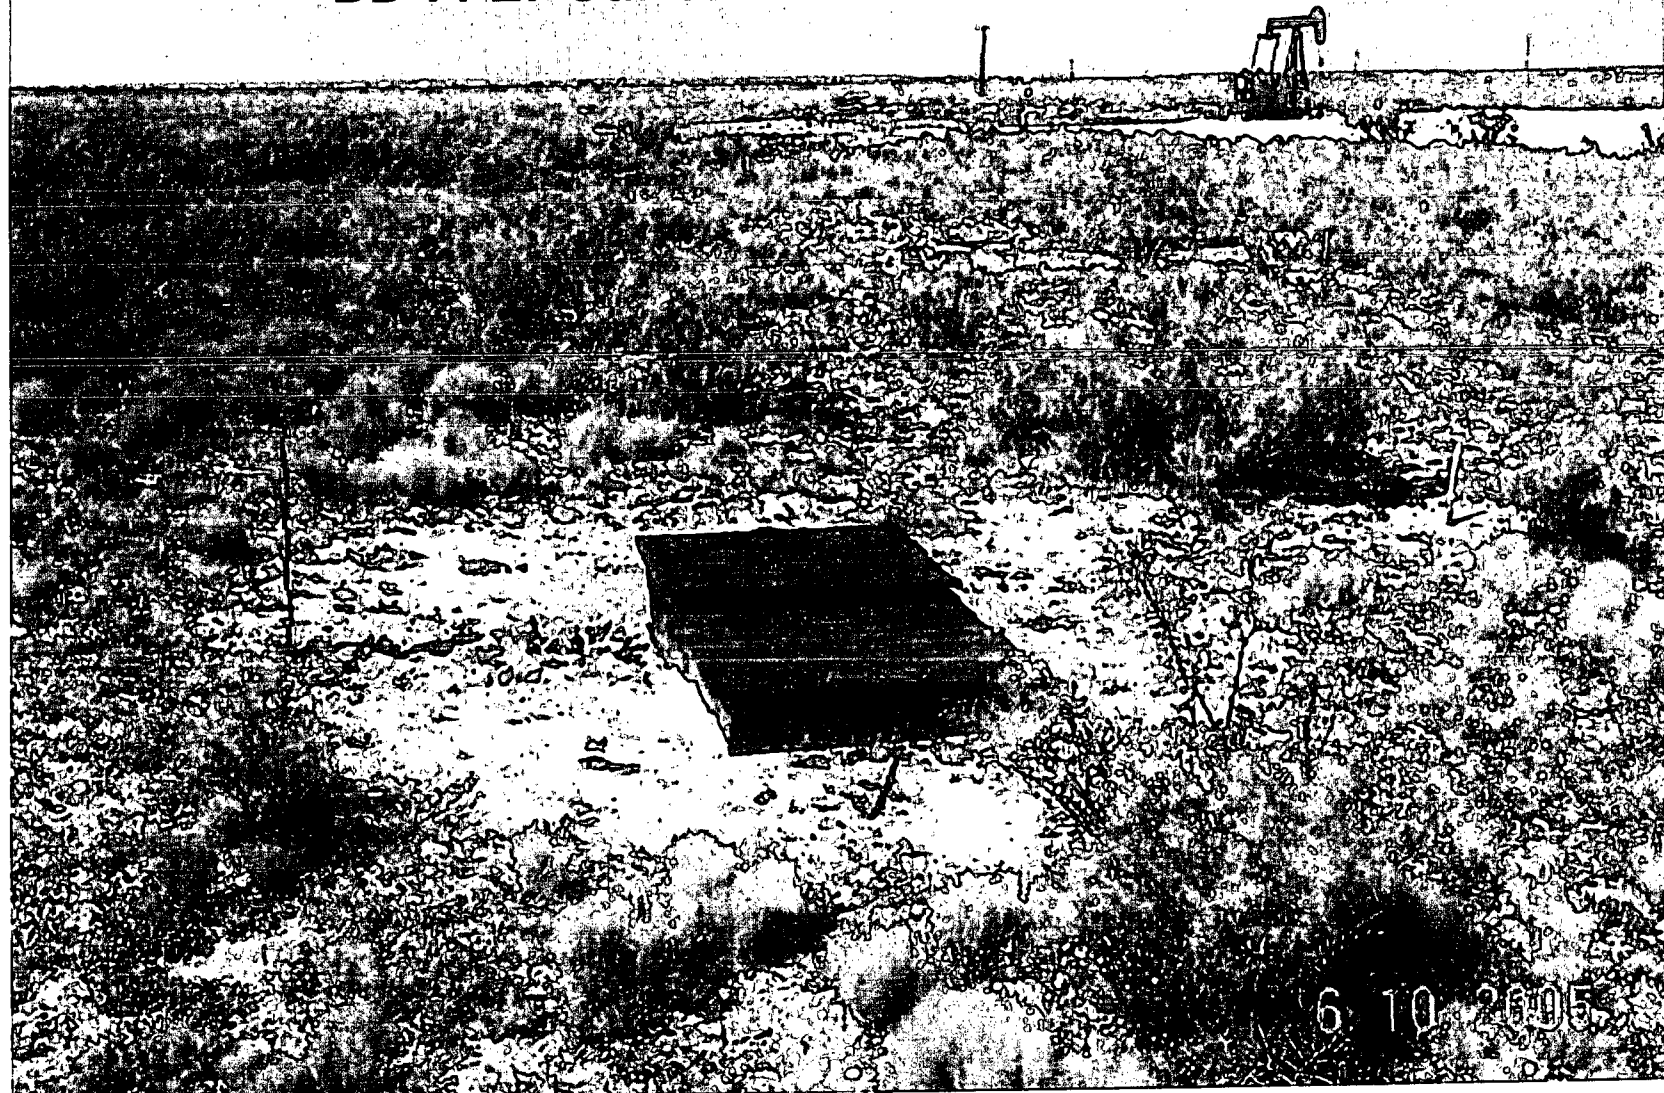
View facing northeast showing
BD A-27 Junction Box Release Site

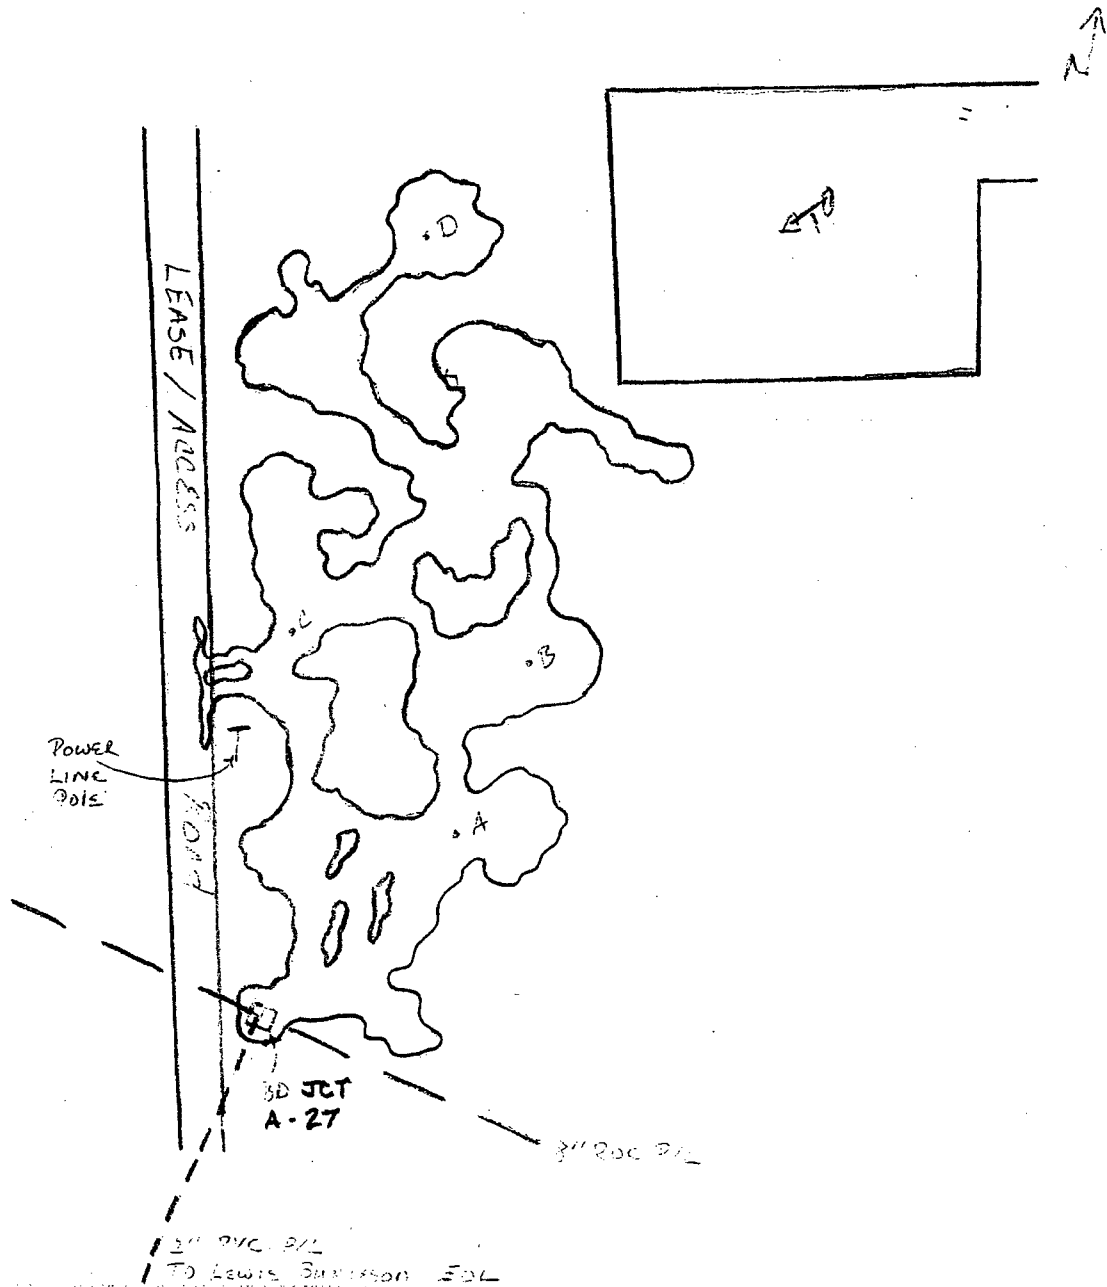
CAUSE OF LEAK

Discribe cause of problem & how it was repaired. Operator Running Heater treater @ to High temp.
swelled PVC & Pushed couplers out, old PVC Removed & Replaced w/ Sch 40 PVC
PIPE & Coupler

Rice Operating Company (ROC) wishes to notify NMOCD of the actions implemented on the above-mentioned release site. On January 27, 2005, the site located in the BD SWD System experienced an accidental discharge of produced water. High temperature in the 2-inch pvc line coming from the Santa Rita Battery's heater, cause the line to swell and separate from its fittings. The line and fittings were replaced as a permanent repair.
