# SITE INVESTIGATION, REMEDiation AND FINAL C-141 CLOSURE DOCUMENTATION

O-LINE RELEASE SITE  
DEFS REF: 130003

LEA COUNTY, NEW MEXICO

OCTOBER 12, 2004

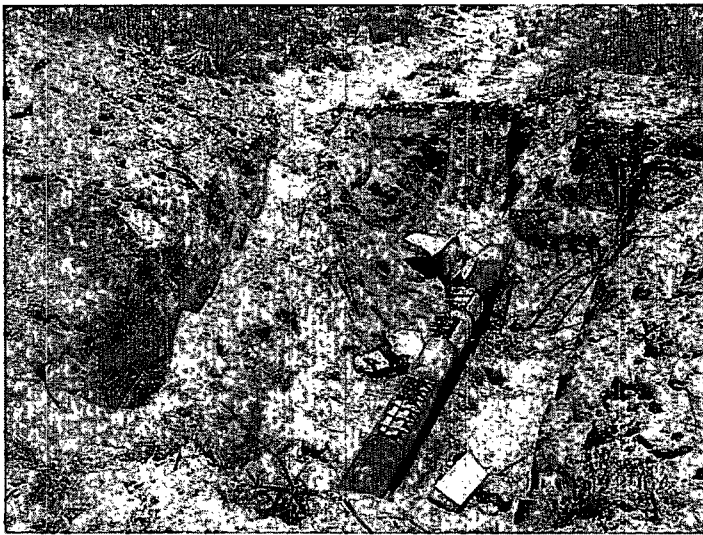
Photo #1: Release area, looking easterly along the pipeline.  
Notice soil staining in bottom of excavation.

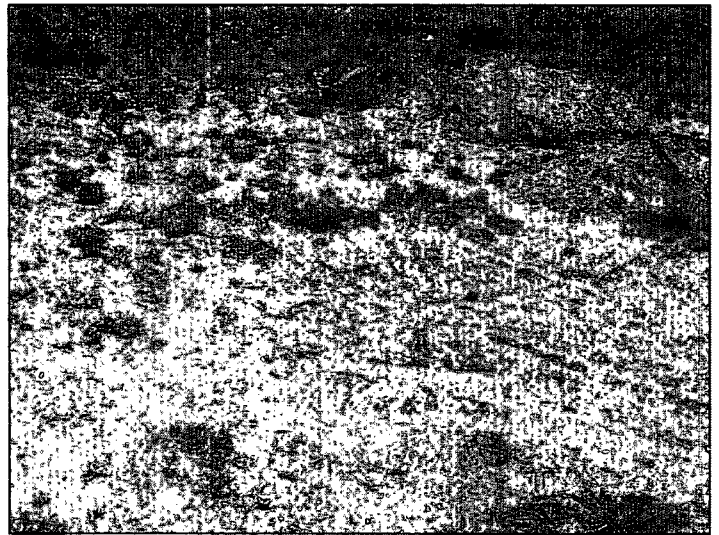
Photo #2: Release area, looking northerly. Notice soil staining in central portion of the photograph.

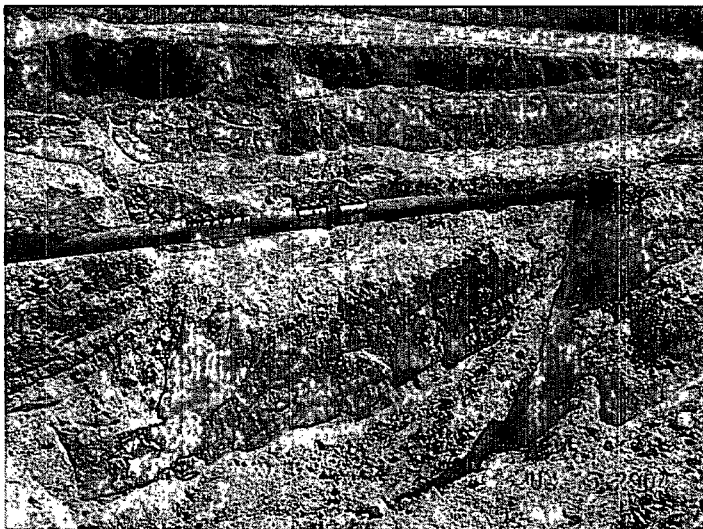
Photo #3: Excavation, looking northerly.

Remediation of the site commenced on June 4, 2004 and continued through June 16, 2004. Remedial activities at the site consisted of excavation and blending of 1,500 yd<sup>3</sup> of NGL contaminated soil from the site. The contaminated soil was blended with clean soil to below NMOCD remedial thresholds obtained from the right-of-way and verified via laboratory analyses of samples SDEOL61004BC 0-50 and SDEOL61004 50-100 (*reference Table 1 and Appendix 1*). After field analyses of soil samples collected from the sidewalls and base of the excavation indicated remedial goals had been achieved, the excavation was backfilled with the blended soil. The backfilling and contouring of the site was completed on June 16, 2004.

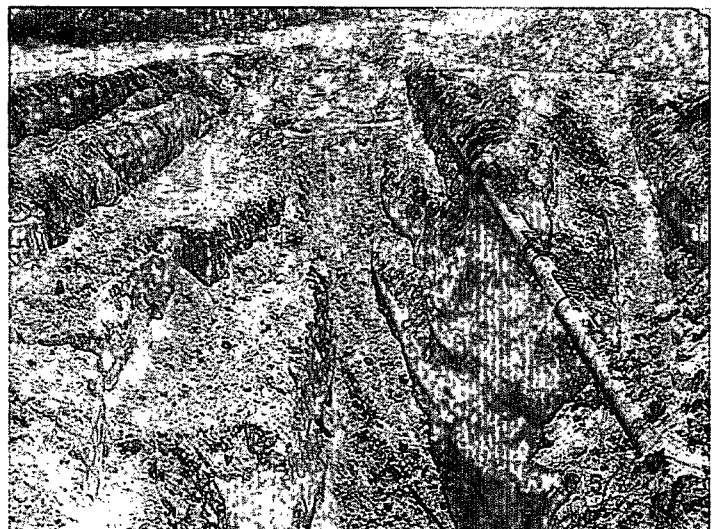
Photo #4: Excavation, looking easterly.
