## CLOSURE REPORT

### WORK PLAN IMPLEMENTATION/ REMEDIATION/DECOMMISSIONING DOCUMENTATION

FOR THE  
CENTRAL DRINKARD UNIT TRACT #3 BATTERY

UL-F, SE¼ NW¼, Section 33  
R37E T21S  
Lea County, New Mexico  
Elevation - 3,462' amsl  
Latitude 32° 26' 19.7"N - Longitude 103° 10' 19.0"W

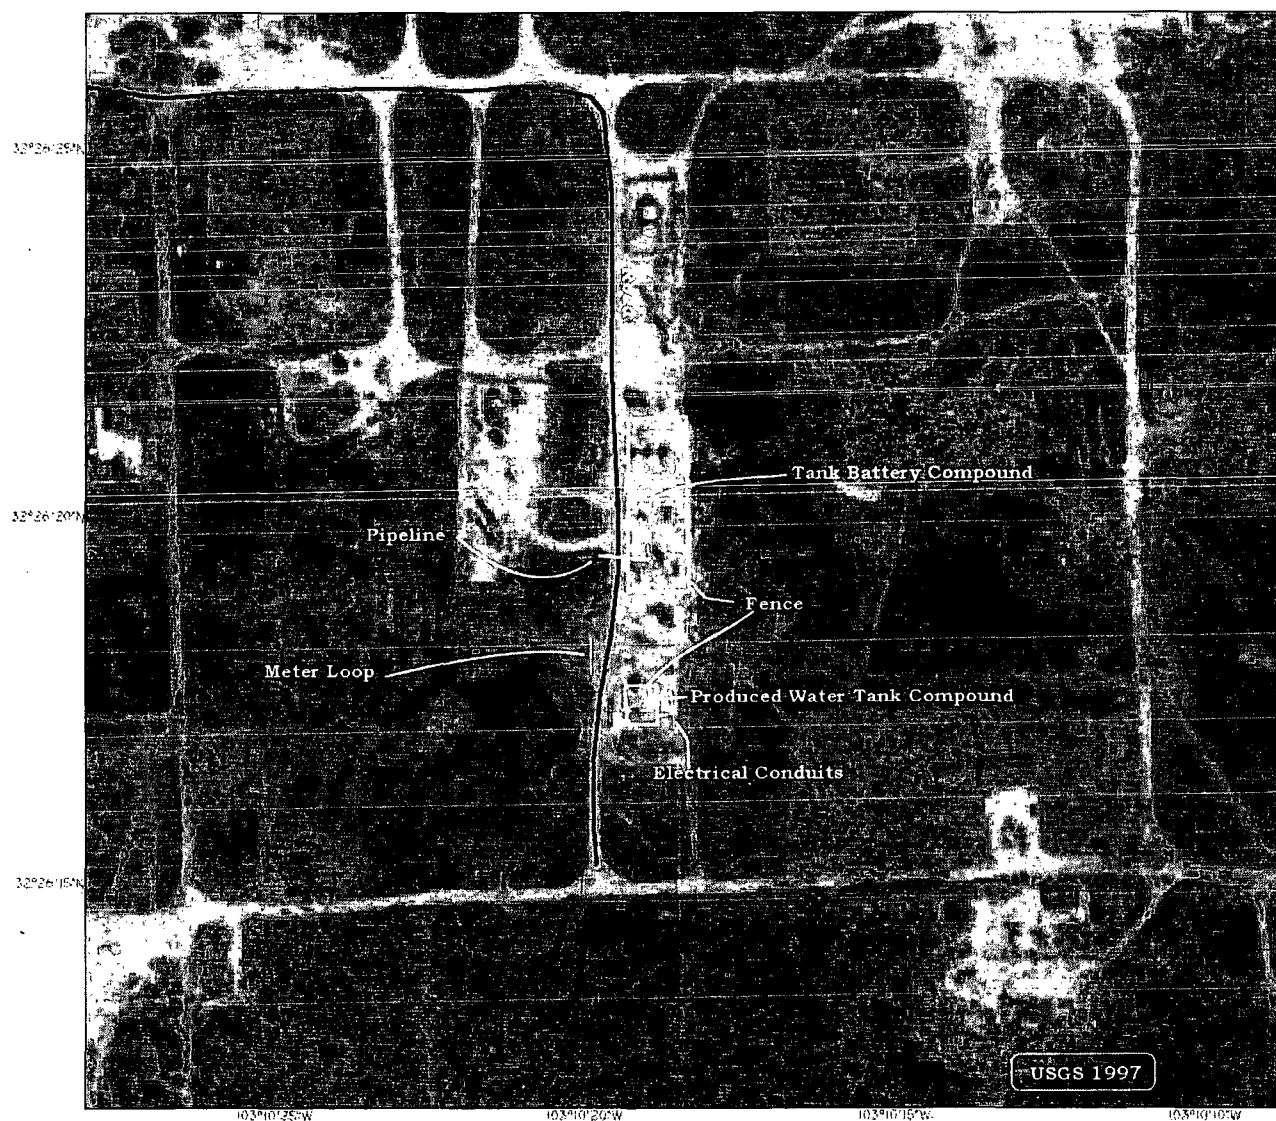
CHEVRONTExACO  
CENTRAL  
DRINKARD UNIT  
TRACT #3  
UL-F SEC 33  
T2IS R37E  
TANK BATTERY  
COMPOUND AREA  
~19,432 SQFT  
WATER TANK  
COMPOUND AREA  
~2,344 SQFT

The site is located 0.2 miles, east of Eunice, New Mexico in an area of several small ranchettes consisting of family dwellings and livestock pens. A site map is included as Attachment I.

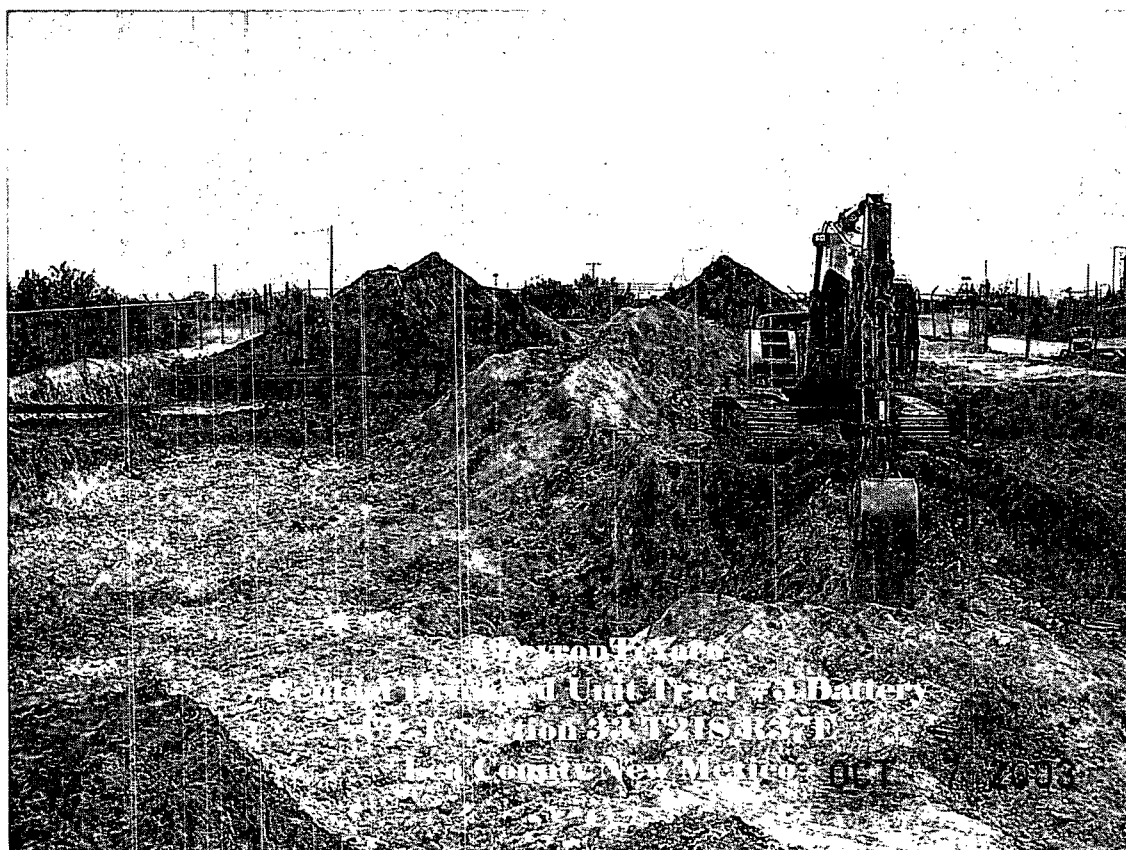
**ChevronTexaco  
Central Drinkard Unit Tract #3 Battery  
UL-F Section 33 T21S R37E  
Lea County New Mexico OCT 10 2013**
