**ChevronTexaco
Remediation/Cleanup
Coleman/Grimes Battery
Section 33, Township 18S, Range 38E
Lea County, New Mexico**

October 1, 2002

***Safety & Environmental Solutions, Inc.
703 E. Clinton Suite 103
Hobbs, New Mexico 88240
(505) 397-0510***

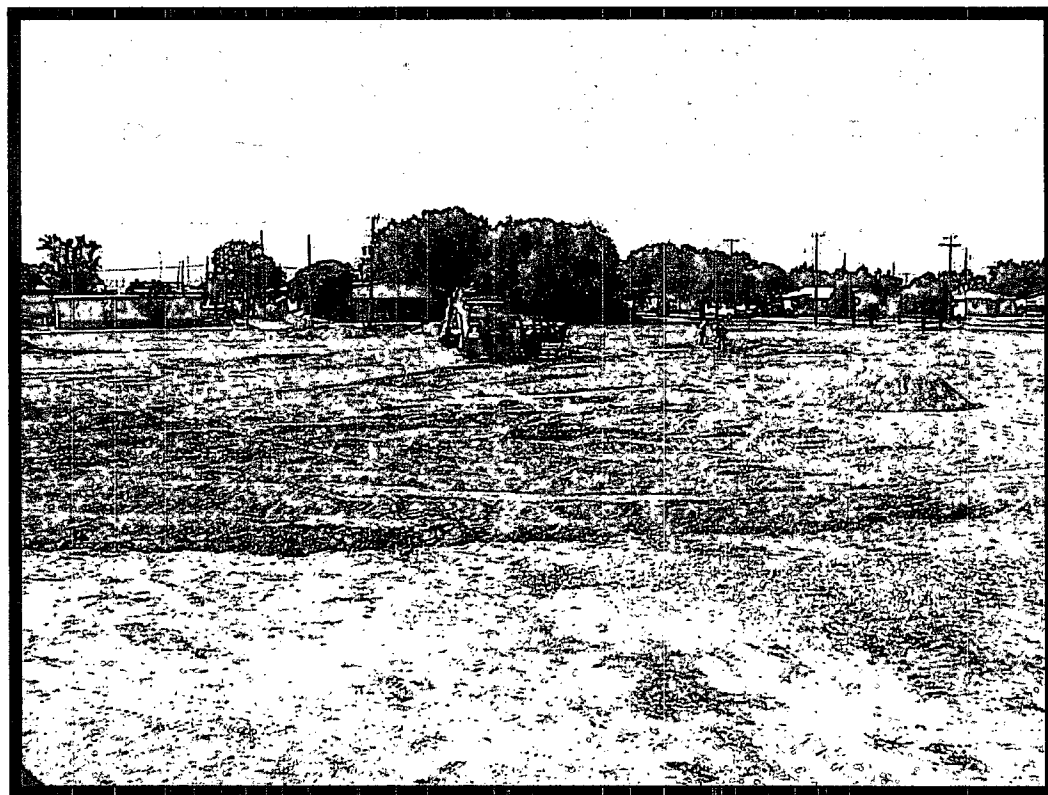
Site Facing South - During Excavation

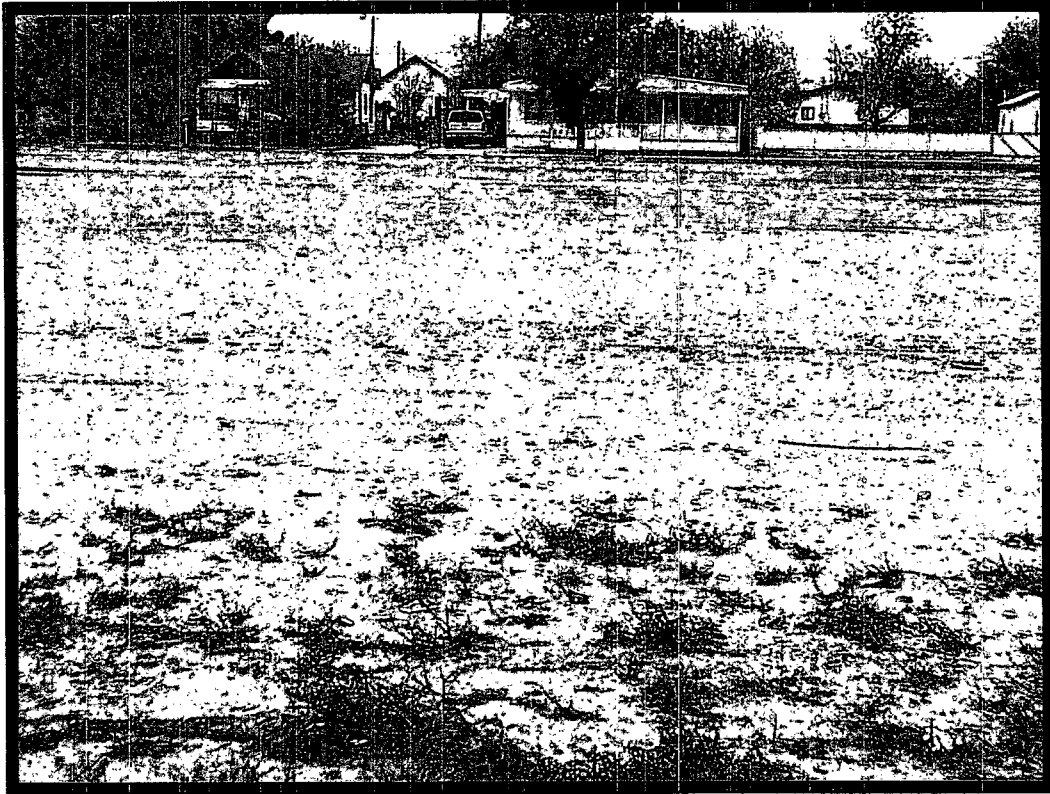
Completed Project Facing West

A suitable soil was located and backfilled into the excavation. Approximately 940 cubic yards of backfill material was replaced in the excavation and the site was returned to the original grade. The backfill operation was completed on September 20, 2002.

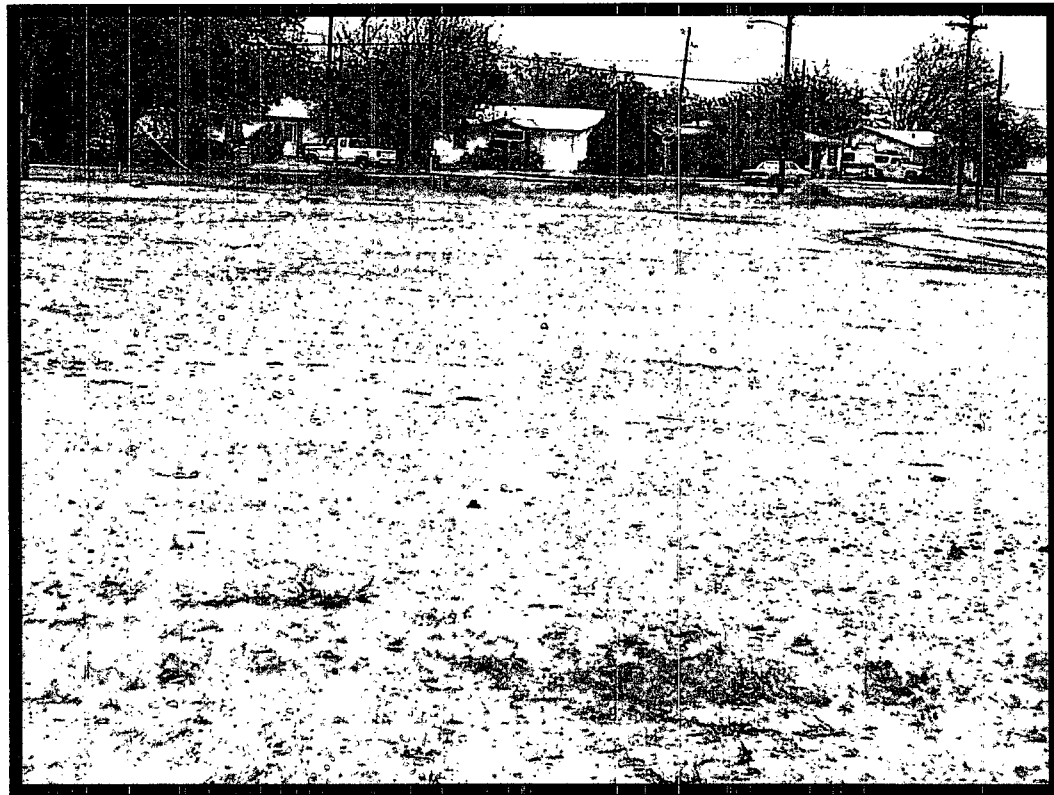
Completed Project Facing South West

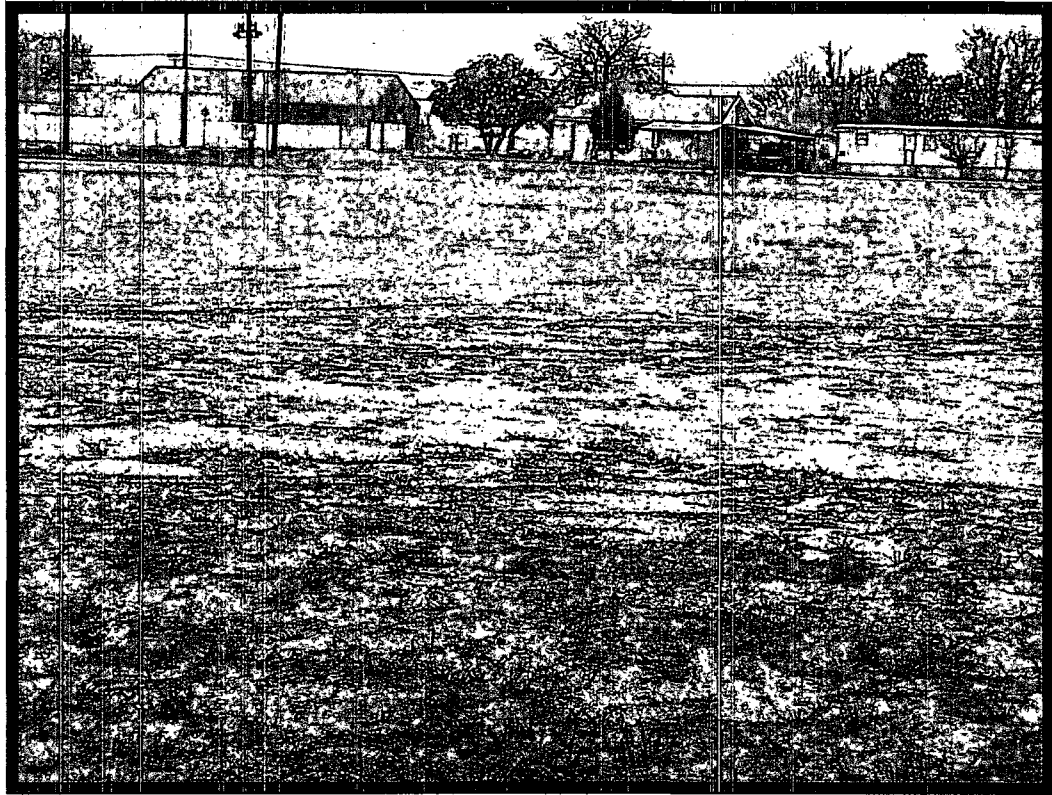
Completed Project Facing South

On September 24, 2002, the site was prepared and seeded with Bermuda seed and watered. The site was watered again on September 27, and October 1, 2002.
