PROJECT PLAN (PIP)
&
SITE INVESTIGATION REPORT

for the
Production Fluid Release
associated with the

SAN ANDRES UNIT
~~WELL #31 TRUNKLINE~~

December 2002

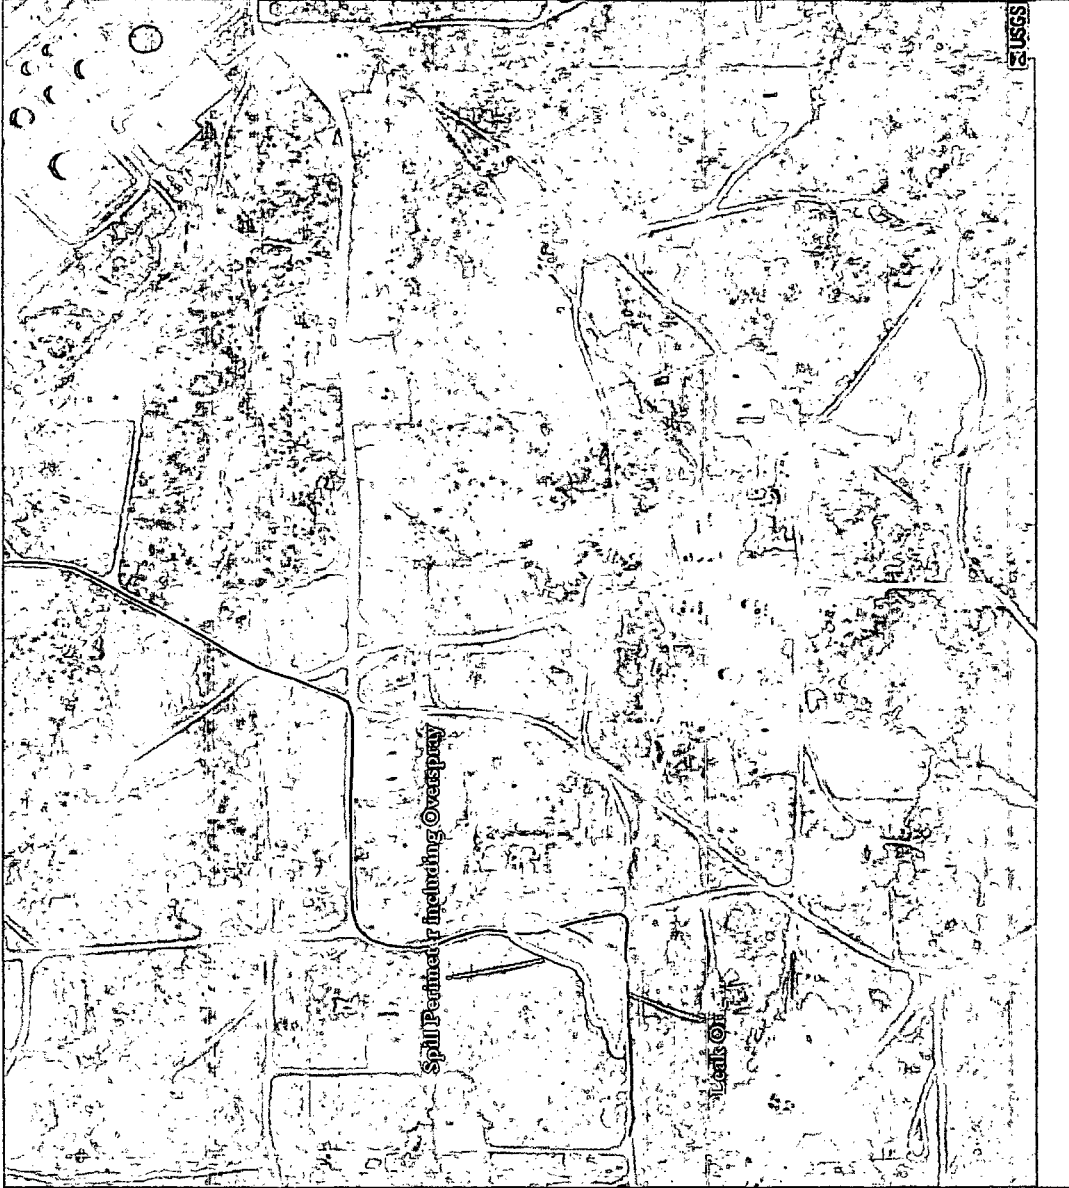
PURE RESOURCES
 SAN ANDRES
 #31
 UL-C SEC I
 T17S R36E
 ESTIMATED
 AFFECTED AREA
 ~70,247 SQFT

Soil samples were collected at 5 strategically located locations within the spill pooling areas and overspray area. The sample locations are noted on the site map included in Attachment I.
