**PRELIMINARY SITE INVESTIGATION REPORT  
AND  
REMEDIAL WORK PLAN**

**Devon Energy  
Patsy #1  
Tank Battery  
Lea County, New Mexico**

ETGI Project # DE 2101

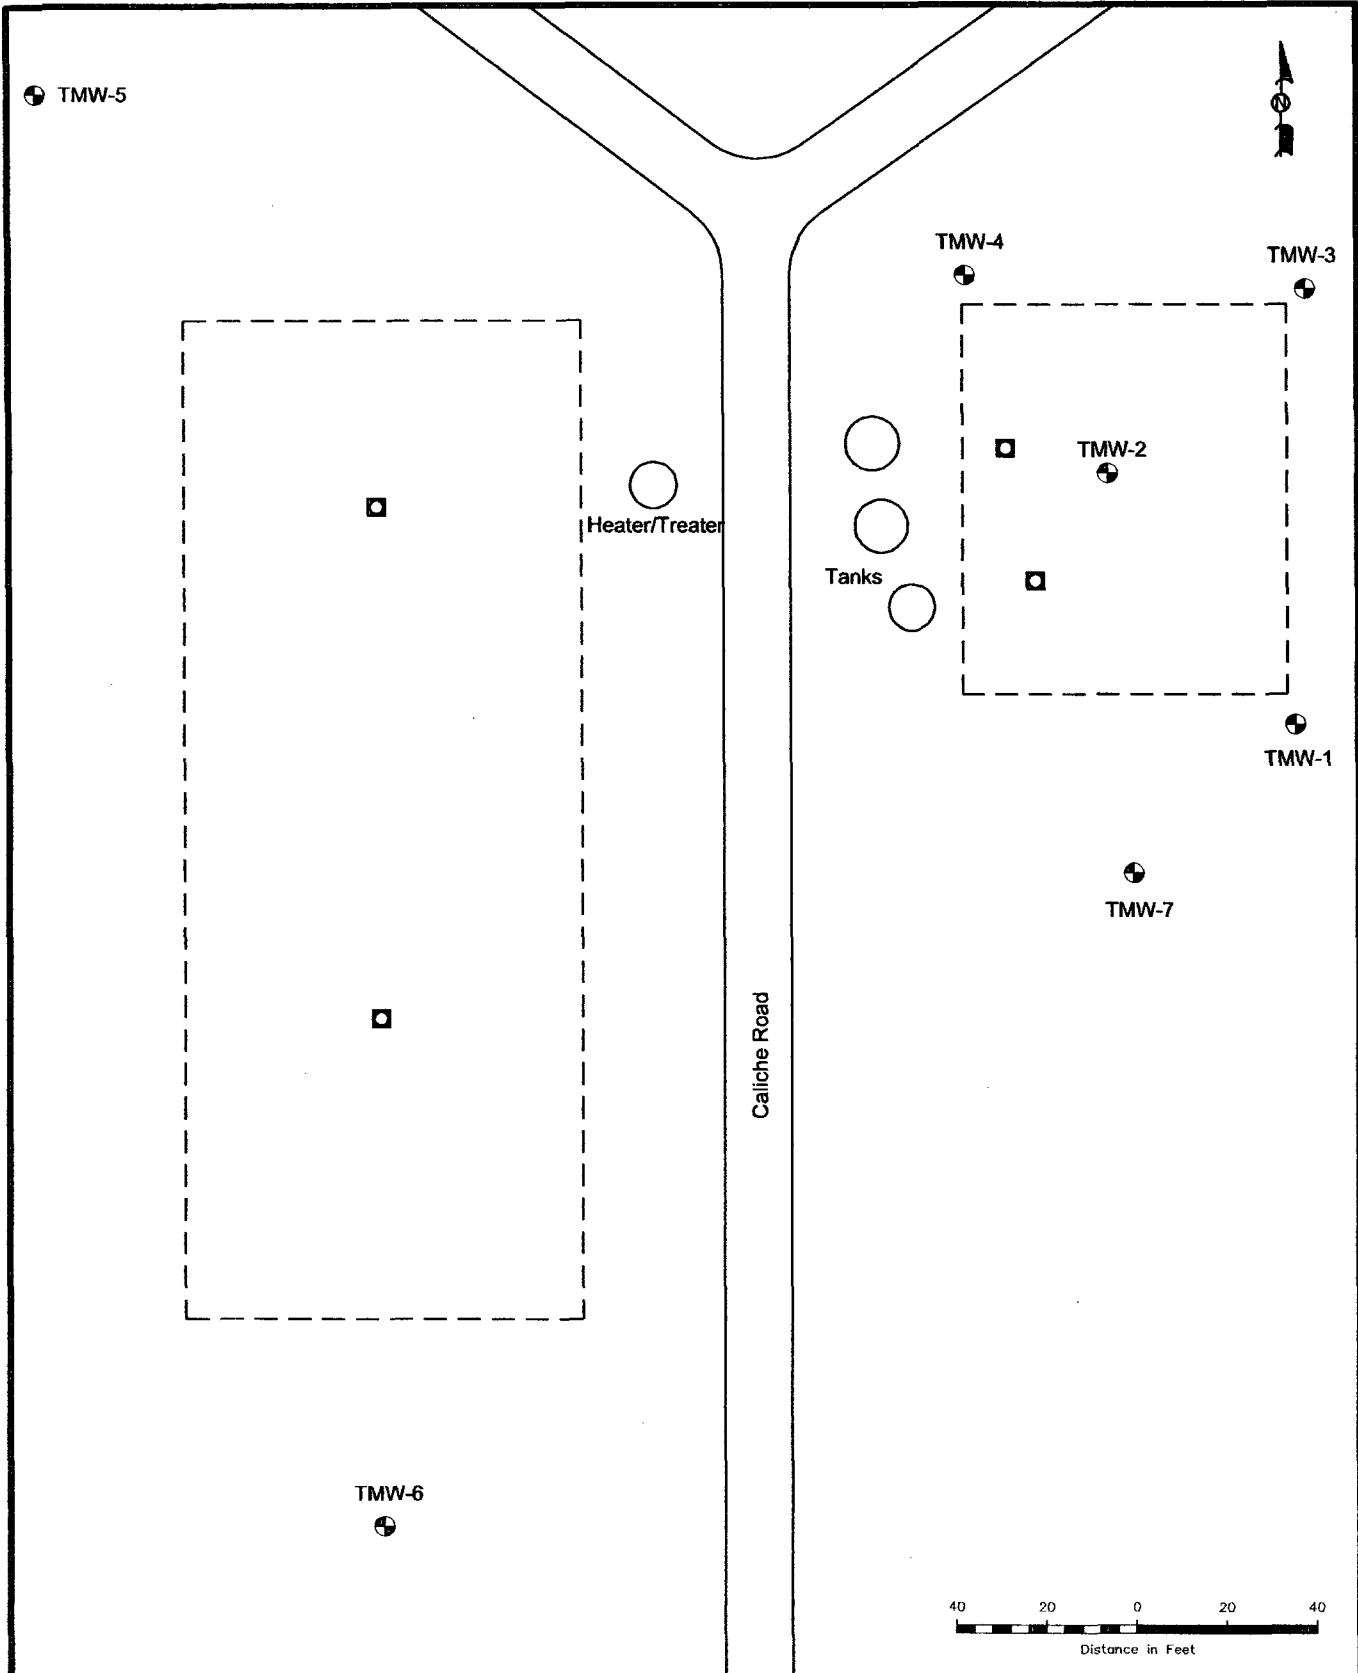
**Site Map**

As depicted on Figures 1 and 2, there are no bodies of surface water located within 1,000 feet of the site. These site conditions result in no points assigned to the site as a result of this criterion.

The visually stained area observed during the initial site investigation indicates that the hydrocarbon-impacted area is delineated to the extent of approximately 90 feet by 70 feet east of the former tank battery. The soil samples collected in the east stained area indicate the staining is limited to approximately 2 feet bgs. The visually stained area observed west of the former tank battery is approximately 220 feet by 90 feet. The soil samples collected in the west stained area indicate the staining is limited to approximately 2 feet bgs. Approximately 468 cubic yards of visually stained soil is located in the east area and 1,464 cubic yards are contained in the west area. During the excavation activities the soils will be blended and shredded with nutrients added to enhance the remediation process. A minimal amount of asphaltines are located on the site, and these soils will be transported to an approved NMOCD landfarm for disposal. Bottom confirmation samples will be collected upon completion of excavation of the east and west areas to determine contaminant level reduction. The blended soils will be landfarmed on-site and once contaminant levels are confirmed below regulatory limits, the remediated soil will be utilized to backfill the excavations, contoured to grade, and seeded with native grasses pursuant to Bureau of Land Management protocol.
