CLOSURE PROPOSAL

LYNCH DISCHARGE LINE

**1RP # 885
COMPANY No. 36785
EPI REF: 130016**

JANUARY 2007

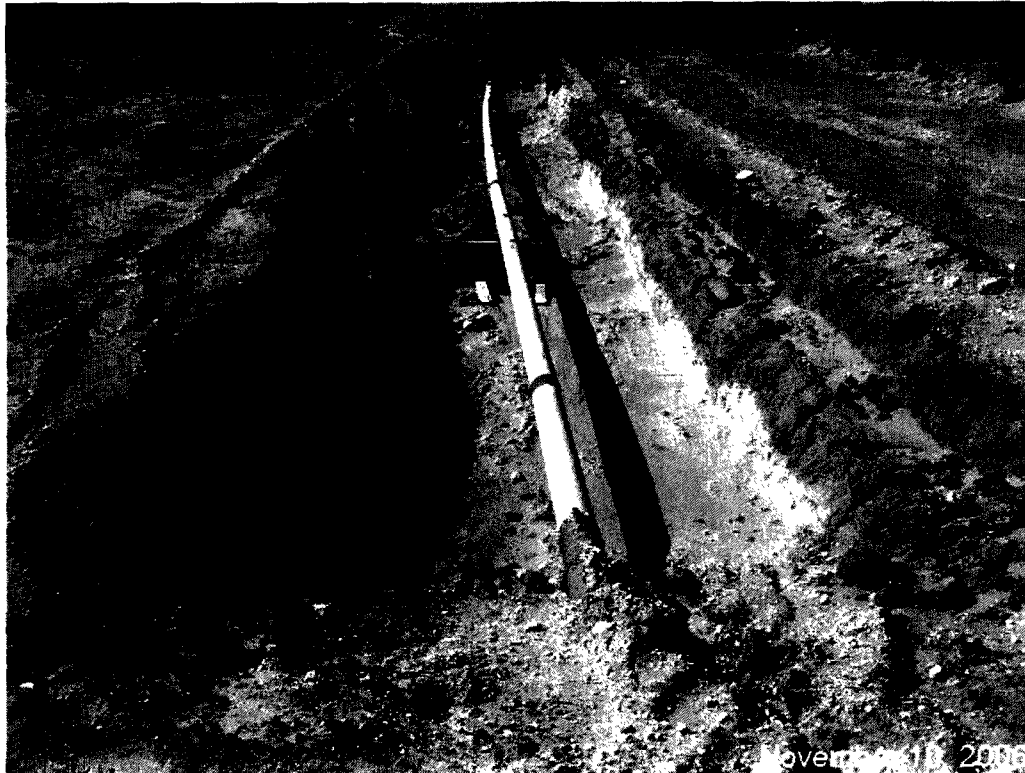
Photo #3: Excavation area current status, looking southwesterly.

8.4 ***If corrective action is recommended, provide a conceptual approach.*** Environmental Plus, Inc. recommends the following actions be taken: a) backfill the excavation utilizing the blended, stockpiled soil; and b) contour/grade the area to ensure natural drainage; and c) seed the area with a blend preferred by the Bureau of Land Management (BLM).
