Termination Request

**RE: Termination Request
ConocoPhillips EVGSAU 0546-002 (1RP-10-12-2859)
UL/G sec. 5 T18S R35E
API No. 300252693200**

**CONOCOPHILLIPS
EVGSAU 0546-002**

NMOCD CASE NO.
1RP-10-12-2859

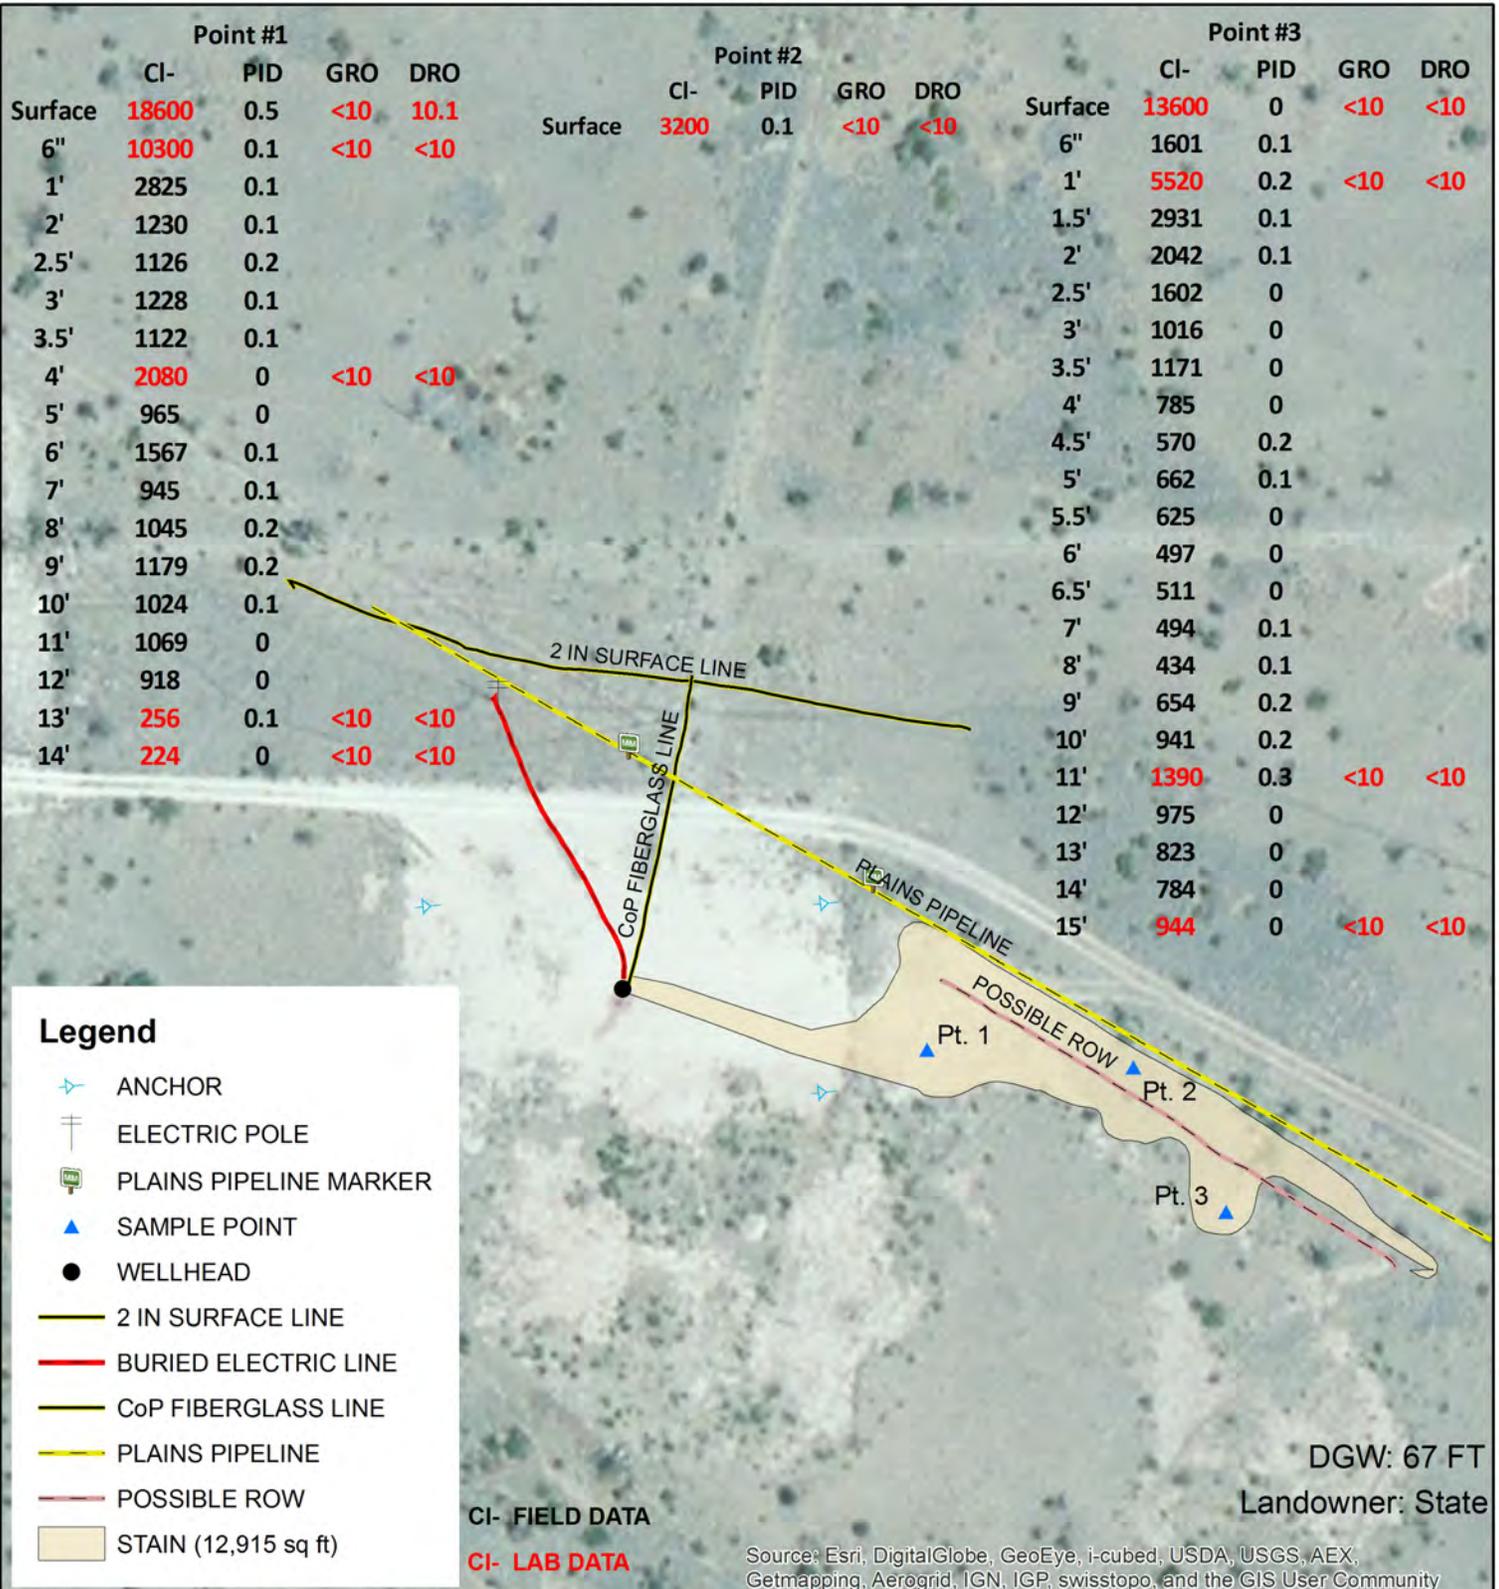
Figure 1

On November 5th, 2013, RECS personnel were on site to assess the release. Soil samples were taken at the surface of the release and with depth. The samples were field tested for chlorides and organic vapors (Figure 1). Representative samples were sent to a commercial laboratory for analysis. Pt. 1 returned elevated chloride readings until 14 ft bgs where the laboratory chloride reading returned a result of 224 mg/kg. Pt. 2 was sampled only at the surface a returned a laboratory chloride reading of 3,200 mg/kg. Pt. 3 was sampled to 15 ft bgs and did not return laboratory chloride readings below regulatory limits throughout the entire vertical (Appendix B). Gasoline Range Organics (GRO) readings and Diesel Range Organics (DRO) readings for all laboratory sample points returned results of at or near non-detectable limits.

Initial Sampling Data

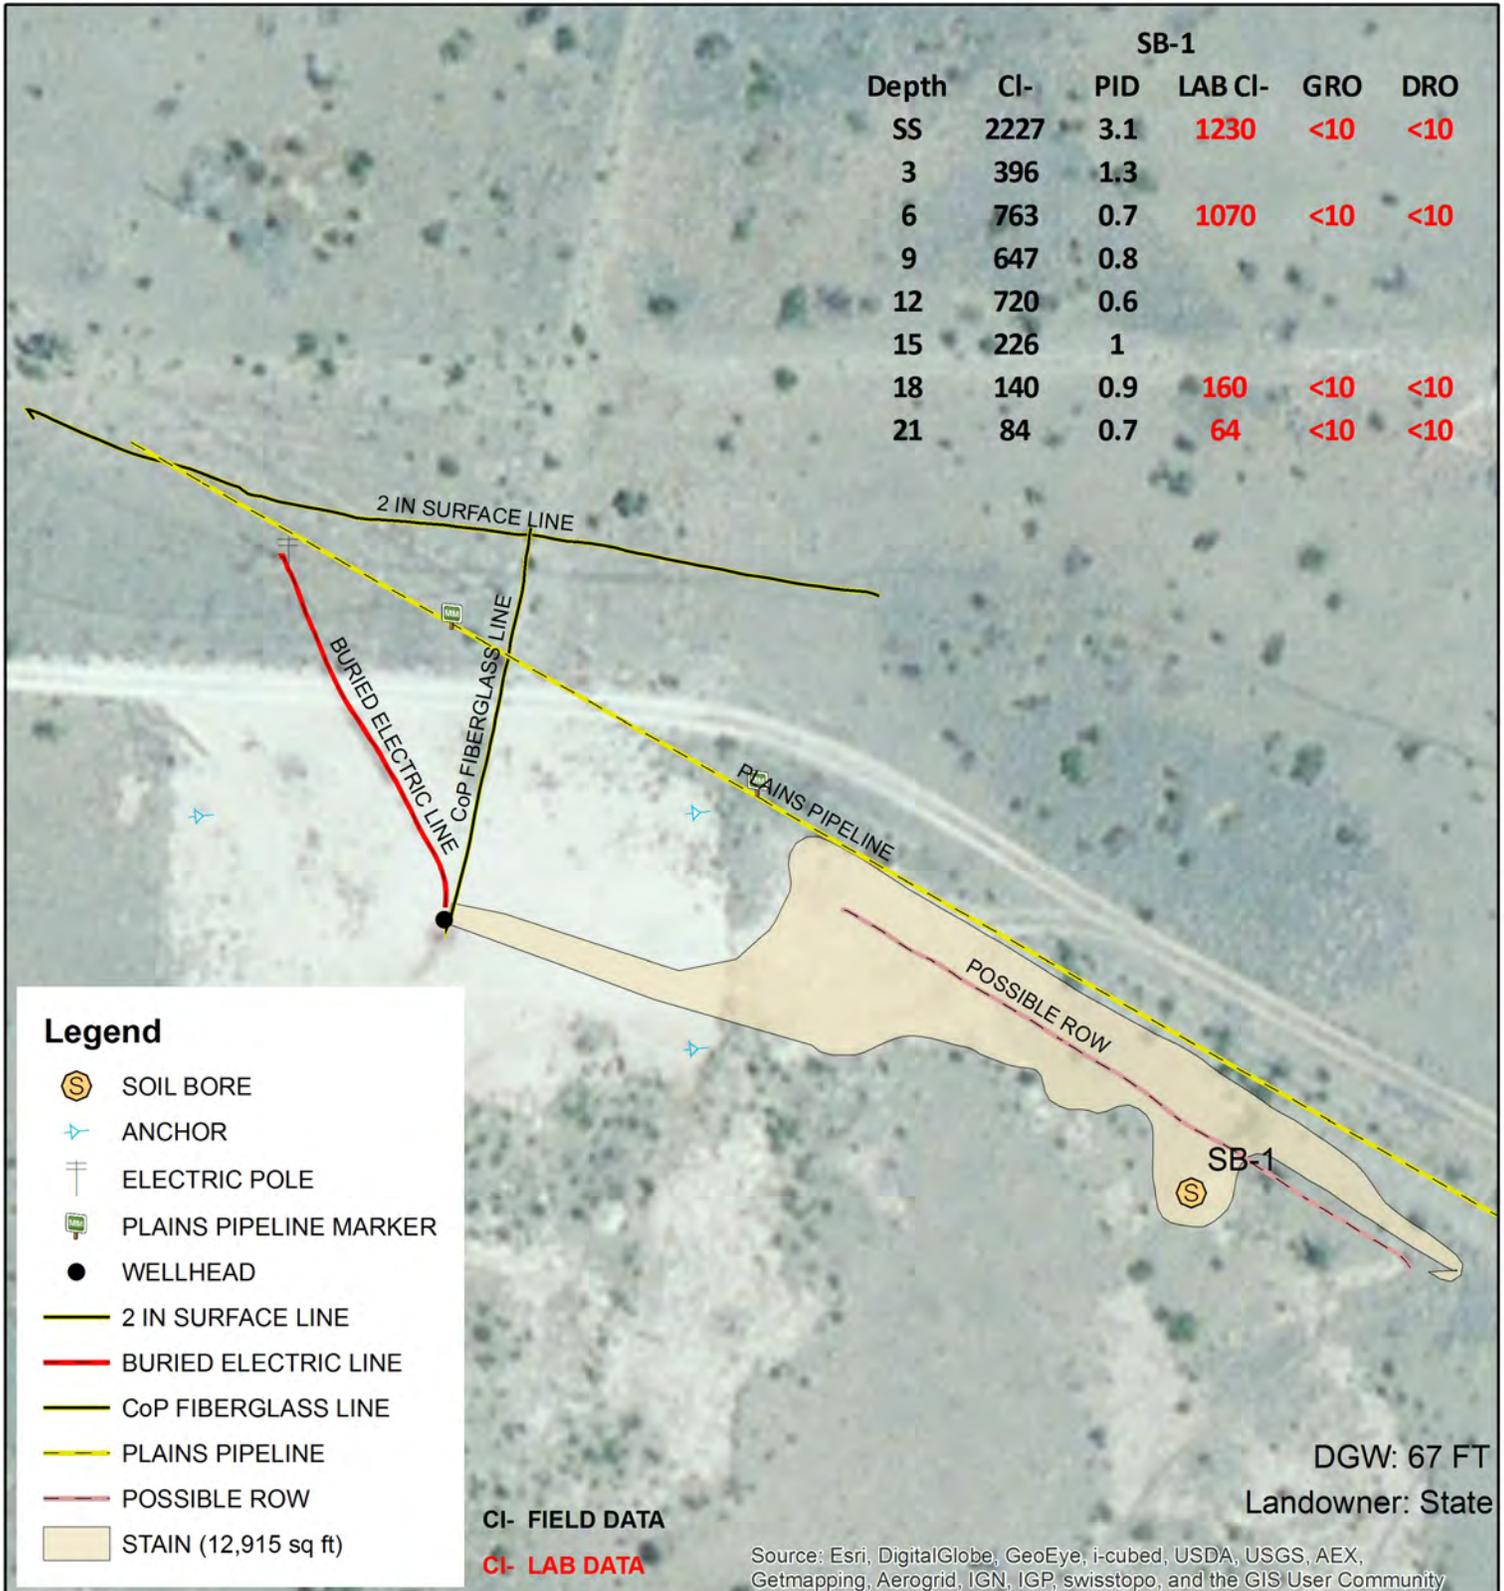
Figure 2

In order to determine the vertical extent of chloride contamination at Pt. 3, a soil bore was installed on November 26th, 2013 (Figure 2). As the bore was advanced, samples were taken every 3 ft and field tested for chlorides and for organic vapors. Representative samples from the bore were taken to a commercial laboratory for analysis. Laboratory chloride readings returned a result of 160 mg/kg at 18 ft bgs and 64 mg/kg at 21 ft bgs (Appendix C). GRO and DRO readings throughout the bore were returned values of non-detect.

Soil Bore Installation

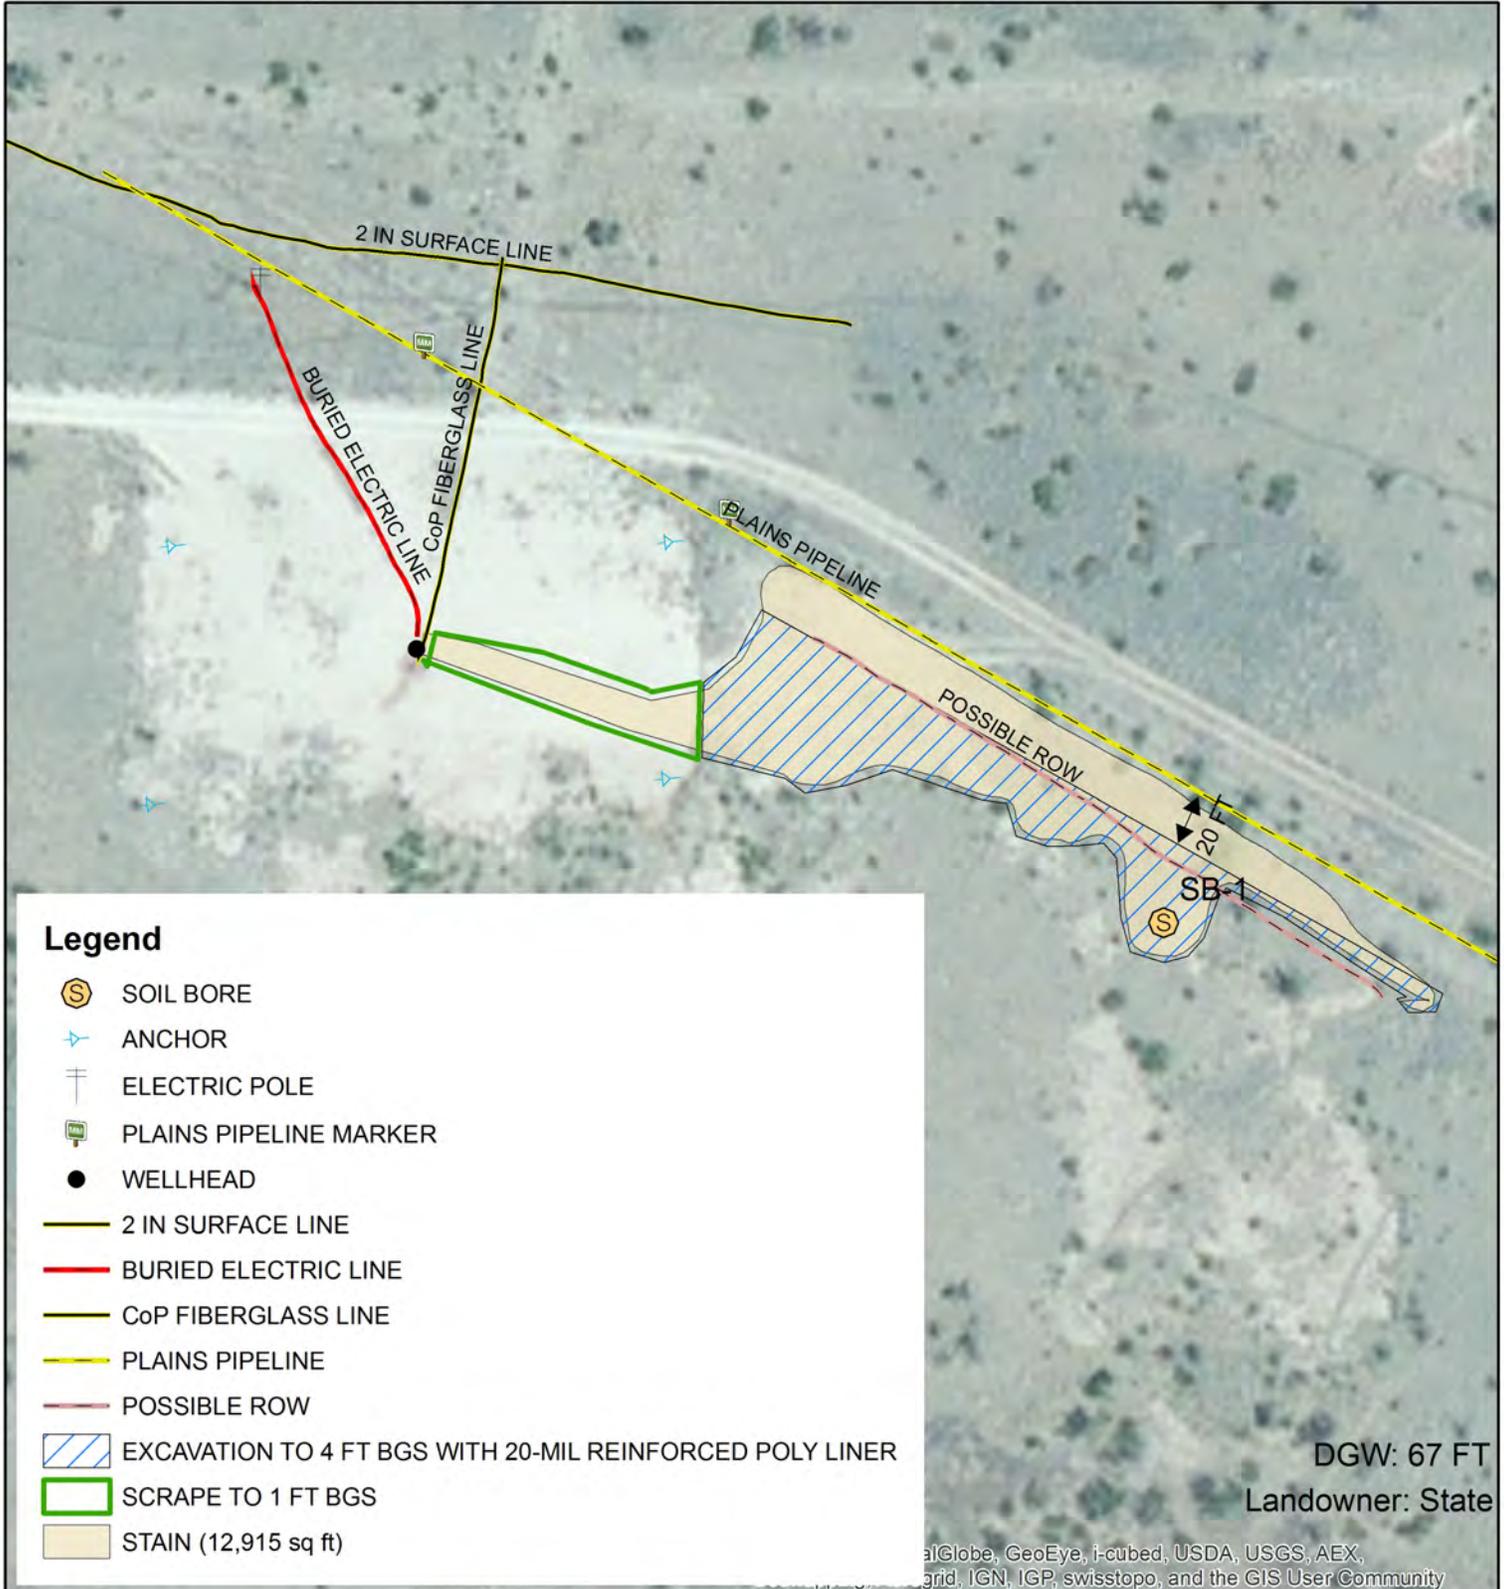
Figure 3

On December 16th, 2013, a Corrective Action Plan (CAP) was submitted to NMOCD and was approved on December 18th, 2013. As part of the CAP, the release over the lease pad would be scraped to a depth of 1 ft bgs and the release area in the pasture would be excavated to a depth of 4 ft bgs. Per a Plains Pipeline Request, the excavation in the pasture would remain 20 ft away from their pipeline (Figure 3). At 4 ft bgs, grab samples from the walls of the pasture excavation would be taken to confirm that laboratory chloride readings are below 250 mg/kg. The excavated soil would be taken to a NMOCD approved facility for disposal. At the base of the pasture excavation, a 20-mil reinforced poly liner would be installed and properly seated. The excavations would be backfilled with clean, imported soil in the pasture and clean, imported caliche on the lease pad. The pasture area would have soil amendments added as necessary and then the area would be seeded.

Proposed Excavations and Liner Installation

The 4 ft bgs excavation was padded with 6 in of top soil to protect the liner from punctures. A 20-mil reinforced poly liner was installed and properly seated into the base of pasture excavation. The pasture was backfilled with the imported top soil and the lease pad was backfilled with the imported caliche. The backfilled excavations were contoured to the surrounding locations. On March 25th, 2014, the pasture area was tilled and then seeded with BLM mix #2.

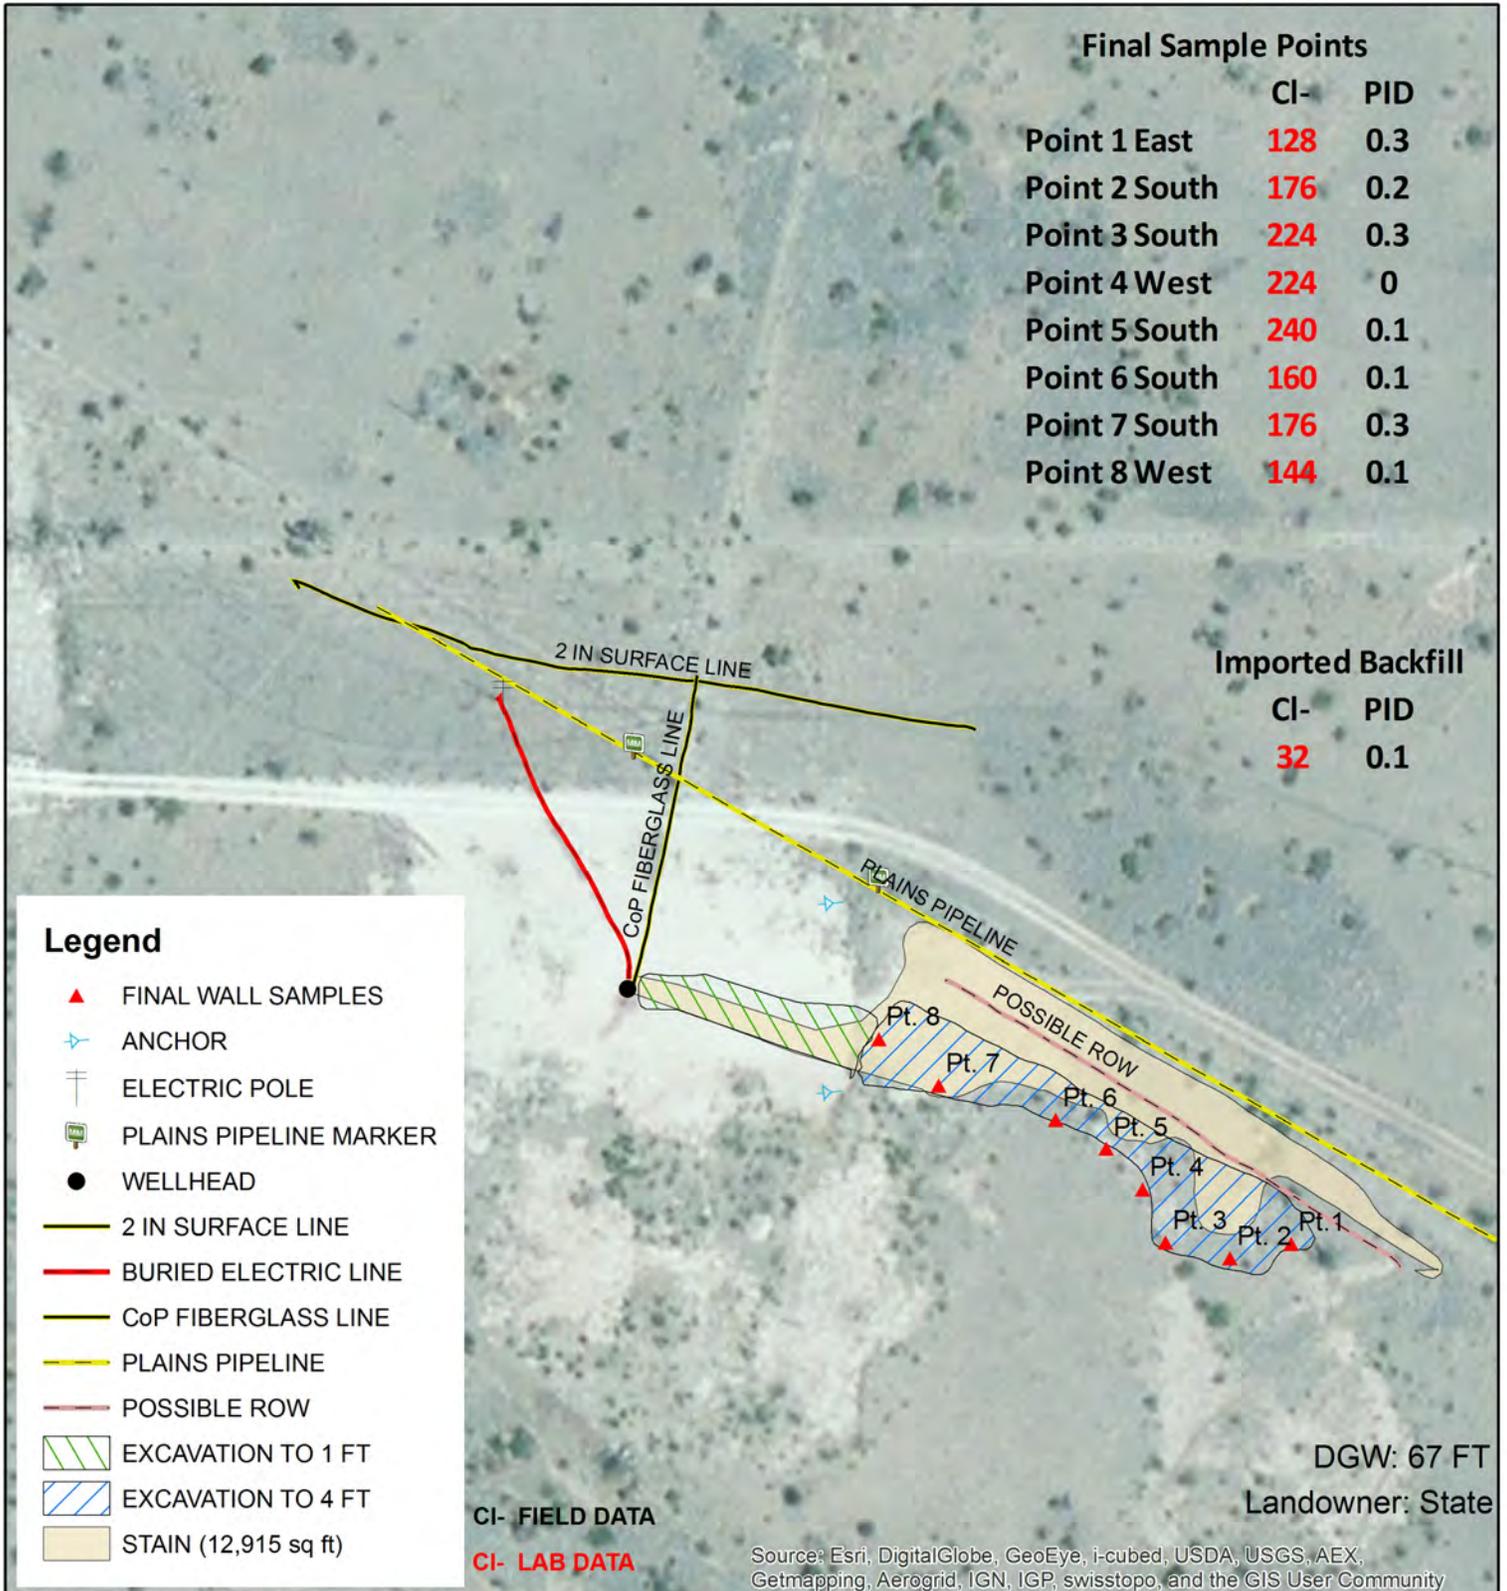
Figure 4

RECS personnel were on site beginning on January 15th, 2014 to begin CAP work. The site was excavated to 4 ft bgs in the pasture area and scraped to a depth of 1 ft bgs on the lease pad (Figure 4). Once the excavation in the pasture was completed, grab samples from the walls of the excavation were field tested for chlorides and organic vapors, and all samples were taken to a commercial laboratory for analysis (Appendix D). All wall samples returned chloride values below regulatory limits. All excavated soil was taken to a NMOCD approved facility for disposal. Clean caliche and top soil were imported to the site to serve as backfill. A sample of the imported soil was taken to a commercial laboratory for analysis and returned a chloride value of 32 mg/kg.

Excavation Data

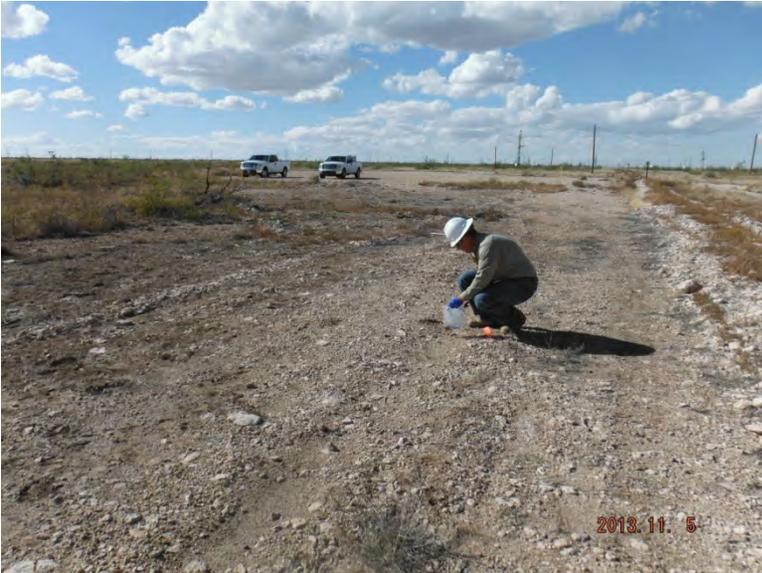
Collecting surface sample, facing northwest 11/5/13

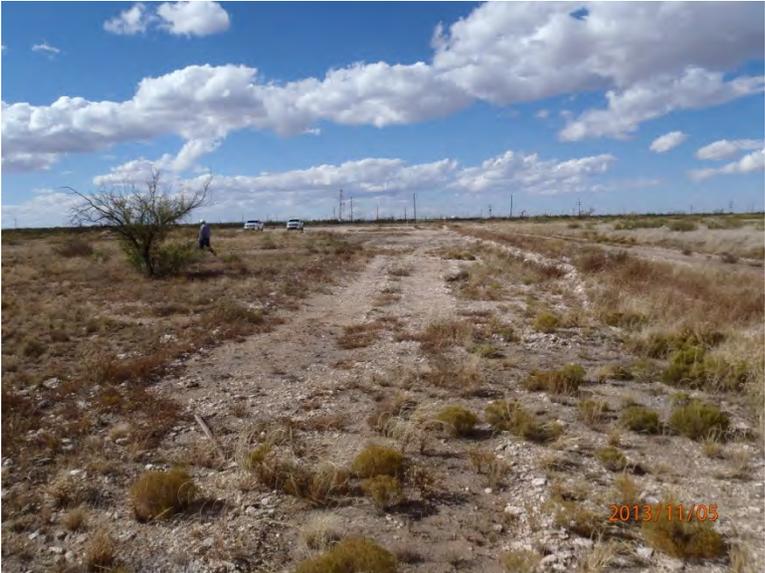
Initial release area, facing northwest 11/5/13

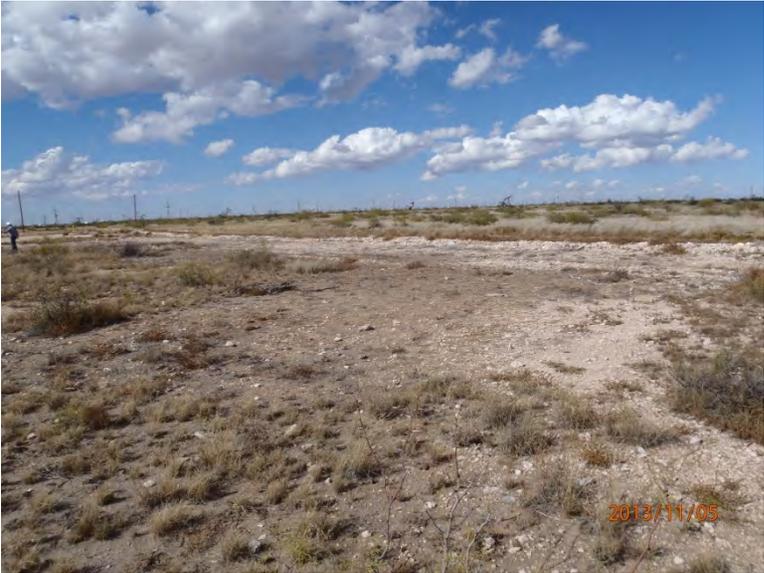
Initial release area, facing north-northwest 11/5/13

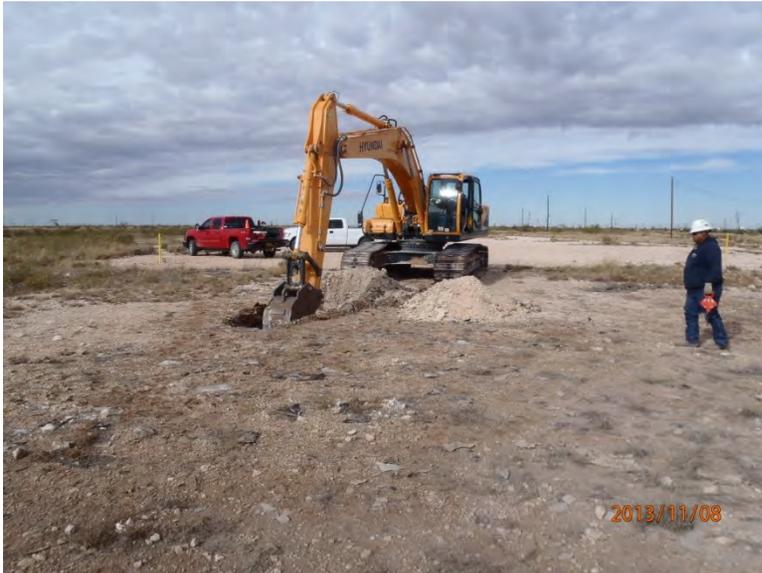
Installing vertical, facing west

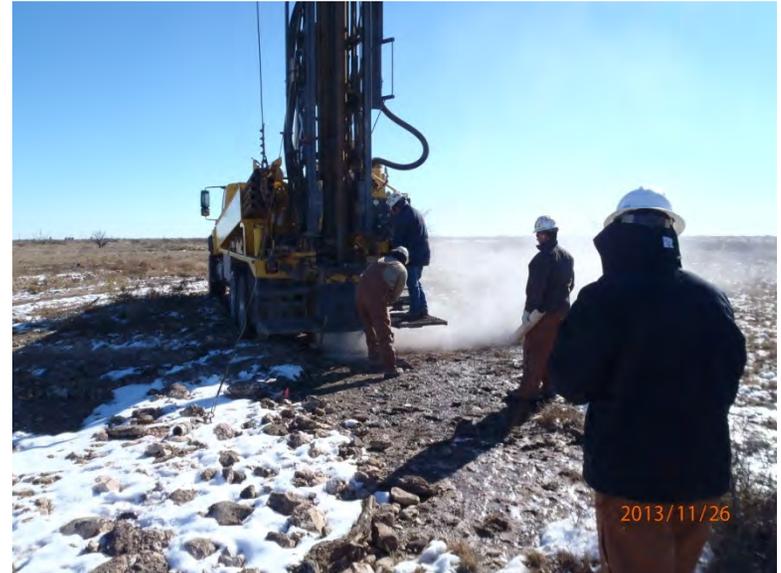
Installing SB-1, facing east

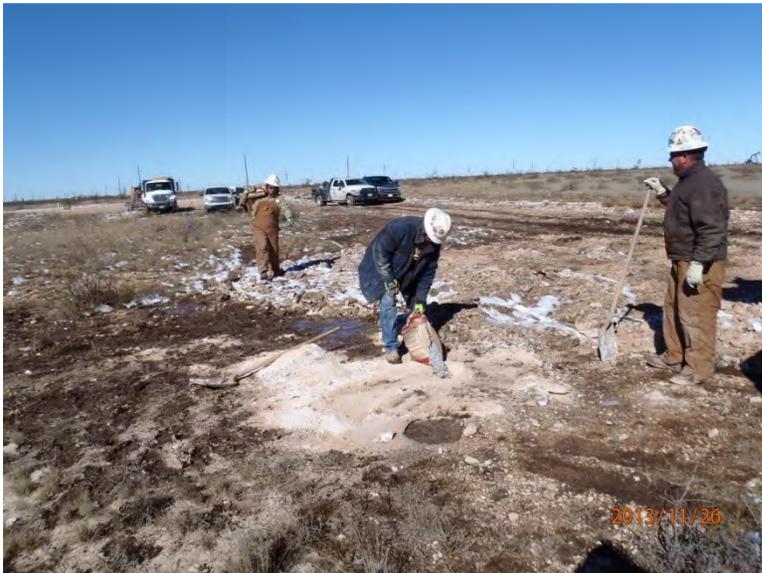
Plugging SB-1 in total with bentonite, facing northwest

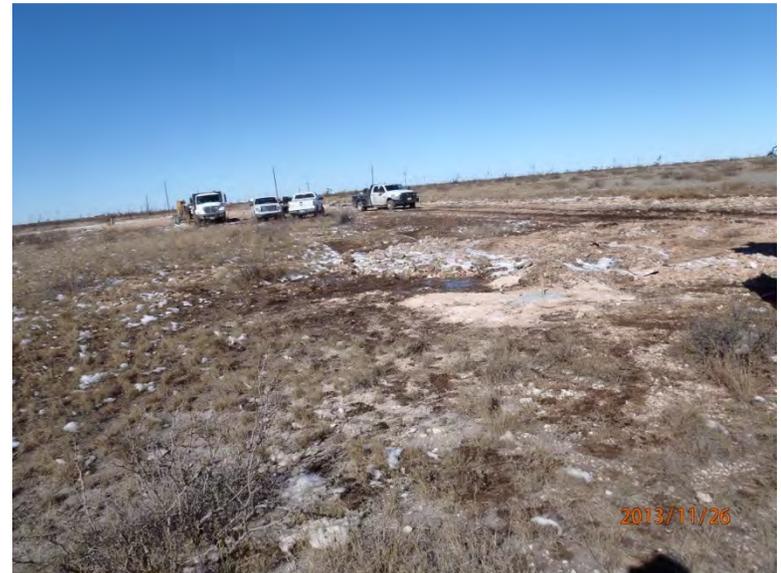
Completed SB-1, facing northwest

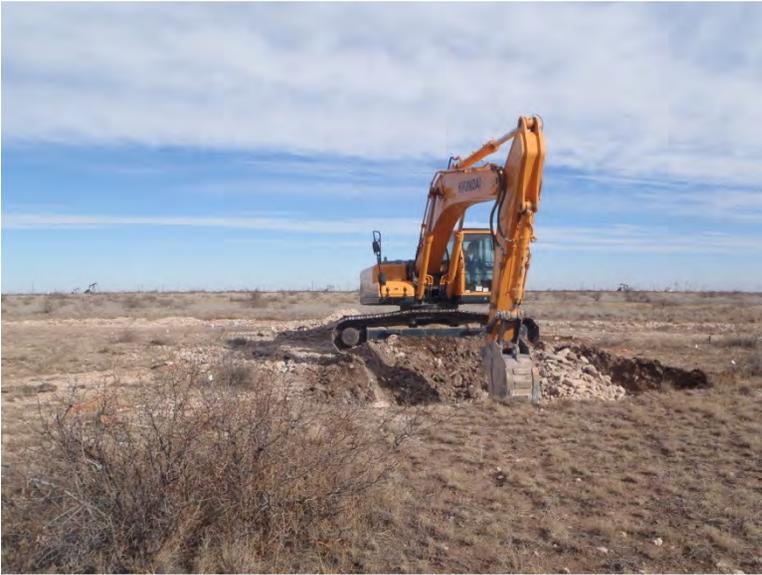
Beginning excavating activities, facing northeast
1/16/14

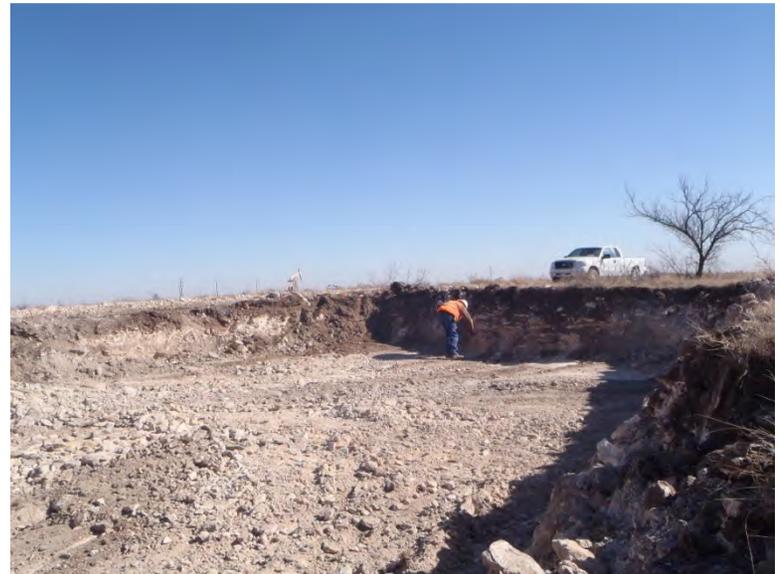
Sampling excavation, facing east
1/17/14

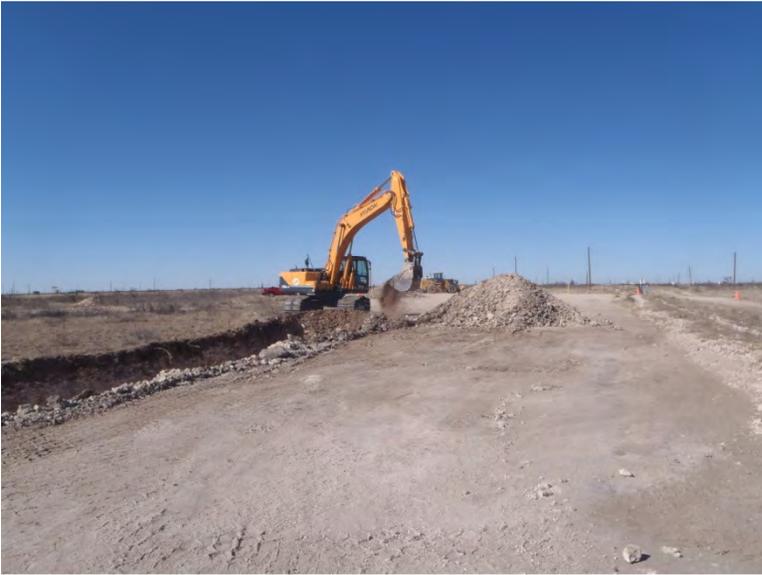
Excavating continuing to the west, facing west 1/21/14

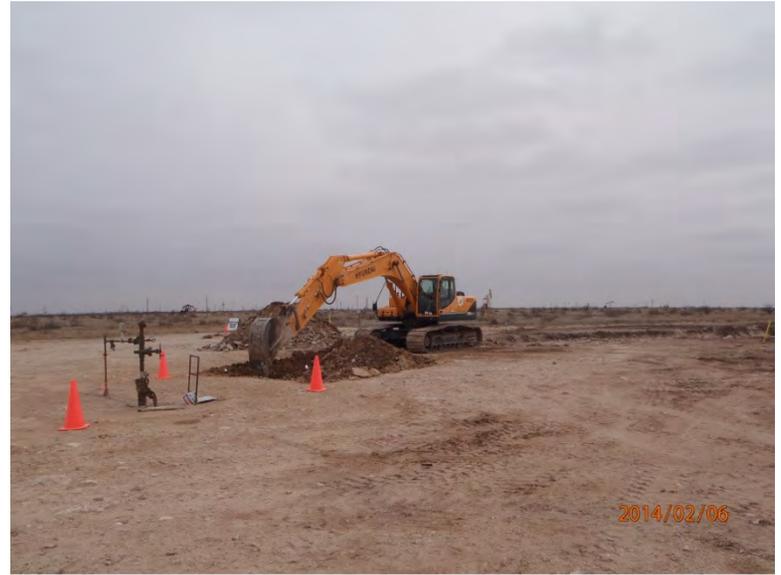
Excavating on pad, facing northeast 2/6/14

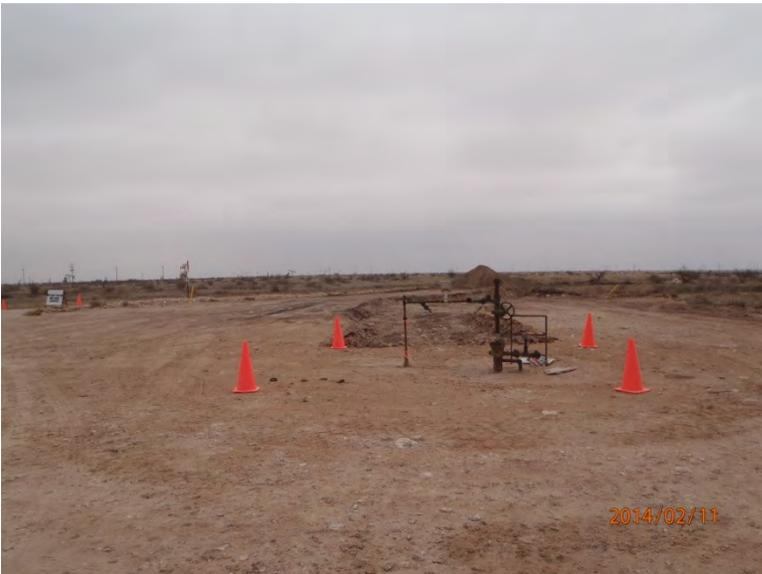
Excavation completed, facing east 2/11/14

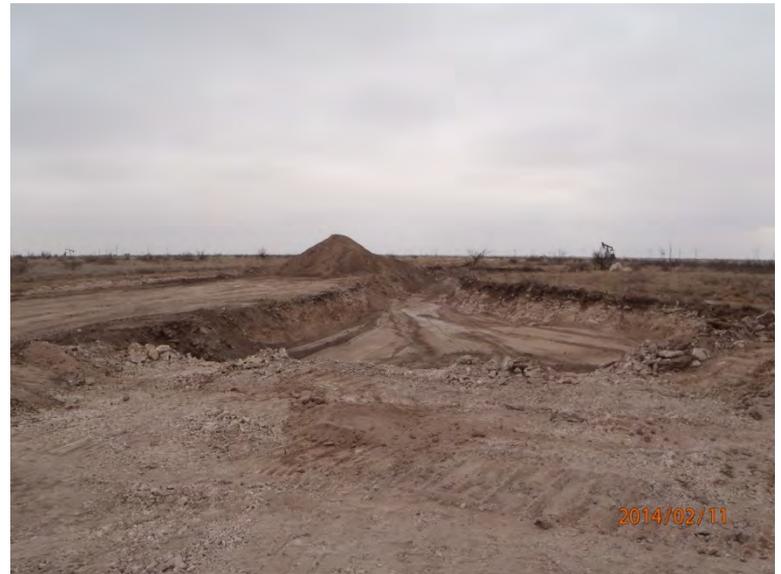
Excavation completed with the bottom padded for liner installation, facing east 2/11/14

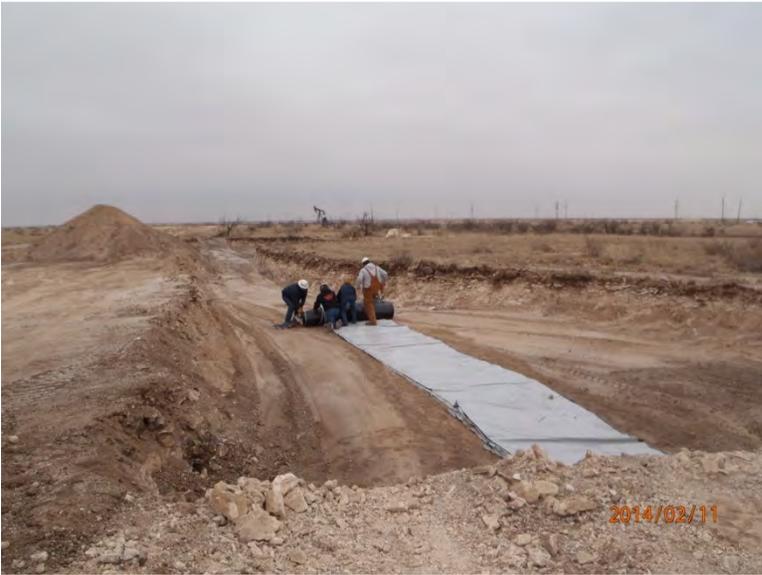
Installing 20-mil reinforced poly liner, facing southeast
2/11/14

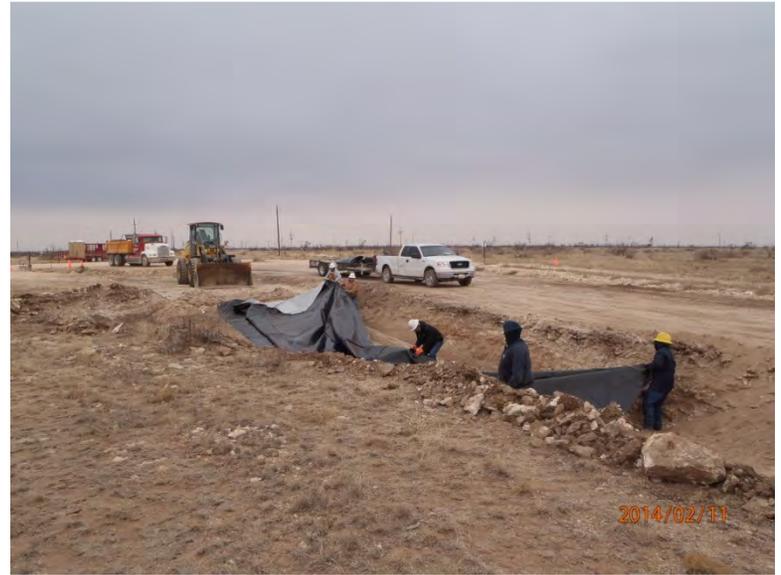
Installing 20-mil reinforced poly liner, facing north
2/11/14

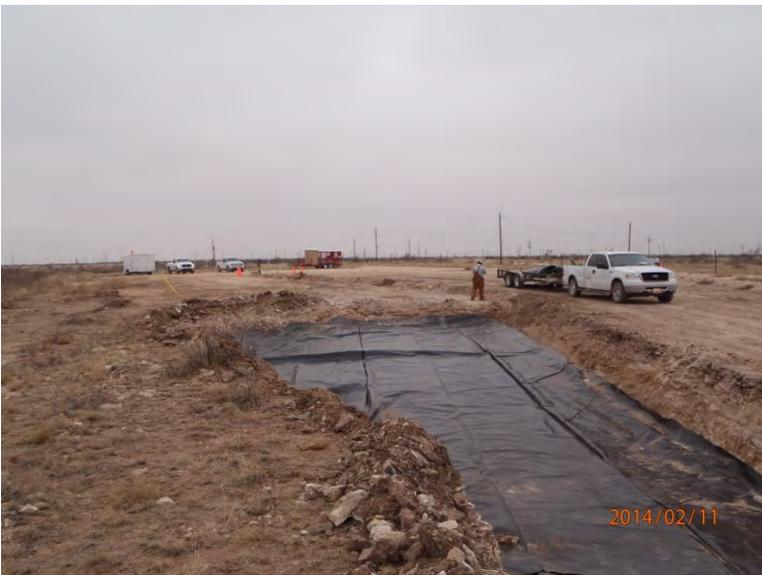
Liner installation completed, facing northwest 2/11/14

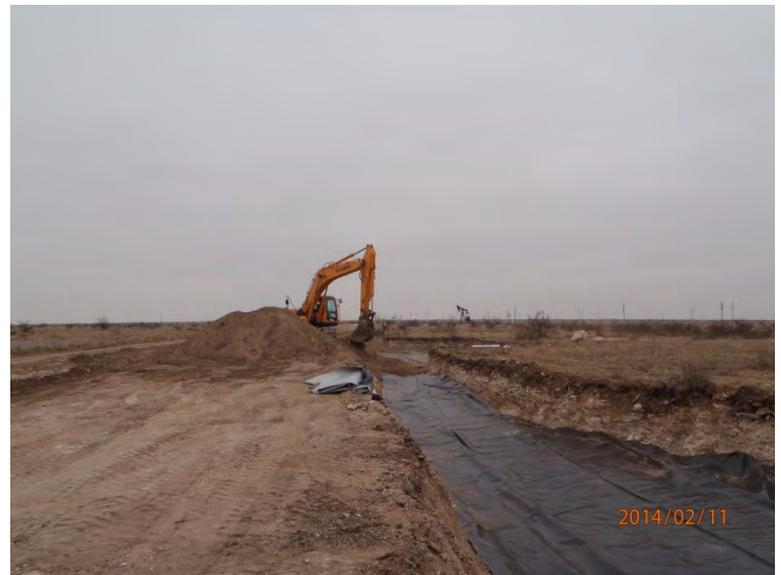
Liner installation completed and beginning backfilling
the excavation, facing southeast 2/11/14

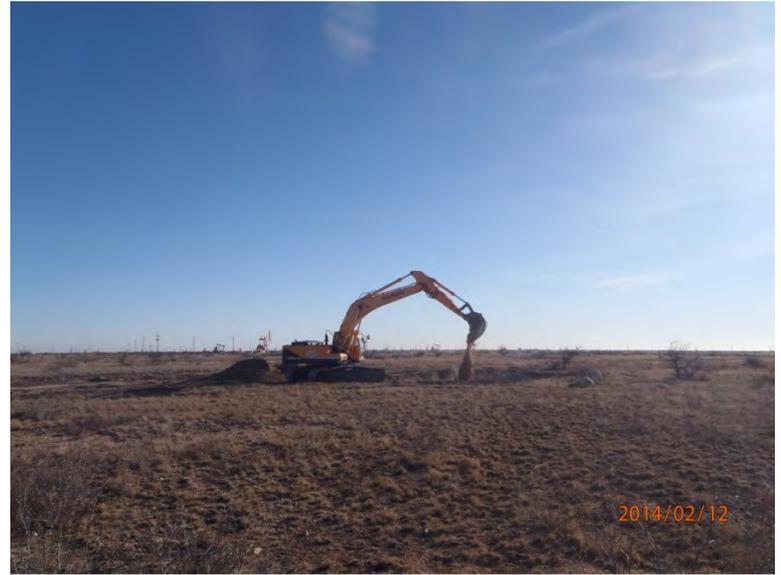
Backfilling site, facing east

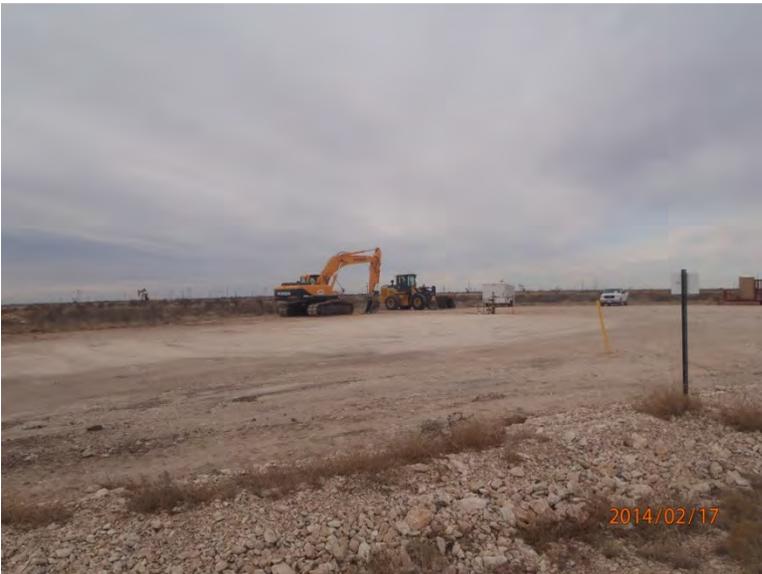
Backfilling of pad completed, facing southwest 2/17/14

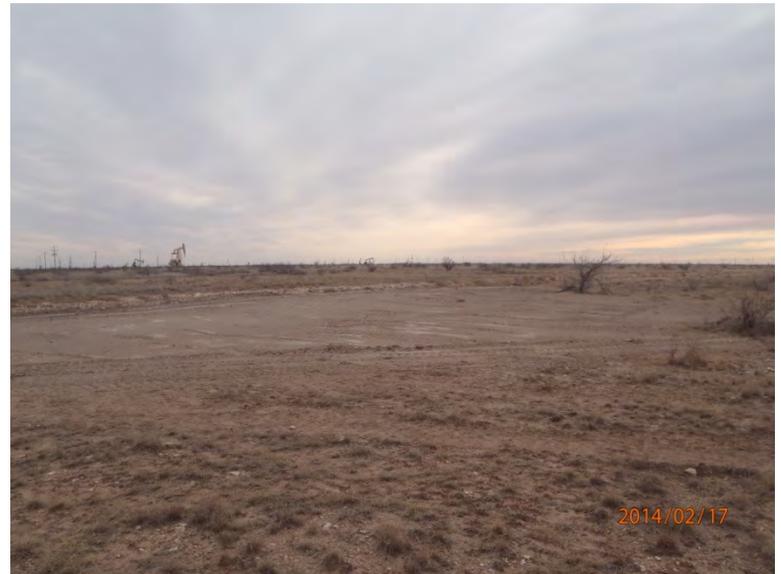
Excavation backfilled, facing east

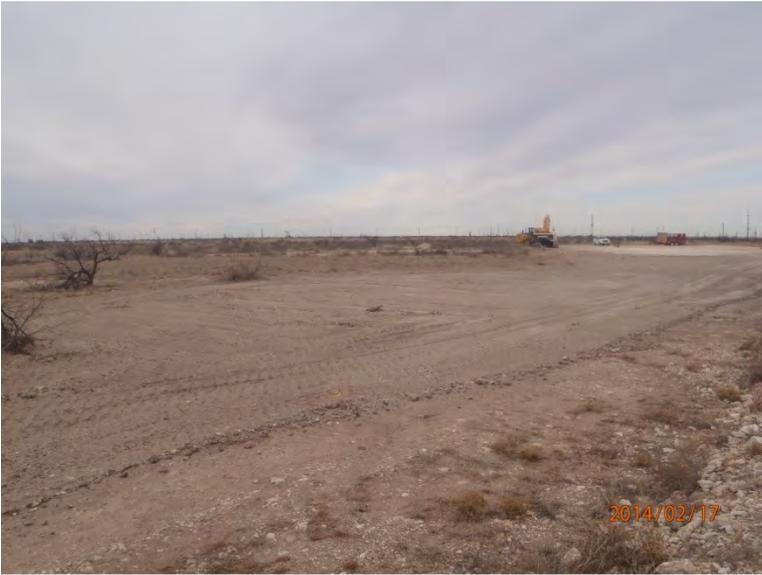
Excavation to pad backfilled, facing west 2/17/14

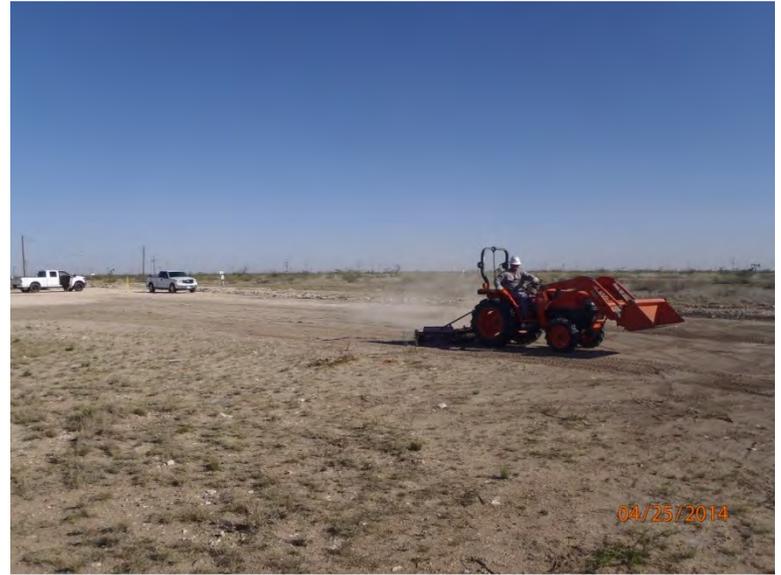
Tilling site to prepare for seeding, facing north 4/25/14

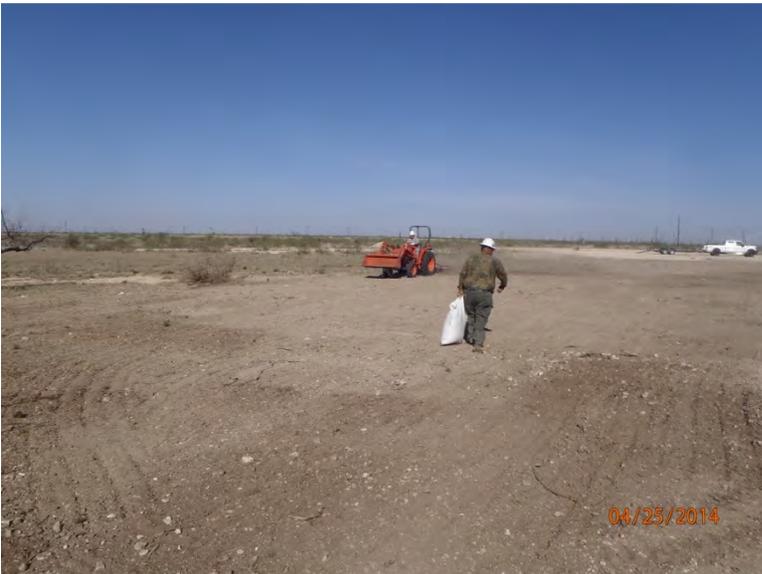
Seeding site and tilling seed into soil, facing west 4/25/14

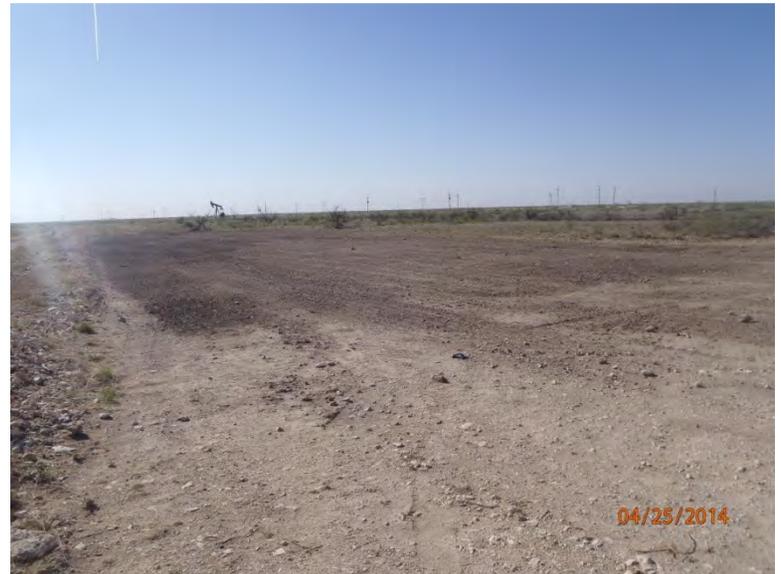
Site seeded, facing south 4/25/14
