White Owl Battery

Closure Report

API 30-025-36689

Apache – White Owl Battery AD

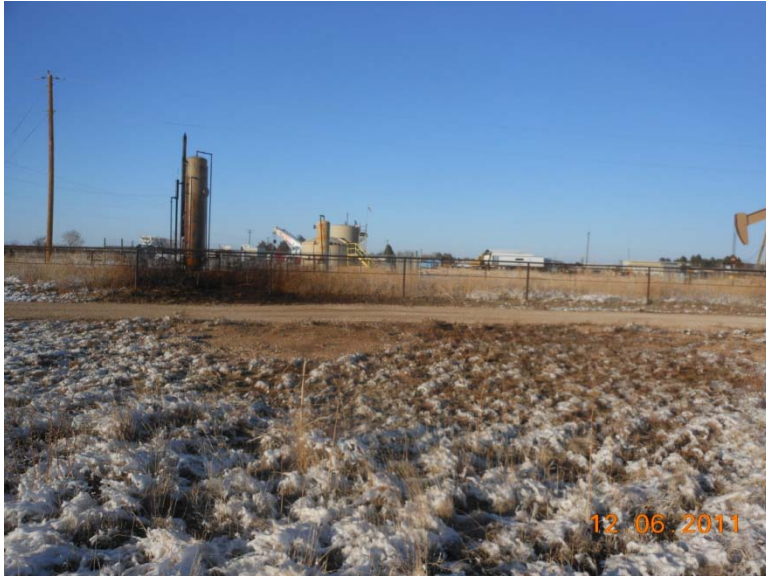
Initial release, facing north

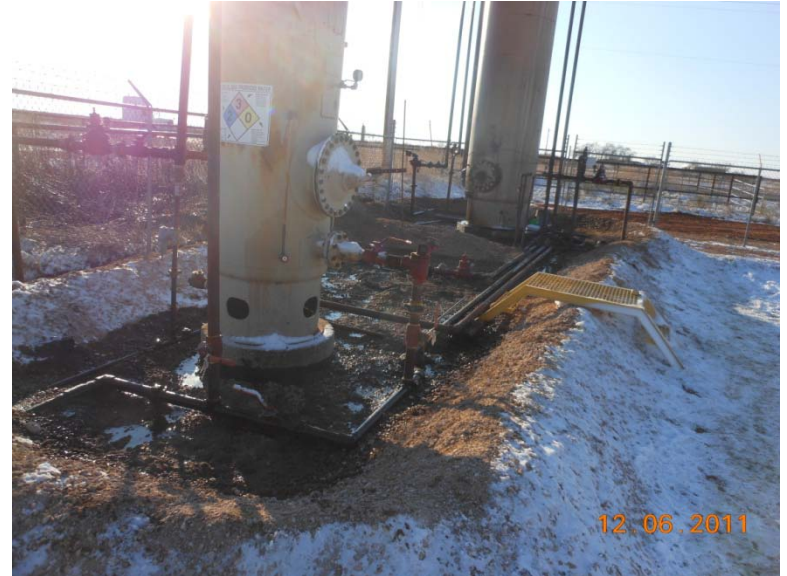
Initial release, facing west

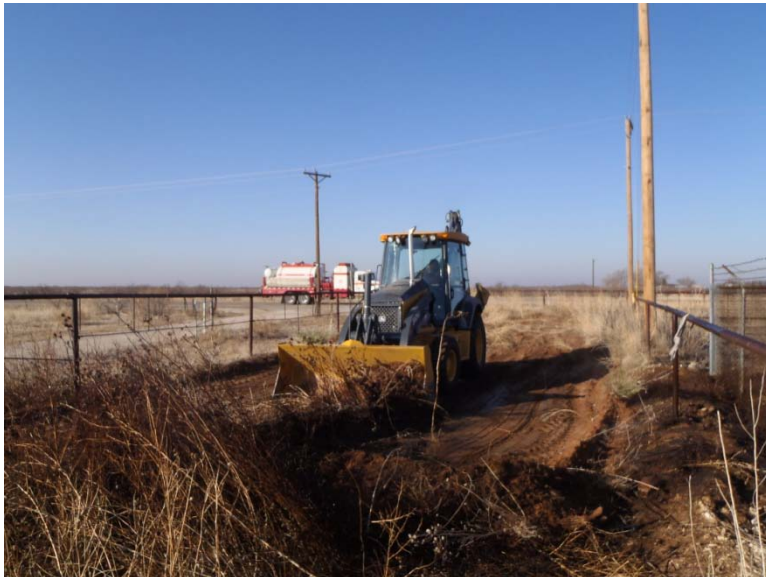
Scraping leak, facing west

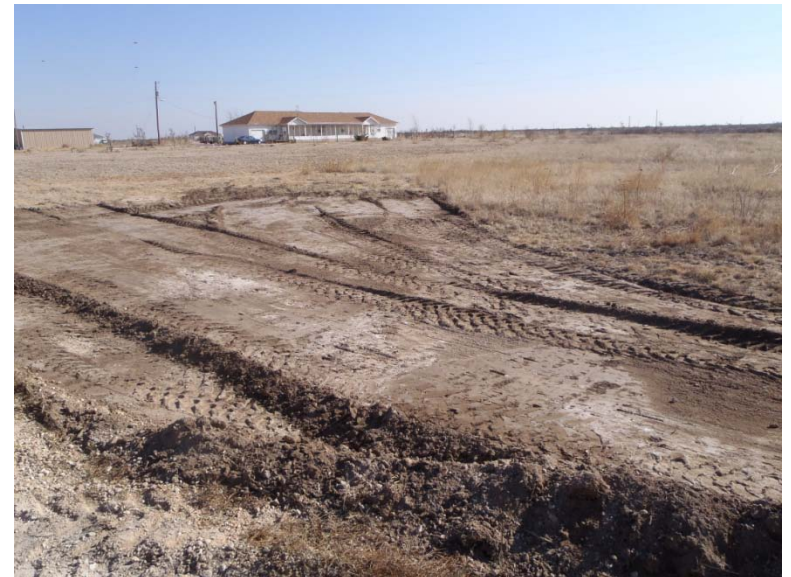
Scraped overspray area, facing southeast

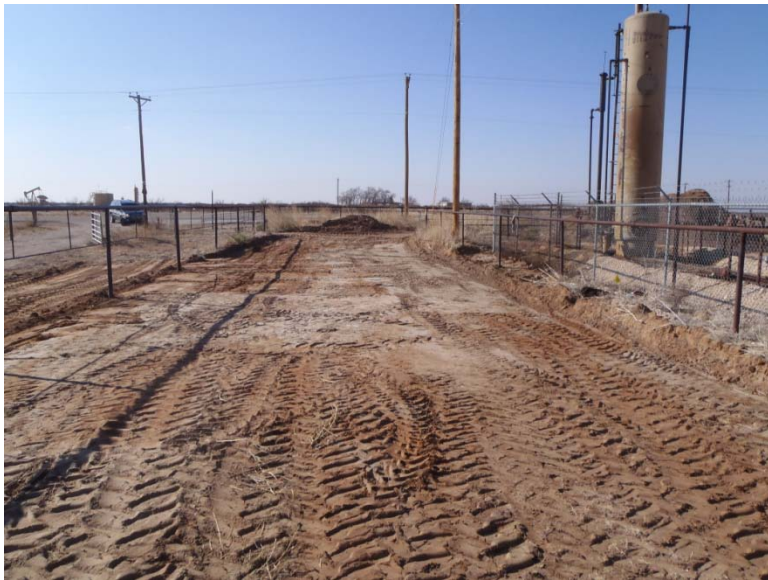
Leak scraped, facing west

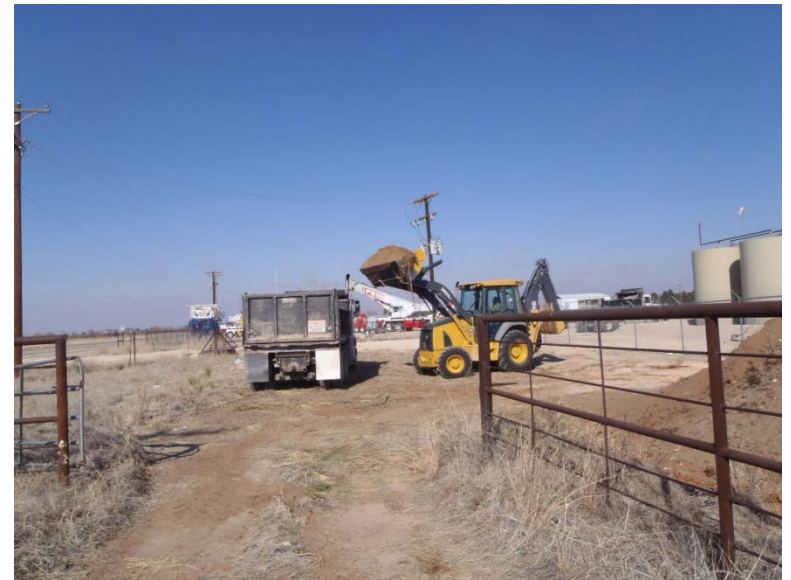
Exporting soil, facing north

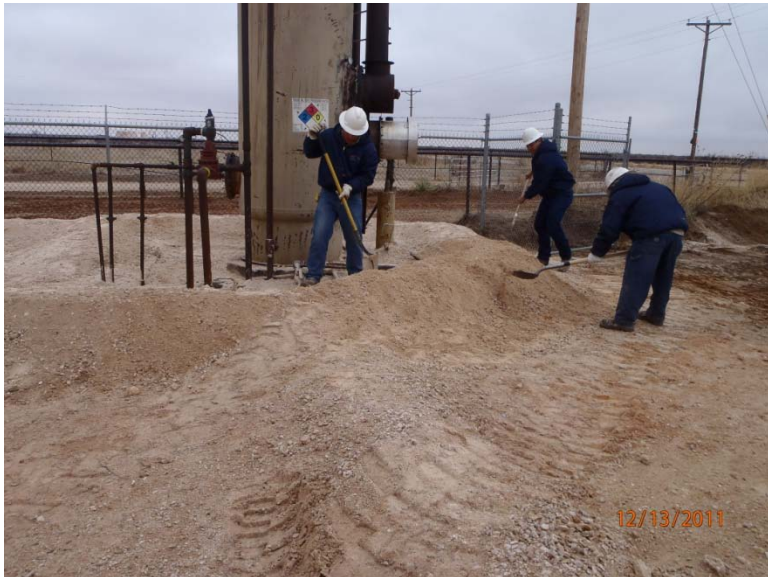
Repairing berm, facing south

The stain surrounding Pt. 3 and Pt. 4 was also scraped. Impacted soils were removed from the excavations and transported to a NMOCD approved disposal facility. The berm area excavation was backfilled with clean caliche and leveled. See Appendix B for photographs of field activities.

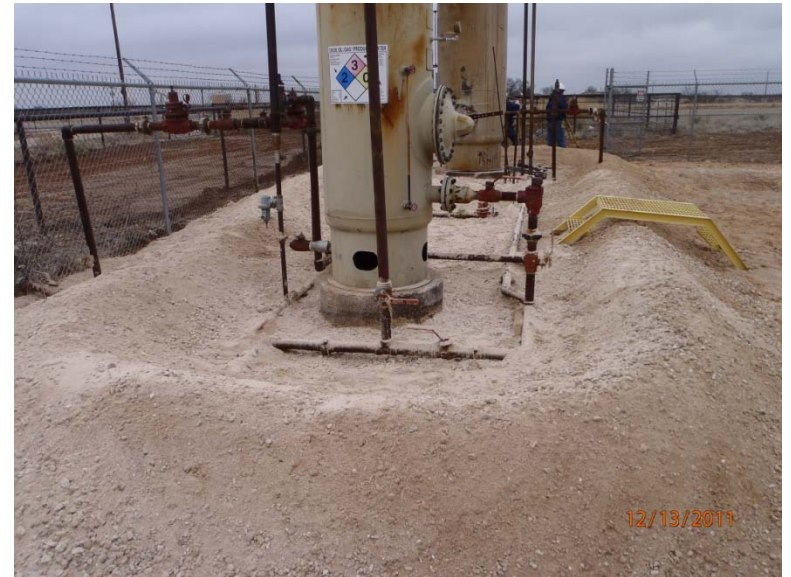
Site complete, facing west
