BURGUNDY OIL & GAS OF NEW MEXICO, INC.

Childress Lease Road

CLOSURE REPORT

1RP-3212

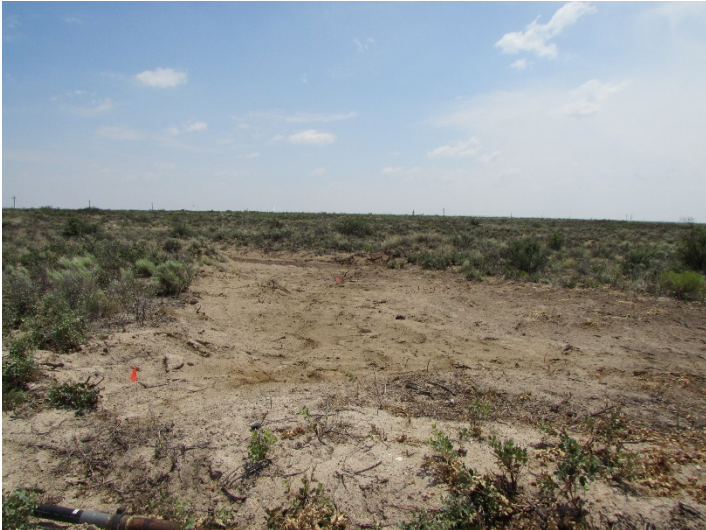
Flowline impact facing east 07/22/14

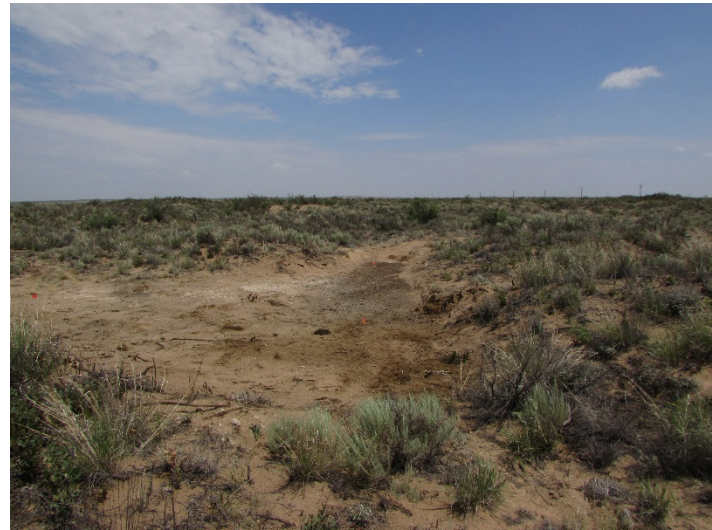
Lease road impact 07/22/14

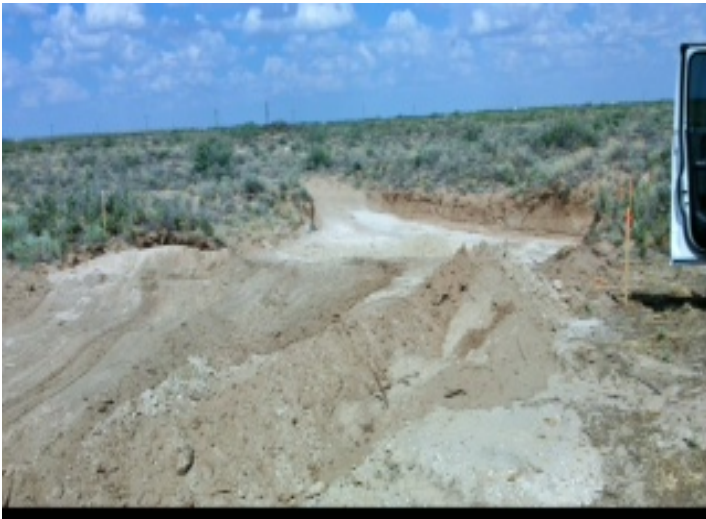
Excavation of lease road 08/21/14

On August 21, 2014 DFSI Personnel revisited the site and excavated the impacted lease road area. The following is a recap of the excavation activities:

SP1, and SP3 thru SP6 were excavated to 3ft. bgs., while SP2 was excavated to 2ft. bgs., as was previously determined by lab confirmations.

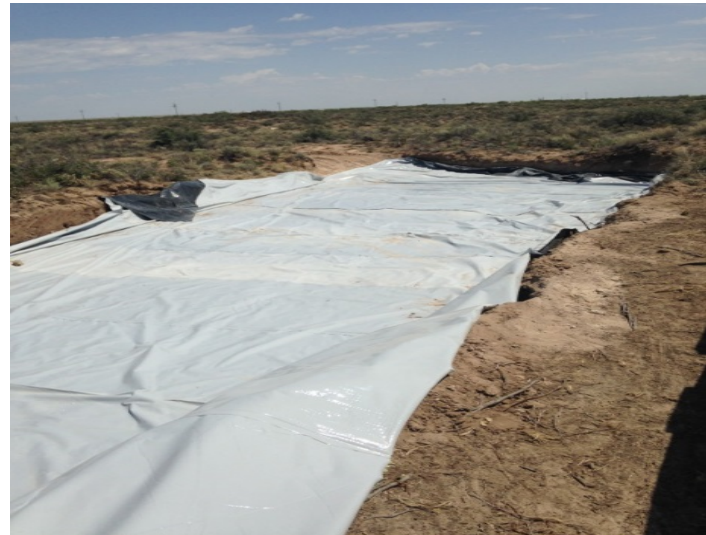
Lined excavated area 08/22/14

This concludes the delineation efforts, in that all constituents were within acceptable limits, therefore on this same said date a 20 mil. liner was installed in accordance with the approved remediation plan, and at the aforementioned depths.

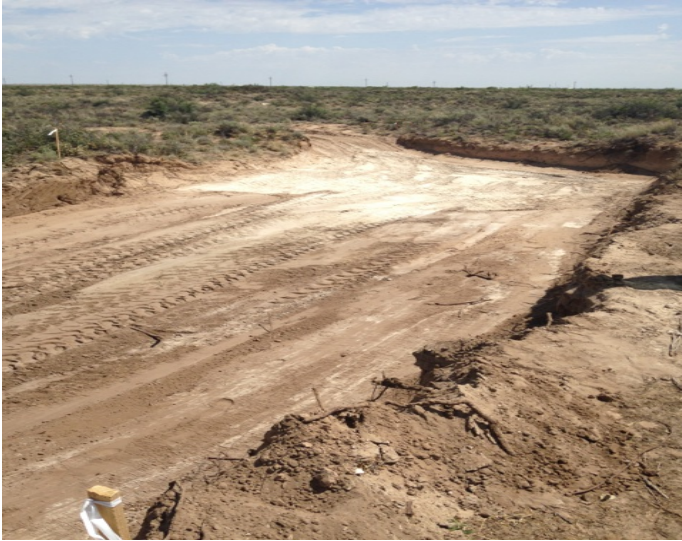
Backfilled road area 08/25/14

On August 25, 2014 the lined area was backfilled with fresh topsoil. DFSI personnel tilled the site and seeded with 50 lbs. of native Lesser Prairie Chicken seed mixture in order to promote vegetation, thereby restoring the site to its natural state per BLM guidelines (Appendix IV).

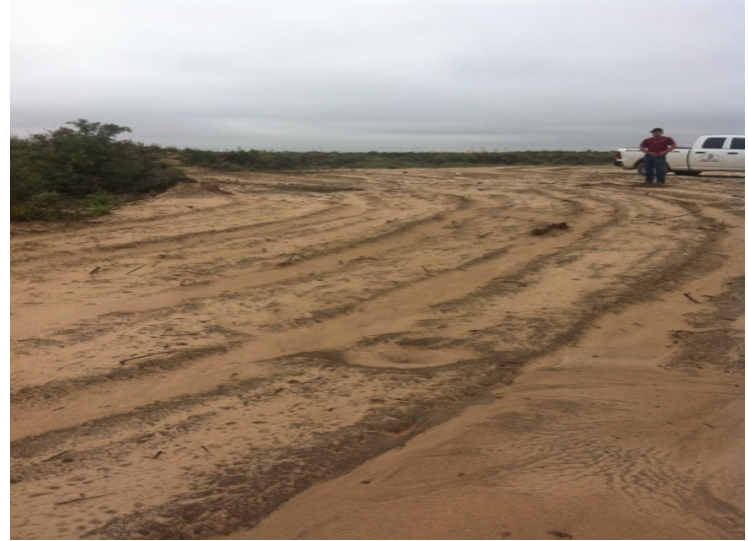
Site at completion-tilled and seeded 08/25
