Release Notification and Corrective Action

Name of Company: ConocoPhillips	Contact: Sean Robinson
Address: 29 Vacuum Complex Lane	Telephone No. 575-390-8873
Facility Name: Philmex #9 SWD	Facility Type: SWD

ConocoPhillips Philmex #9 SWD

Unit Letter B Section 26, T17S, R33E

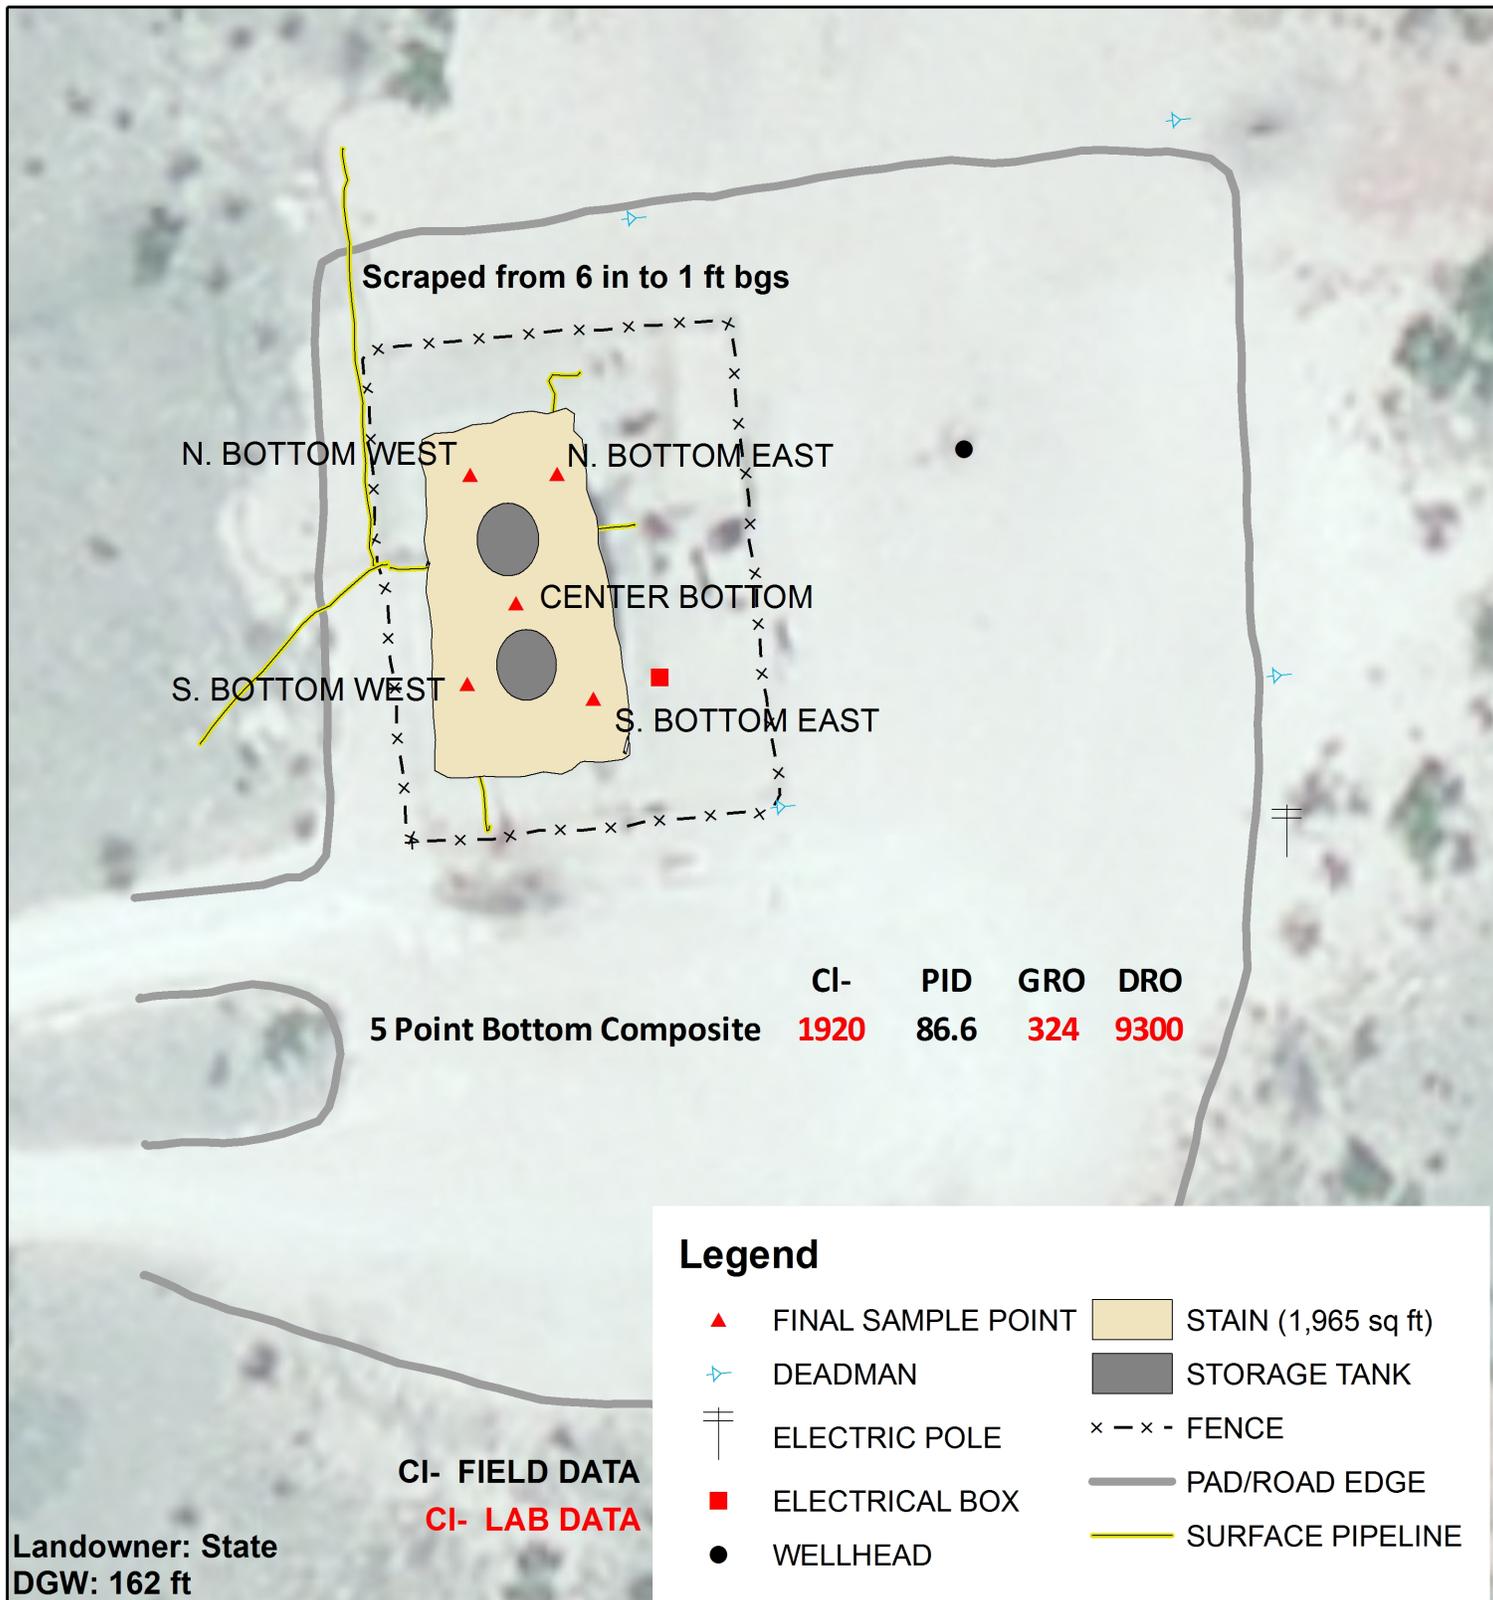
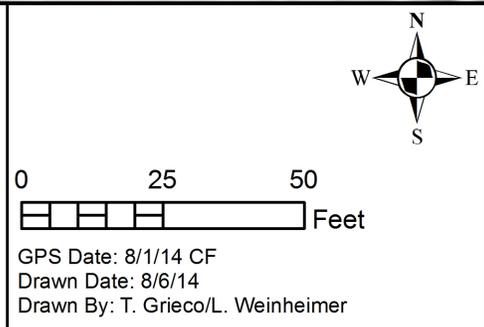
Excavation Data

**CONOCOPHILLIPS
PHILMEX #9**

UL B SECTION 26
T-17-S R-33-E
LEA COUNTY, NM

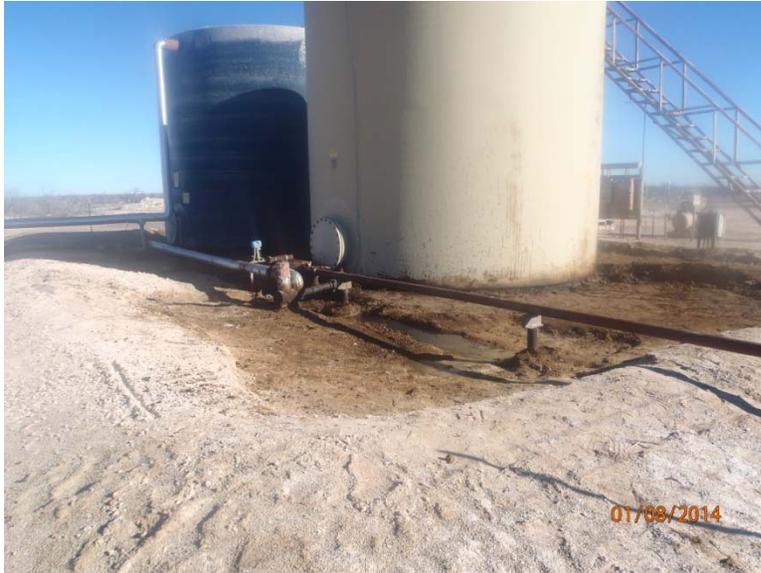
1/8/14

Inside Battery, facing northeast

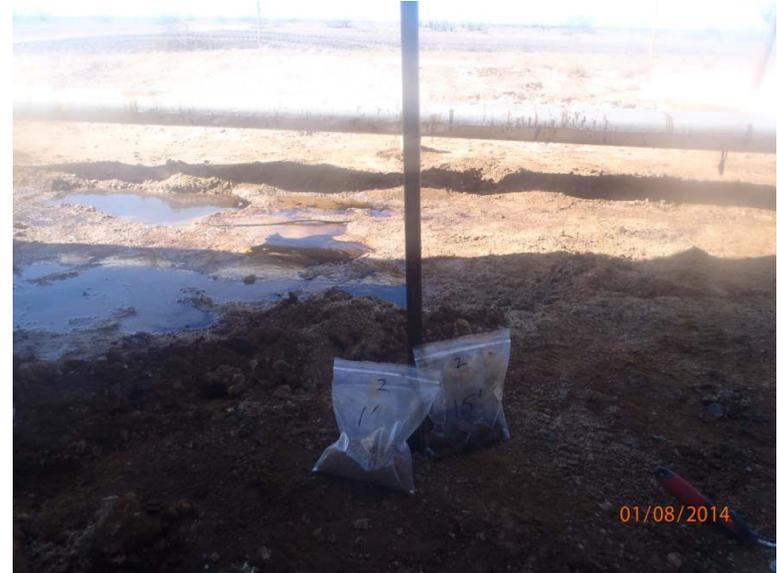
1/8/14

Hand Auger pt. 2, facing west

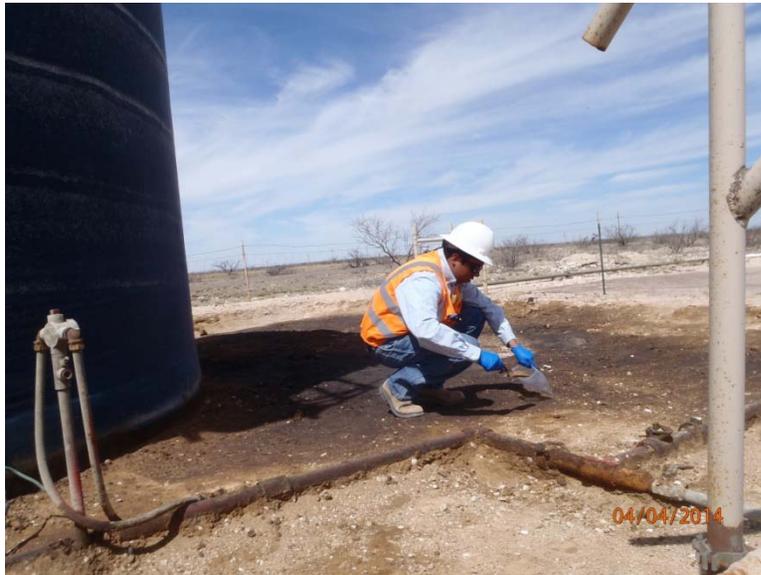
4/4/14

Collecting composite sample, facing southwest

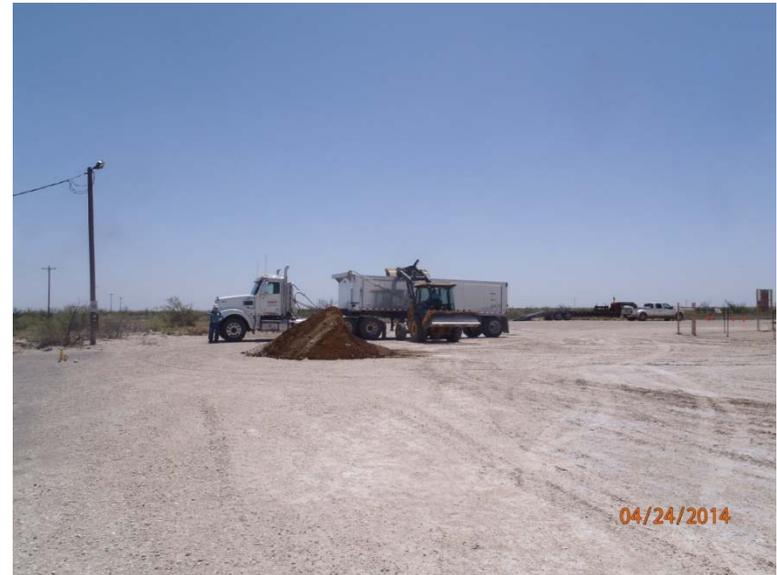
4/24/14

Exporting spoiled material, facing east

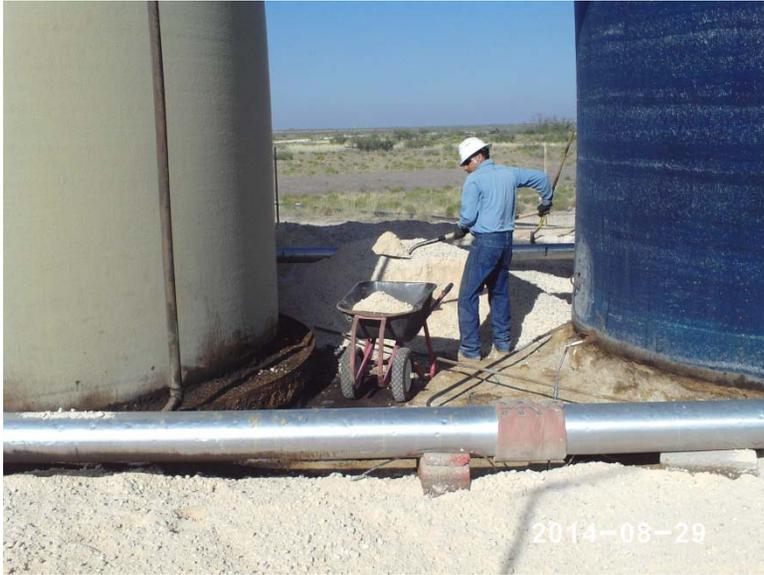
8/29/14

Backfilling battery, facing west

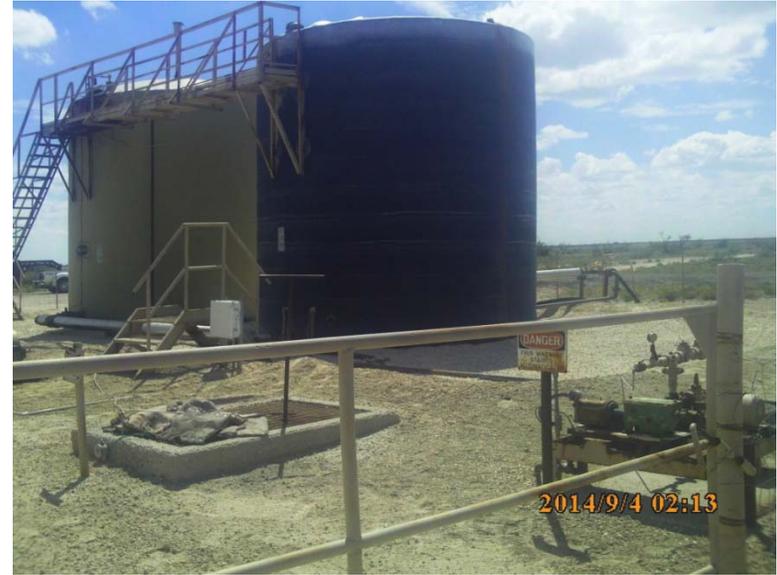
9/4/14

Final photo, facing southwest

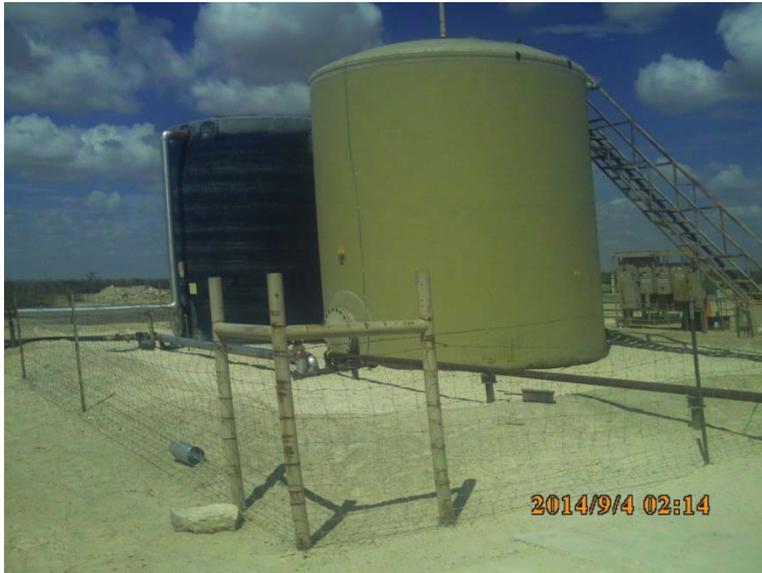
9/4/14

Final photo, facing northeast

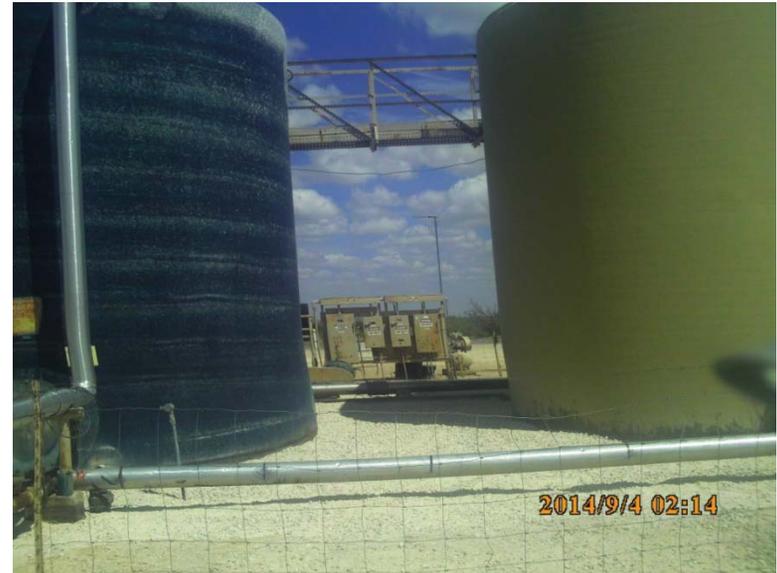
9/4/14

Final photo, facing east
