REMEDIATION SUMMARY & SITE CLOSURE REQUEST

**SOUTHERN UNION GAS SERVICES
6-INCH LATERAL EXXON MOBIL
Lea County, New Mexico
Unit Letter "D" (NW/NW), Section 2, Township 22 South, Range 37 East
Latitude 32° 25.341' North, Longitude 103° 08.405' West
NMOCD Reference #1RP-03-11-2690**

April 2012

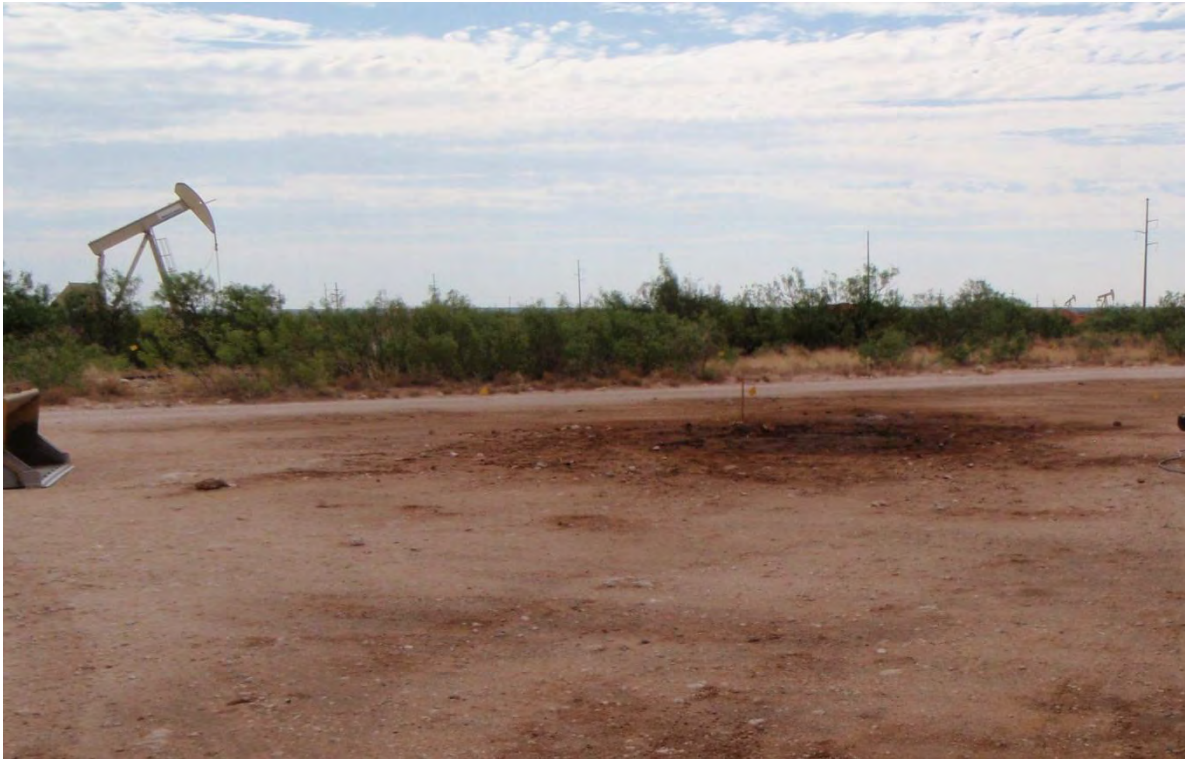
6-Inch Lateral Exxon Mobil - Release Site

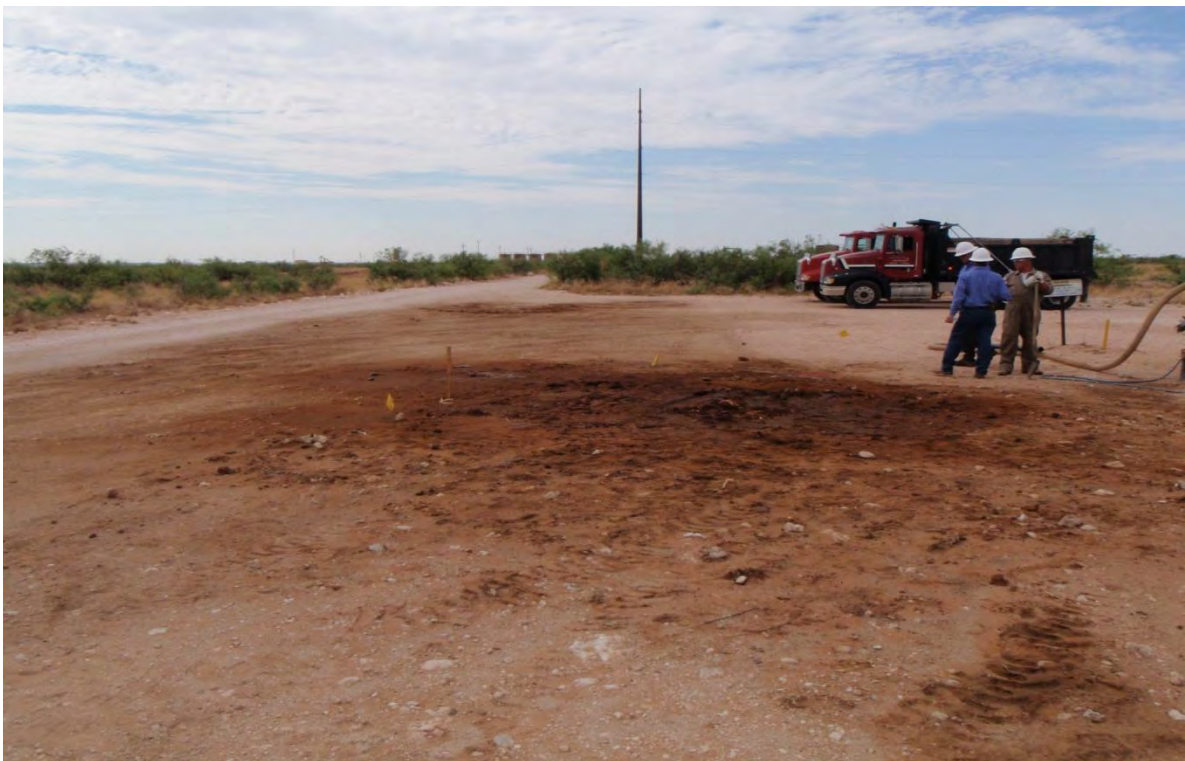
6-Inch Lateral Exxon Mobil - Release Site (Prior to Hydro Excavation)

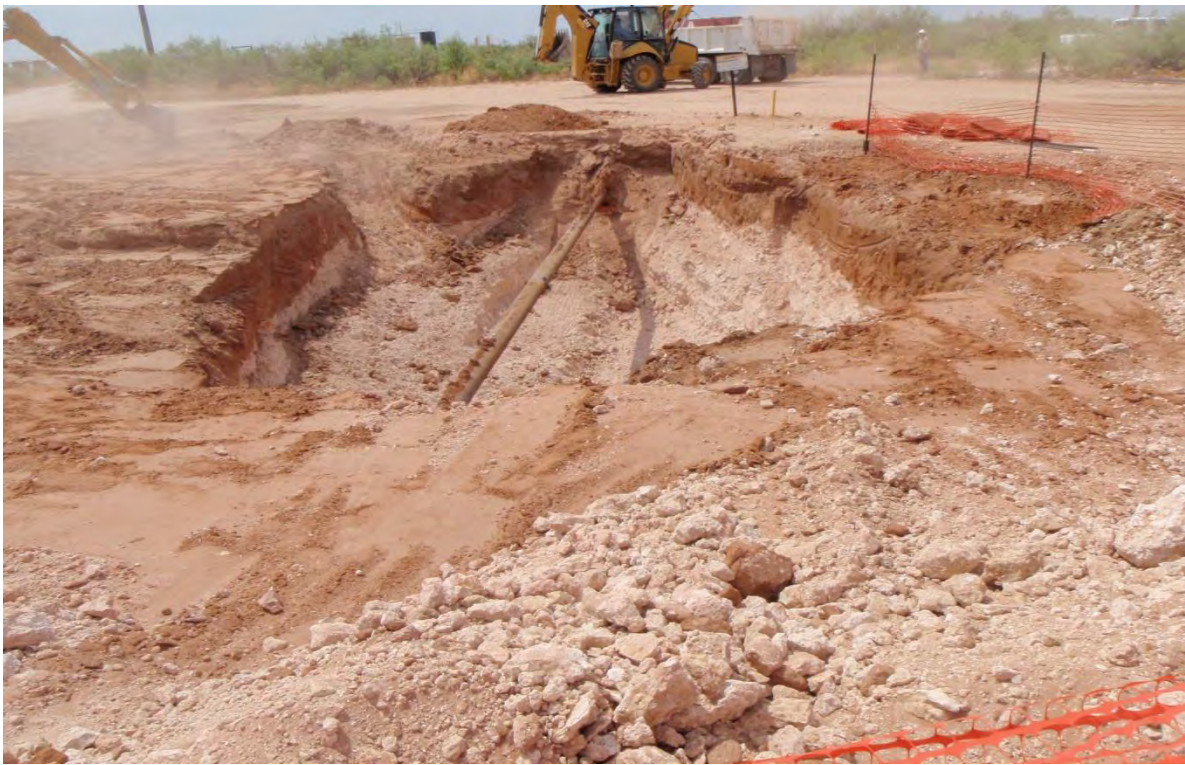
6-Inch Lateral Exxon Mobil - Excavation (Release Point)

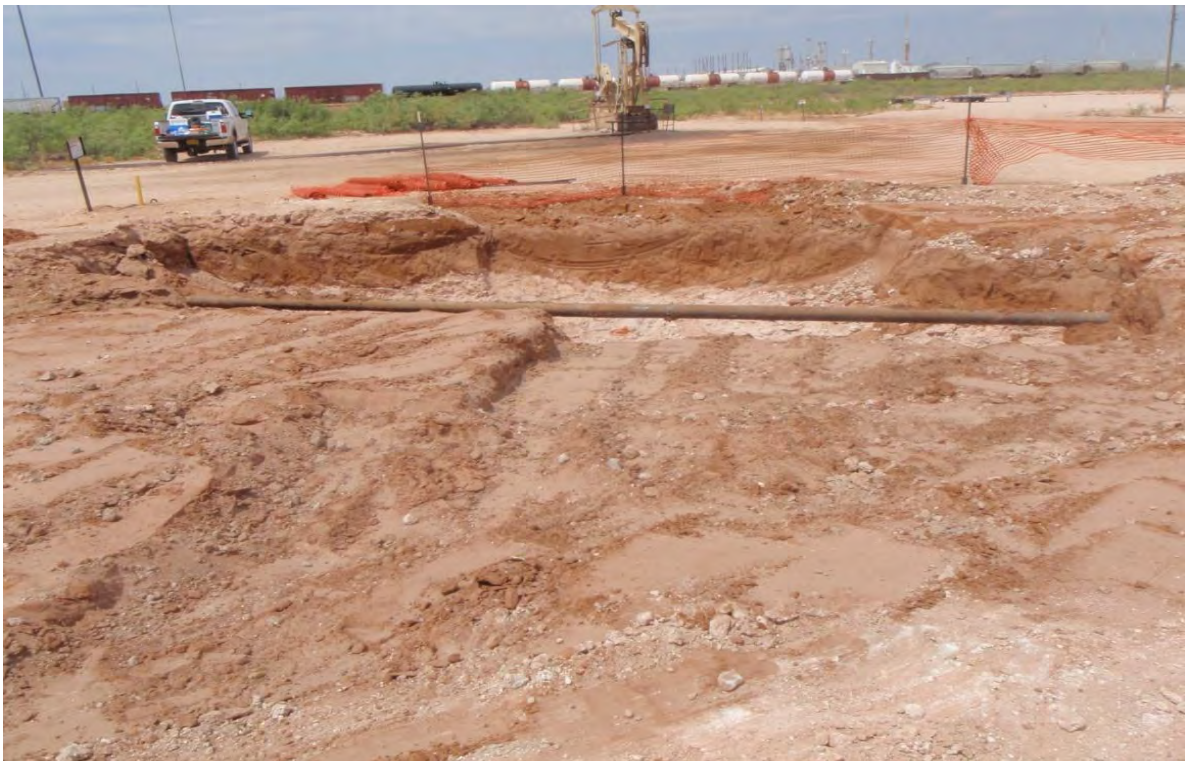
6-Inch Lateral Exxon Mobil - Excavation (Release Point)

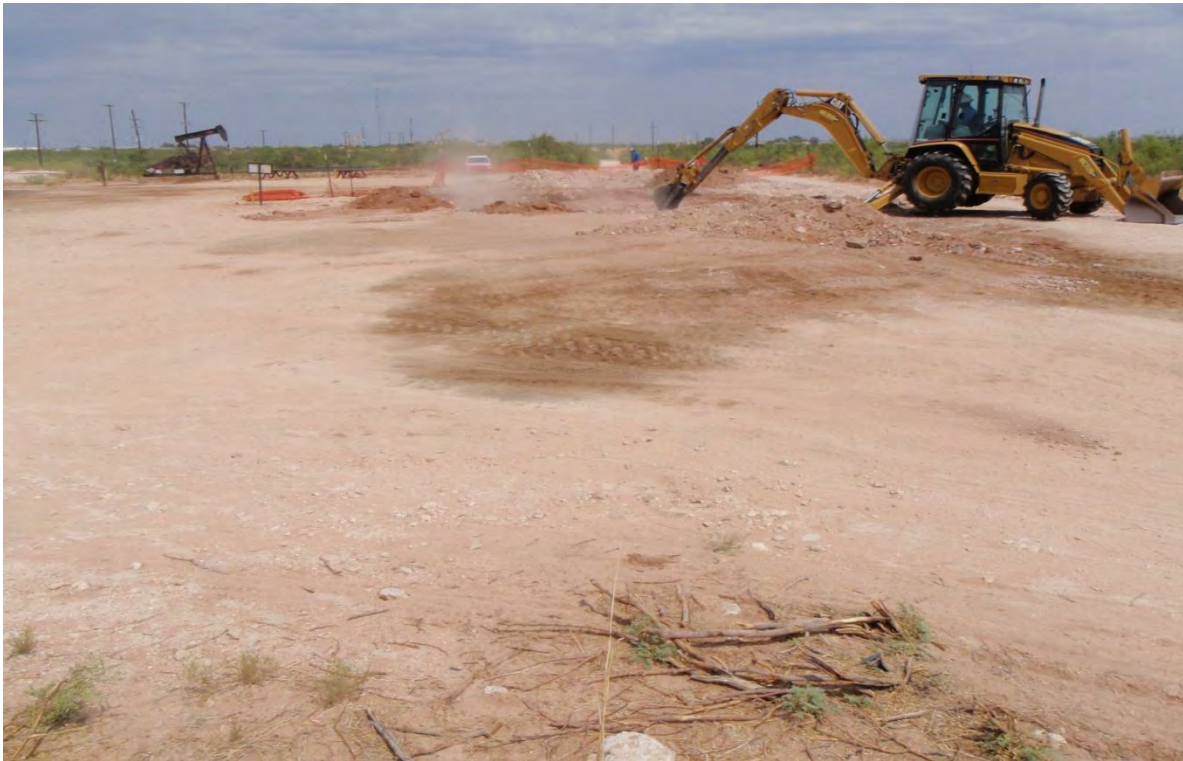
6-Inch Lateral Exxon Mobil - Excavation (Flowpath)

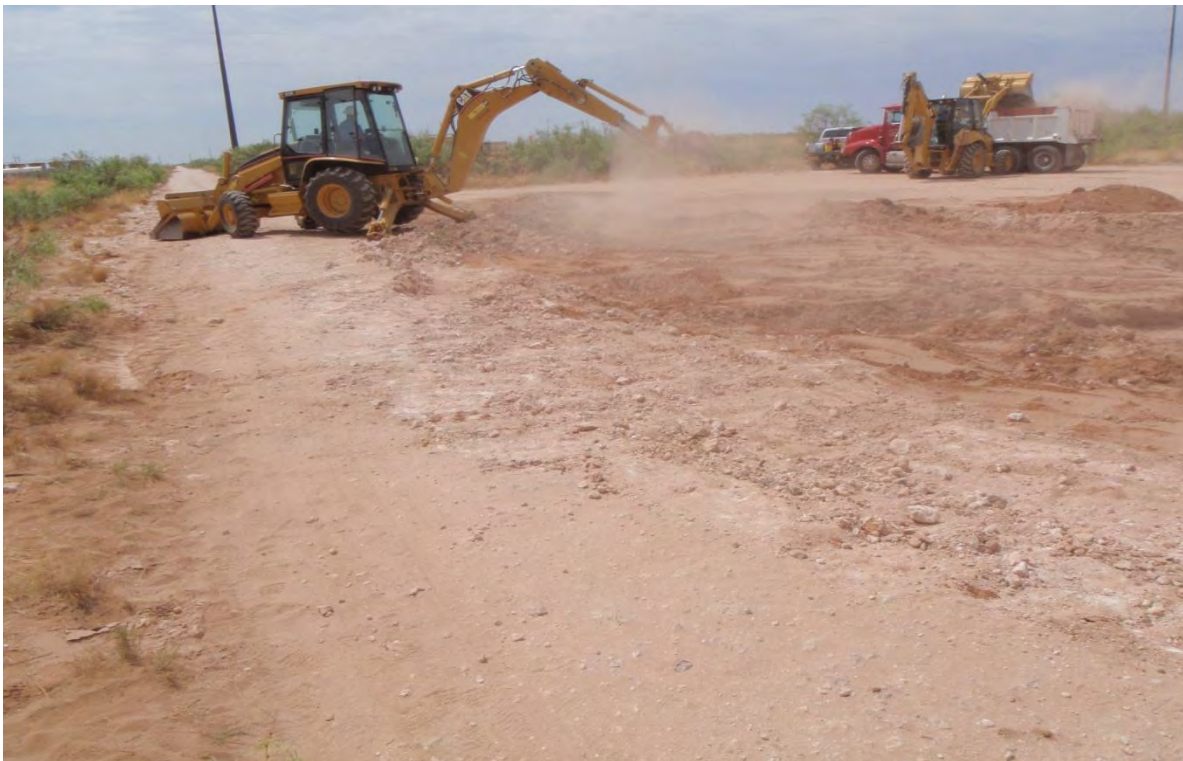
6-Inch Lateral Exxon Mobil - Excavation (Flowpath)

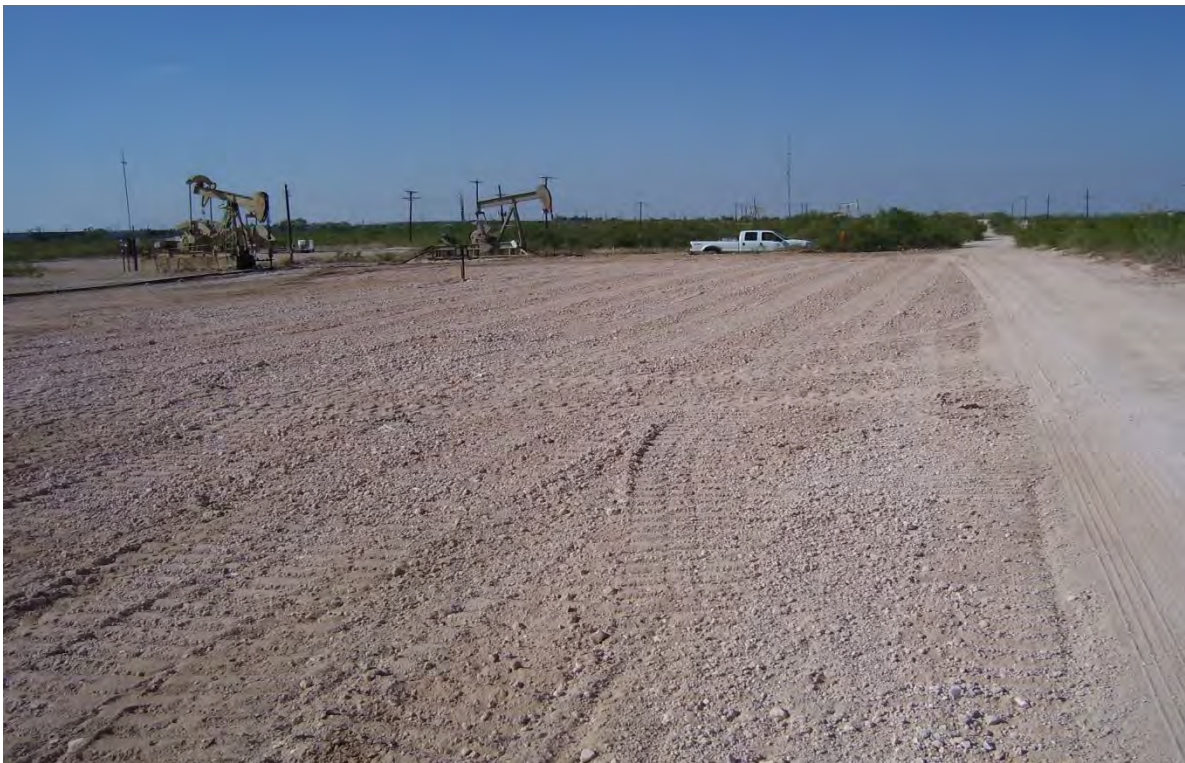
6-Inch Lateral Exxon Mobil - Excavation (Following Backfill)

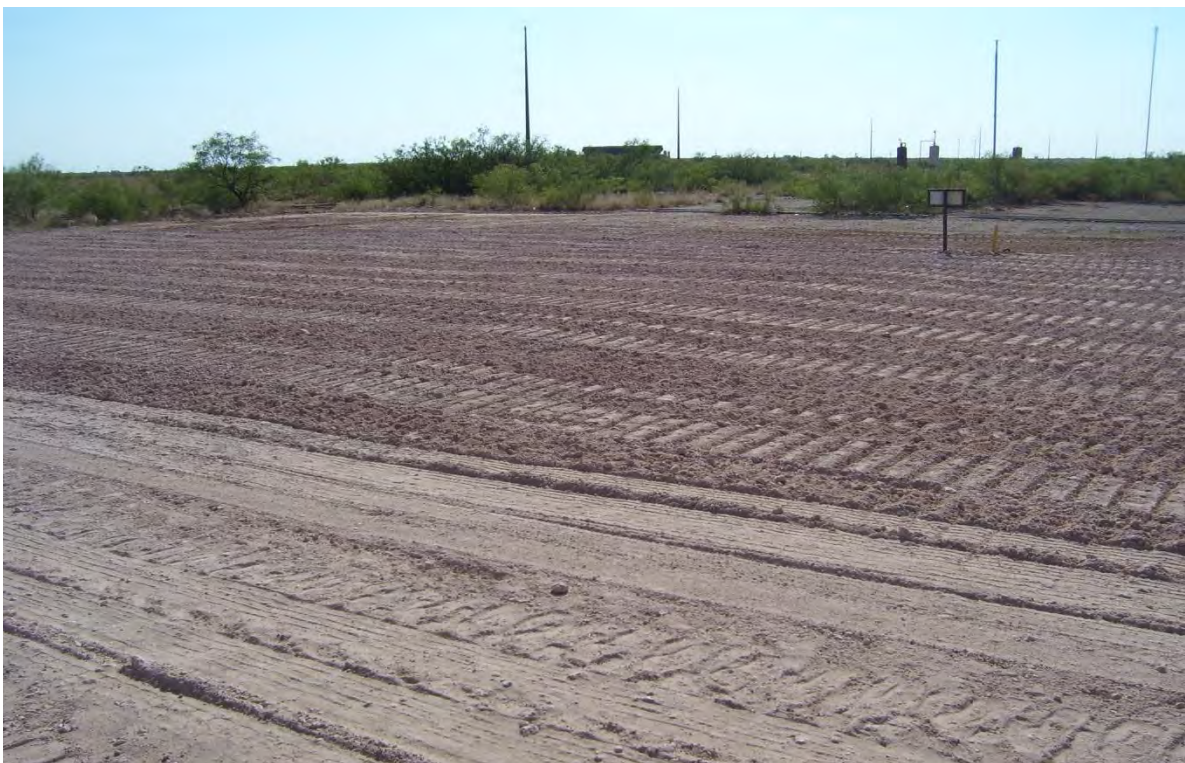
6-Inch Lateral Exxon Mobil - Excavation (Following Backfill)
