**OXY USA, Inc.**  
**West Dollarhide Devonian Unit #121**  
**Closure Report**  
**Section 33, T24S, R38E**  
**Lea County, New Mexico**

**December 8, 2014**

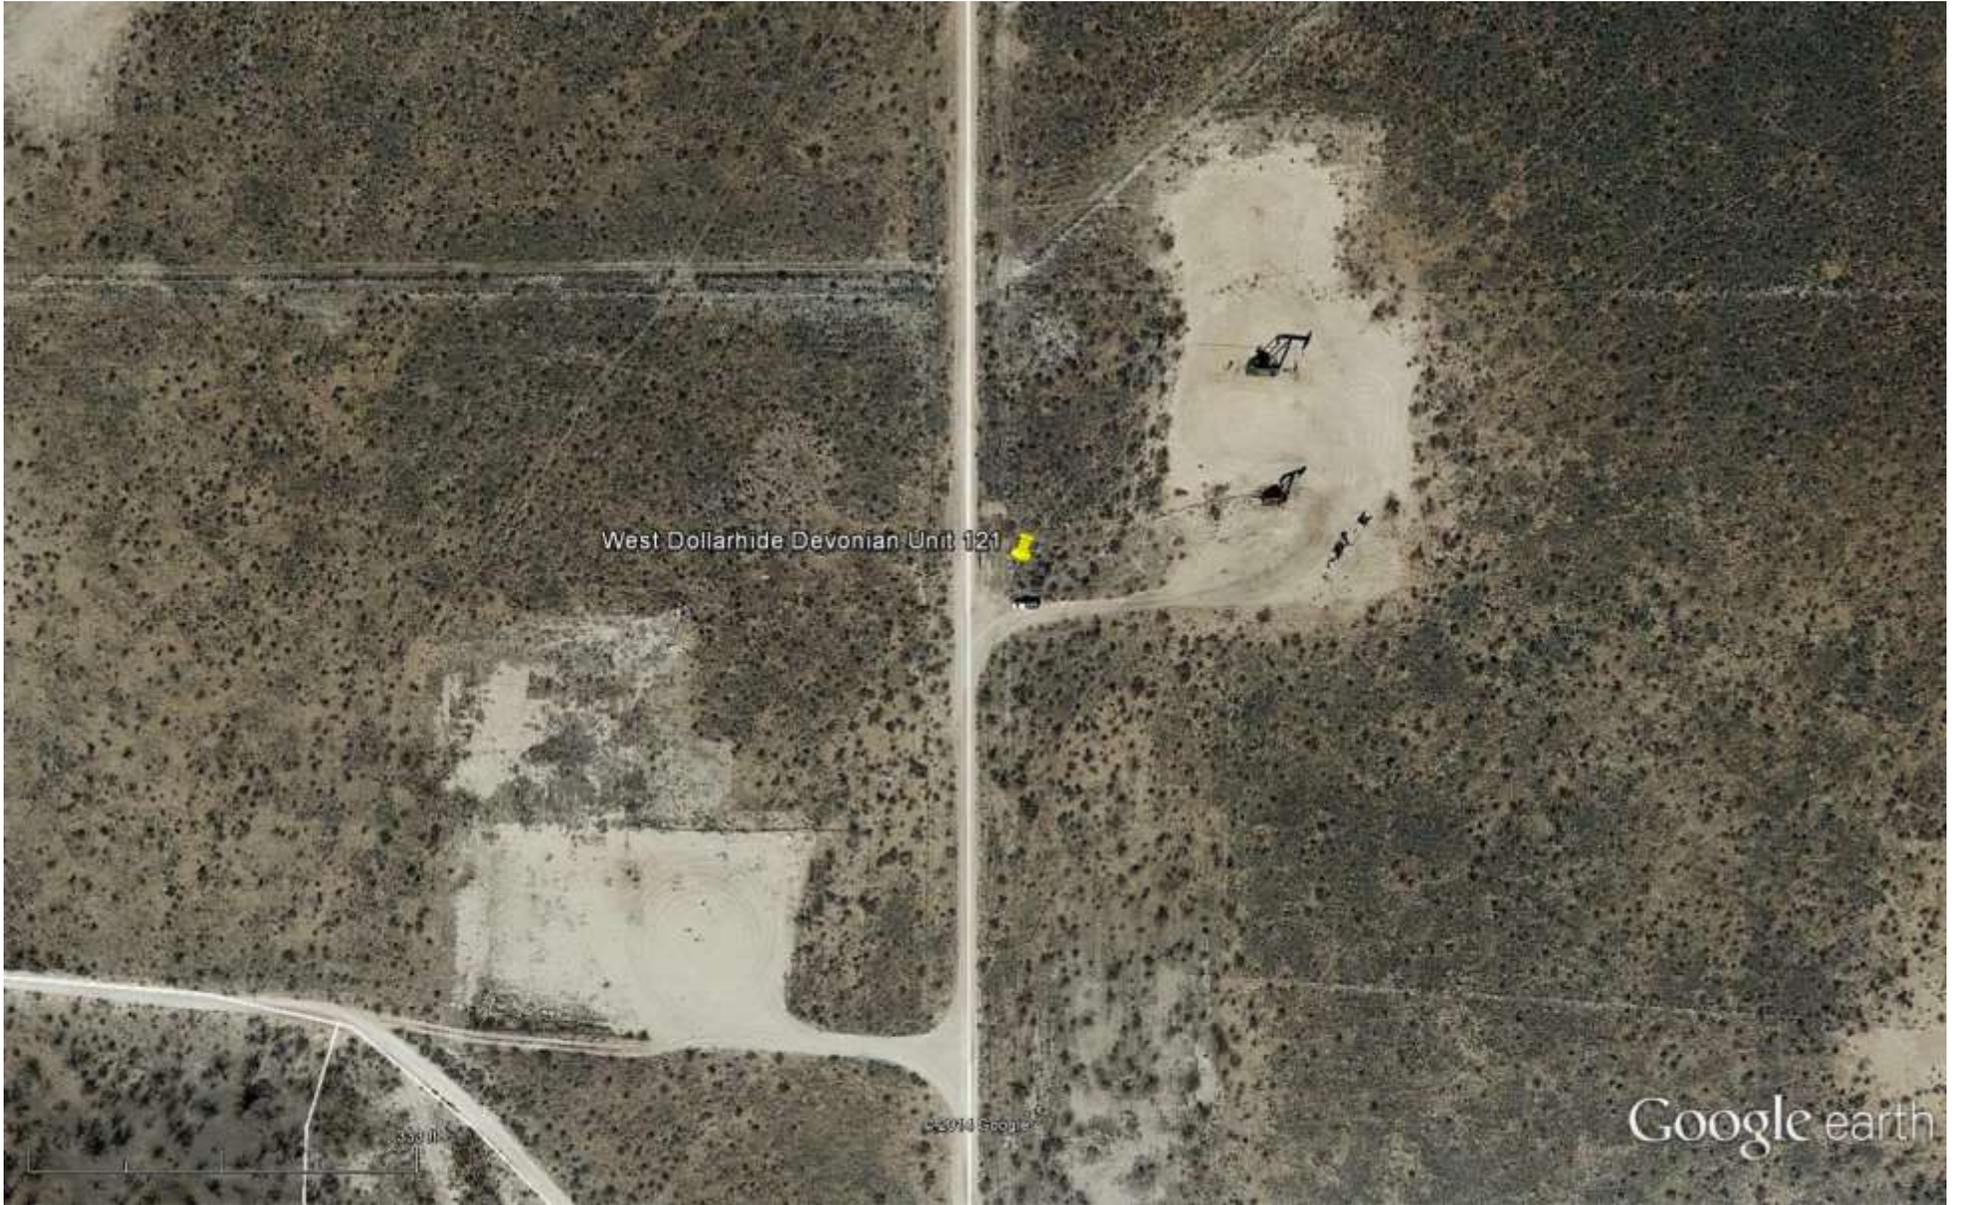
**Figure 2**  
**Site Plan**

West Dollarhide Devonian Unit 121

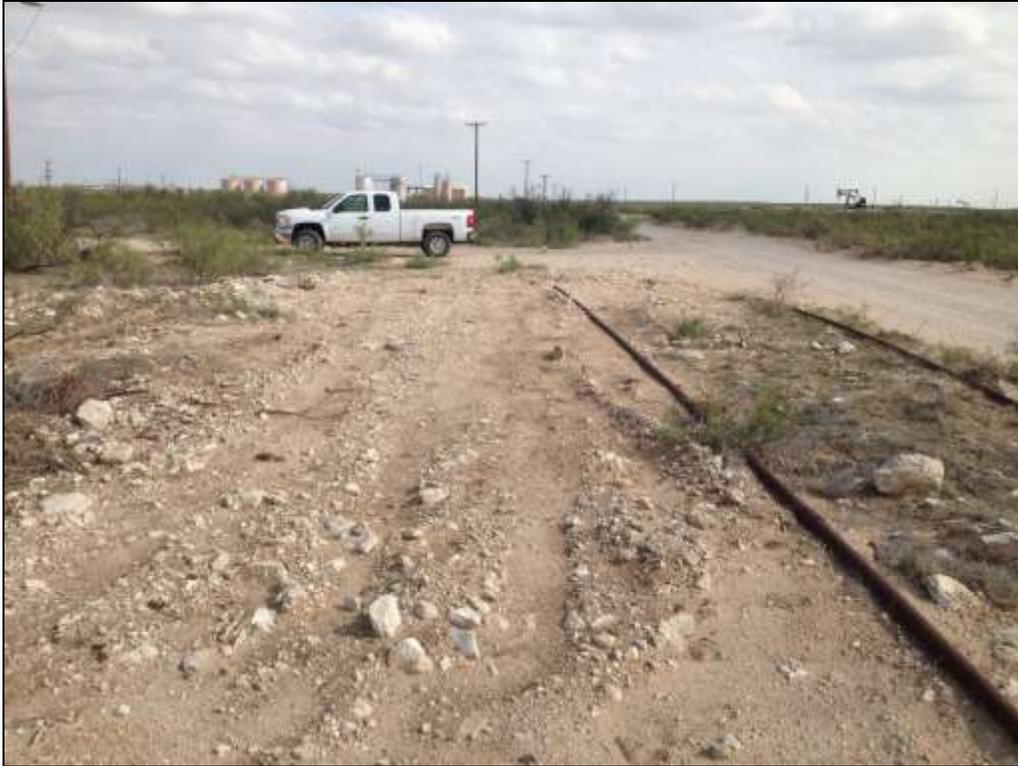
Looking south from leak following removal of stained surficial soil

Excavated approximately 1' and removed all the contaminated soil from the spill area, transported to Sundance. The excavated has been backfilled with native soil and returned to natural grade.

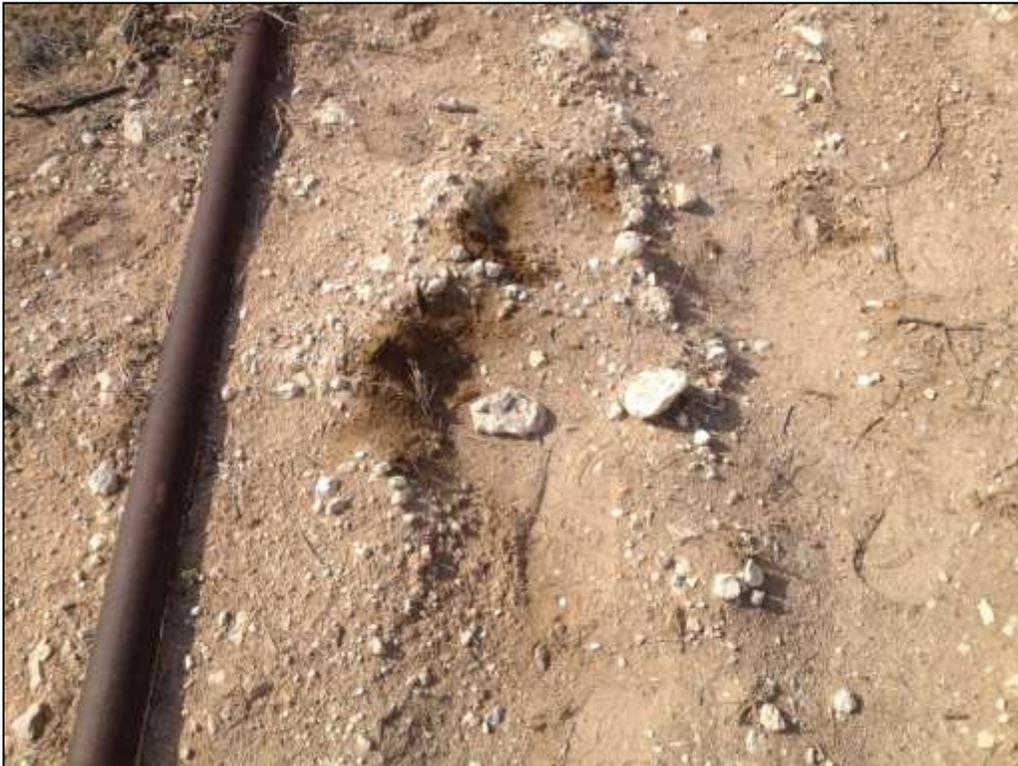
Soil staining remaining near leak location

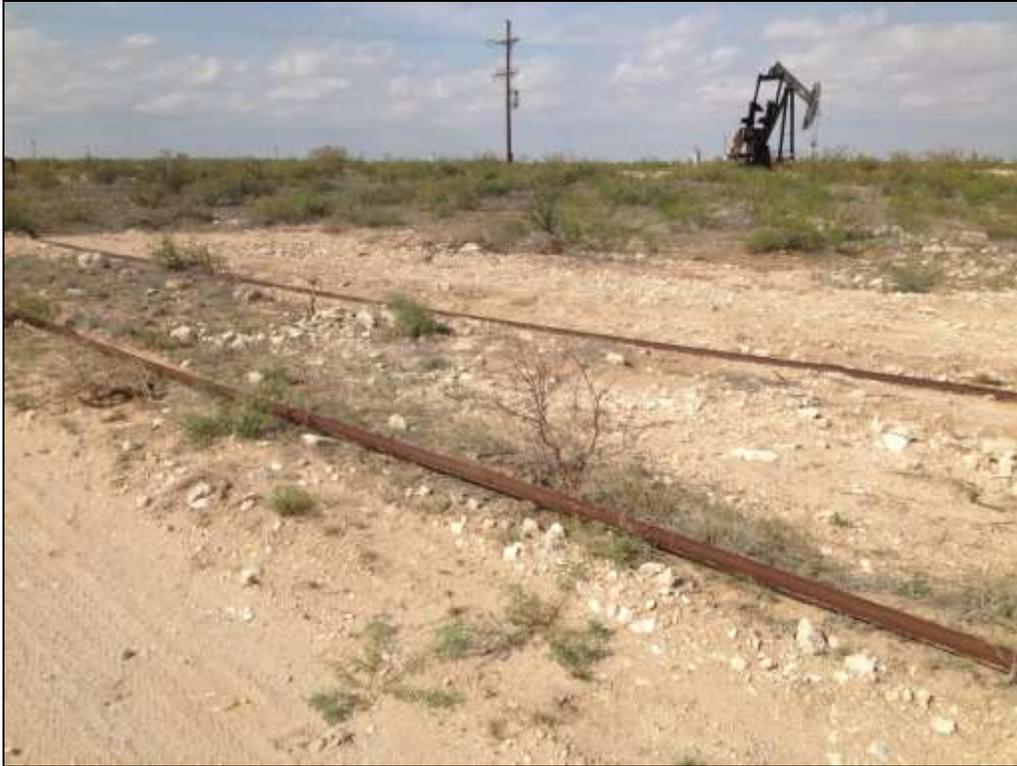
Looking northeast from lease road. Leak was from rear pipe

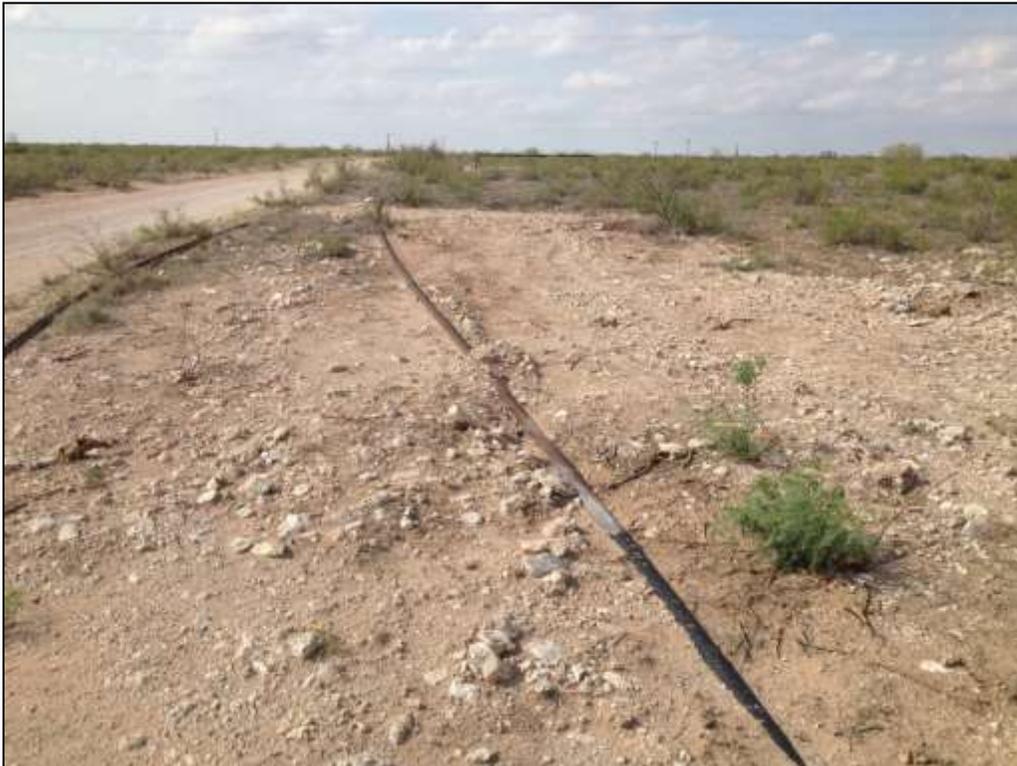
Looking north toward leak release point

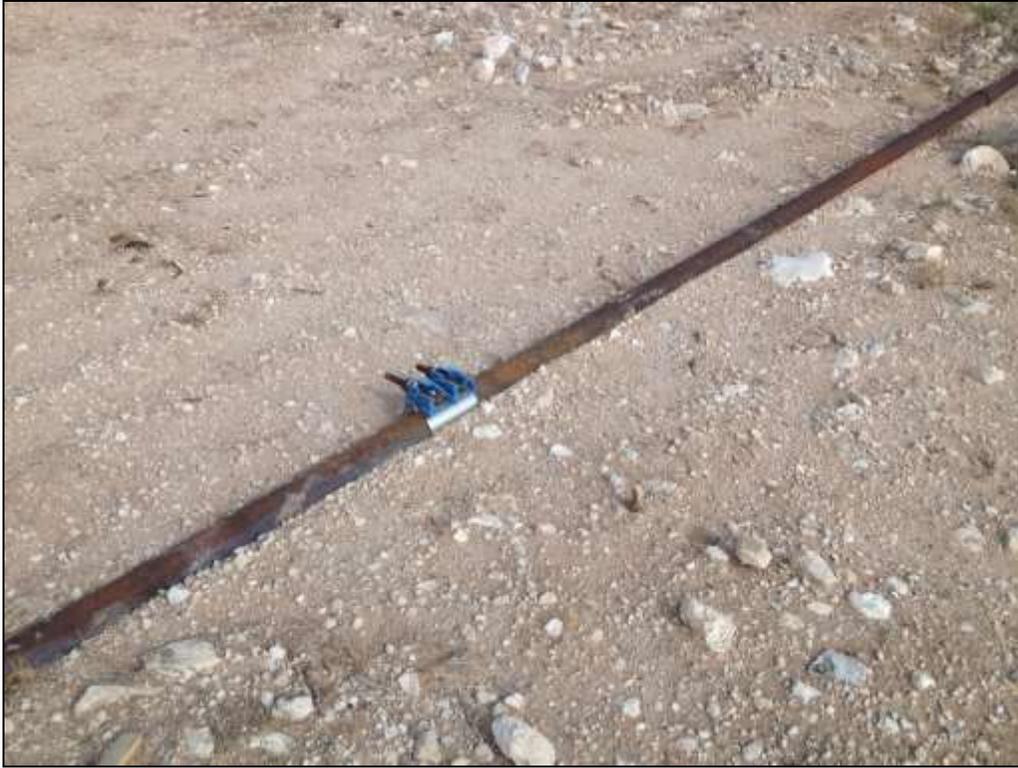
Clamp on pipe which leaked
