# FINAL REPORT SUMMARIZING CLOSURE FOR INCIDENT 1RP-3447 AND 1RP-3474

MADRON SERVICES INC  
LUSK DEEP UNIT A #019  
API# 30-025-35244  
SECTION 17, T19S R32E, NM  
LEA COUNTY, NM

Prepared by:  
Souder, Miller & Associates  
201 S. Halagueno  
Carlsbad, NM 88221  
575-689-7040

June 1, 2015  
Reference 5B23776 BG1

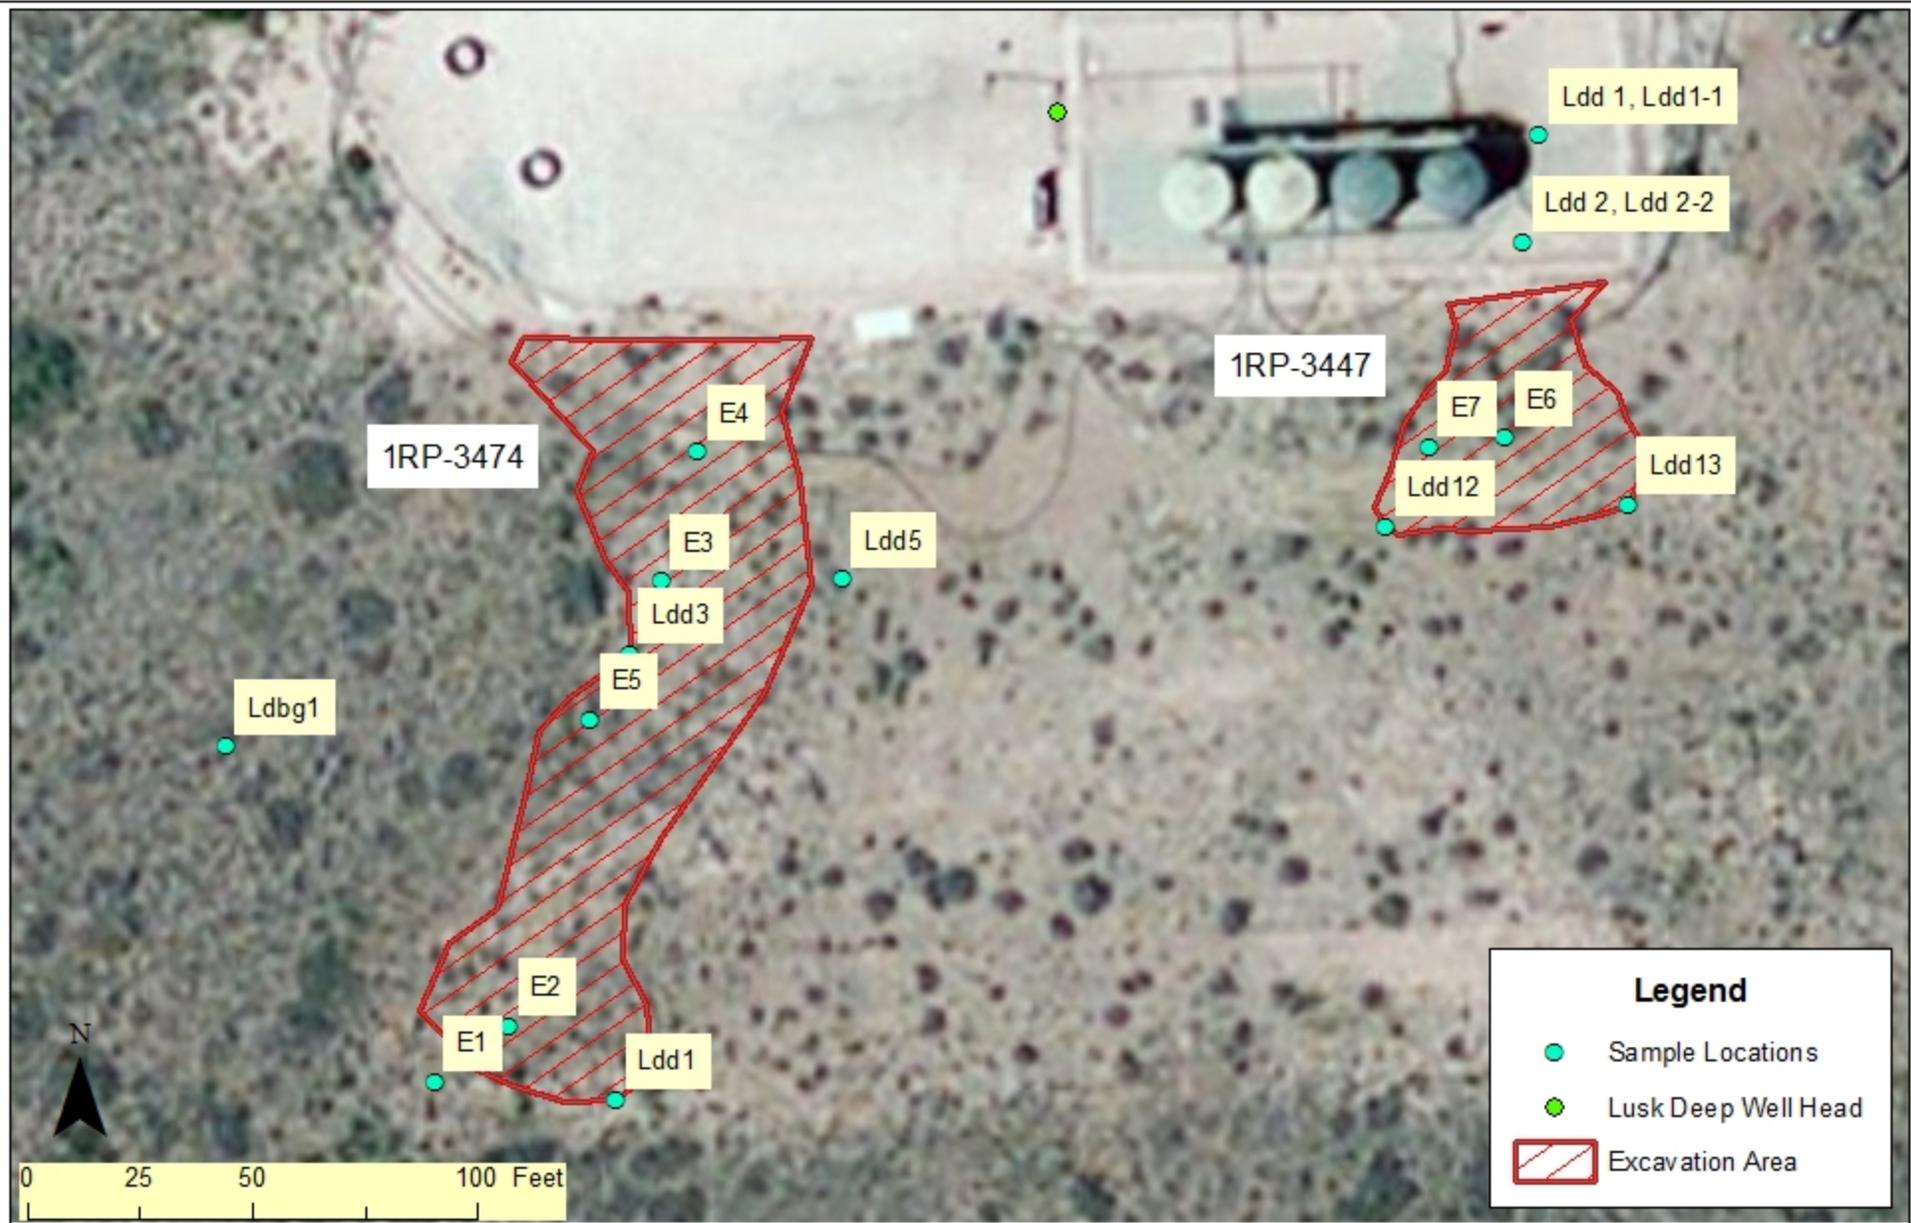
Figure 2

## SITE DETAILS AND SAMPLE LOCATIONS MAP

Site Map for Lusk Deep SWD  
MSI  
Carlsbad, New Mexico

Side-wall samples were taken to confirm the contaminated soils had been removed to the horizontal extent depicted on Figure 2, with the analytical results shown in Table 3. Bottom-hole samples were taken with to document the characteristics of the soils left in place. Each sample container was labeled, placed on ice in an insulated cooler, and chilled to a temperature of approximately 40°F (4°C). The cooler was sealed for shipment to the laboratory, accompanied by proper chain-of-custody documentation. The soil samples were delivered on 3/12/15 to Hall Environmental Analysis Laboratory, Inc., in Albuquerque, New Mexico for analysis for Benzene and Total BTEX using EPA Method 8021B, DRO and GRO by EPA Method 8015D, and total Chlorides using EPA Method 300.0.

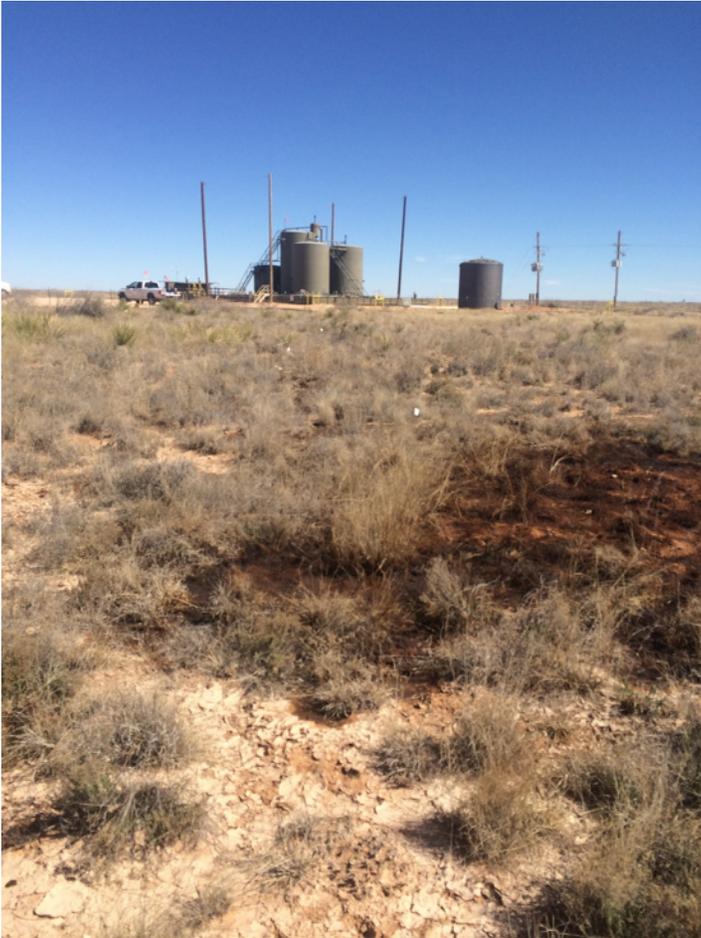
Contaminated soil on Southwest side off of pad.  
Taken on 02/25/15

Contaminated soil was excavated using heavy equipment and transported off location to an NMOCD approved disposal facility. Soil samples were taken within the excavation to confirm that remediation goals had been achieved. The samples were sent to Hall Environmental Analysis Laboratory under standard Chain of Custody protocol. The analytical results are summarized in Tables 1, 2 and 3. Since the old reserve pit is located below both spill areas off of the pad, vertical excavation was limited to three feet bsg in an effort to not disturb the historic reserve pit. As a result, some contaminated soils were left in place. A barrier of a one foot thick layer of caliche was placed on top of the remaining contaminated soil in an effort to isolate the contaminated soils from the clean top soil used for backfill.

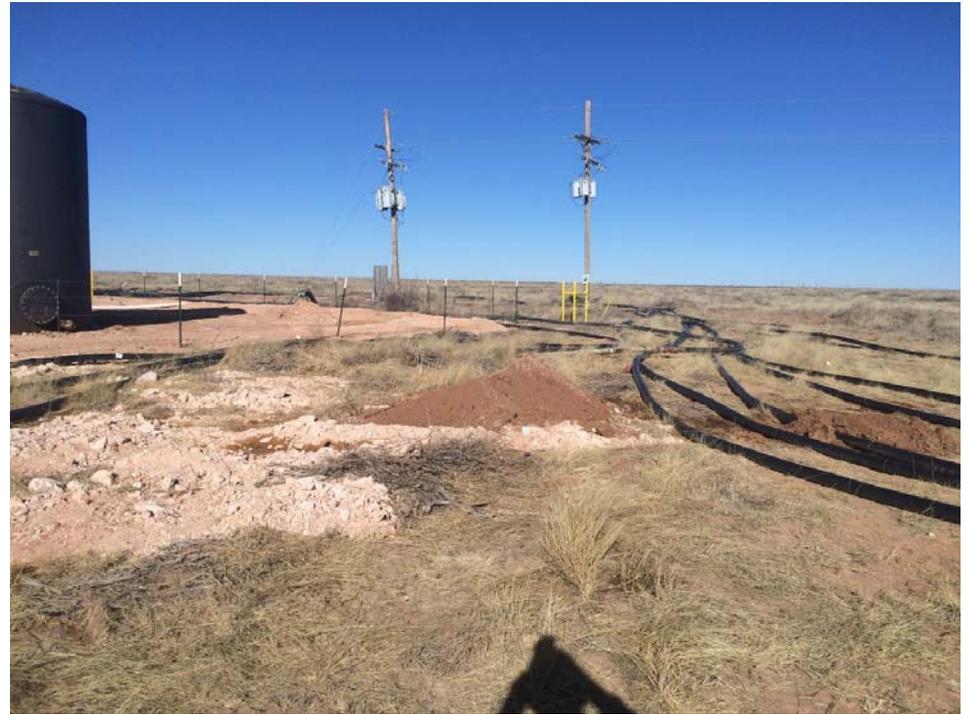
Contaminated soil on Southeast side off of pad. taken  
on 02/25/15

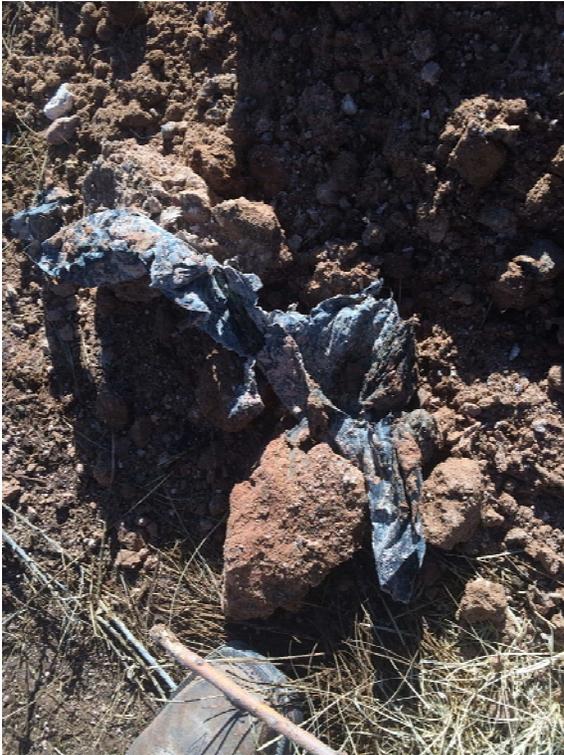
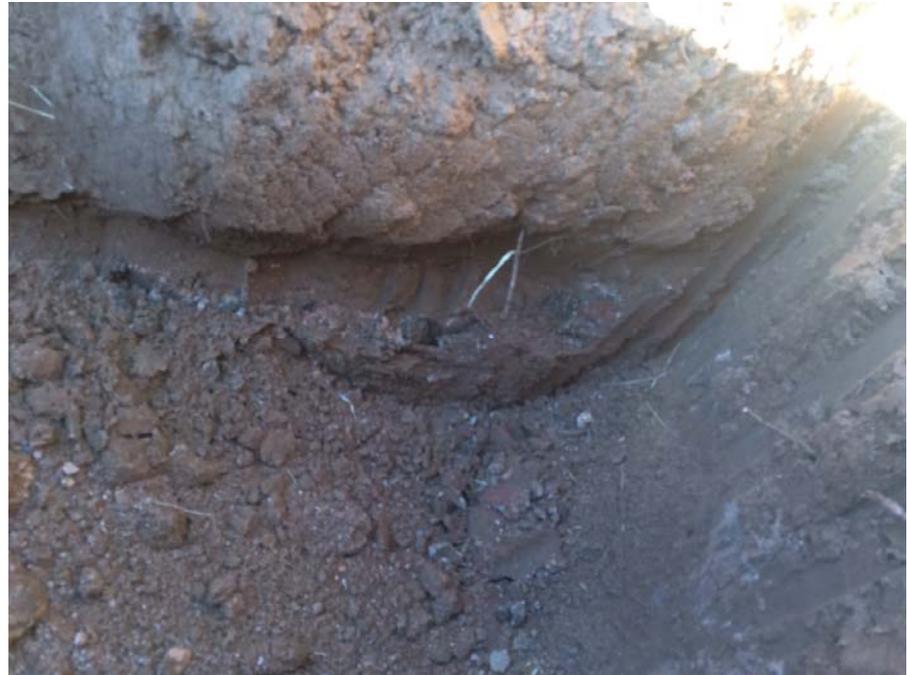
Historic pit liner. Taken on 02/25/15

When mitigating the contaminated soil on the south side off of the pad, precaution was taken to avoid contact with the old buried reserve pit. BLM personnel informed SMA of the buried pit. The southeast and southwest sides off of the well pad were excavated with screening guidance from SMA personnel, using EPA Method 4500 titrations along with the PID meter in accordance to the NMOCD Guidelines. To delineate the 1RP-3447 spill on the southeast side, two holes were dug as depicted on Figure 2. One delineation hole was initially advanced to three foot bsg. At three feet eight inches, a liner for the reserve pit was encountered and digging stopped. The second delineation hole was dug to two feet bsg at which point the reserve pit liner was found. For this area, excavation was limited to two feet bsg in an effort to avoid disturbance of the reserve pit liner. The 1RP-3474 spill, which ran off of the pad on the southwest side, extended 220 feet south from the pad, as shown on Figure 2. This area was excavated between one and a half feet to three feet bsg to removed contaminated soils.

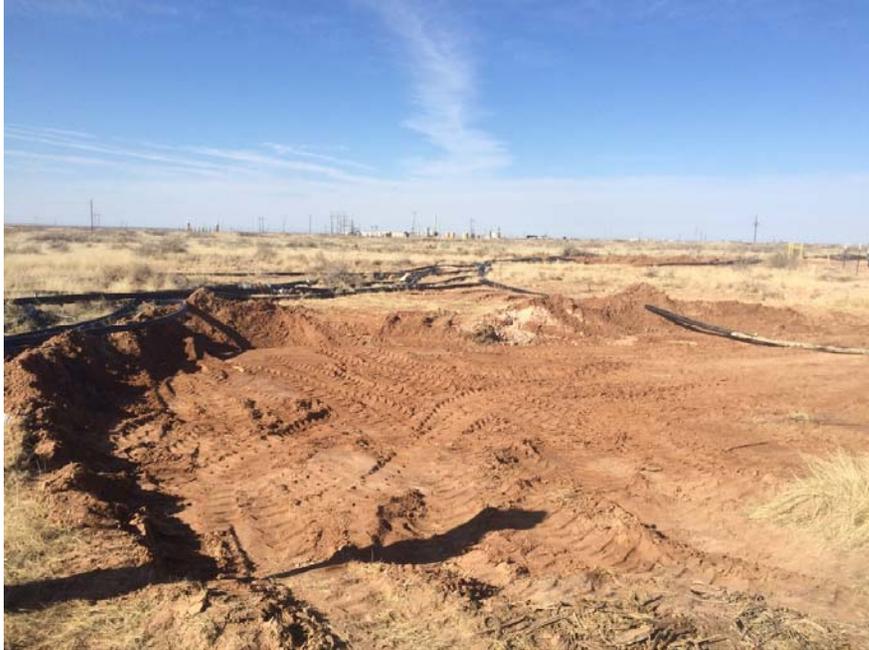
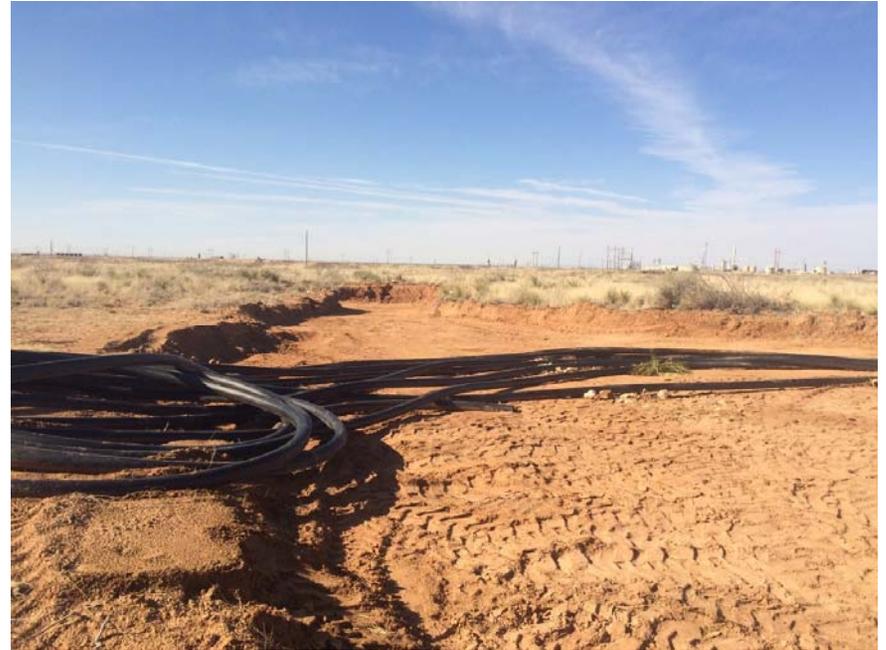
Excavation activities off pad taken on 03/12/15
