Re: **Assessment Corrective Action Plan**
SOGO III, LLC, State 20 Battery - RP No.: 3674
API No.: 30-025-28421
Legal: Unit B – Sec 20 – T23S – R36E – 660 FSL, 1980 FEL - Lea Co., NM
GPS: 32.295464, -103.284939
Depth to Groundwater: 75 – 100 ft bgs

Release Type: Crude Oil

Attachment B
Annotated Aerial Imagery

Attachment C
Photograph Log

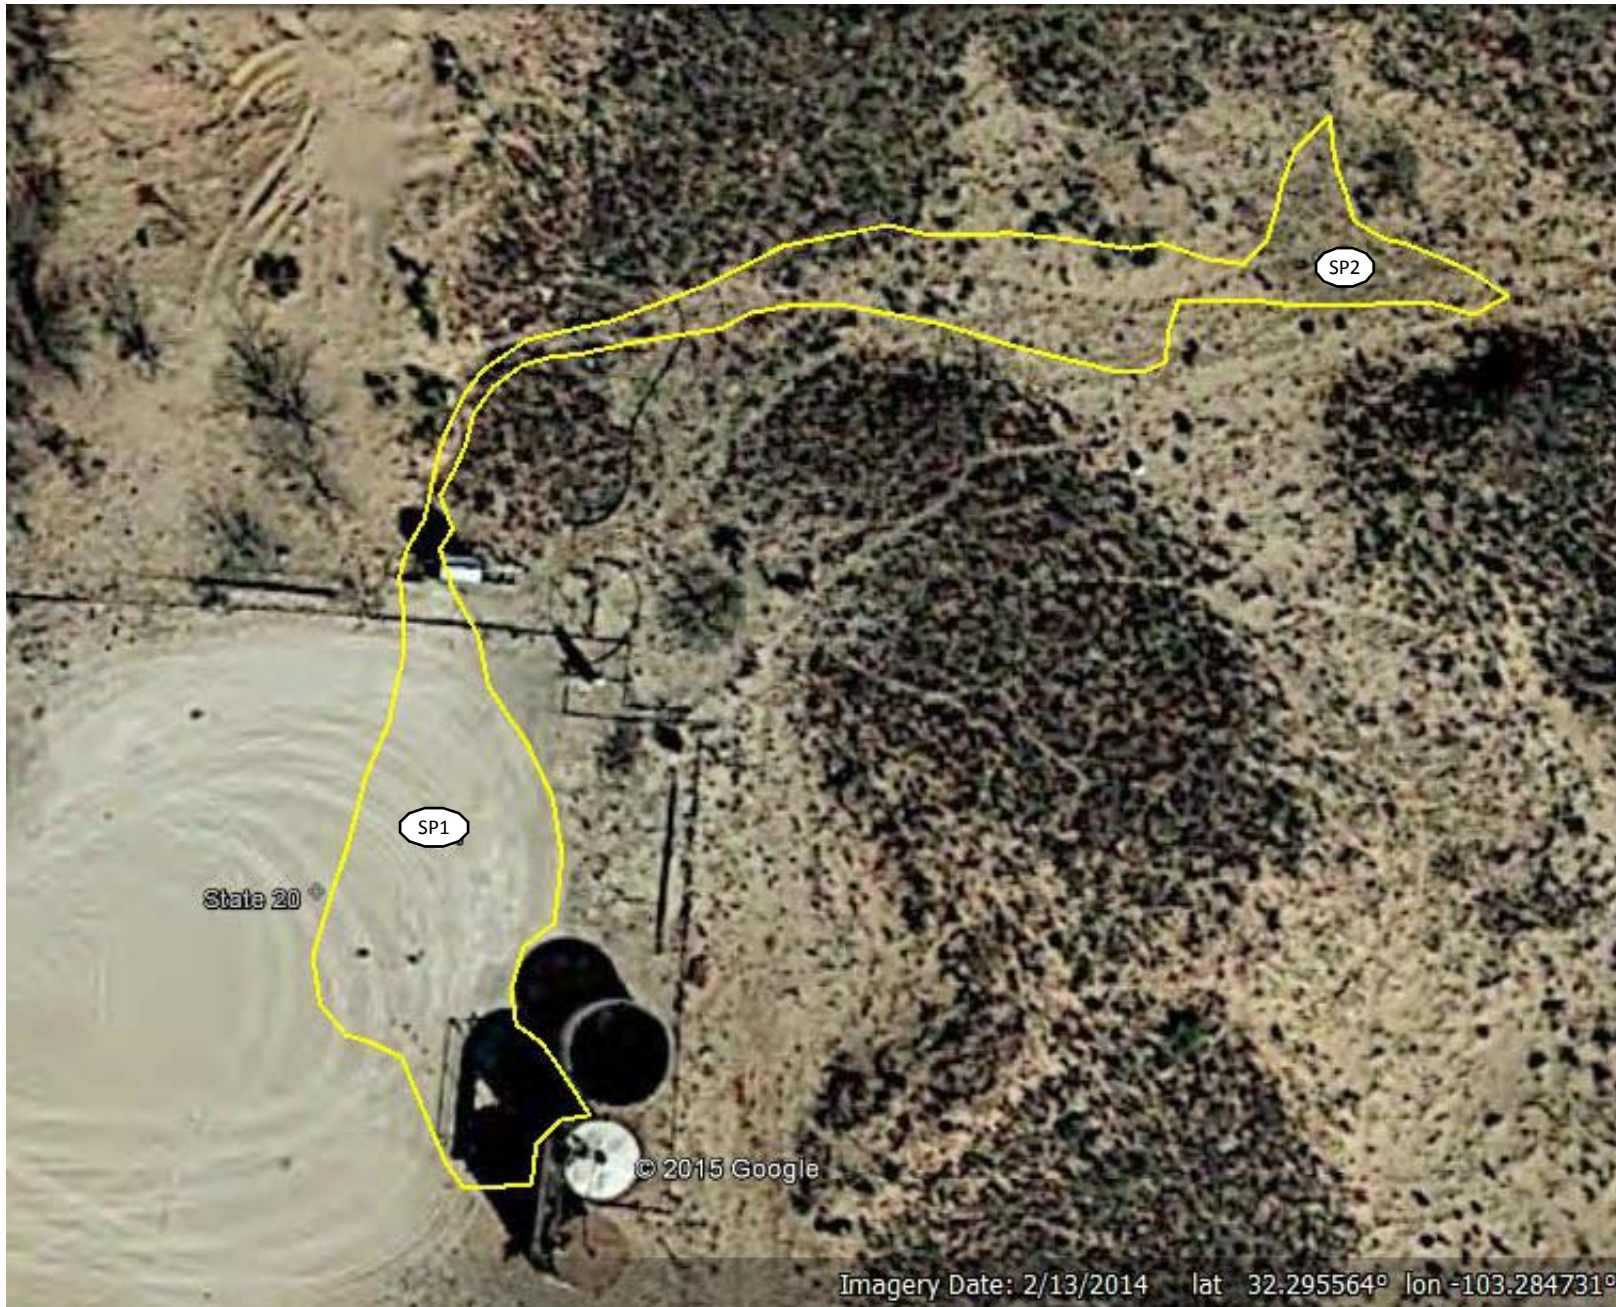
The release occurred due to failure on the tank at a small point of external corrosion. The release migrated northwest on the pad, then migrated eastward off site and followed a narrow surface channel to a depression where the majority of the release pooled. The impacted area of the pad and the surface channel appeared to be surficial and limited to the first 2 feet. The majority of the spill had collected in the pooled area. A copy of the C-141 is provided in Attachment A. An annotated aerial photograph showing the release area and TPH levels is provided in Attachment B. Photographs of the release area are provided in Attachment C.
