August 20 2015

Reference No. 088210-13

**Re: Remediation Summary Report
Vaca 24 Fed Com 3H (API #30-025-40530)
1RP-3610
EOG Resources
Site Location: Unit N, Sec. 24, T 25-S, R 33-E
(Lat 32.113754°, Long -103.530836°)
Lea County, New Mexico**

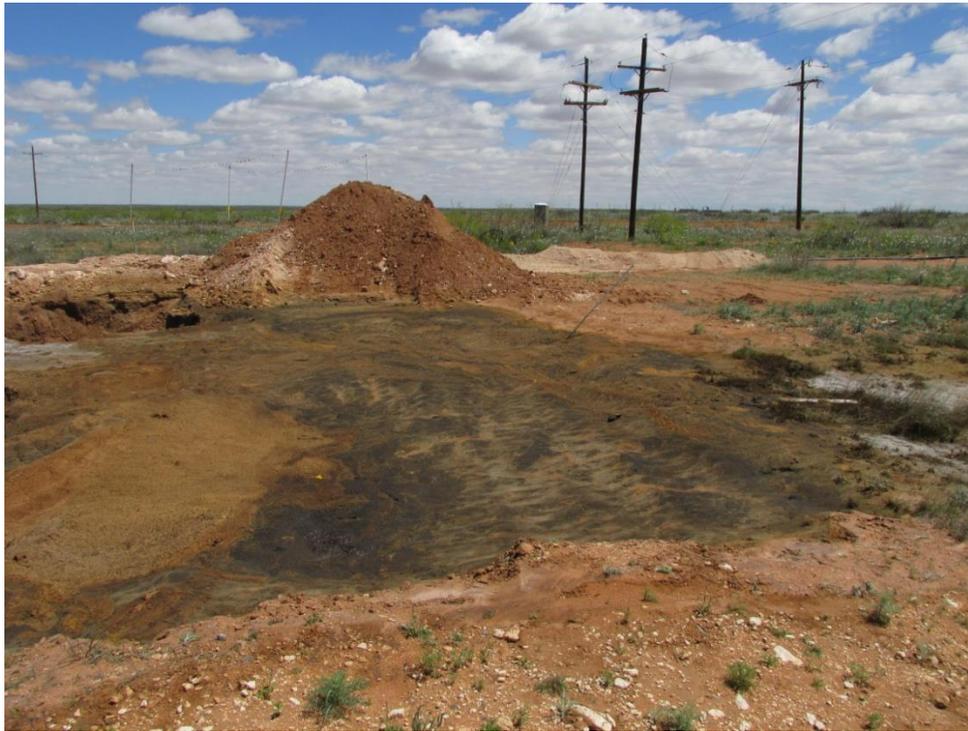
Photo 1 – Impacted area with previous excavation and stockpile. Photo taken facing northeast.

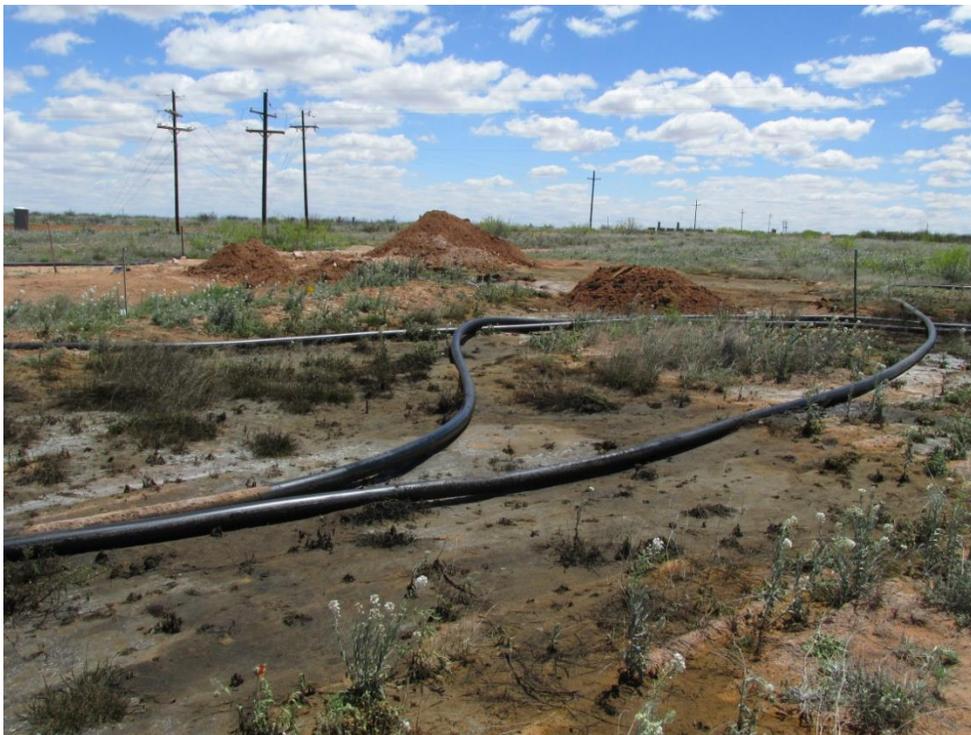
Photo 2 – Impacted area with previous excavations and stockpiles. Photo taken facing southeast.

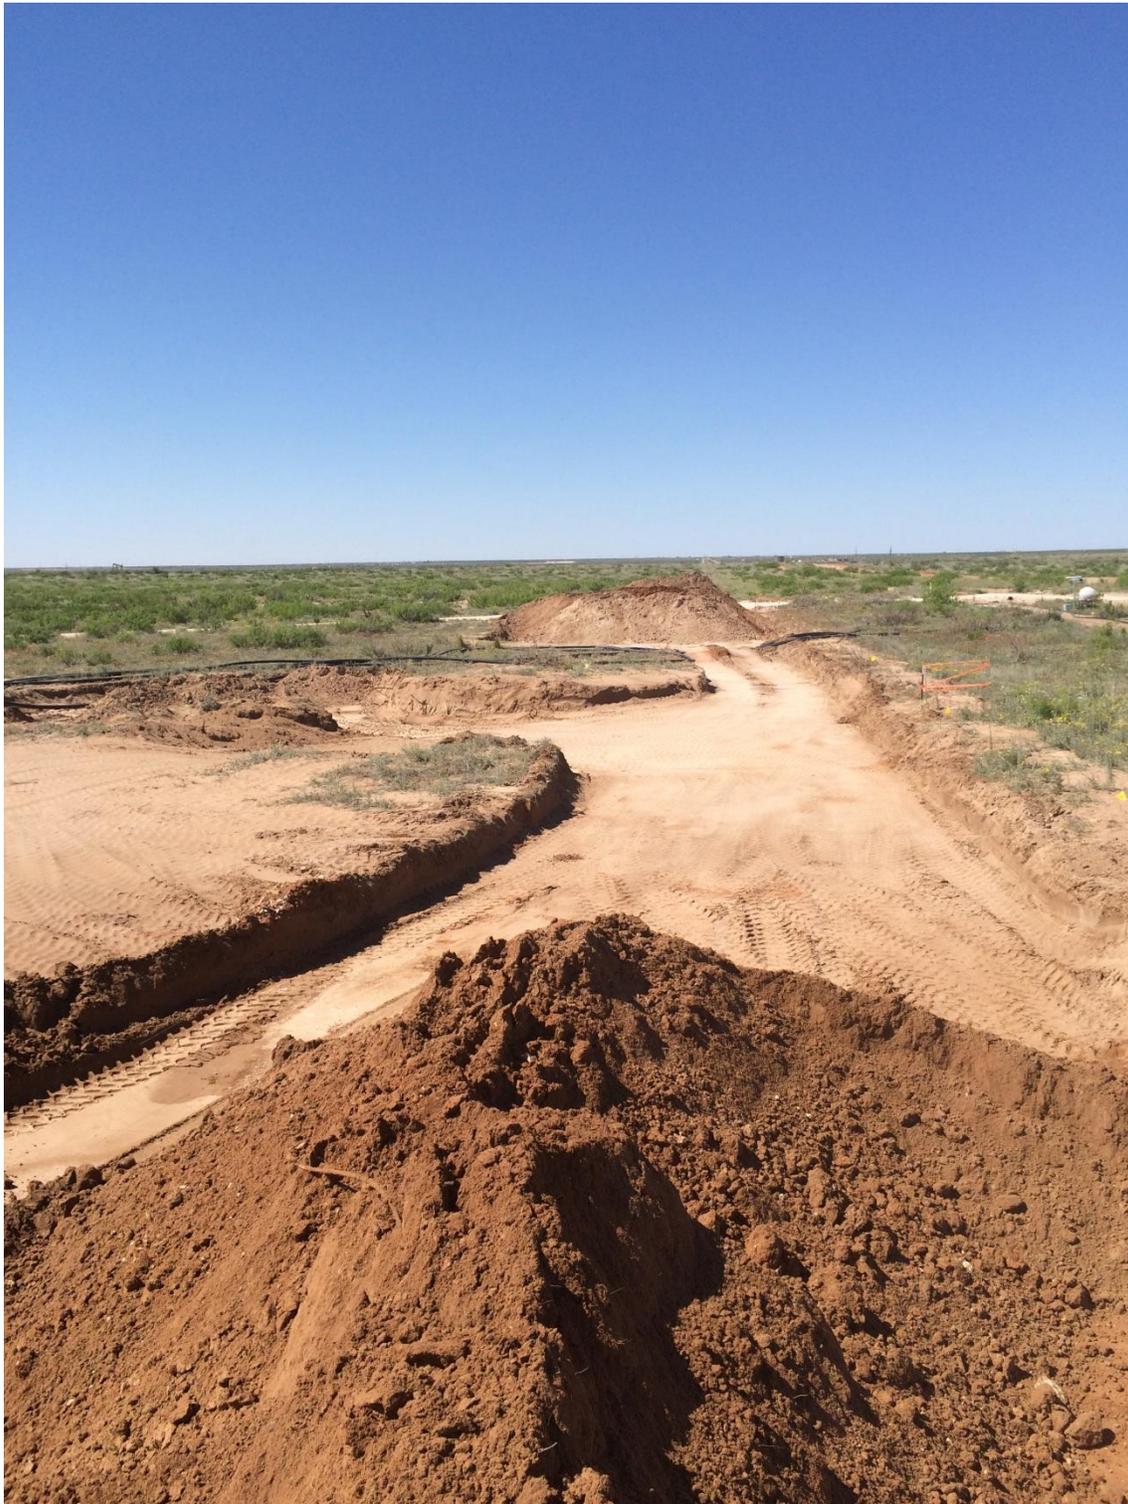
Photo 3 – Northern portion of excavation. Photo taken facing north.

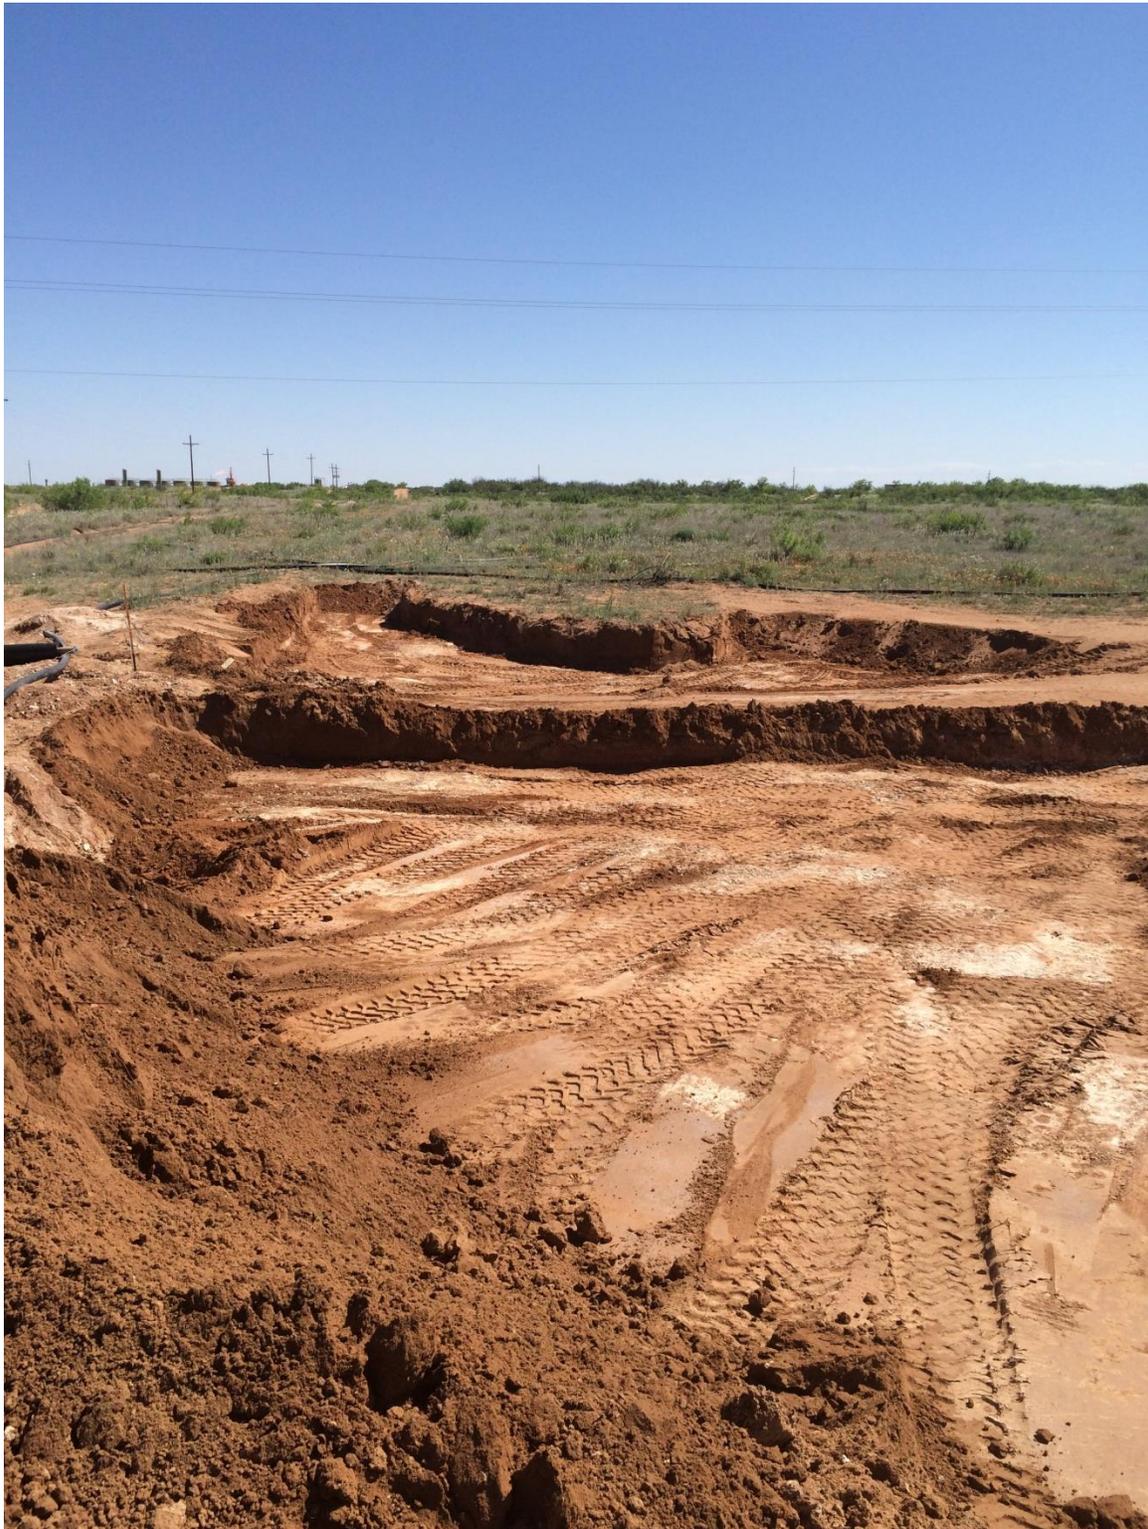
Photo 4 – Southern portion of excavation. Photo taken facing south.

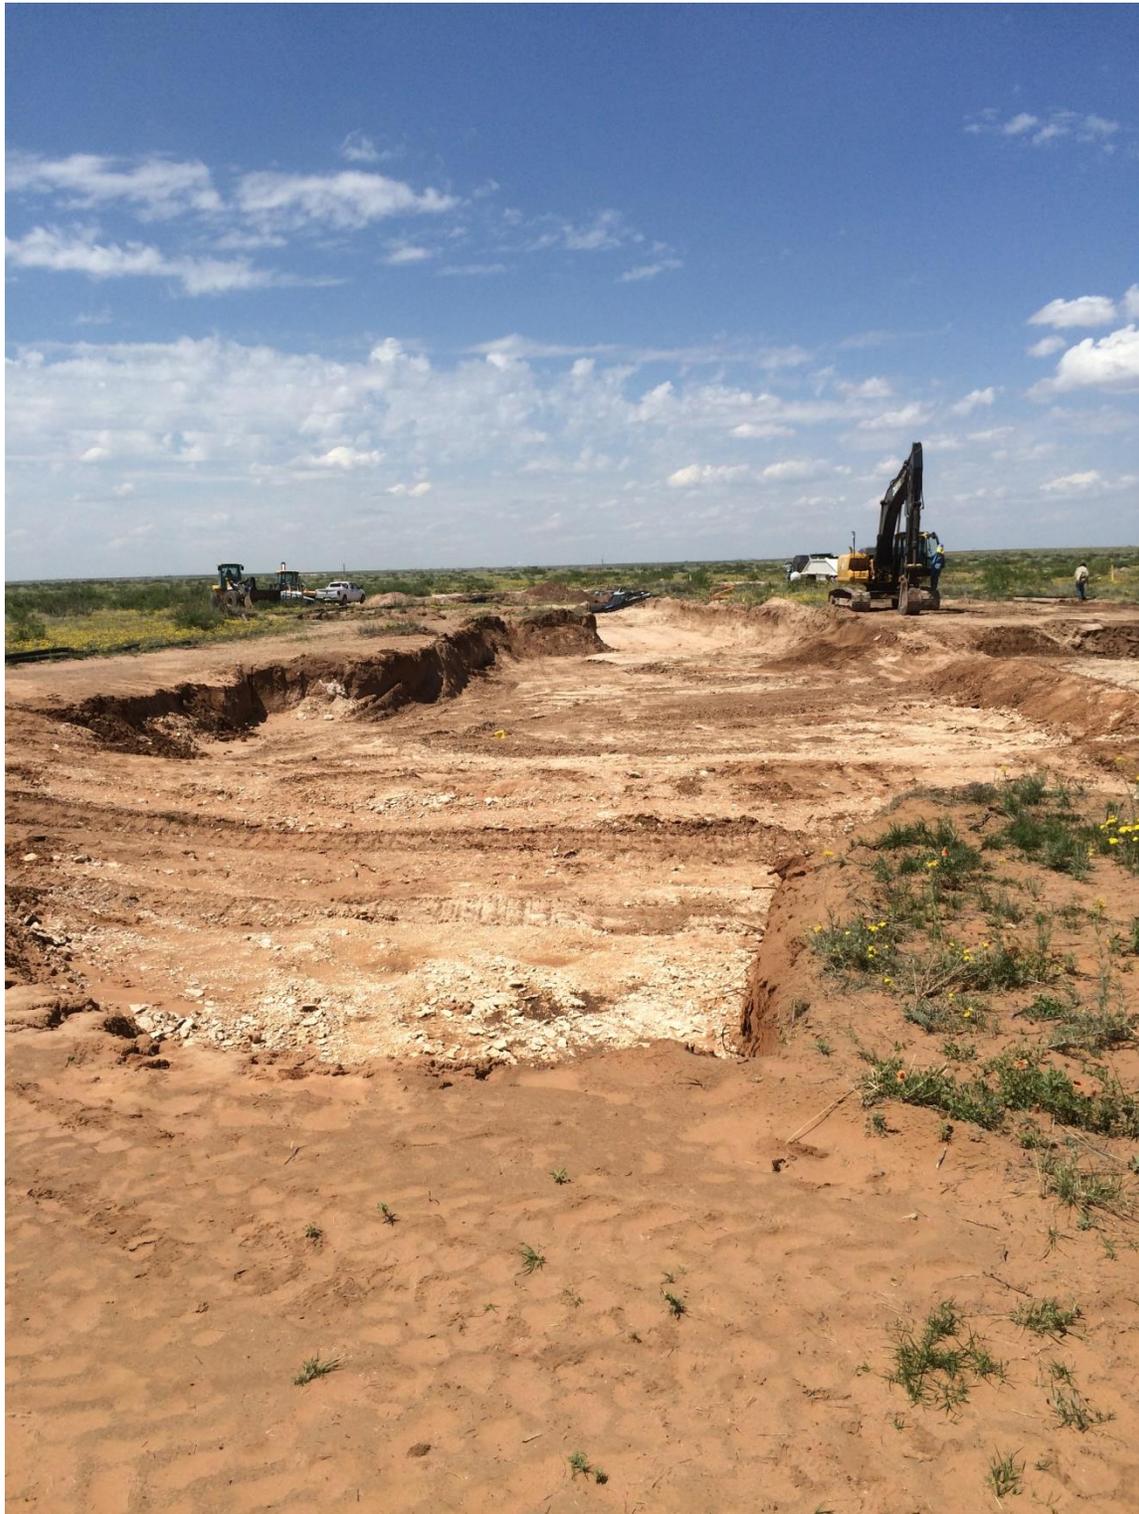
Photo 5 – Completed excavation with liner being placed in southern end. Photo taken facing south.

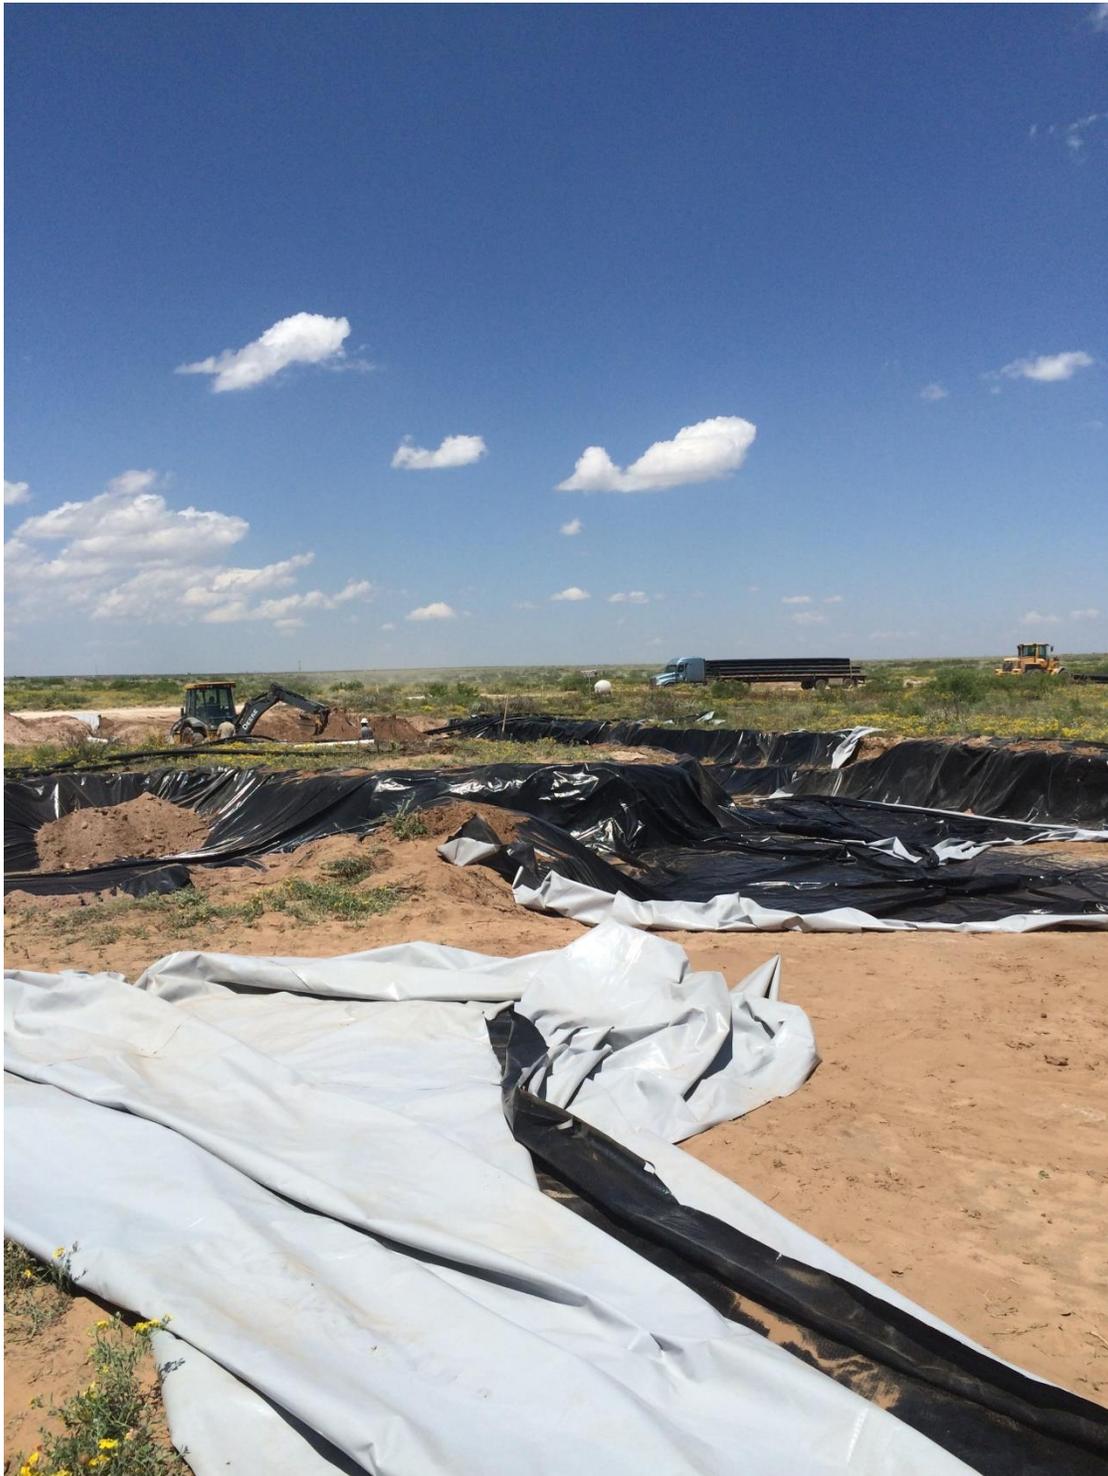
Photo 6 – Liner and backfill being placed in the excavation. Photo taken facing southeast.

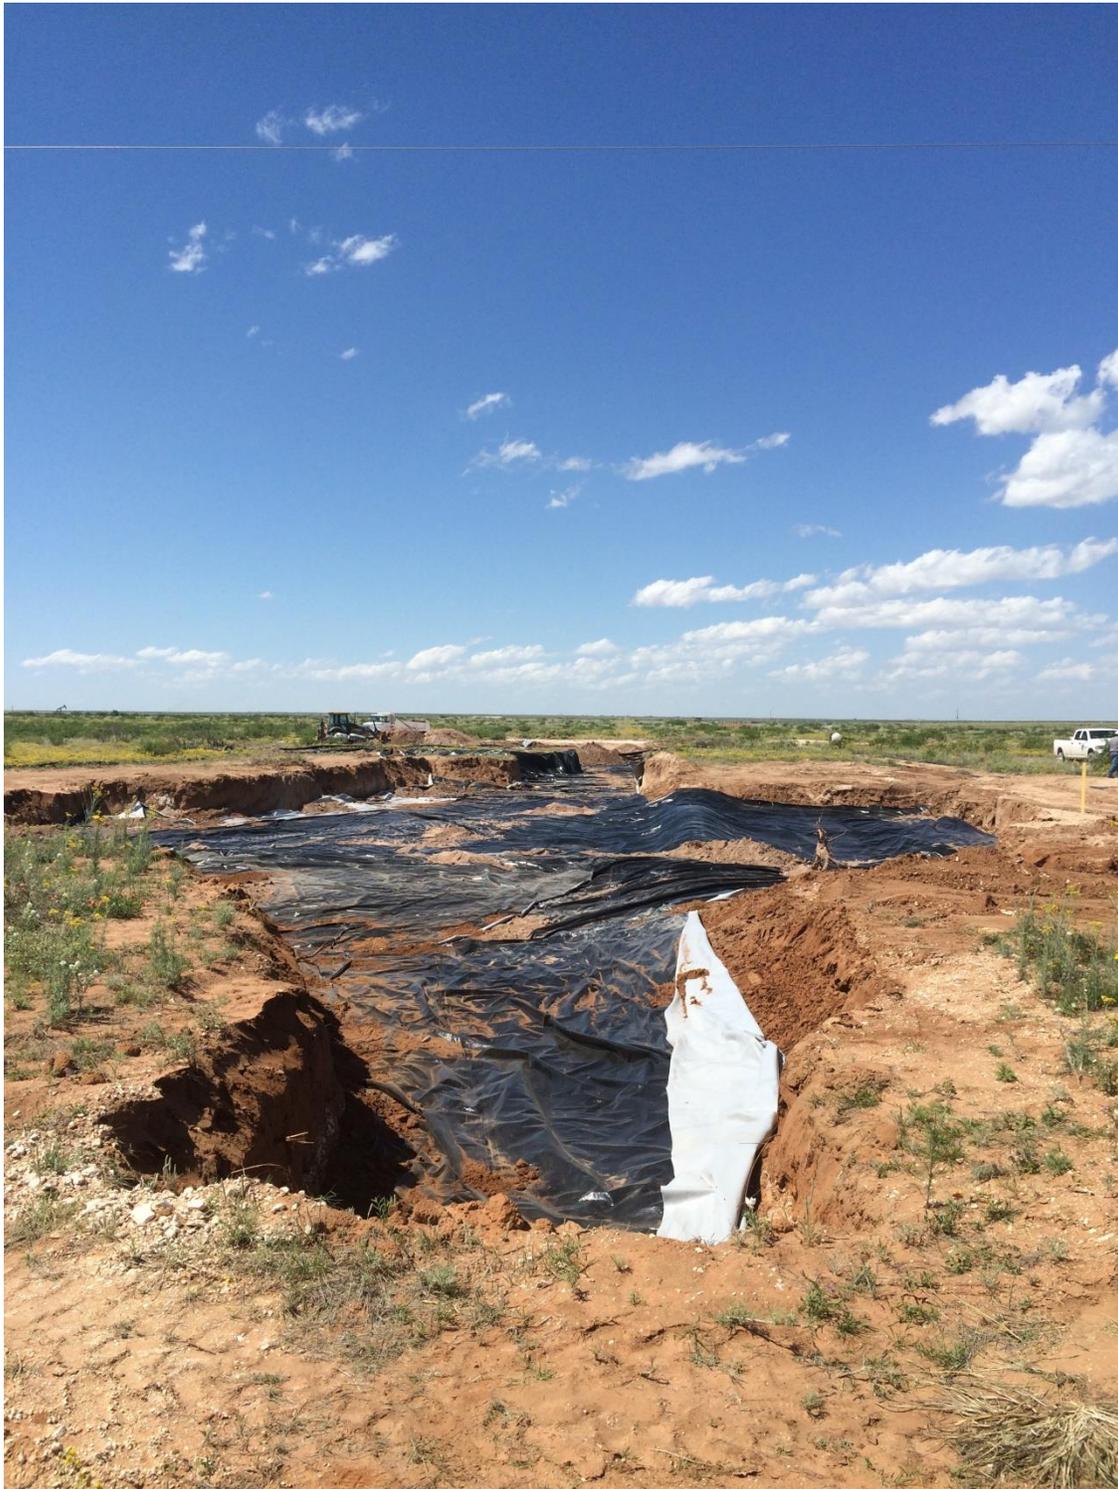
Photo 7 – Excavation after liner placement. Photo taken facing north.

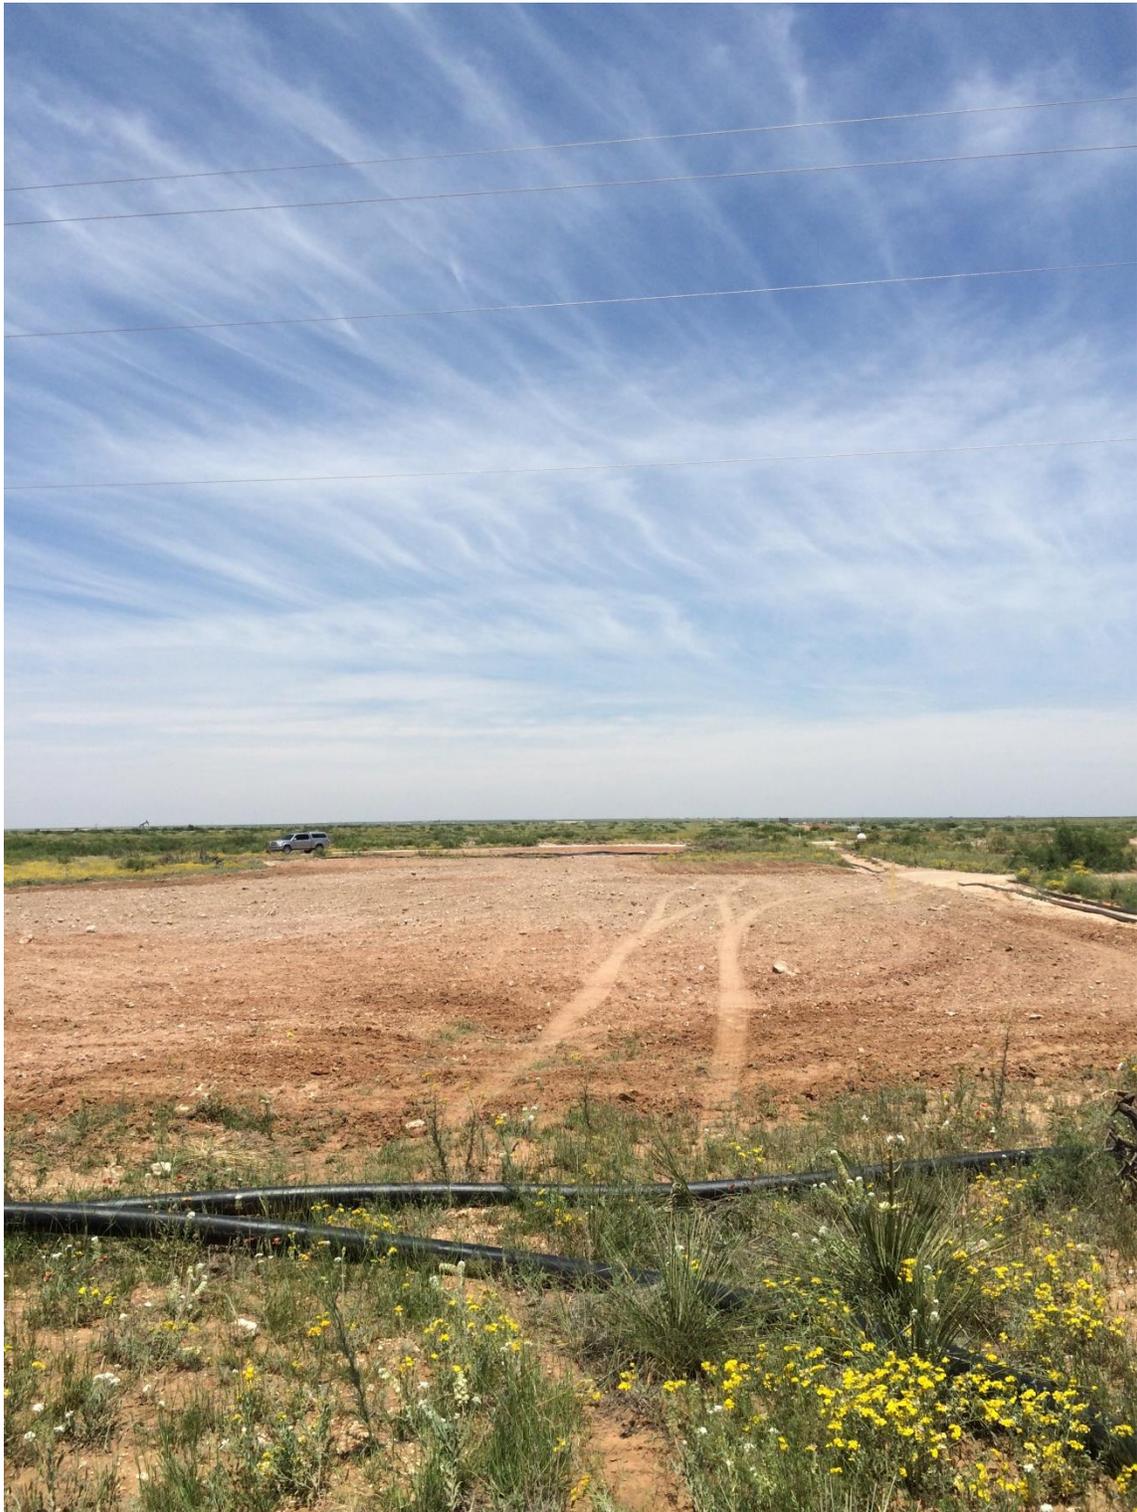
Photo 8 – Disturbed area after backfilling and grading. Photo taken facing north.

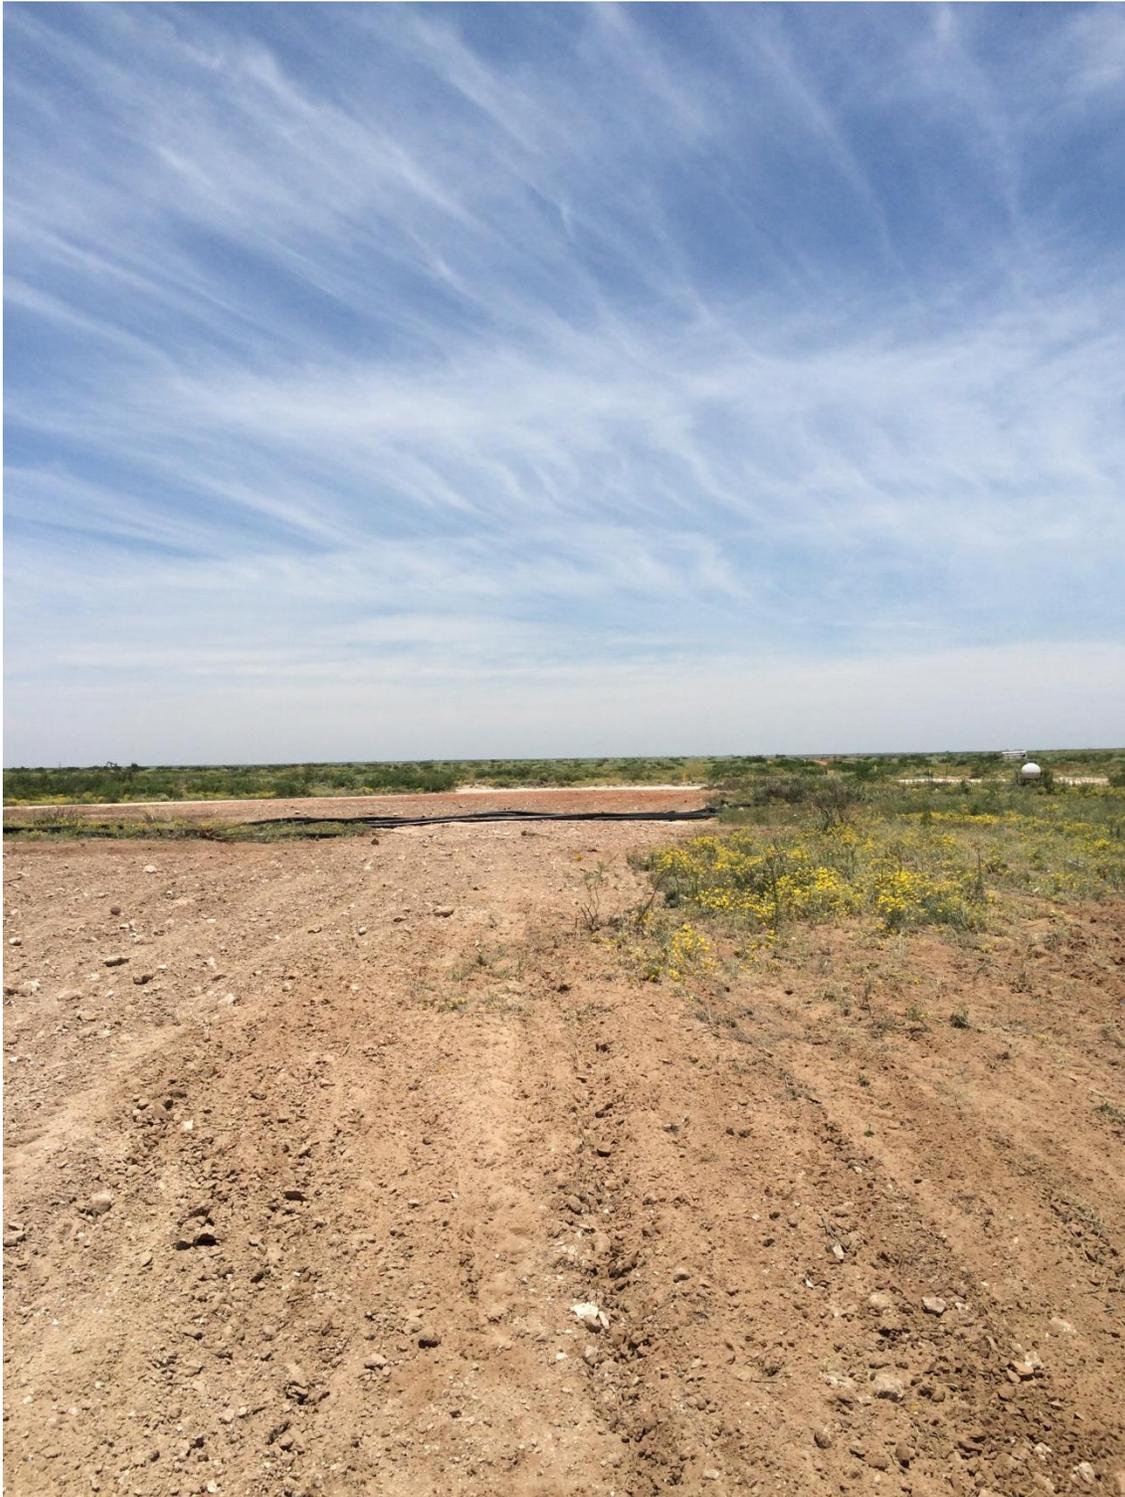
Photo 9 – Disturbed area after backfilling and grading. Photo taken facing south.
