SUBJECT: FINAL CLOSURE REPORT FOR INCIDENT 1RP-3804 ROY BATTY FEDERAL COM NO. 003H, LEA COUNTY, NEW MEXICO

# FINAL CLOSURE REPORT FOR INCIDENT 1RP-3804

ROY BATTY FEDERAL COM No. 003H API# 30-025-41333 SECTION 11, T24S R33E, NMPM LEA COUNTY, NM

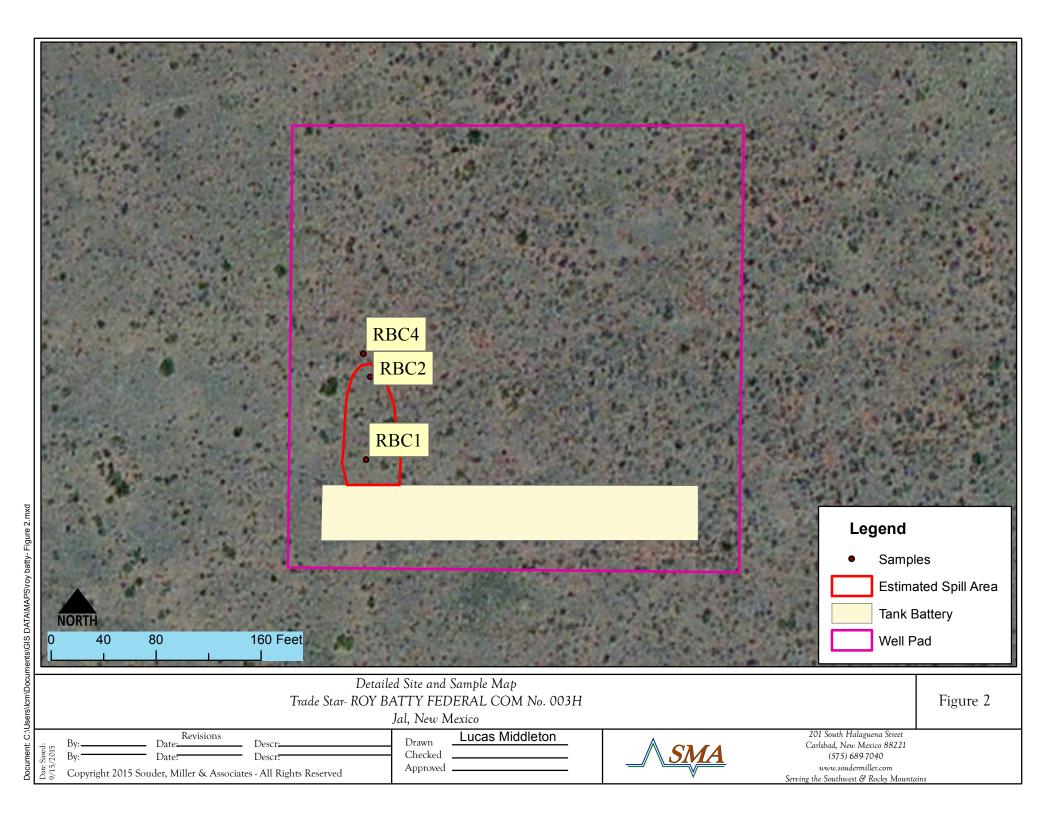
# FIGURE 2 DETAILED SITE AND SAMPLE MAP

Soil contaminant concentrations are illustrated in Figure 2. A summary of laboratory analytical results for closure confirmation is included in Table 2. Laboratory reports are included in Appendix A.

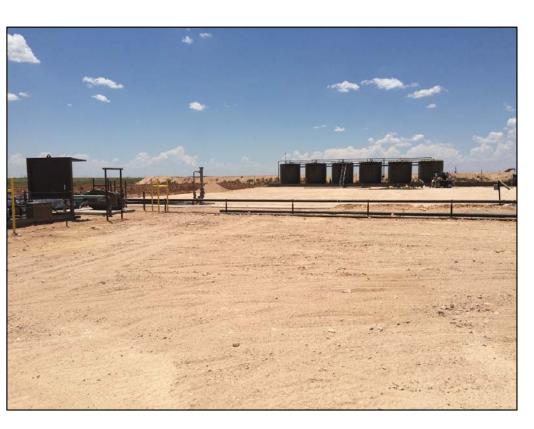
Photo 1: Remediation Area after clean-up Taken on 7/28/15

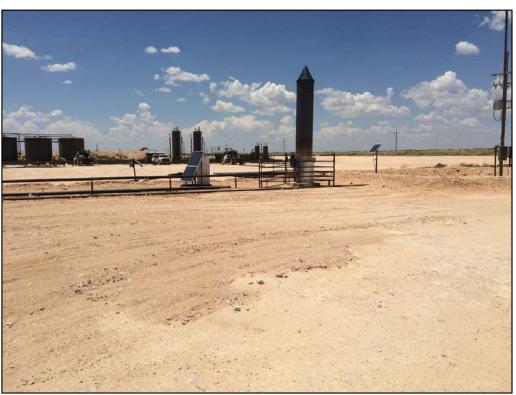
Photo 1: Remediation Area after clean-up Taken on 7/28/15

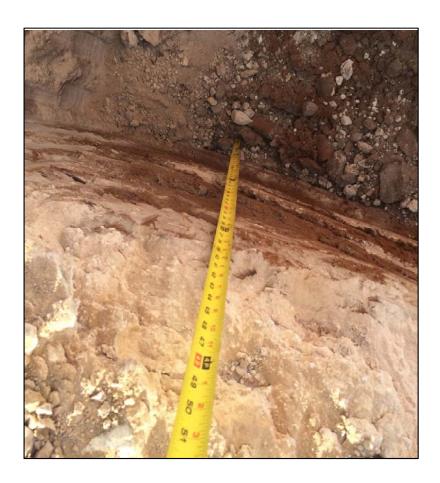
Photo 3: Take to show depth of conformation samples Taken on 8/3/15

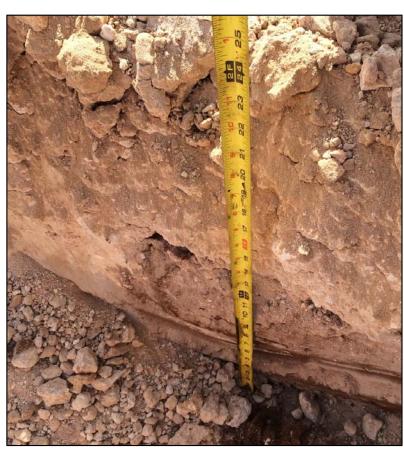
Photo 4: Take to show depth of conformation samples Taken on 8/3/15
