URSA Major 8 Federal #1

API: 30-025-34346

Matador Resources Company

Follow- up

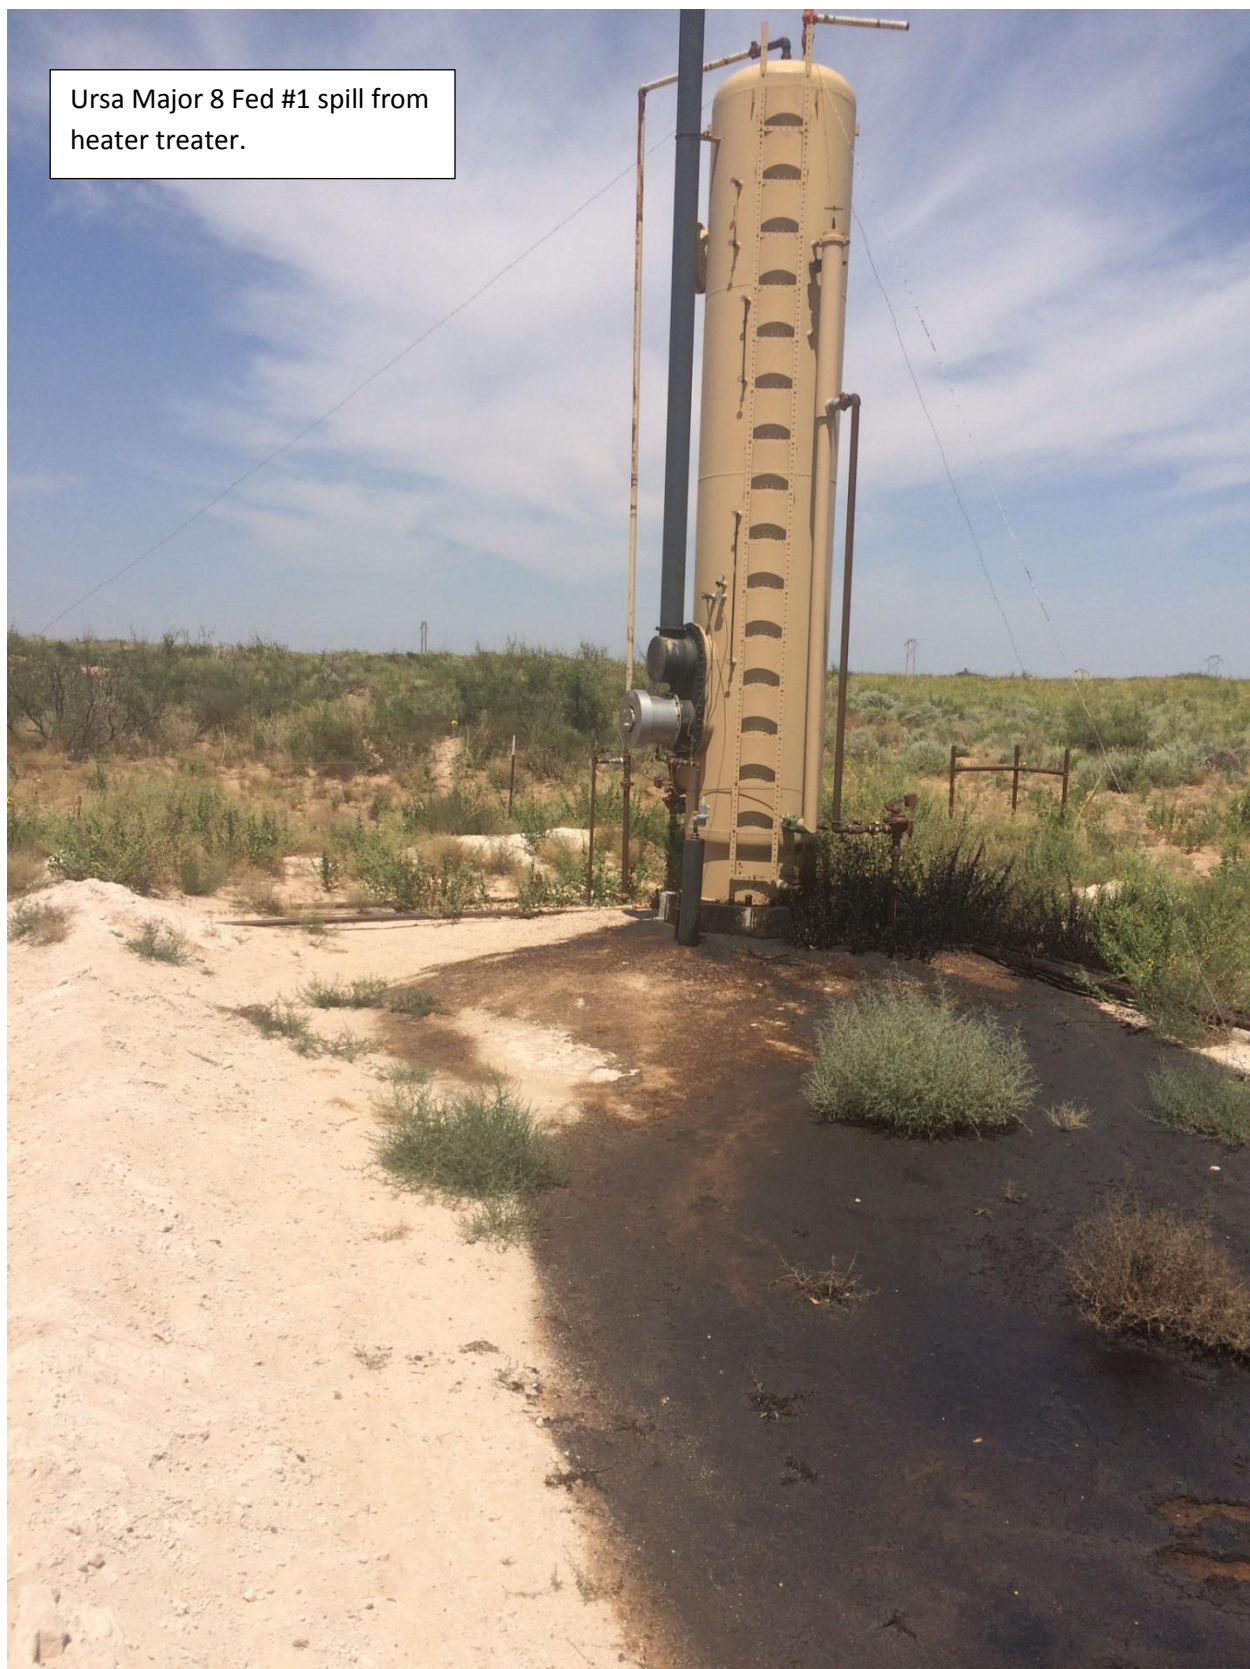
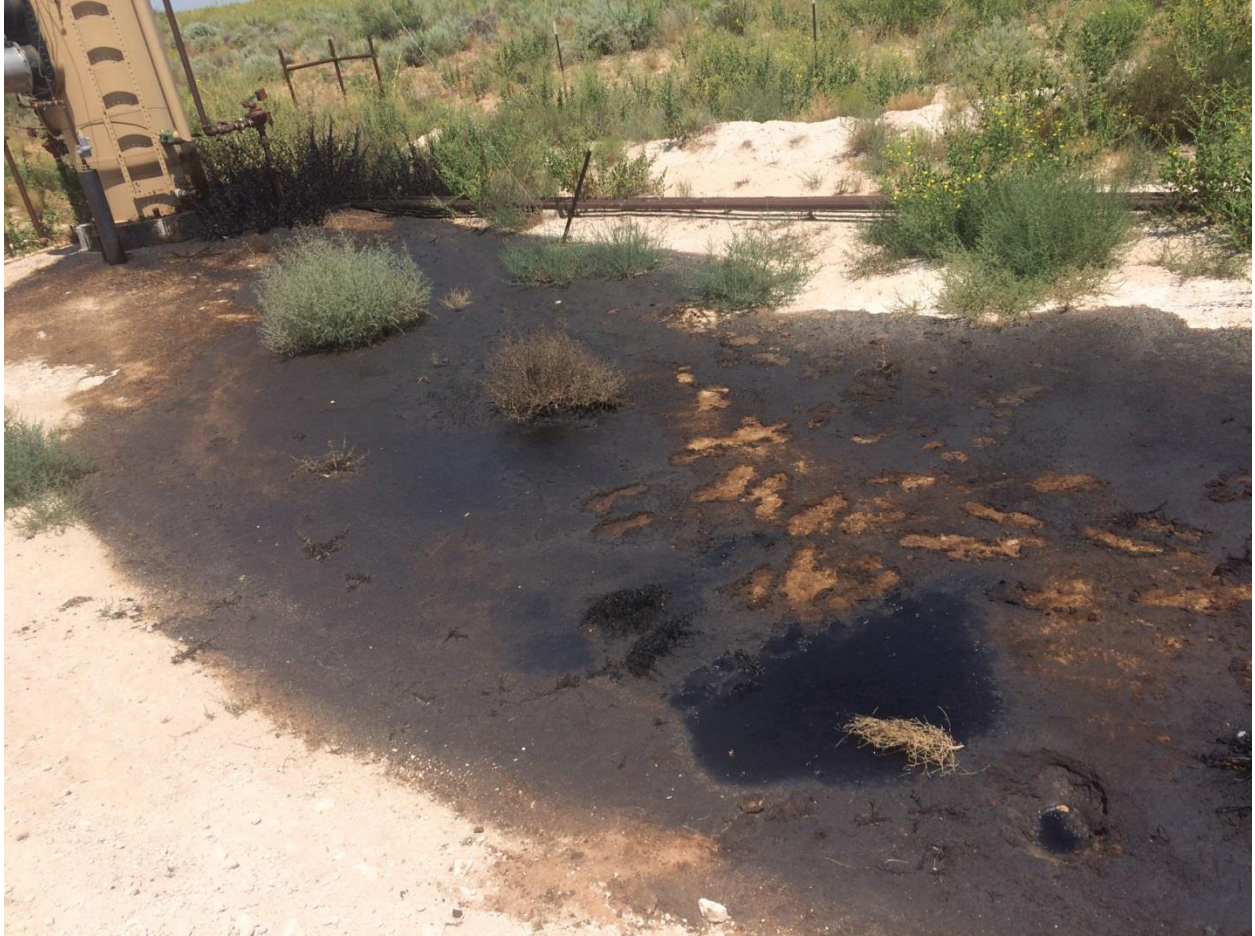
Matador Resources received notice of a spill at the above reference facility on August 10, 2015. The production supervisor reported that a heater treater located in a dike had a hole in the bottom of it. Approximately 35 barrels of fluid spilled into the dike. 19 barrels were recovered. Please see attached photos showing damage to the area.

Ursa Major 8 Fed #1 spill from
heater treater.

On August 27, 2015 Cardinal Labs was on site collecting soil samples to determine the depth of contamination. Diamondback Disposal Service was on location to remove and properly dispose of the contaminated soil. Diamondback Disposal Service was contracted to rebuild the dike with uncontaminated soil. Cardinal Labs will sample, and report the results.

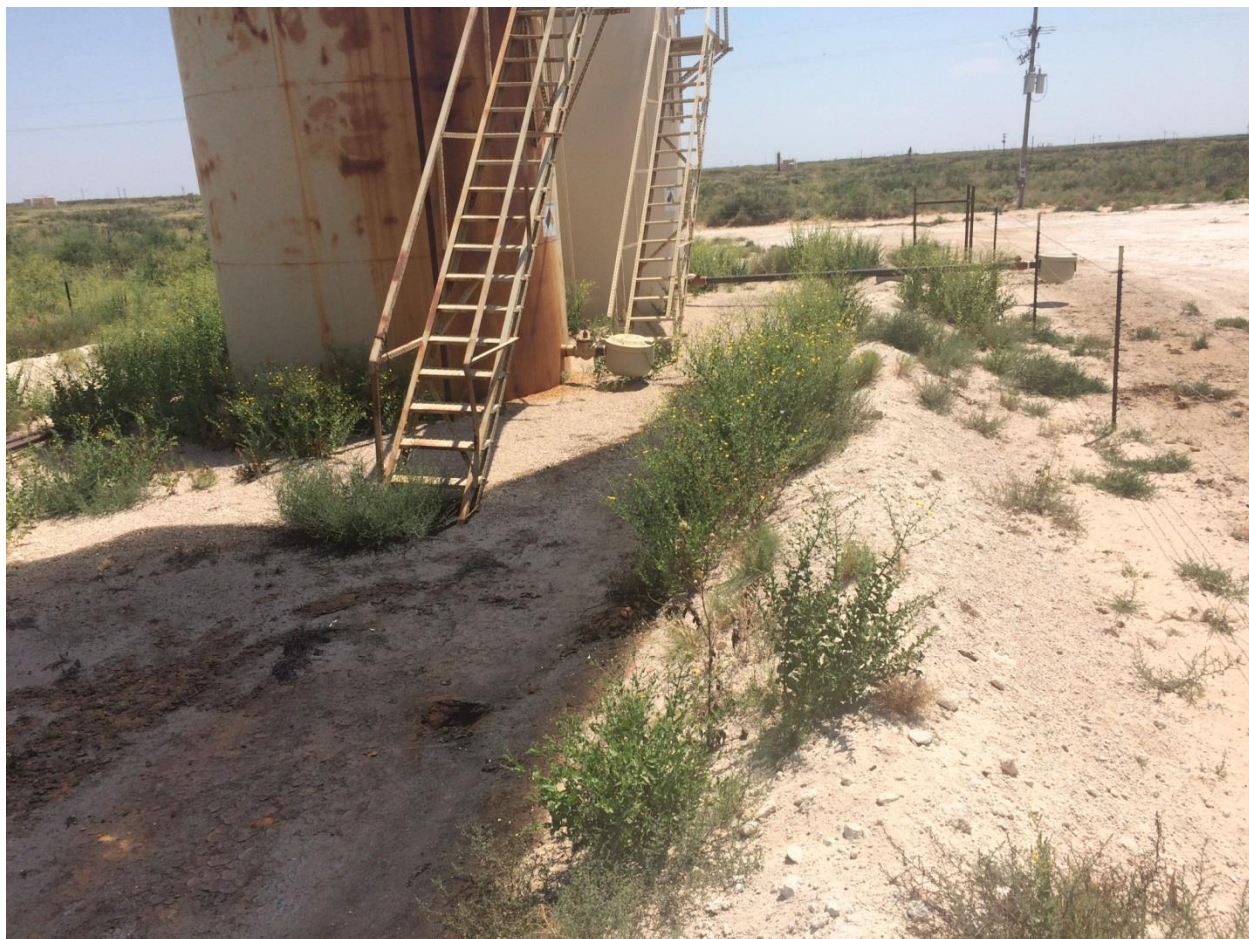
Ursa Major 8 Fed #1 spill photo.

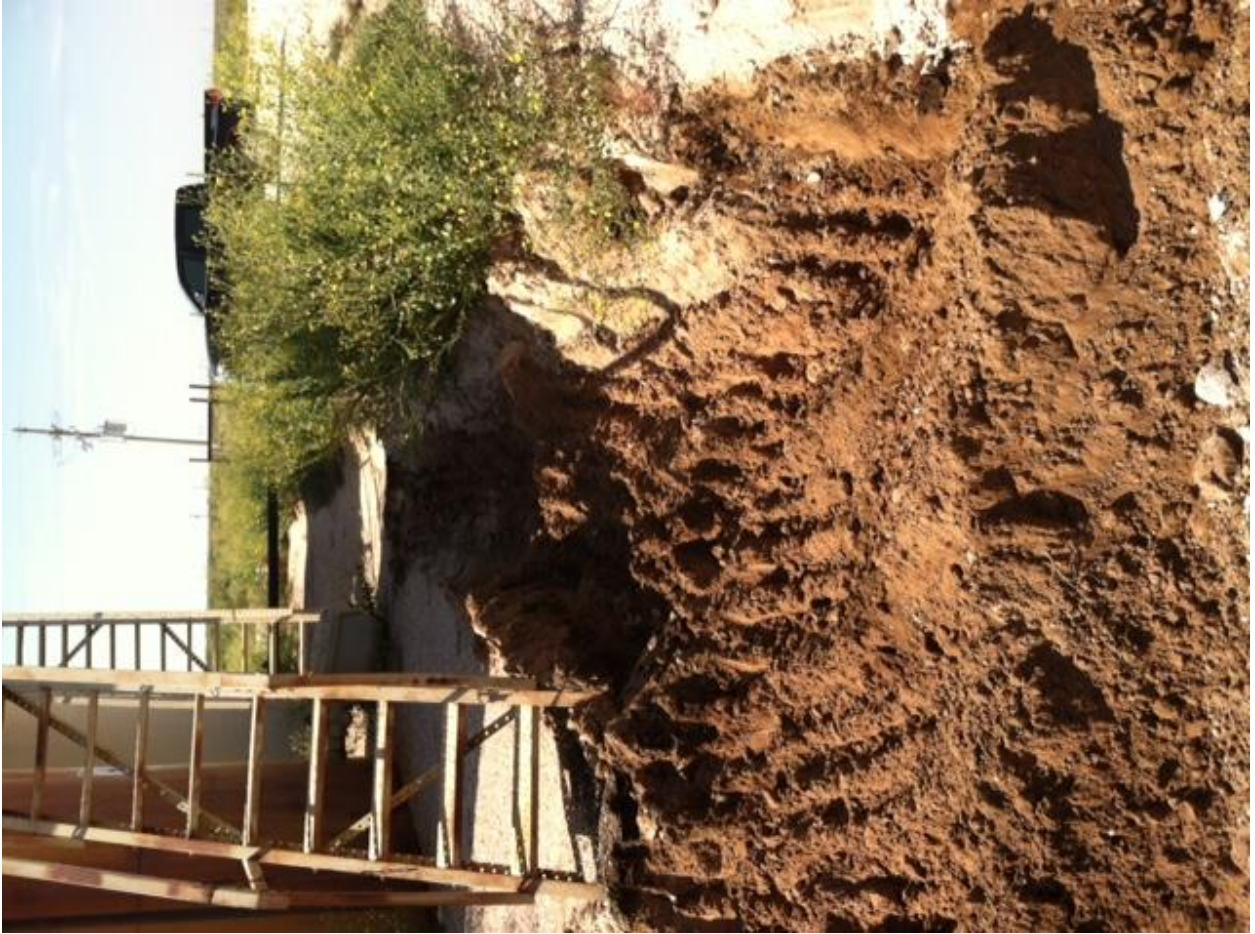
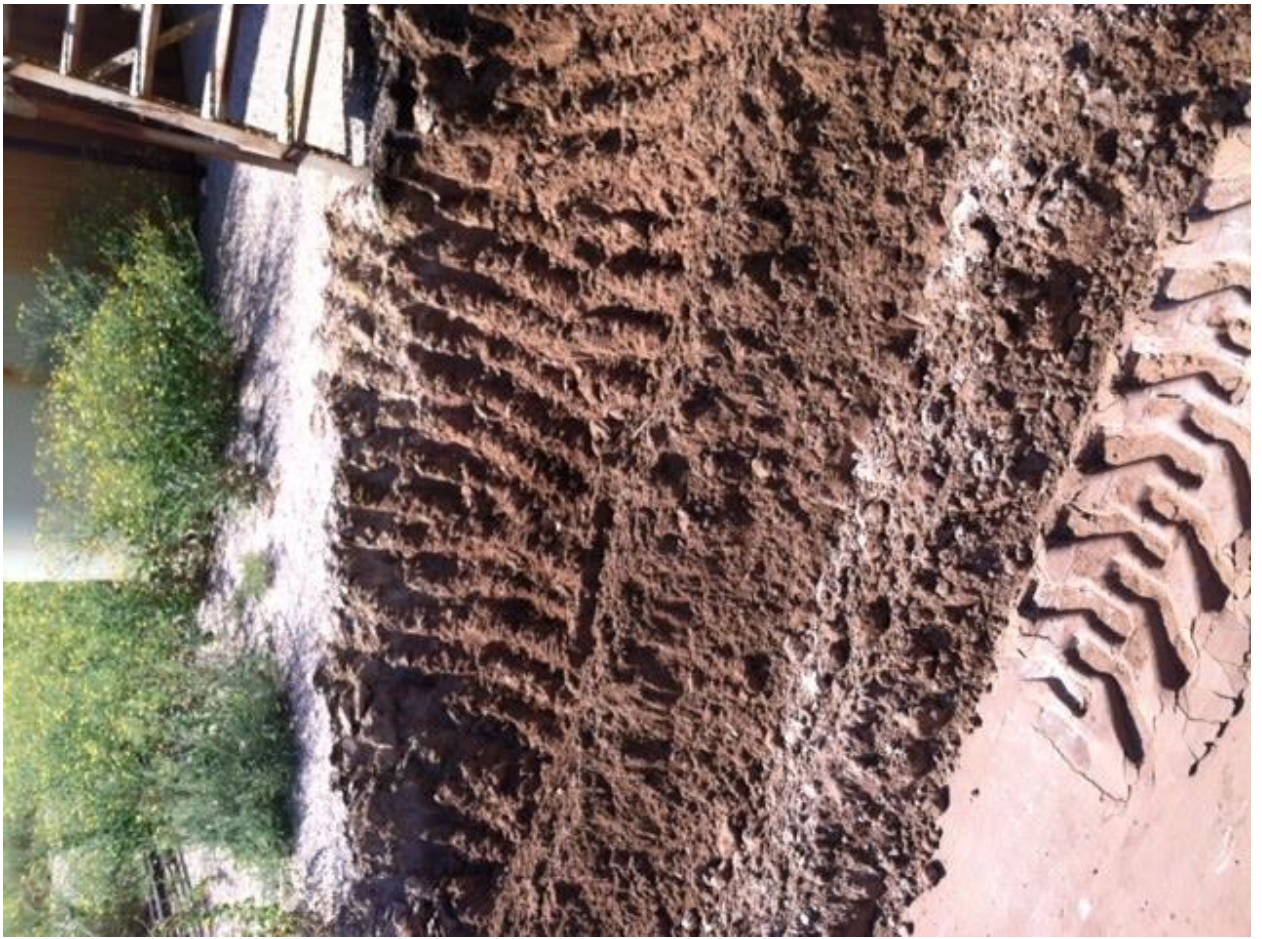
Ursa Major 8 Fed #1 spill in the dike.

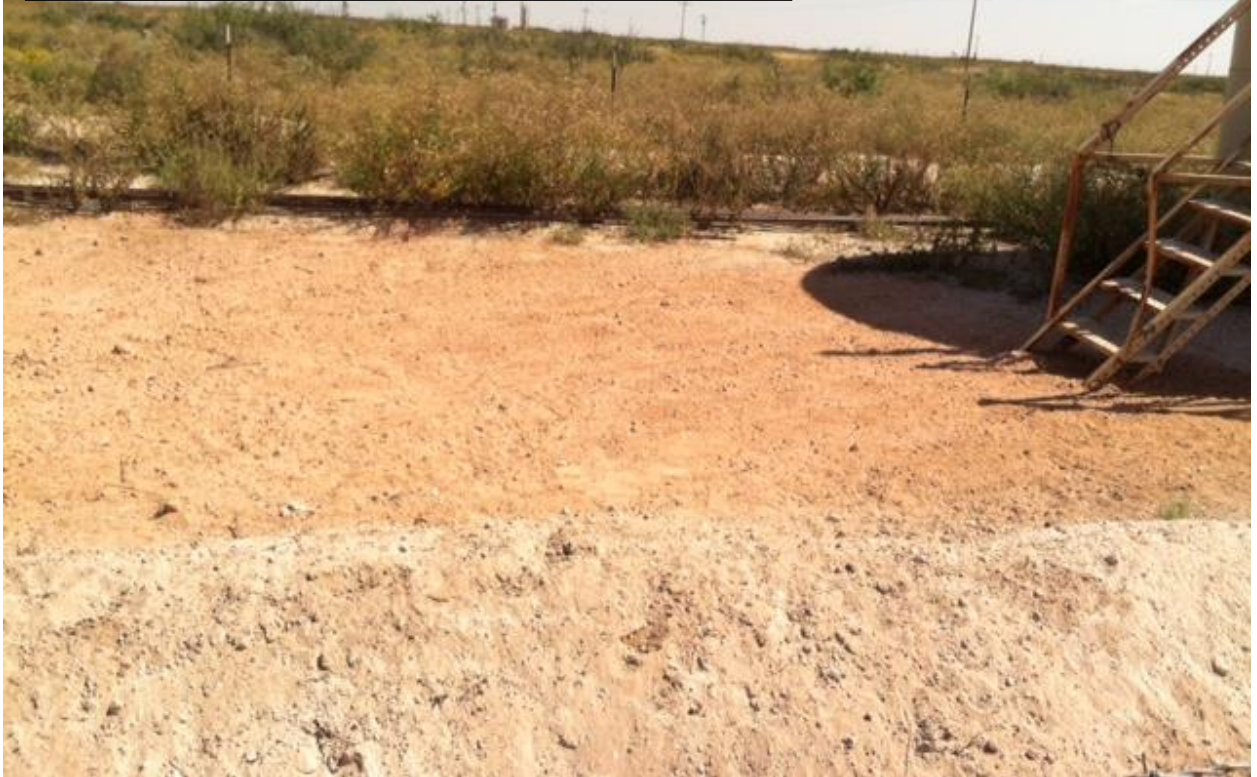
Uncontaminated soil in the dike at the Ursa Major 8 Fed #1.
Sept. 29, 2015

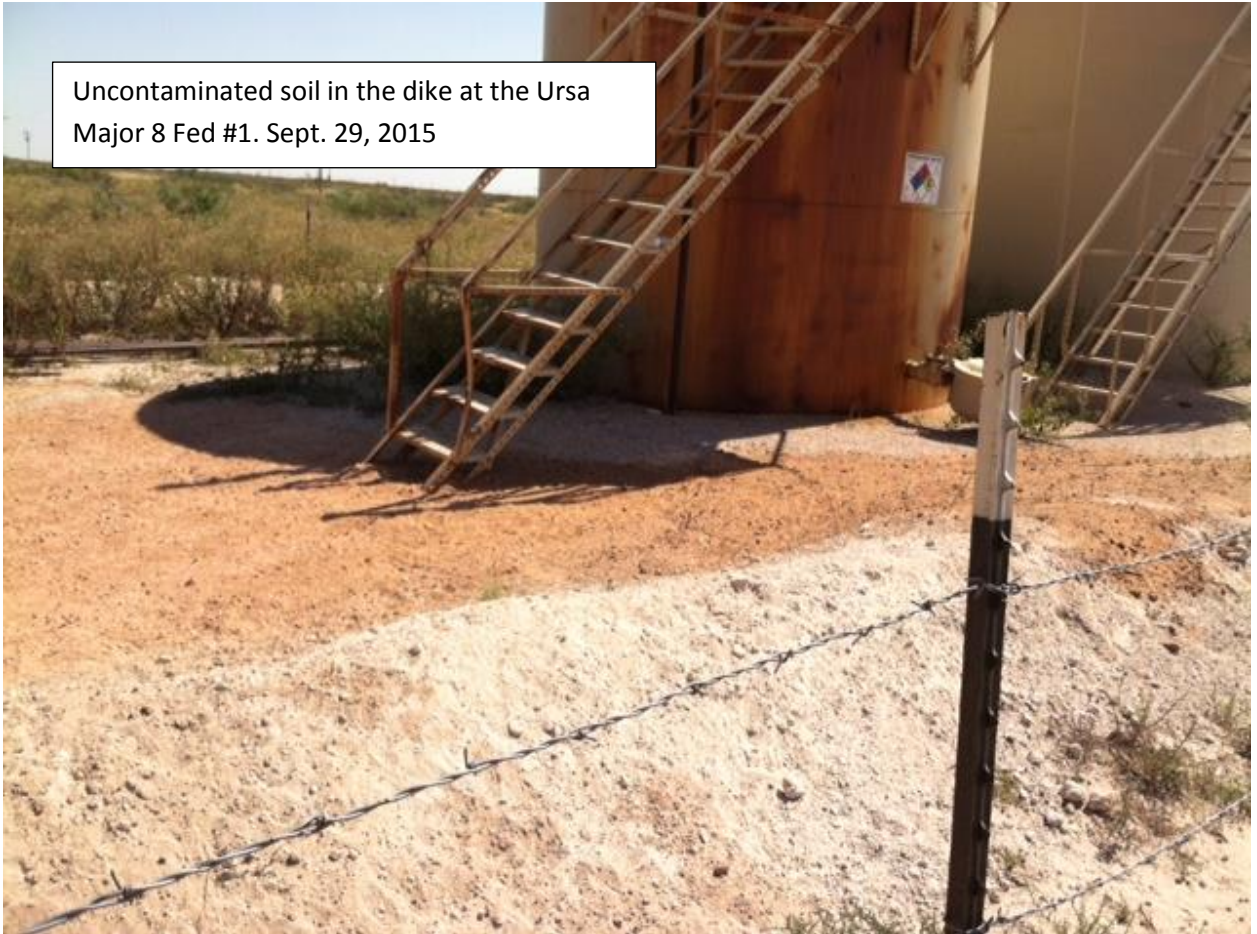
Uncontaminated soil in the dike at the Ursa
Major 8 Fed #1. Sept. 29, 2015
