Release Notification and Corrective Action

Report Type: Closure Report

Site:	Lusk Deep Unit #22H					
Company:	COG Operating, LLC					
Section, Township and Range	Unit C	Sec 17	T 19S	R 32E		
Lease Number:	API No. 30-025-40705					
County:	Lea					
GPS:	32.66682° N			103.79121° W		
Surface Owner:	Federal					
Mineral Owner:						
Directions:	In Rural Lea County at the intersection of Hwy 243 and CR 126A for 6.75 miles, the spill is on the EAST side of 126A in the pasture.

Re: Closure Report for the COG Operating, LLC location Lusk Deep Unit #22H, Unit C, Section 17, Township 19 South, Range 32 East, Lea County, New Mexico.

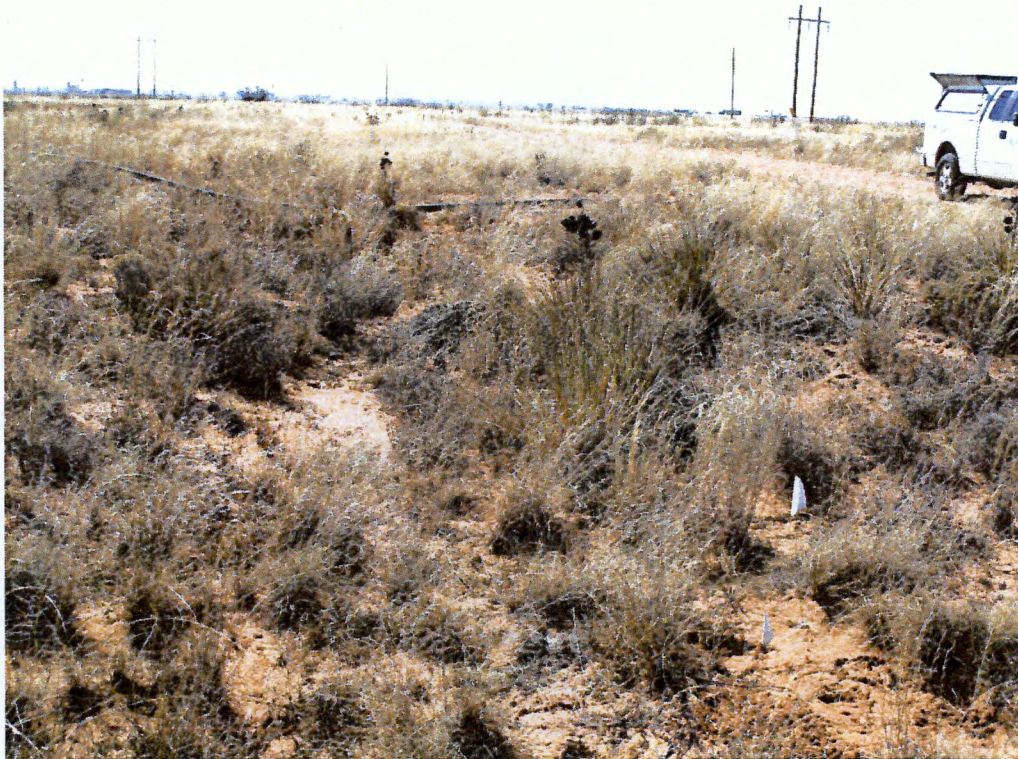
View North – Area of AH-1

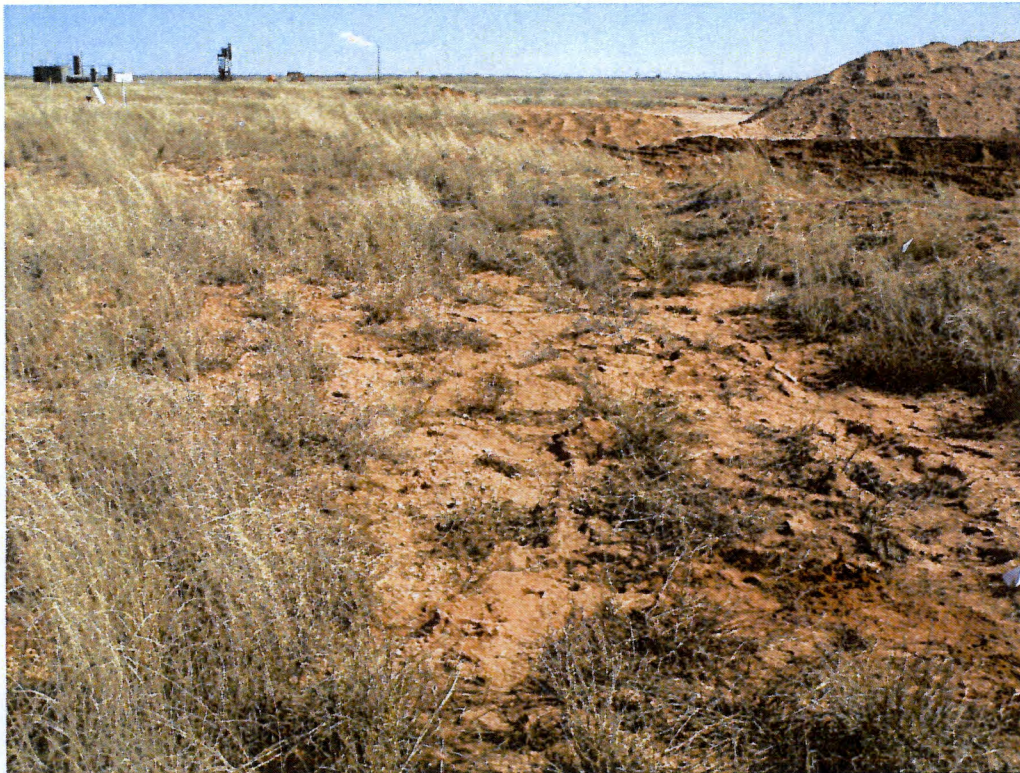
View East – Area of AH-4

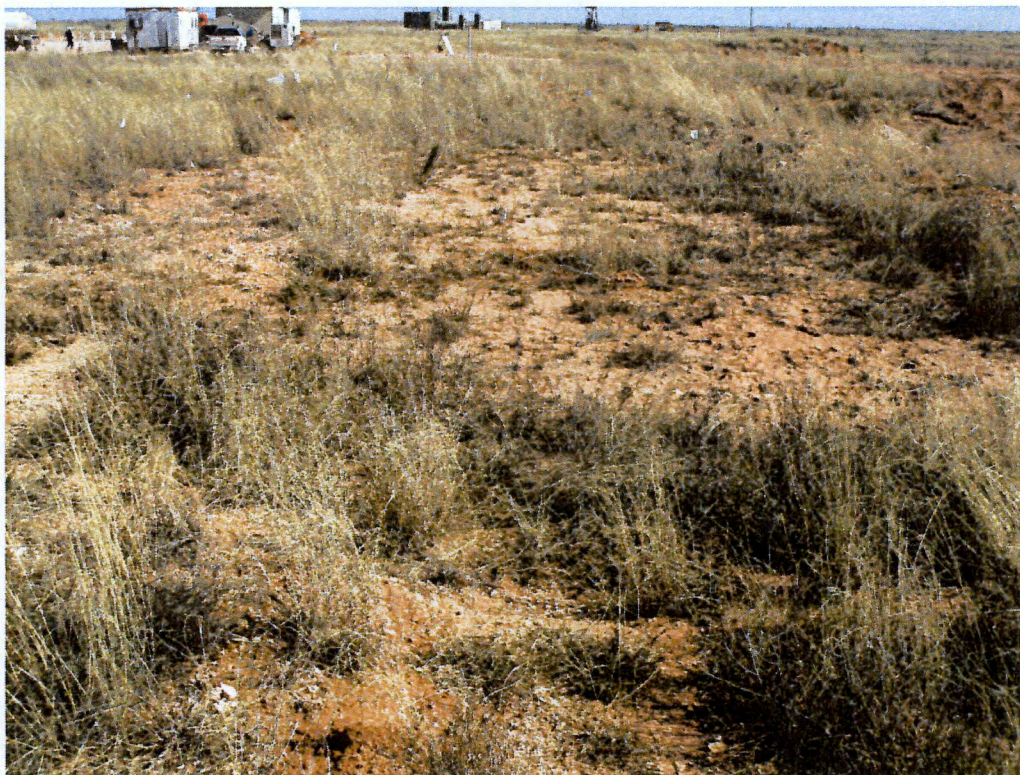
View East - Area of AH-5

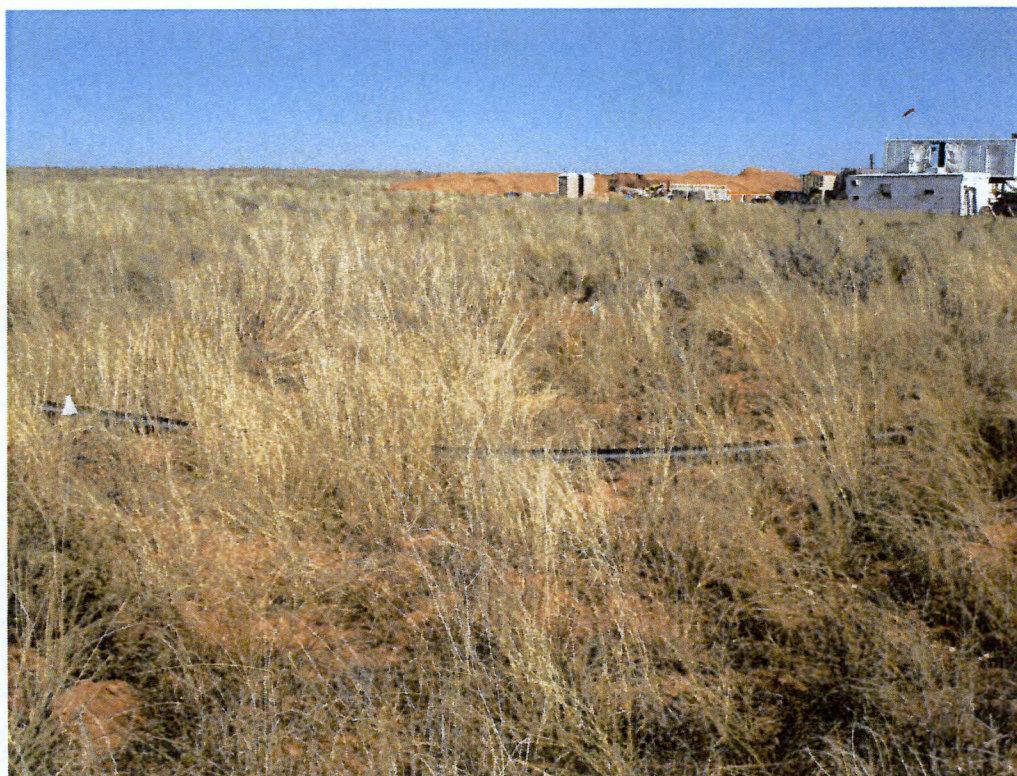
View North – Area of AH-6

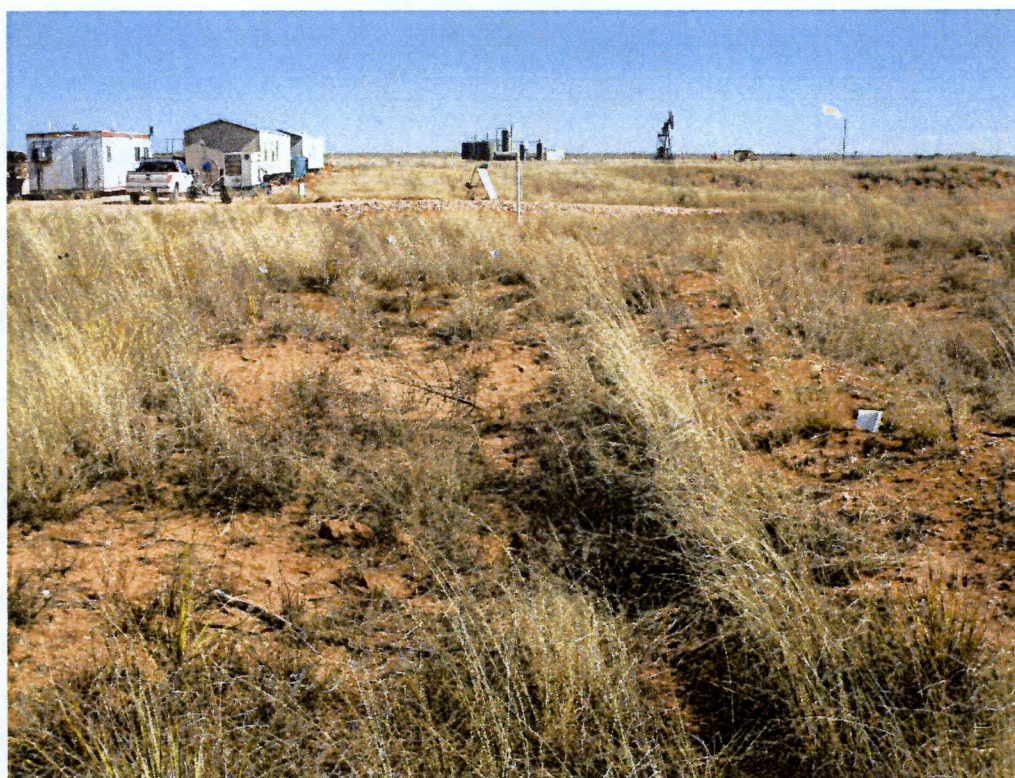
View East – areas of AH-7 and AH-8

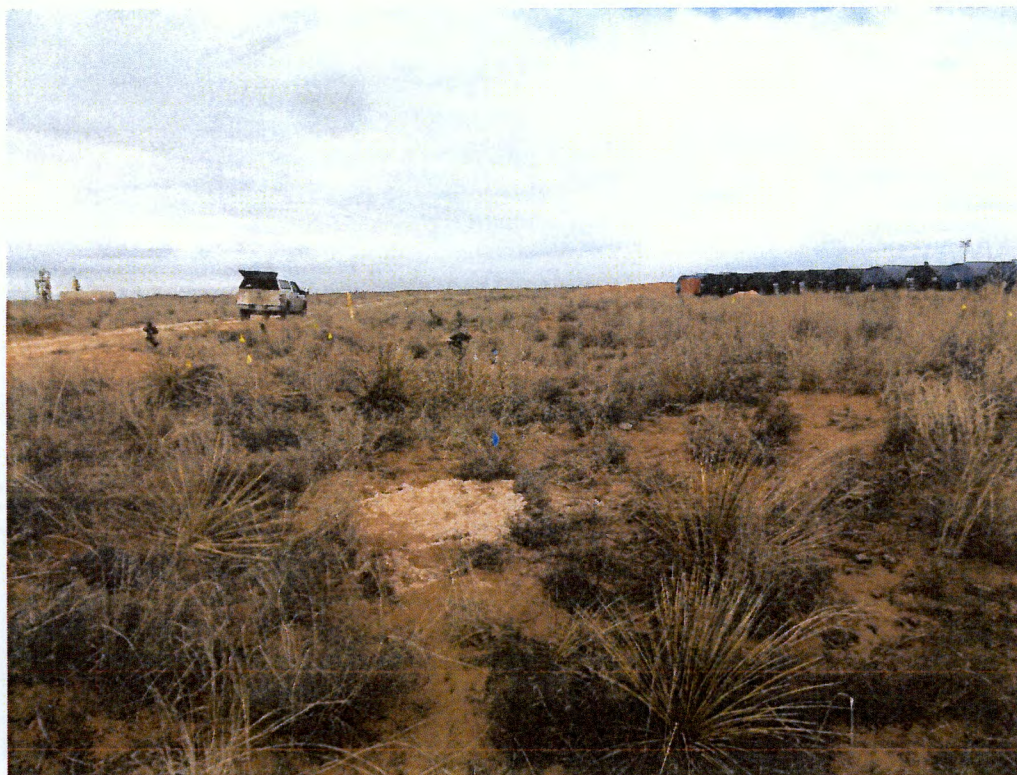
View North – Area of BH-1

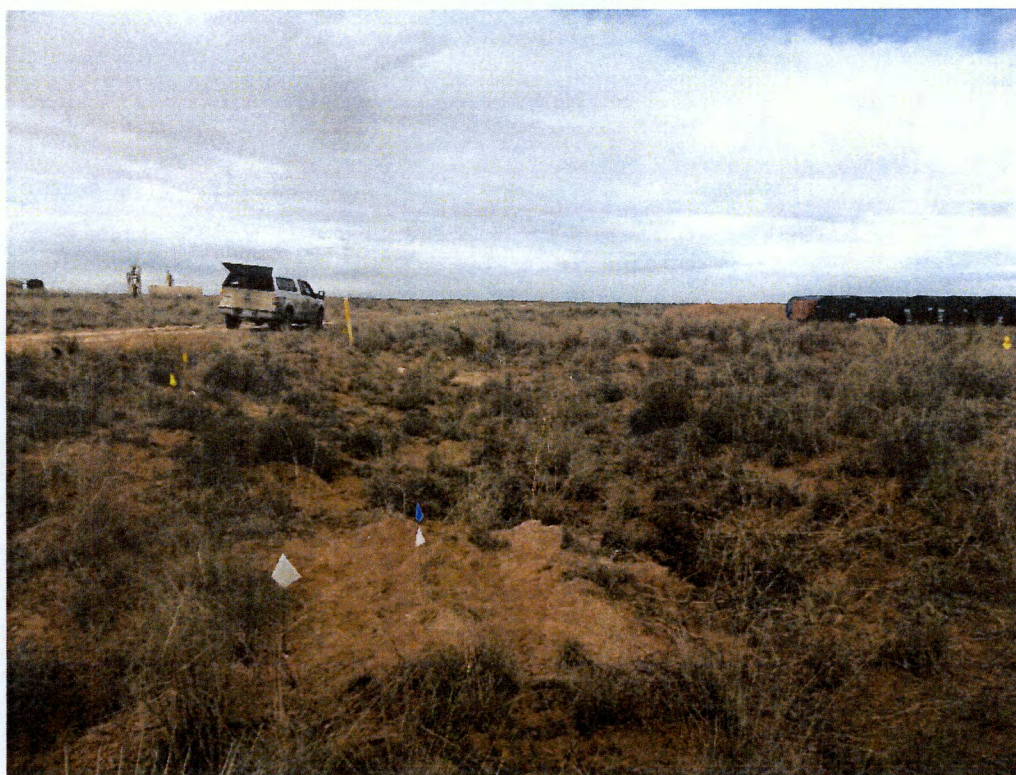
View North – Area of BH-2

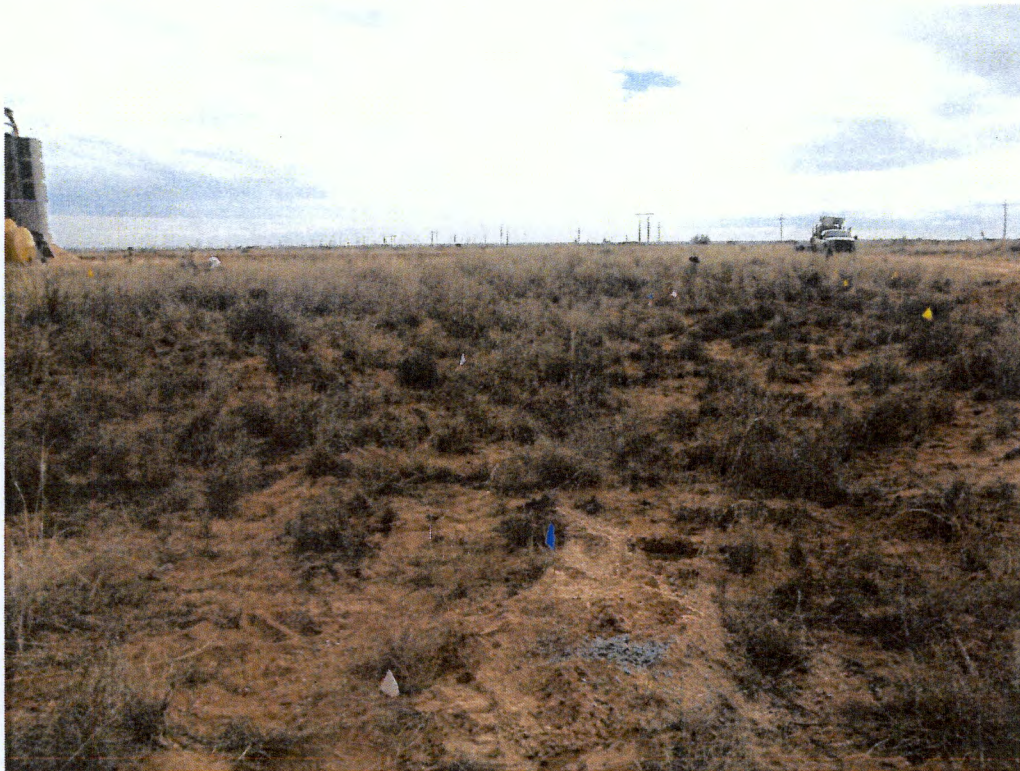
View South – Area of BH-3

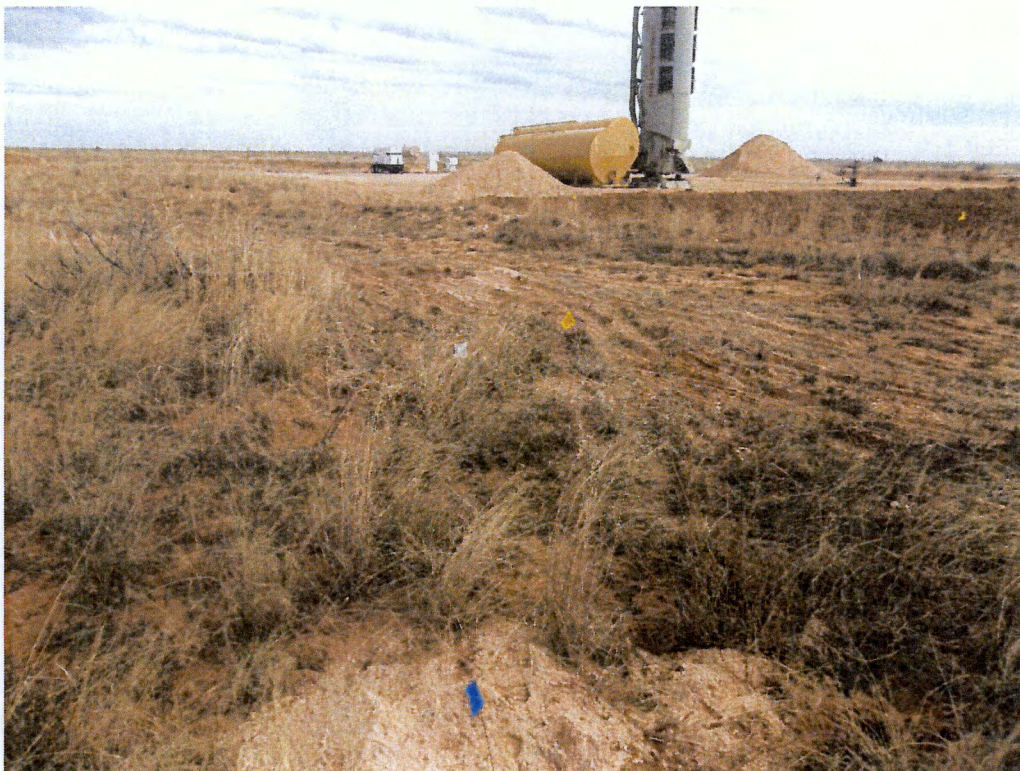
View East – Area of BH-4 and BH-5

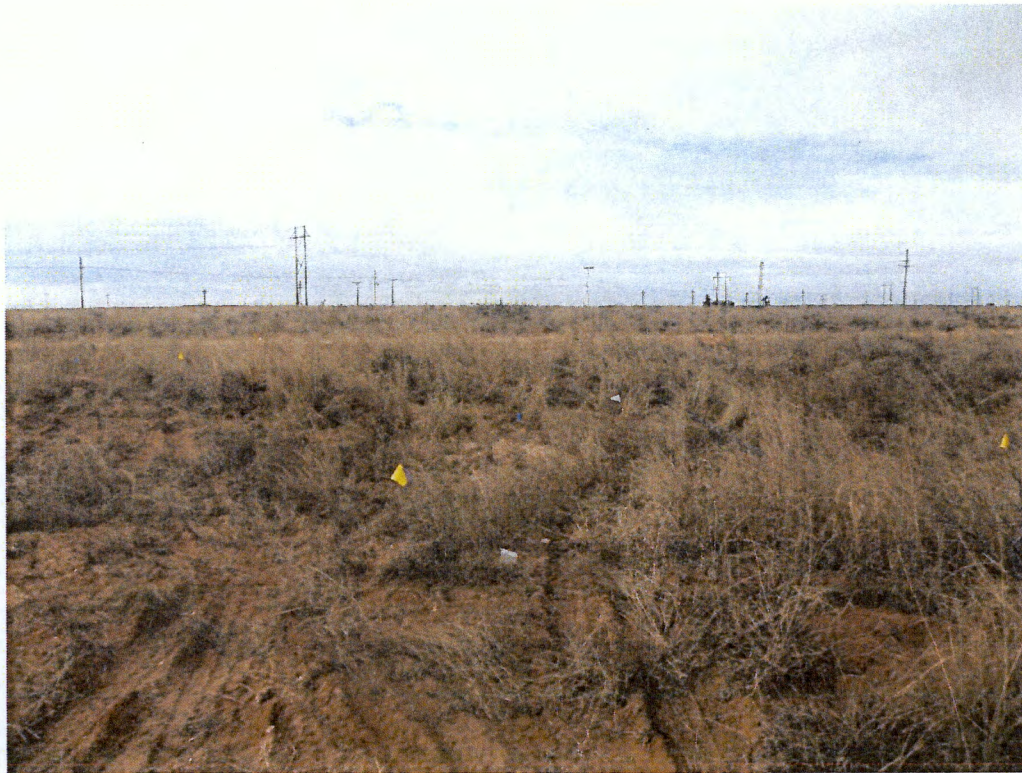
View Northwest – Area of BH-6

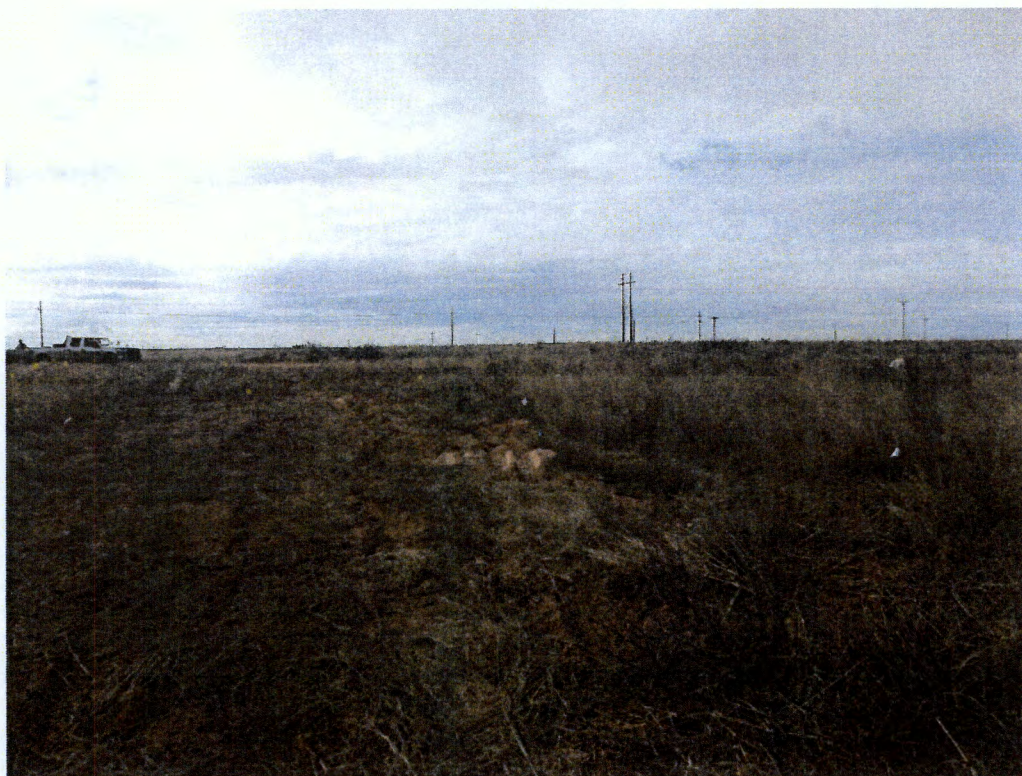
View West – Area of BH-7

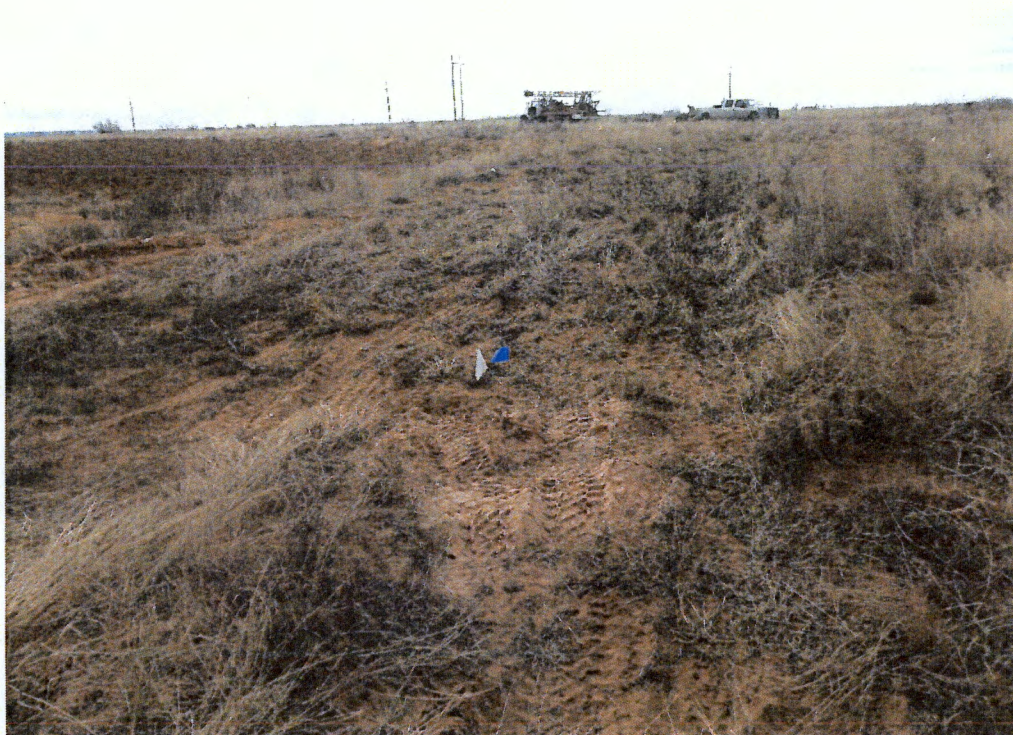
View West – Area of BH-8

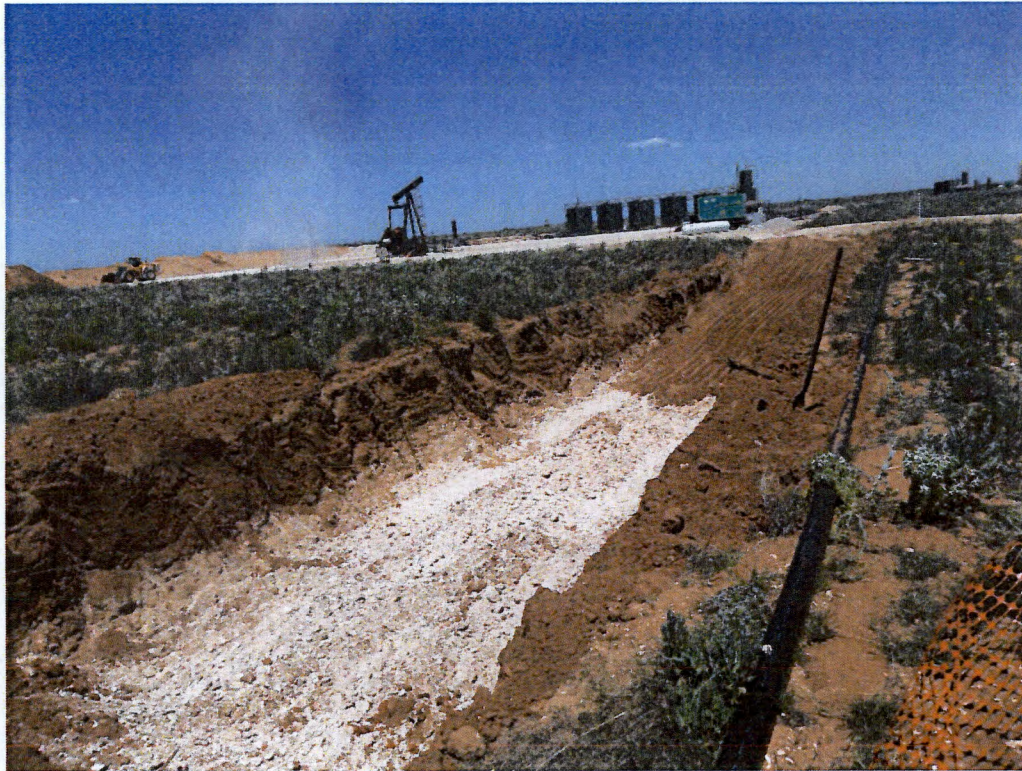
View Northeast – Excavated area of AH-7 and AH-8

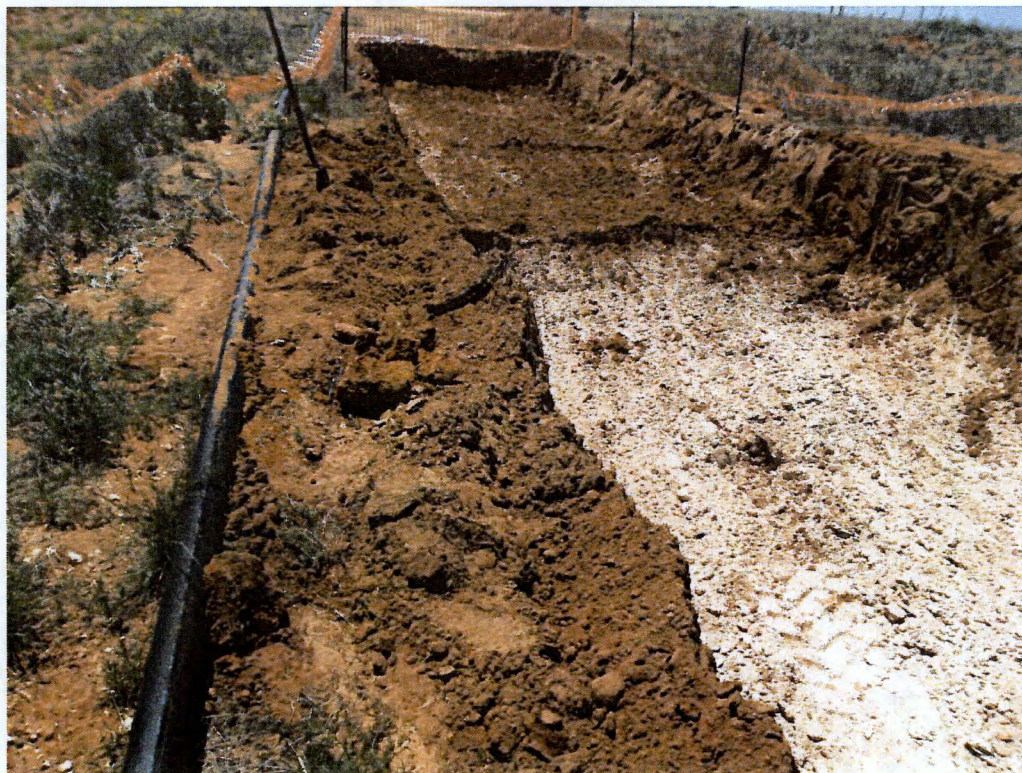
View West – Excavated area of AH-4 and AH-5

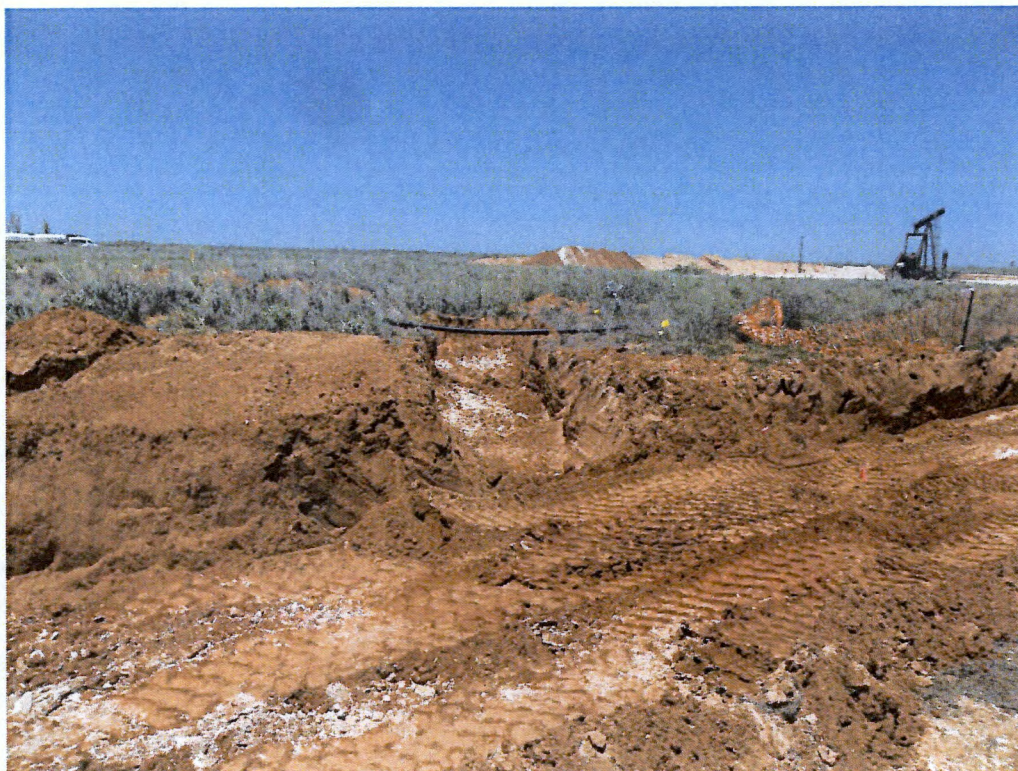
View North – Excavated area of AH-6

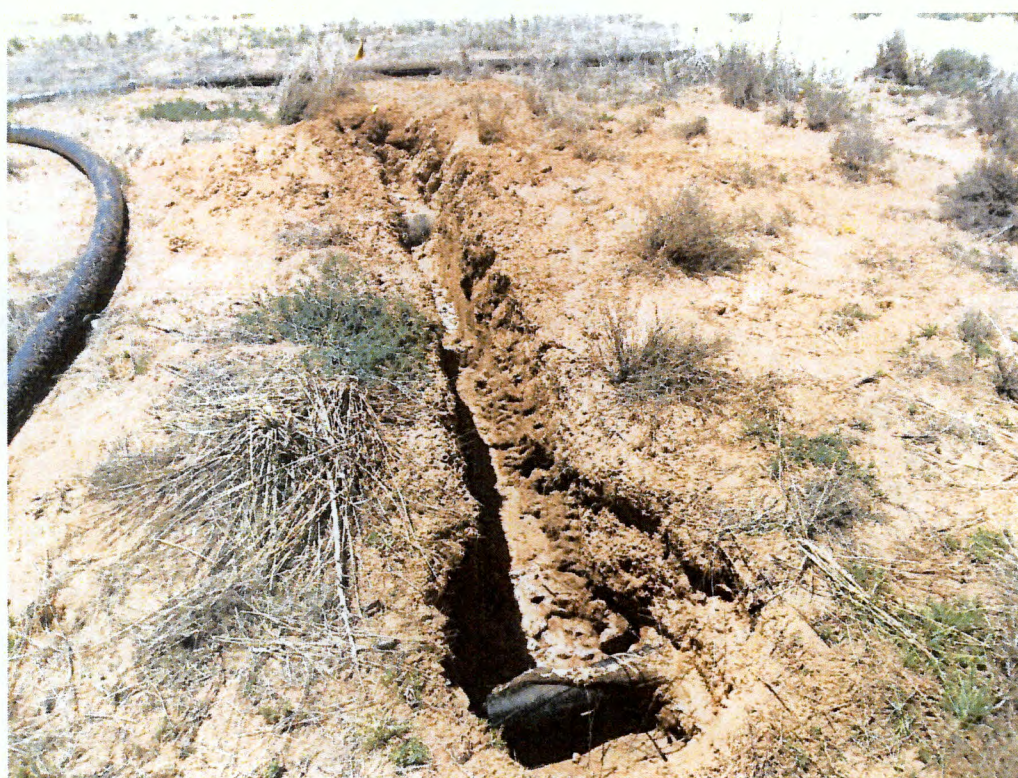
On June 2, 2015, Tetra Tech supervised the removal of impacted material as highlighted (green) on Table 1 and shown on Figure 4. Due to an incorrect spot by DCP of the underground poly line, a line was found to run North to South in the areas of auger holes (AH-1, AH-2, AH-3, and AH-4), which somewhat altered the proposed excavation areas. The areas of auger holes (AH-1, AH-3, AH-4, AH-5 and AH-6) were excavated to a depth of 4.0' below surface and the areas of auger holes (AH-2, AH-7, and AH-8) were excavated to 6.0' below surface.

View West – Spotted DCP Midstream lines along the west portion of the spill area.

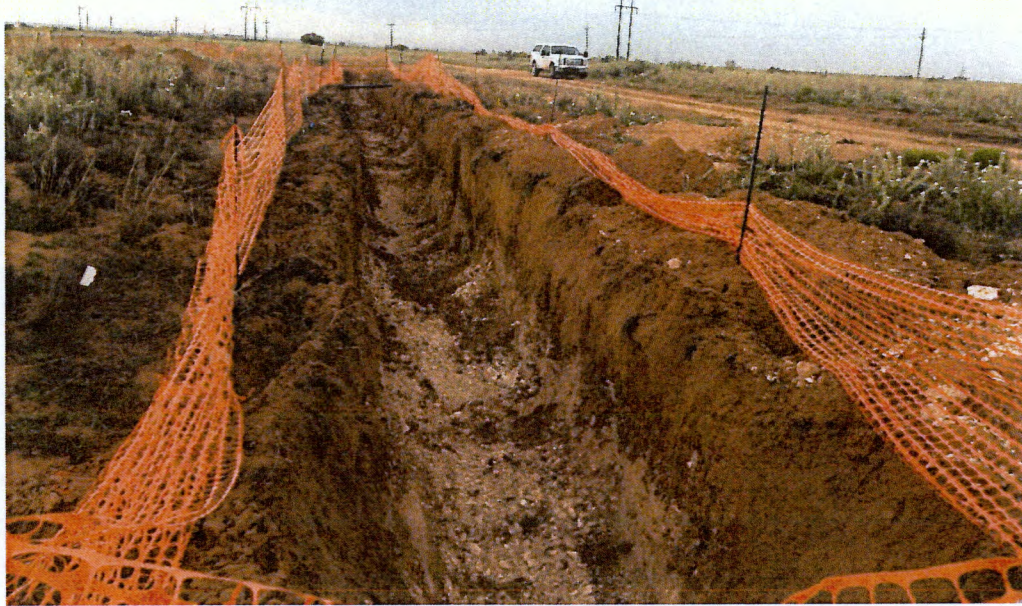
View South – Excavated area of AH-3, AH-2, AH-1, and AH-4

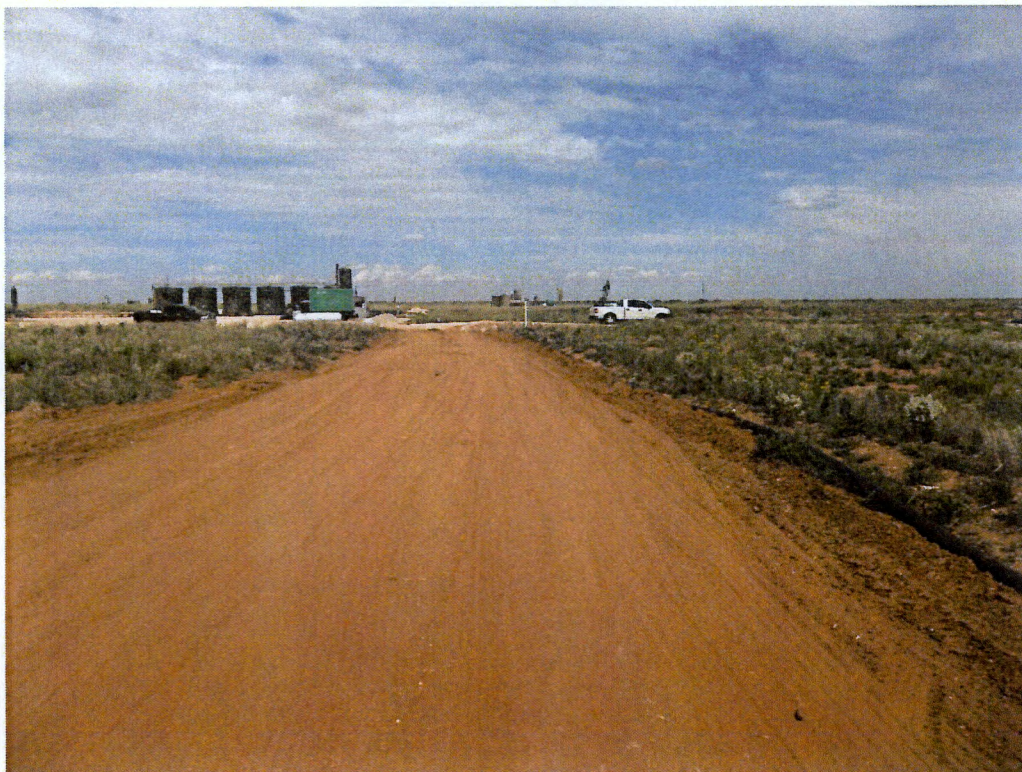
View East – Backfilled area of AH-4, AH-5, AH-7, and AH-8

Approximately 1,490 yards of excavated soil were transported offsite for proper disposal. The excavations were all backfilled with clean soil to grade. The area was also tilled and seeded with BLM seed mixture #2.

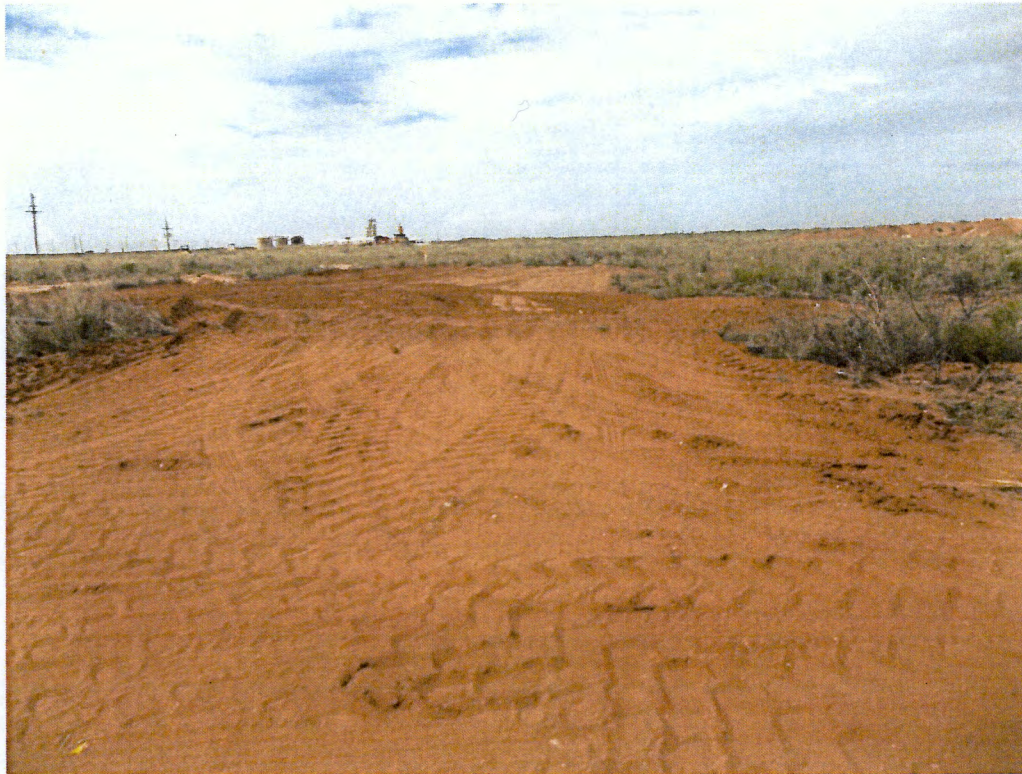
View North – Backfilled area of AH-6

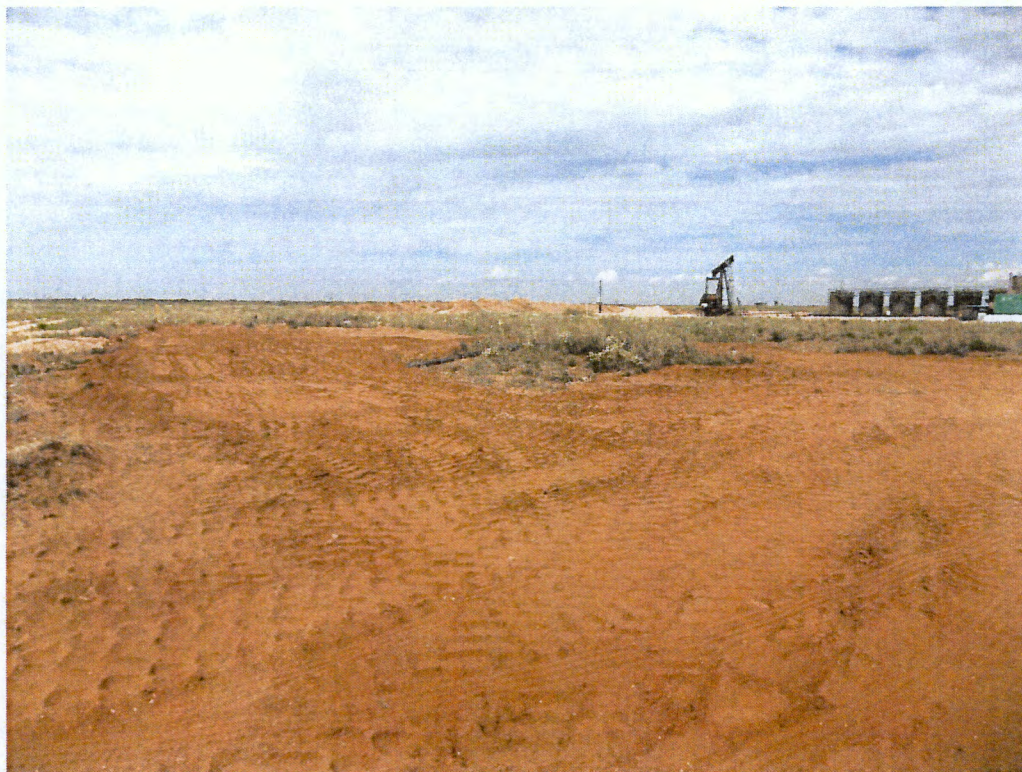
View North – Backfilled area of AH-4 and AH-1
