Re : Chevron Special Projects – VGWU No. 118 (RP# 3260)

Site Assessment Report
Vacuum Glorieta West Unit #118
Lea County, New Mexico

Site Conceptual Model

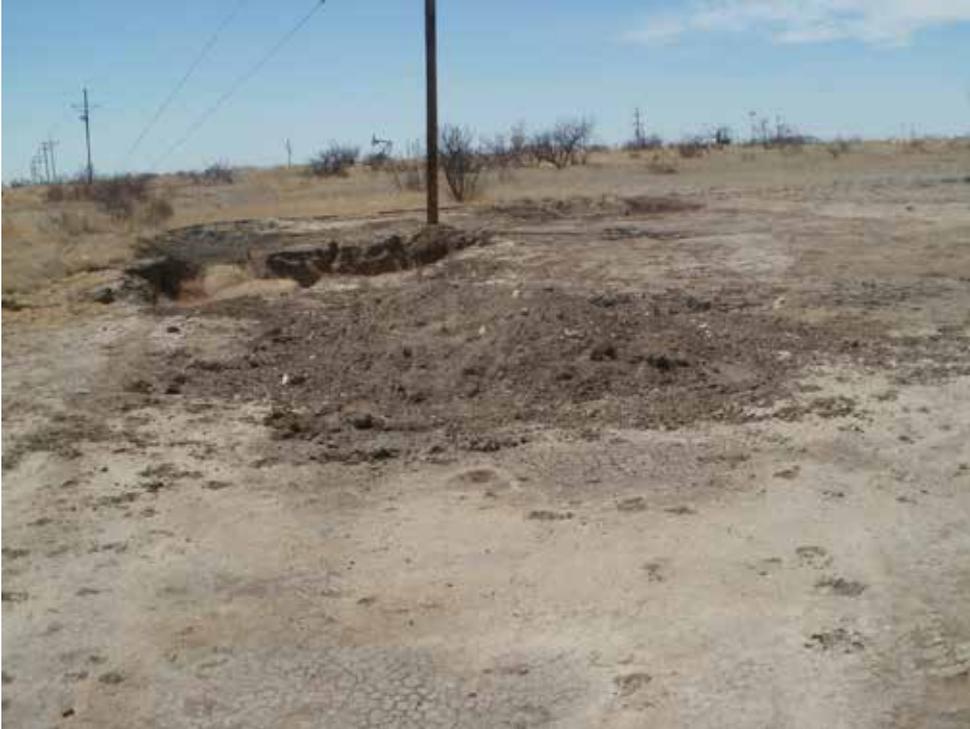
Photograph 1 – Vacuum Glorieta West Unit #118 release area; Facing South

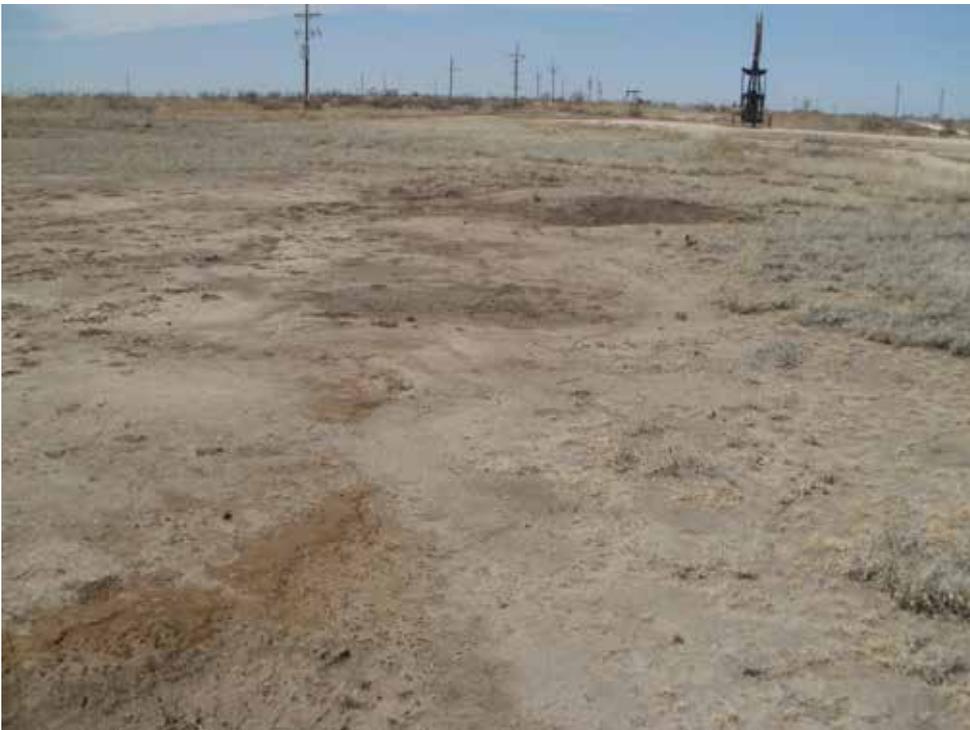
Photograph 2 – Vacuum Glorieta West Unit #118 release area; Facing West

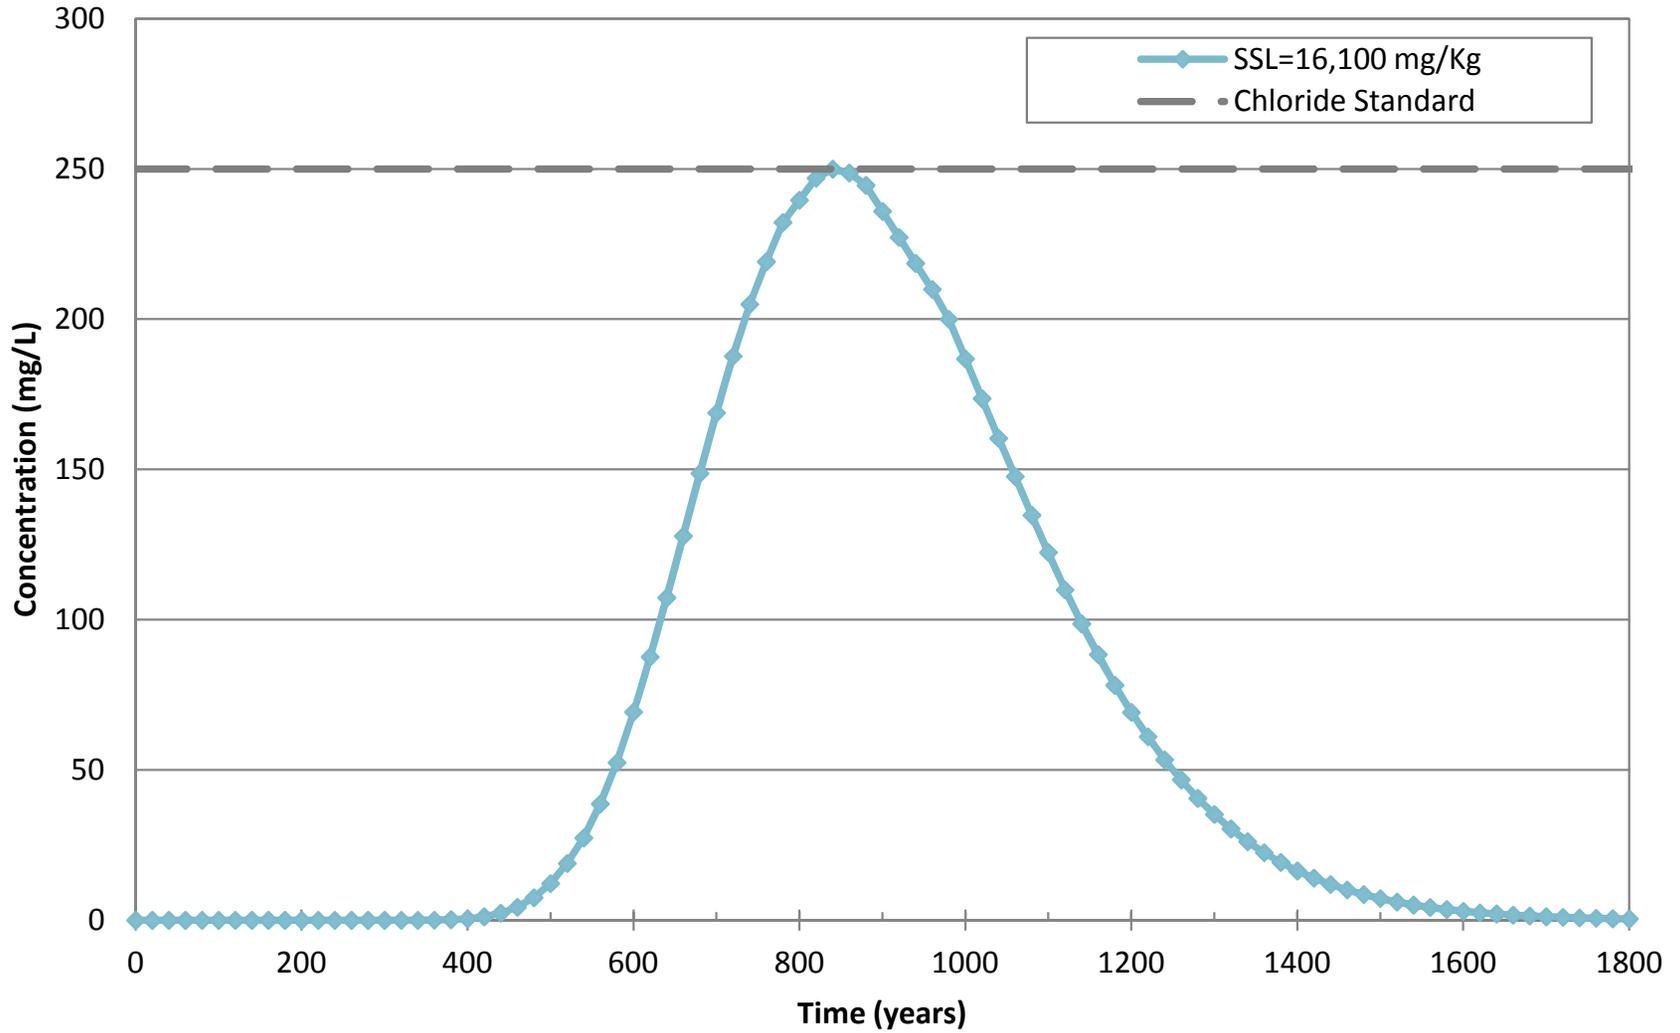
Figure 8
MULTIMED Simulated Chloride Concentration Vs Time in Groundwater
(Source = 45m, Chloride 0-3m, & Depth to Groundwater = 30.5m)
