# CMU 42 (A Battery)

## REMEDIATION WORK PLAN

**January 6, 2016**

**RE: Linn Energy, CMU #42 (A Battery) – Remediation Work Plan**  
UL/C, Section 20, T17S, R33E  
API No. 30-025-01499

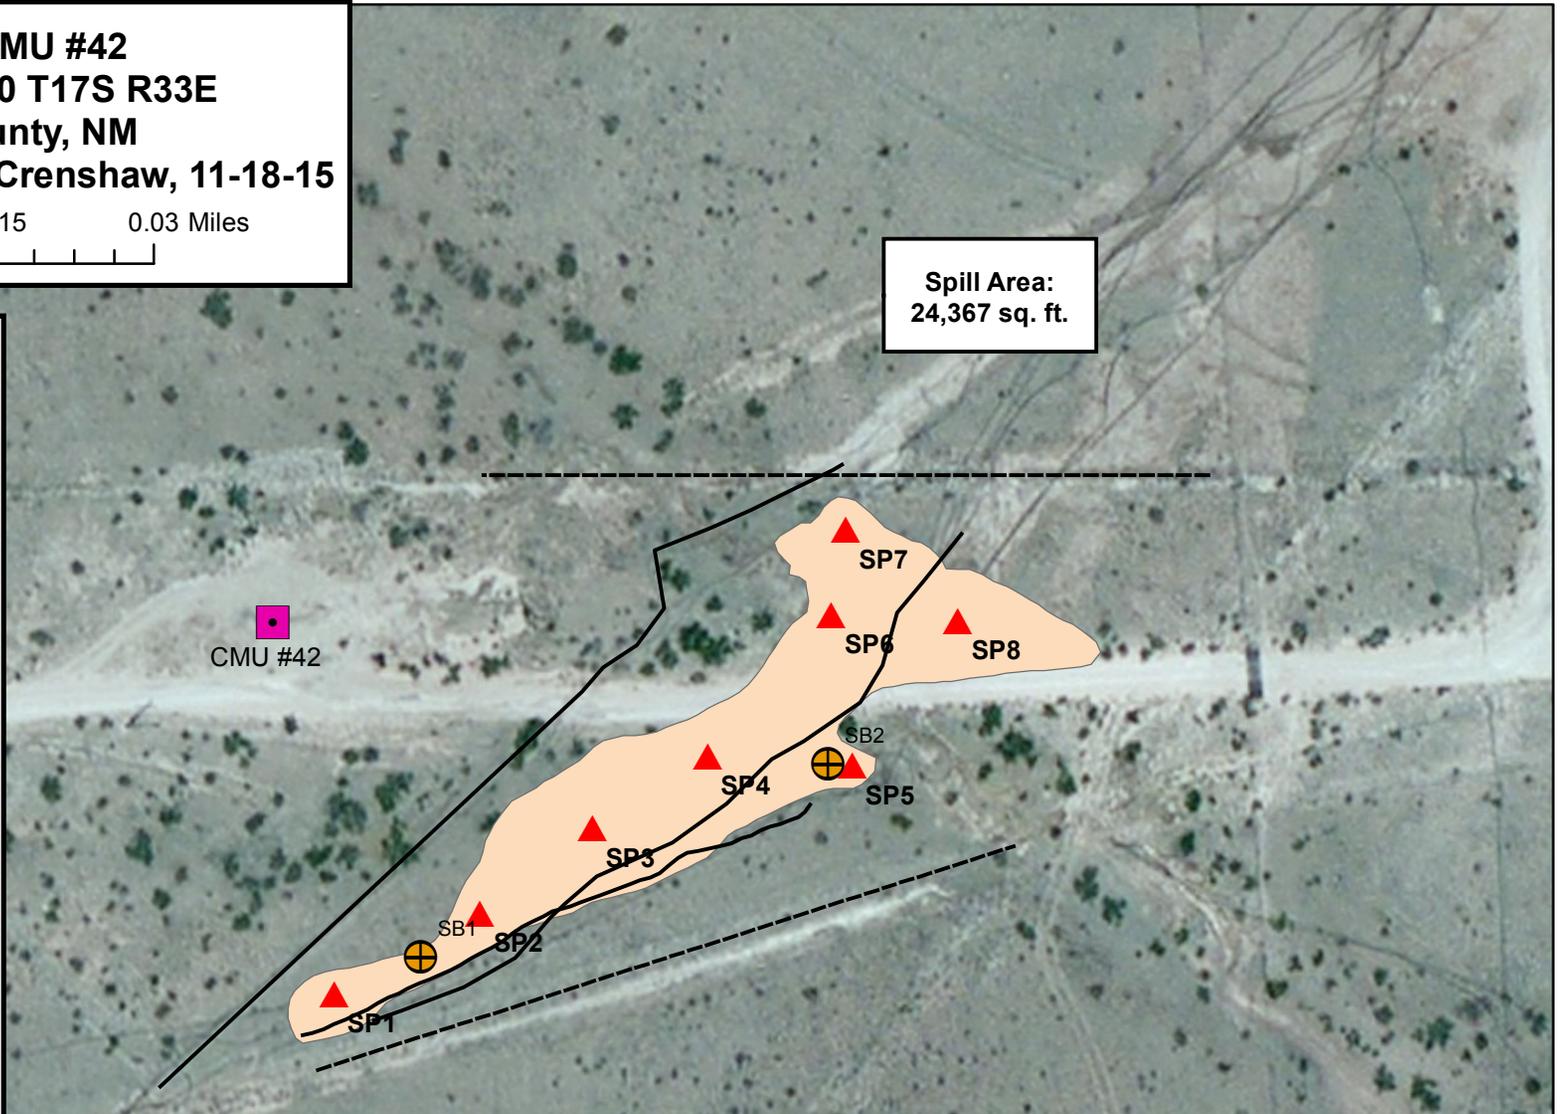
# Site Diagram

The site is located southeast of Maljamar, NM, in Lea County. The leak site resulted from a split in the poly line that runs from the transfer pump at the CMU A Battery to the CMU North Injection Plant. The poly line had a split on the bottom side. The leak ran down a slope towards the northeast for approximately 100', with the widest point of the leak at 40'. Approximately 10 bbls of produced water was released, with none recovered. A site map is attached. This spill occurred on top of the Caprock Escarpment. A C-141 was drafted on July 8, 2015.

**Spill Area:**  
**24,367 sq. ft.**

In the areas of SP1, SP2, and SP5, excavate to 4' BGS, install either river rock or a 20-mil liner, and backfill with native topsoil. The area will be seeded with a BLM approved mix. Since the rest of the sample points were clean at the surface and down to 2' BGS, DFSI proposes to just reseed the entire affected area with a BLM approved mix. All contaminated materials will be hauled to an approved NM State Disposal.

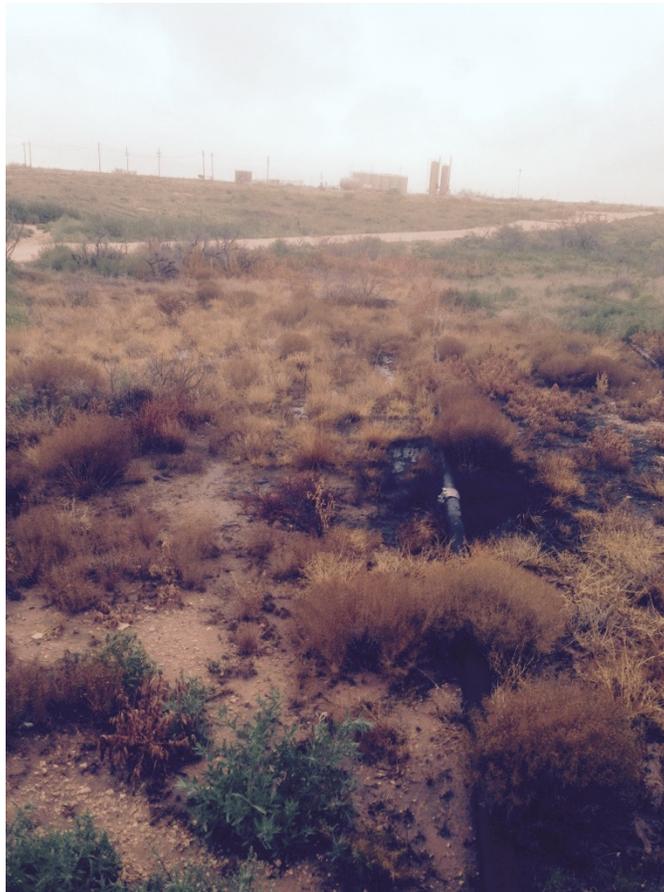
Describe Cause of Problem and Remedial Action Taken.\* At approx. 7am leak was found at CMU Leases. When I arrived I had found that the poly line from our transfer pump at the CMU A battery to the CMU N. Inj plant. The poly pipe had a split on the bottom side.

Source of spill in pasture area

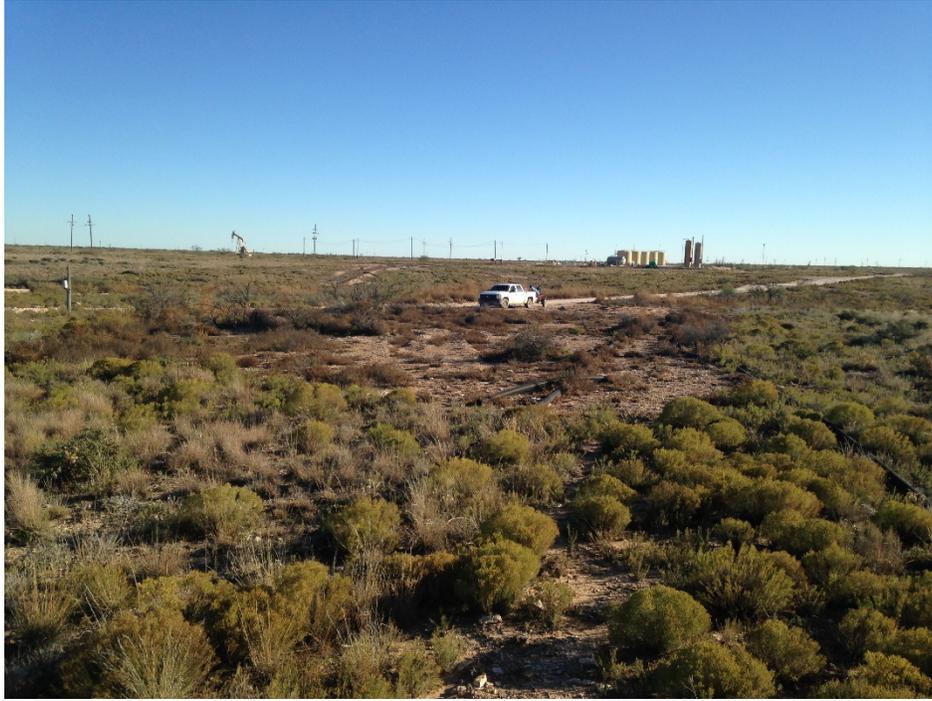
On December 10, 2015 DFSI personnel returned to the site and to drill two bore holes for confirmation samples. SB1 was placed in between SP1 and SP2, and SB2 was placed in the area of SP5. Clean samples attained at the bore holes were taken to a commercial laboratory for confirmation. Those results are attached

Preparing to drill bore holes at spill area

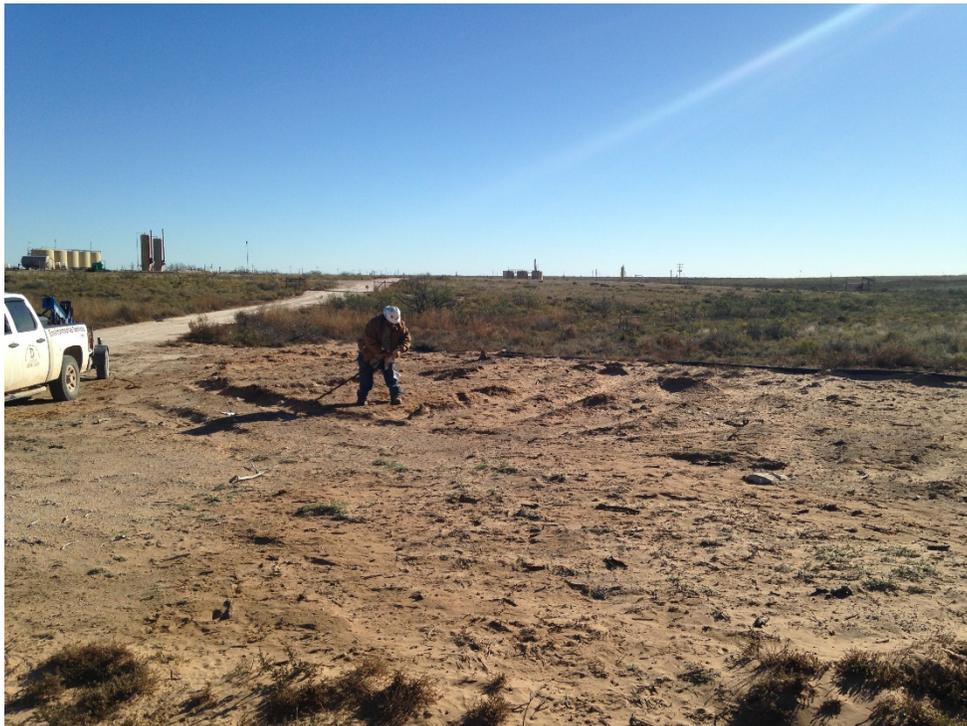
On November 19, 2015 DFSI personnel responded to the release site to sample eight points of the spill area. The samples were tested for chloride levels as well as BTEX. The BTEX samples

Collecting samples

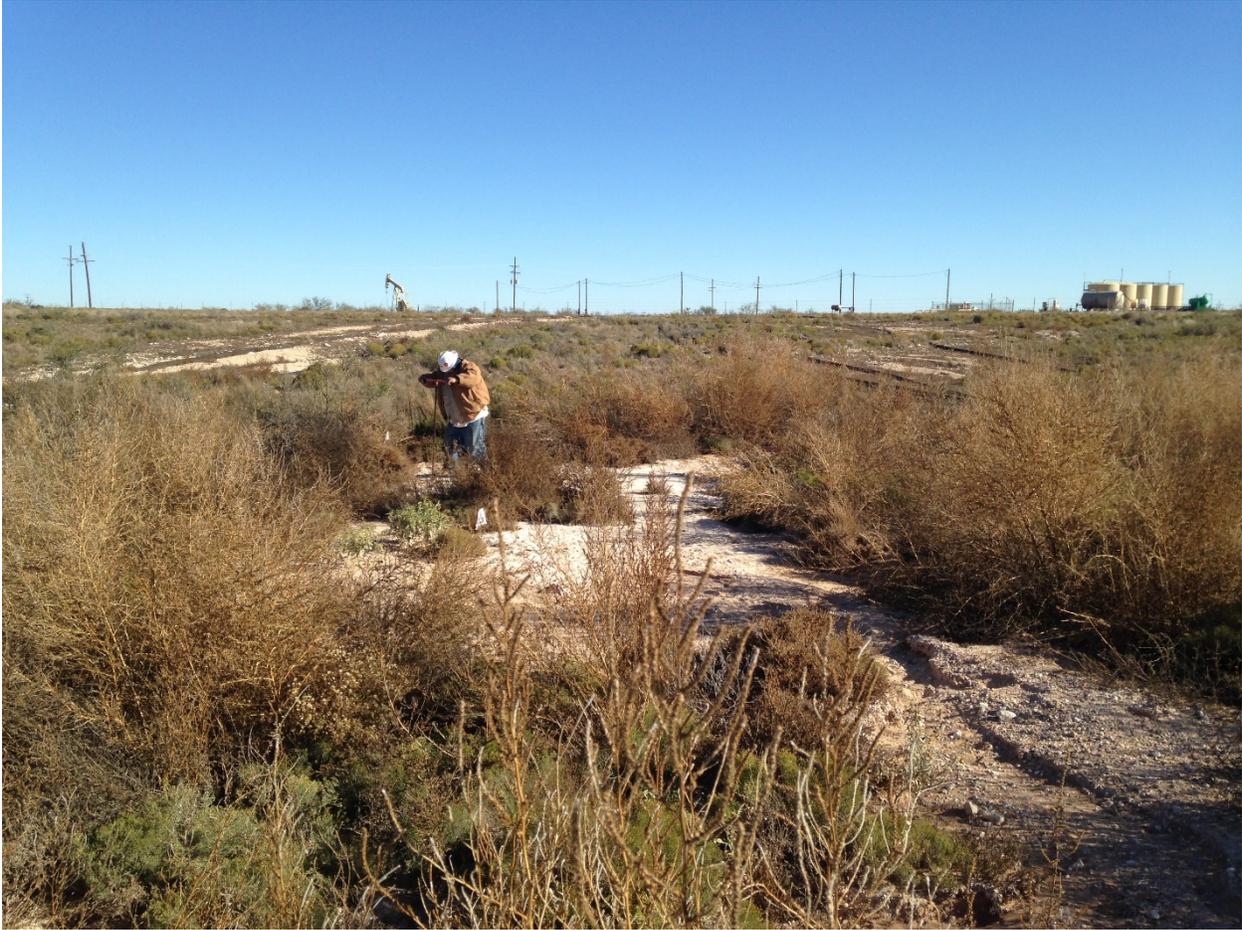
Collecting samples
