Re: Stratojet 31 State Com #6H
30-025-42452
Sec. 31, T20S-R35E
Lea County, NM

COG Operating LLC would like to submit for your consideration the enclosed work plan for the above captioned well. The request is in response to the C-141 Initial report dated August 8, 2015.

Background

Work Plan

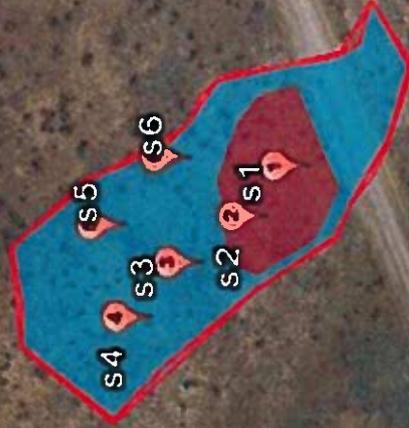
This release was caused when a dump valve failed and oil was sent to the flare resulting in the release of 20 bbls of oil where 1 bbls was recovered. This release caused a spray that impacted approximately 1.12 acres of pasture on the northwest side of the location. Vacuum trucks were dispatched immediately to recover all standing fluid and soapy water and Microblaze were applied to the impacted soil and vegetation. The attached site diagram depicts the approximate area impacted by the release along with the approximate sampling points.

Initial soil samples were taken on 11-02-2015 with approximate sample locations depicted on the attached Site Diagram. Sample points were chosen based on safe proximity to existing gas lines. Samples indicated TPH and BTEX were within RRALs in all samples except for the surface samples taken at S1 and S2. Below is a summary of the attached analytical results:

Site Ranking: 10

Depth to GW per SEO: 87ft

S1	BTEX	GRO	DRO	TPH	CI-
Surface	<0.300	<50.0	12500	12500	128
1'	<0.300	<10.0	13.1	13.1	<16.0
2'	<0.300	<10.0	12.4	12.4	<16.0
3'	<0.300	<10.0	10	10	<16.0
S2	BTEX	GRO	DRO	TPH	CI-
Surface	<0.300	<50.0	2510	2510	<16.0
1'	<0.300	<10.0	38.9	38.9	<16.0
2'	<0.300	<10.0	159	159	<16.0
S3	BTEX	GRO	DRO	TPH	CI-
Surface	<0.300	<10.0	341	341	<16.0
1'	<0.300	<10.0	10.1	10.1	<16.0
2'	<0.300	<10.0	<10.0	<10.0	<16.0
S4	BTEX	GRO	DRO	TPH	CI-
Surface	<0.300	<10.0	145	145	<16.0
1'	<0.300	<10.0	<10.0	<10.0	<16.0
S5	BTEX	GRO	DRO	TPH	CI-
Surface	<0.300	<10.0	95.3	95.3	<16.0
1'	<0.300	<10.0	<10.0	<10.0	<16.0
S6	BTEX	GRO	DRO	TPH	CI-
Surface	<0.300	<10.0	35.5	35.5	<16.0
1'	<0.300	<10.0	<10.0	<10.0	<16.0

- **S1 & S2:** Surface tillage with no excavation followed by an application of Microblaze. Area is ~10,000 sq ft. and is depicted by the red shaded area in the site diagram.
- **S3 – S6:** No excavation or further work required based on the attached analytical data. Area depicted by the blue shaded area in the site diagram.
