MCA Unit Station No. 2 (1RP-3311)

Termination Request

**RE: Termination Request
ConocoPhillips MCA Unit Station No. 2 (1RP-3311)
UL/C sec. 28 T17S R32E**

Figure 1

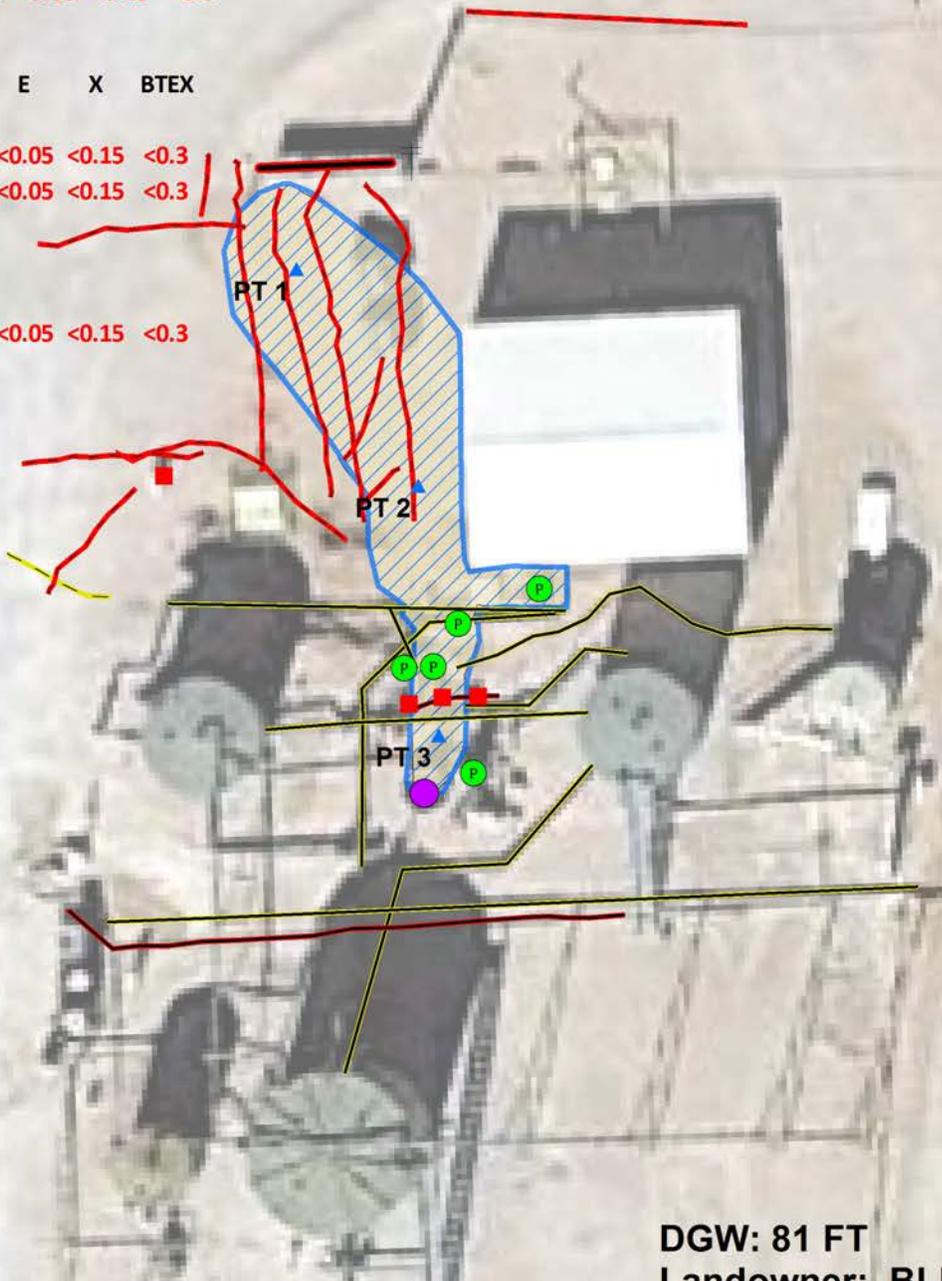
Scrape

Point 1										Point 2									
	CI-	PID	GRO	DRO	B	T	E	X	BTEX		CI-	PID	GRO	DRO	B	T	E	X	BTEX
SS	1035	7.9								SS	128	3.5	<10	<10	<0.05	<0.05	<0.05	<0.15	<0.3
6"	3000	1.6	<10	<10	<0.05	<0.05	<0.05	<0.15	<0.3	6"	112	1.2	<10	23.7	<0.05	<0.05	<0.05	<0.15	<0.3
1'	272	2.2	<10	<10	<0.05	<0.05	<0.05	<0.15	<0.3										
1.5'	264	1.7																	
2'	234	2.1																	
2.5'	176	1.8	<10	<10	<0.05	<0.05	<0.05	<0.15	<0.3

Point 3									
	CI-	PID	GRO	DRO	B	T	E	X	BTEX
SS	474	7.1							
6"	992	1.7	<10	<10	<0.05	<0.05	<0.05	<0.15	<0.3
1'	320	2.1	<10	<10	<0.05	<0.05	<0.05	<0.15	<0.3
1.5'	322	1.8							
2'	305	1.1							
2.5'	279	1.8							
3'	160	1.7	<10	<10	<0.05	<0.05	<0.05	<0.15	<0.3

DGW: 81 FT
Landowner: BLM

CAP activities began August 11th, 2015. The release was scraped down to 1 ft bgs (Figure 1). All excavated soil, a total of 45 yards, was taken to a NMOCD approved facility for disposal. A total of 45 yards of clean caliche were imported to the site to serve as backfill. A representative sample of the imported caliche was taken to a commercial laboratory for analysis and returned a chloride value of 64 mg/kg (Appendix B). The scrape was then backfilled with the clean, imported caliche and contoured to the surrounding location.

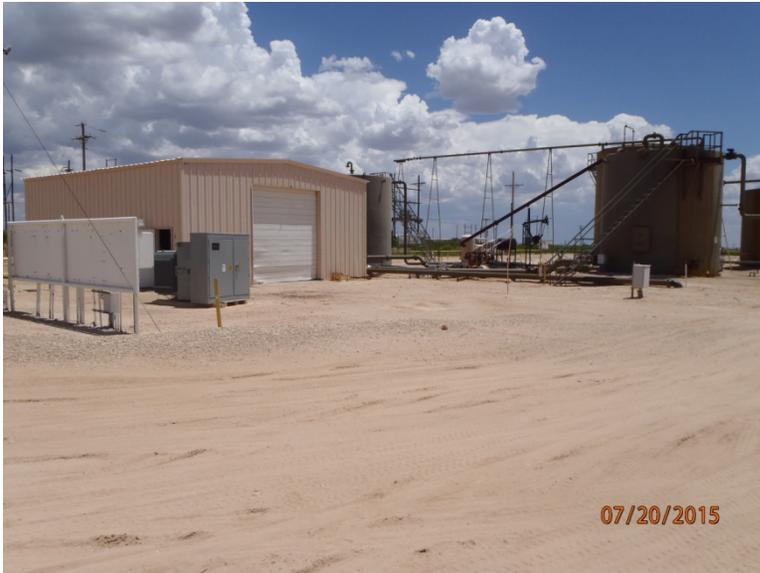
Initial release area, facing southeast

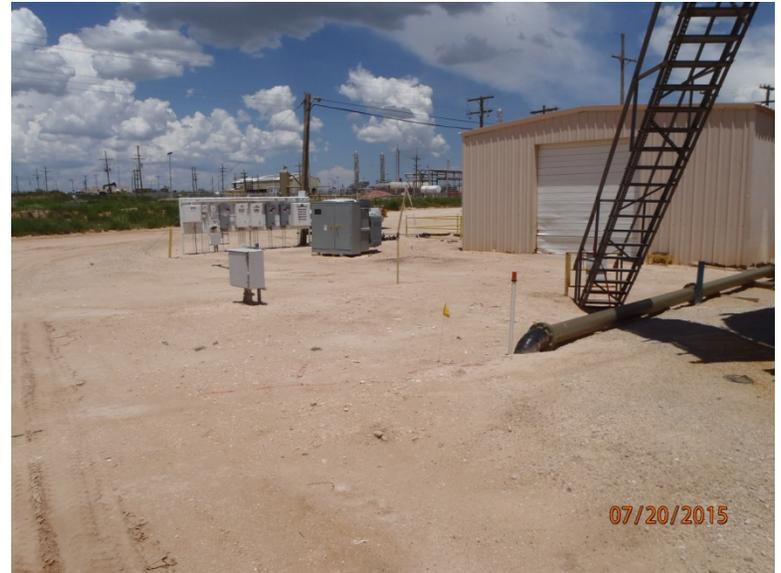
Initial release area, facing northeast

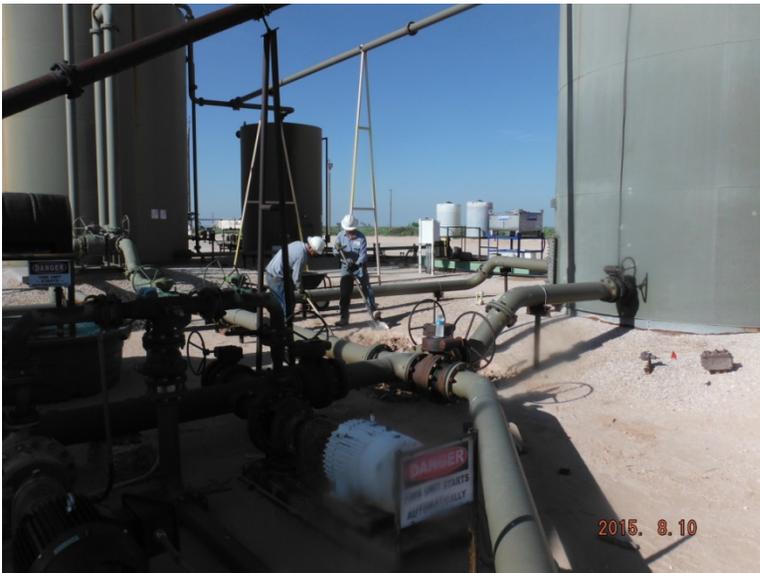
Shoveling release, facing southwest

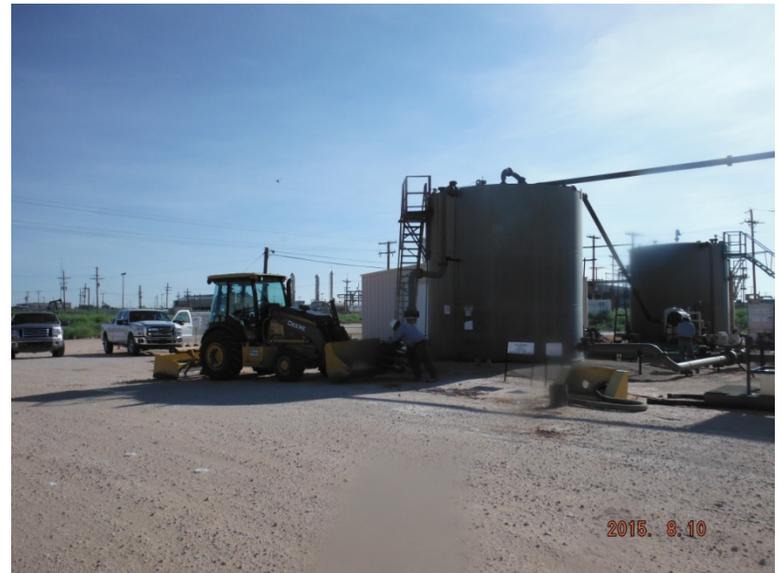
Exporting, facing northeast

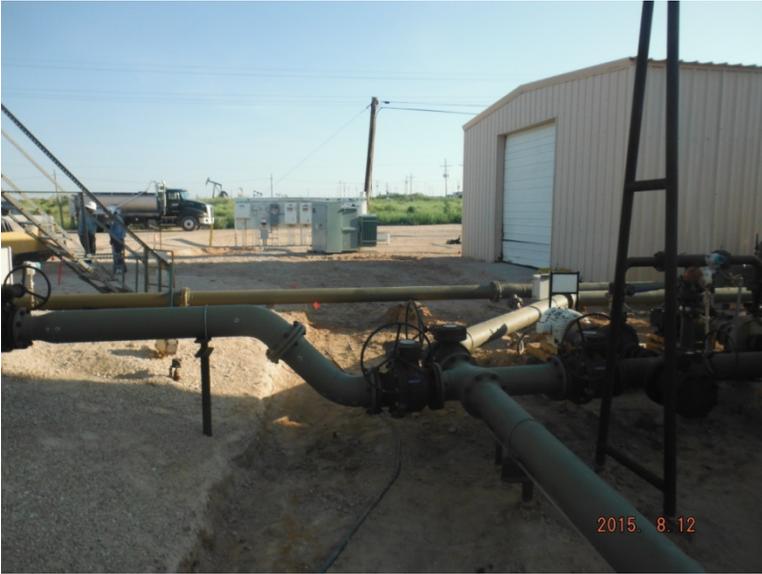
Completed scrape, facing north

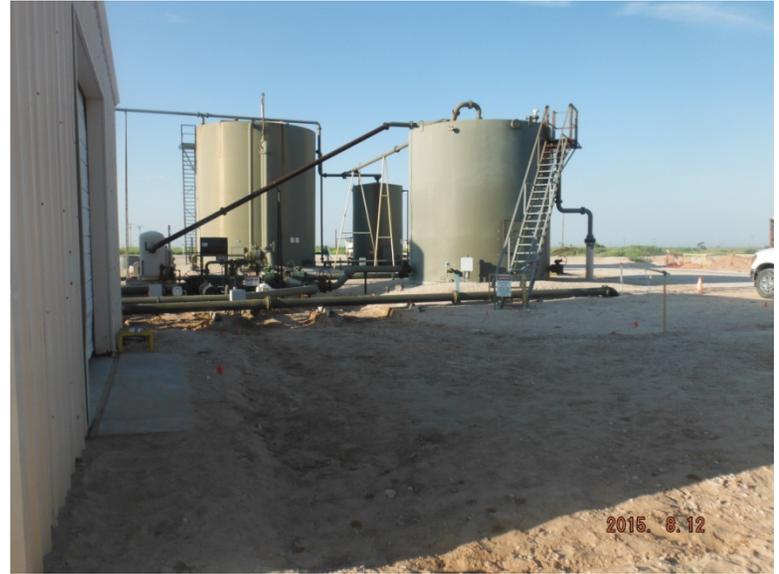
Completed scrape, facing southwest

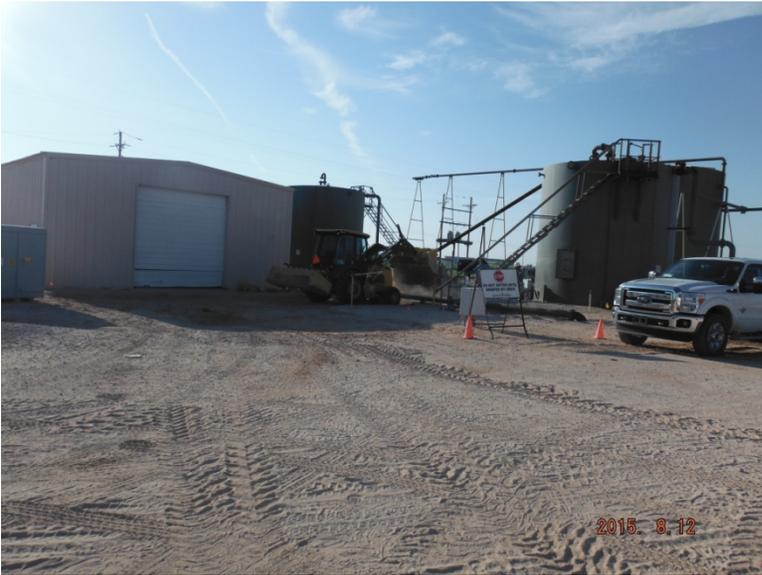
Importing, facing southeast

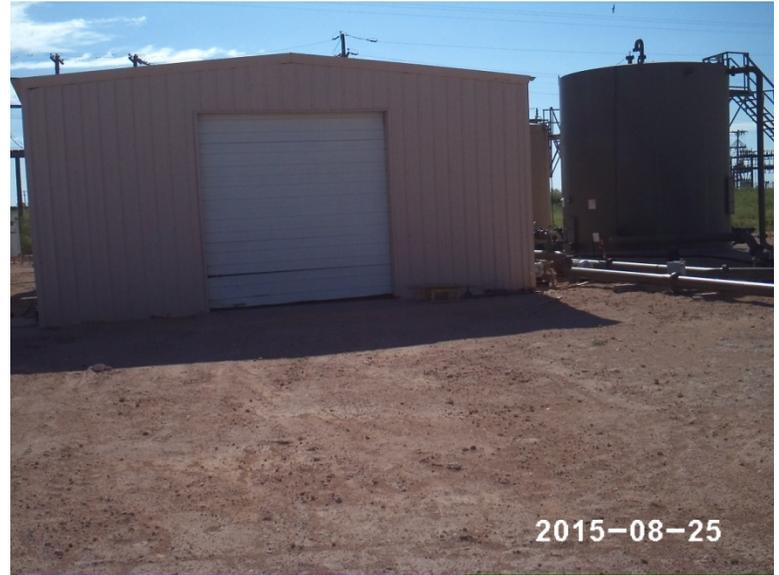
Completed site, facing east

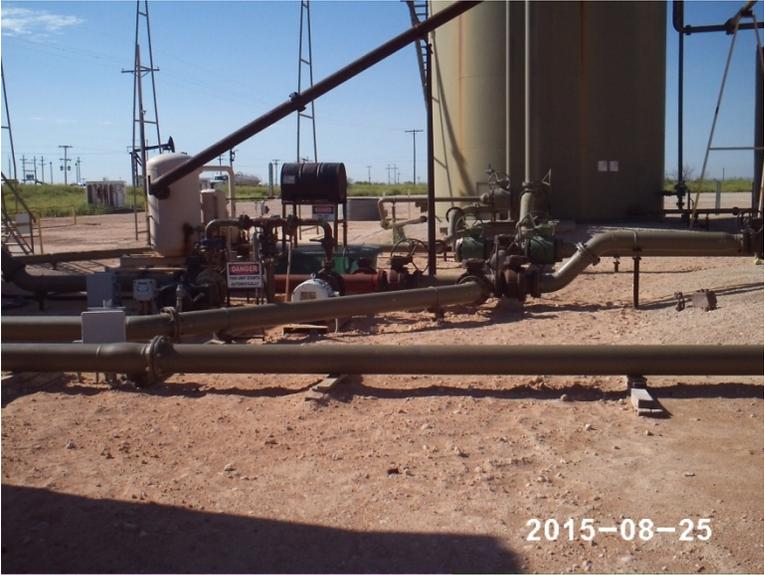
Completed site, facing south

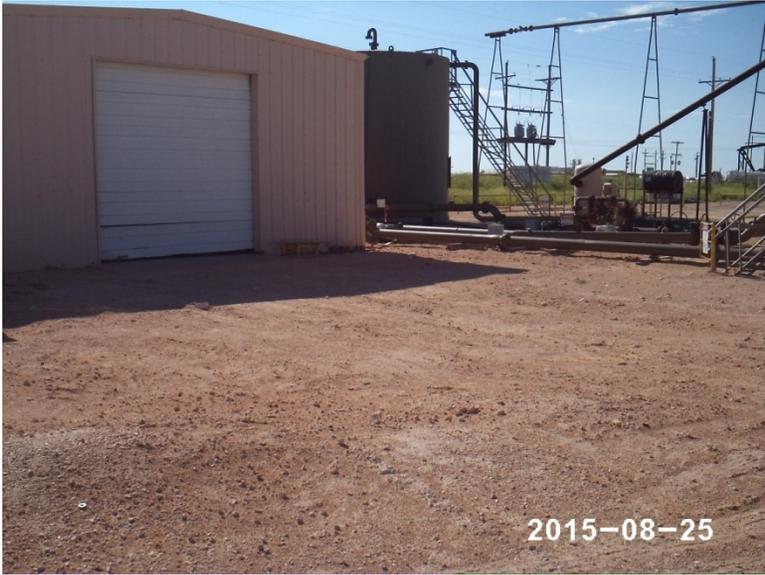
Completed site, facing southeast
