To: Kellie Jones, New Mexico Oil Conservation Division, District 1
Jim Amos, Bureau of Land Management
Reference: Remediation Work Plan
Operator: Devon Energy Production Company
Location: Rio Blanco 4 Fed Com #3
API: 30-025-36425
Legals: UL, J, Sec.4, T23S, R34E, Lea County
GPS: 32.3309, -103.4718

Devon Energy Production Company-Rio Blanco 4 Fed Com #3

Devon Energy Production Company – Rio Blanco 4 Fed Com 3

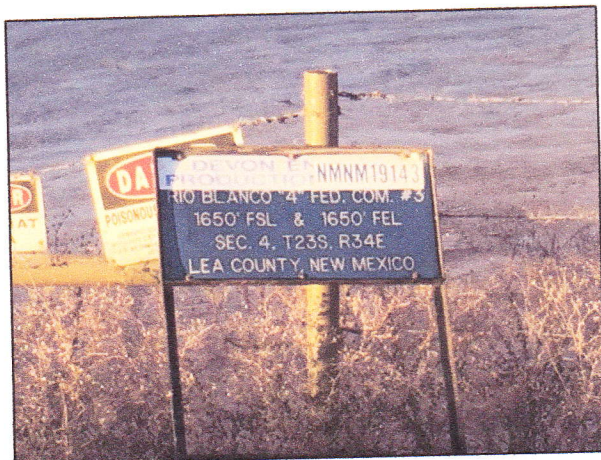
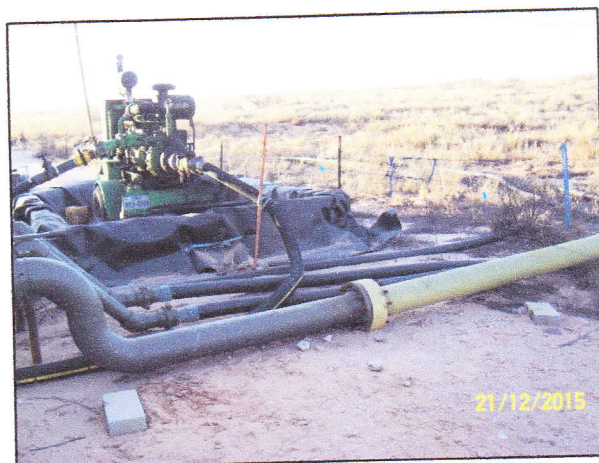
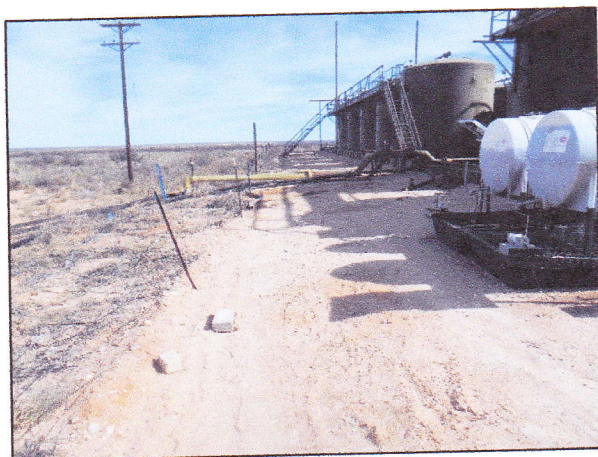
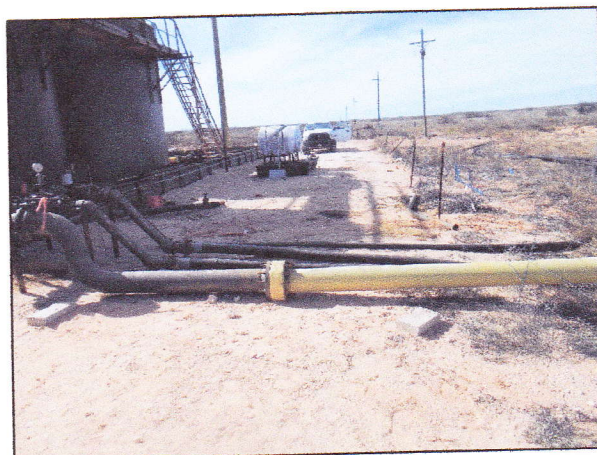
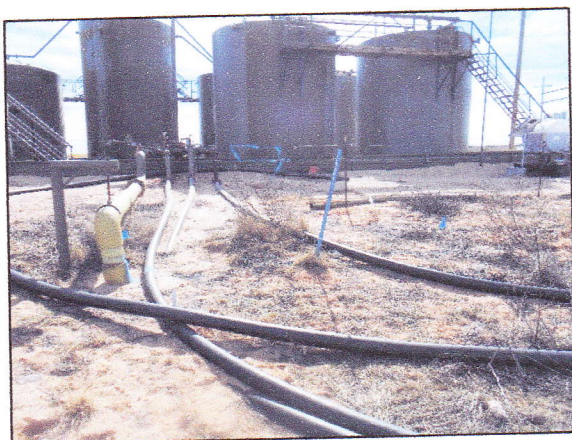
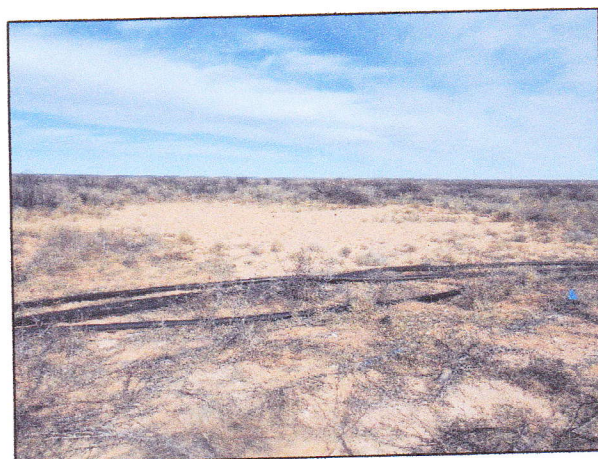
This remediation work plan is in response to a release of produced water from a failed fitting on a water pump. The water pump was located behind the battery (north side) on the edge of the caliche pad.

A delineation of four sample points was conducted using a hand auger (See attached map). The only sample point indicating a presence of chlorides was SP #1, the place where the water transfer pump was sitting behind the battery and on the caliche pad. Field test indicated a continual decline in chlorides form the surface down to 9' BGS. At this point, hard soil was encountered resulting in auger refusal. The impacted area is 21' x 13'.

Based upon soil analysis, the small size of the impacted area, and the fact that the impacted area is on the caliche pad, I propose to excavate the impacted area at SP #1 to 3' BGS and line with a synthetic liner. Due to no presence of contaminants, I propose to leave SP's 2-4 as is with no further work being performed.

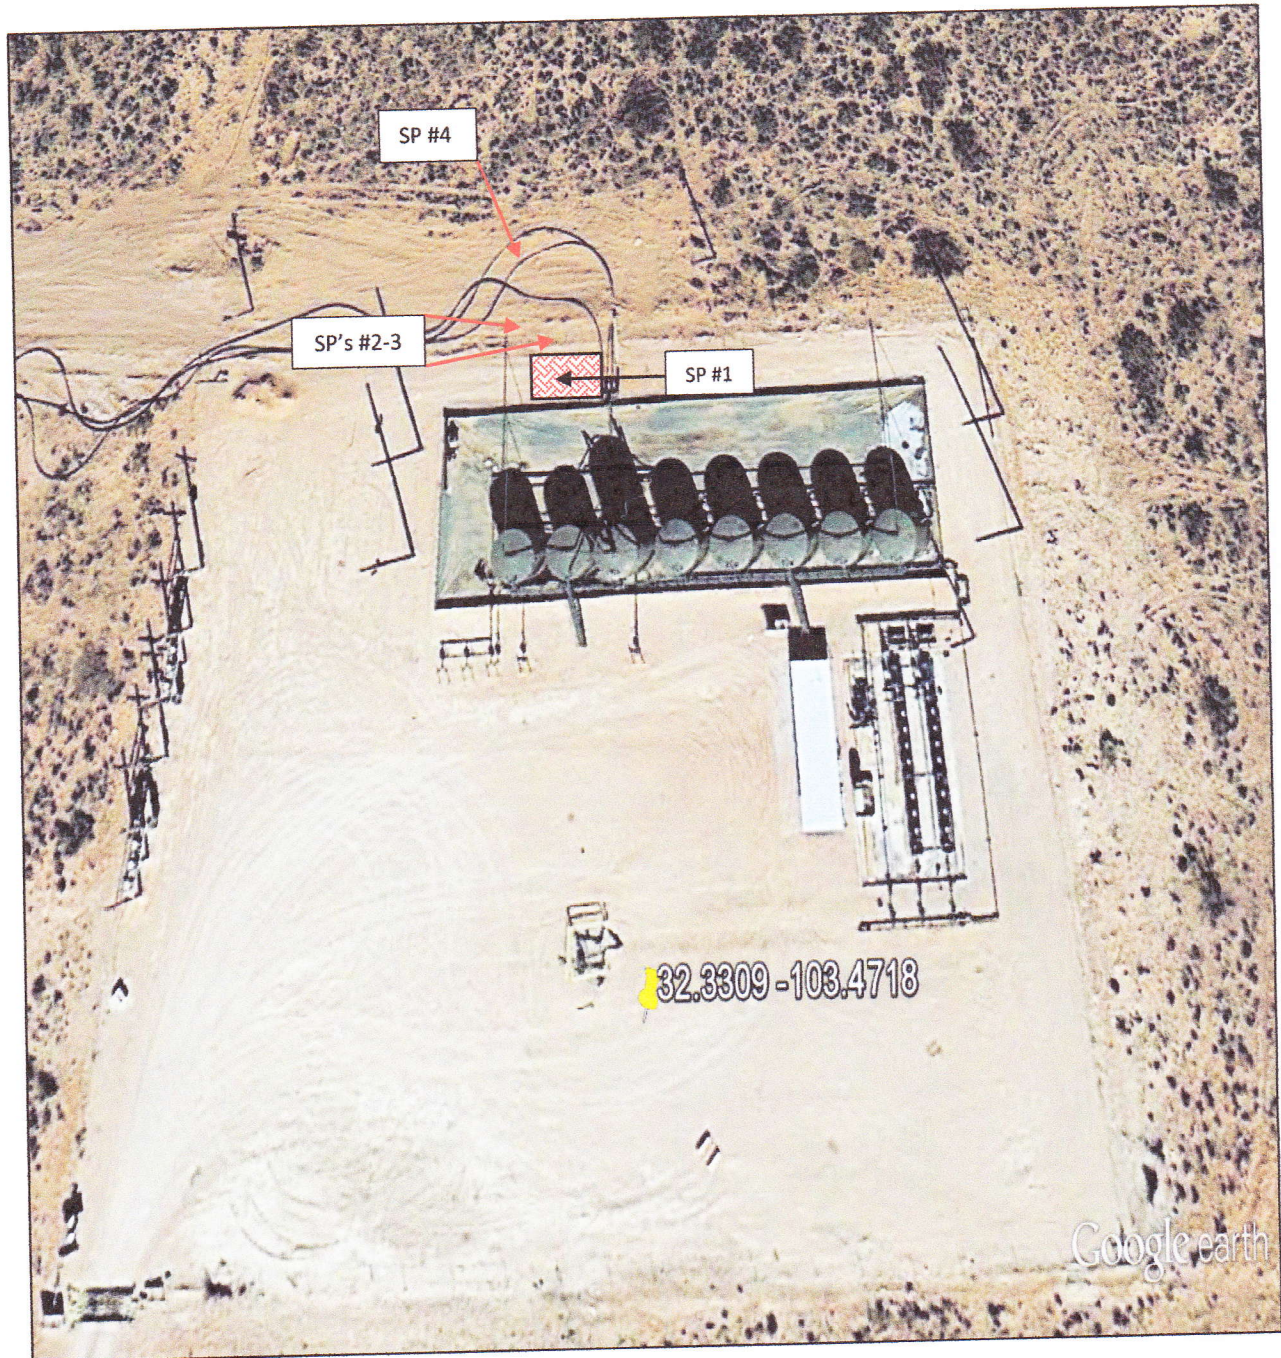
SP's 2-3 were selected just off the edge of the caliche pad to check for run off, lab analysis supported the field test results of chlorides being non-detectable. SP #4 was selected in the pasture in the area of a slight overspray. As before, lab analysis supported the field test results of chlorides being non-detectable.

SP #1-Impacted area on pad, 21' x 13'
SP #2-4 – light over spray

1. OCD gives the option to remove an additional 2' at SP1 and not install a liner.
2. A confirmation sample will need to be pulled prior to backfill.
