CMU #140

CLOSURE REPORT

API No. 30-025-32923

NMOCD Case # 1R-3931

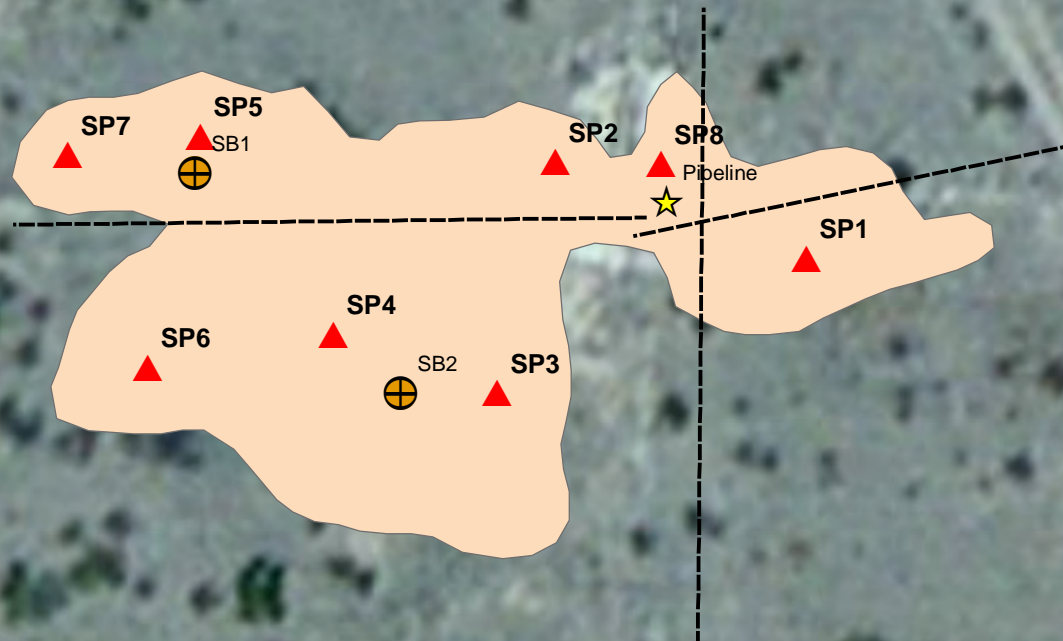
Site Diagram

Spill Area:
9,262 sq. ft.

On October 17, 2015, DFSI personnel responded to the site and exposed the line for repair. The release area was then scraped to minimize environmental impact (Appendix II).

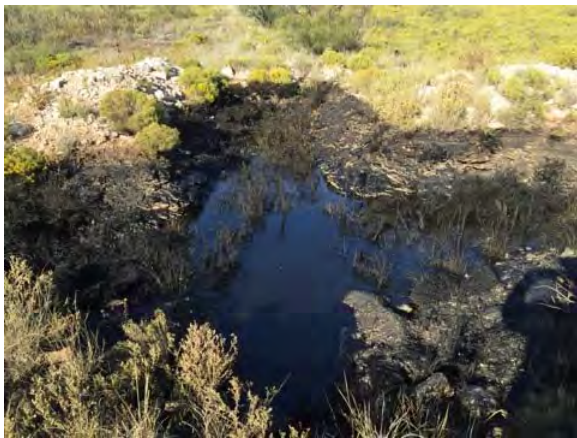
Release area

10/17/2015

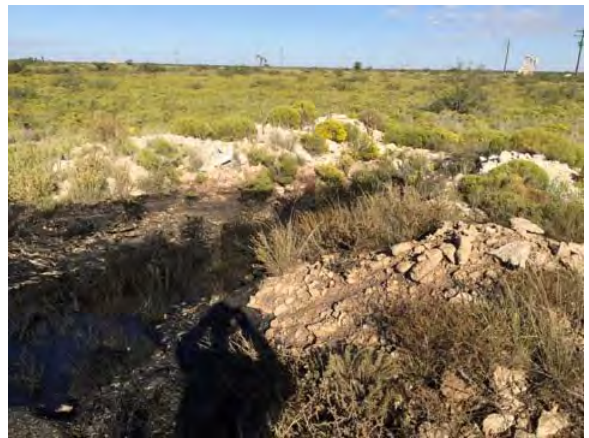
Release area

10/17/2015

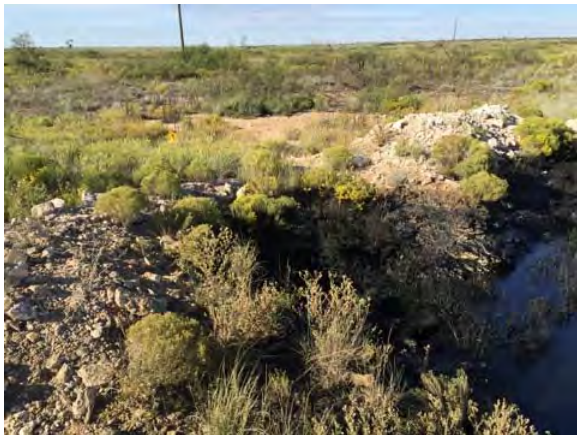
Release area

10/17/2015

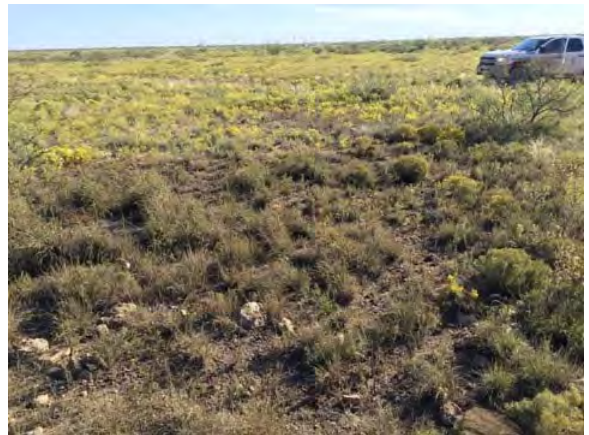
Release area

10/17/2015

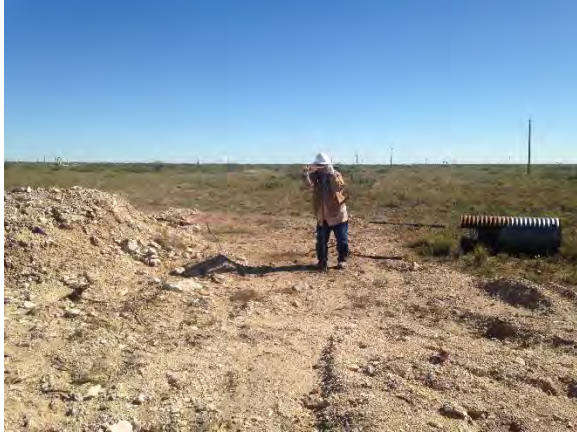
Collecting samples by augering, facing east
11/6/2015

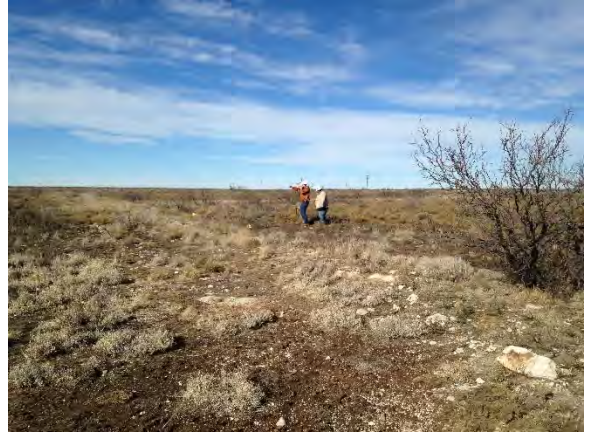
Collecting samples by auguring, facing northwest
1/15/2016

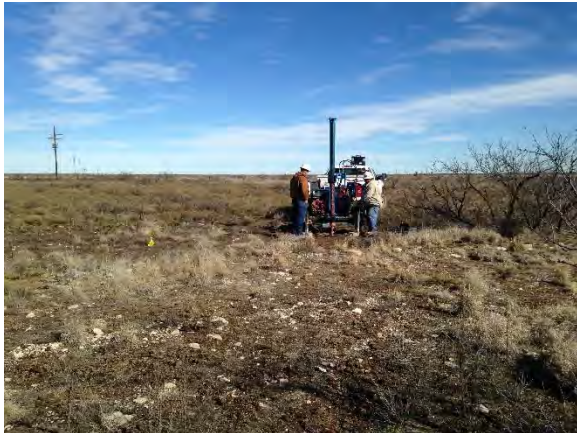
Installing SB-1, facing north
1/15/2016

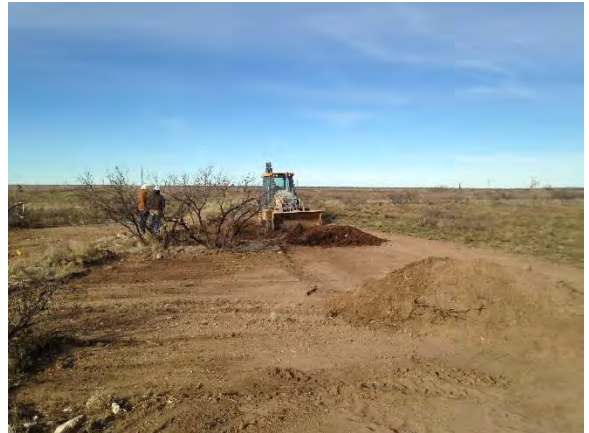
Excavating site, facing west
2/16/2016

A work plan was submitted to NMOCD and BLM on December 1, 2015. Beginning February 16, 2016, DFSI personnel were on site to scrape the affected area to 6" bgs and backfill with clean, imported topsoil (Appendix IV). Contaminated soil was properly disposed of at an NMOCD approved facility. An approximate area of ½ acre was seeded with a mix of BLM #1 and BLM #2 on February 19, 2016 (Appendix V).

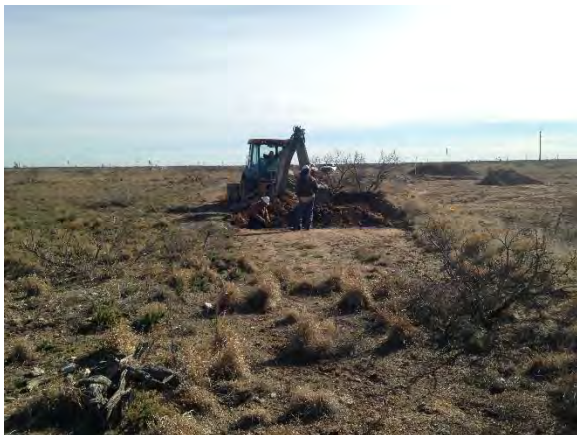
Collecting samples, facing east
2/16/2016

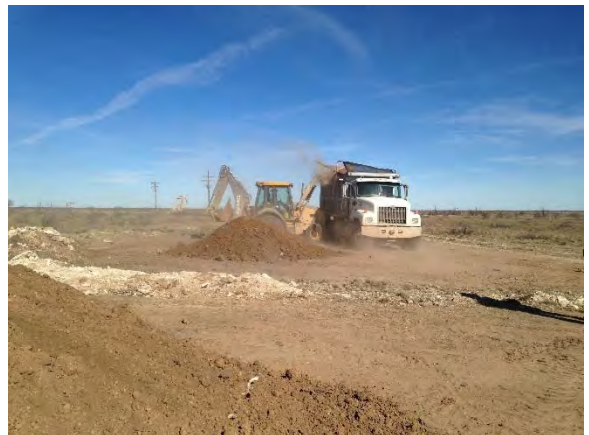
Exporting soil, facing northwest
2/16/2016

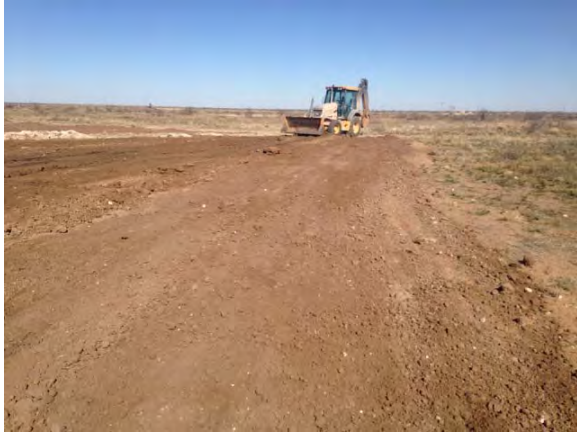
Backfilling site, facing west 2/18/2016

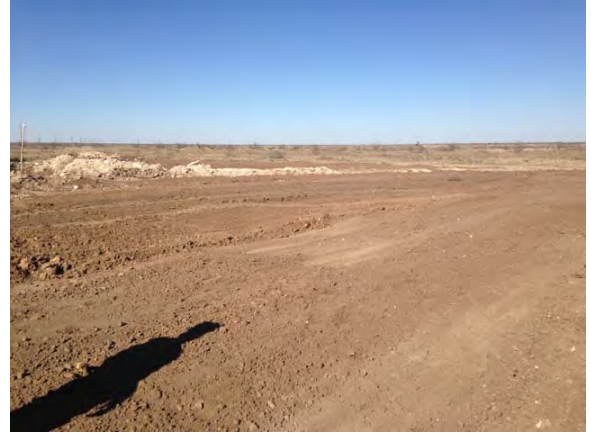
Backfill completed, facing west 2/18/2016

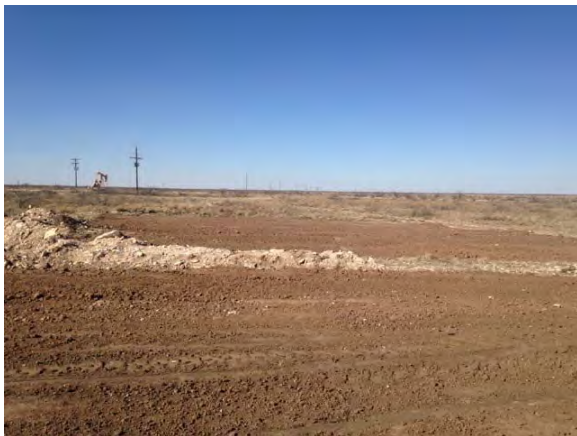
Site completed, facing southwest 2/18/2016
