RE: Final Closure Report
XTO Energy – Monument State 36 #1
UL-P, Section 36, Township 18 South, Range 36 East
Lea County, New Mexico
NMOCD Reference # 1RP-3963

The following *Final Closure Report* serves as a condensed update on closure activities for the above referenced Site.

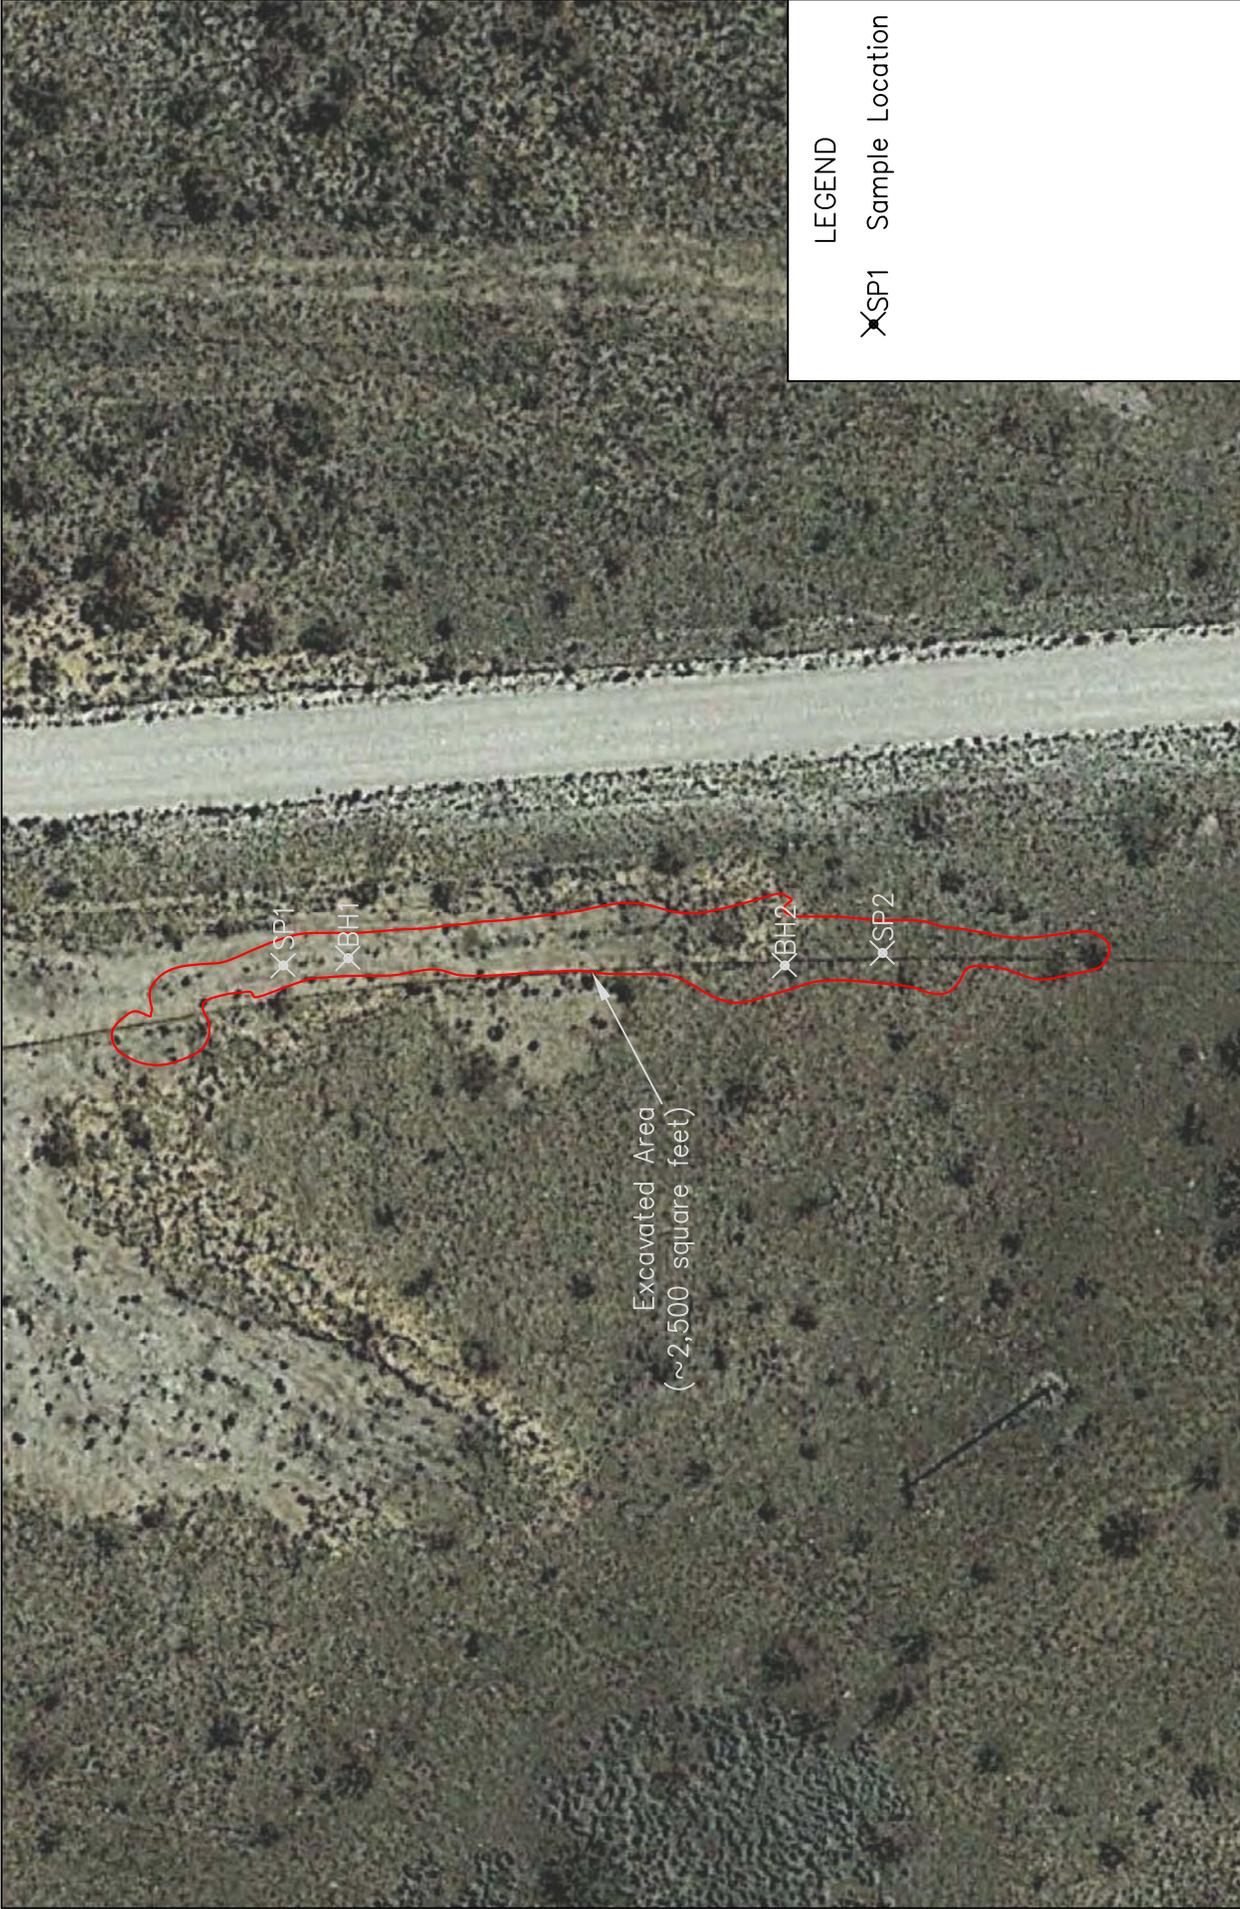
Figure 3
 Sample/Site Map
 XTO Energy
 Monument State 36 #1

EPI personnel mobilized on the site on November 10, 2015 to collect soil samples to determine the vertical extent of contamination. A total of seven (7) soil samples were collected at varying depths from two (2) sample location; SP1 and SP2. Two (2) representative samples, one (1) from each sample point, were sent to Cardinal Labs for testing. Laboratory analytical results indicate Benzene, BTEX, TPH, and Chloride concentrations do not exceed NMOCD Recommended Remedial Action Levels (NMOCD RRALs) of 10 mg/Kg, 50 mg/Kg, 1,000 mg/Kg, and 500 mg/Kg respectively (reference *Figure 3* and *Table 2*).

On November 16, 2015 two (2) additional soil samples were collected from excavation floor and sent to Cardinal Labs for testing. Laboratory analytical results indicate Benzene, BTEX, TPH, and Chloride concentrations do not exceed NMOCD RRALs of 10 mg/Kg, 50 mg/Kg, 1,000 mg/Kg, and 500 mg/Kg respectively (reference *Figure 3* and *Table 2*).

Excavated Area
 (~2,500 square feet)

The release area was excavated approximately three (3) feet bgs. Approximately 270 cubic yards of contaminated material were excavated and transported to a state approved facility for disposal.

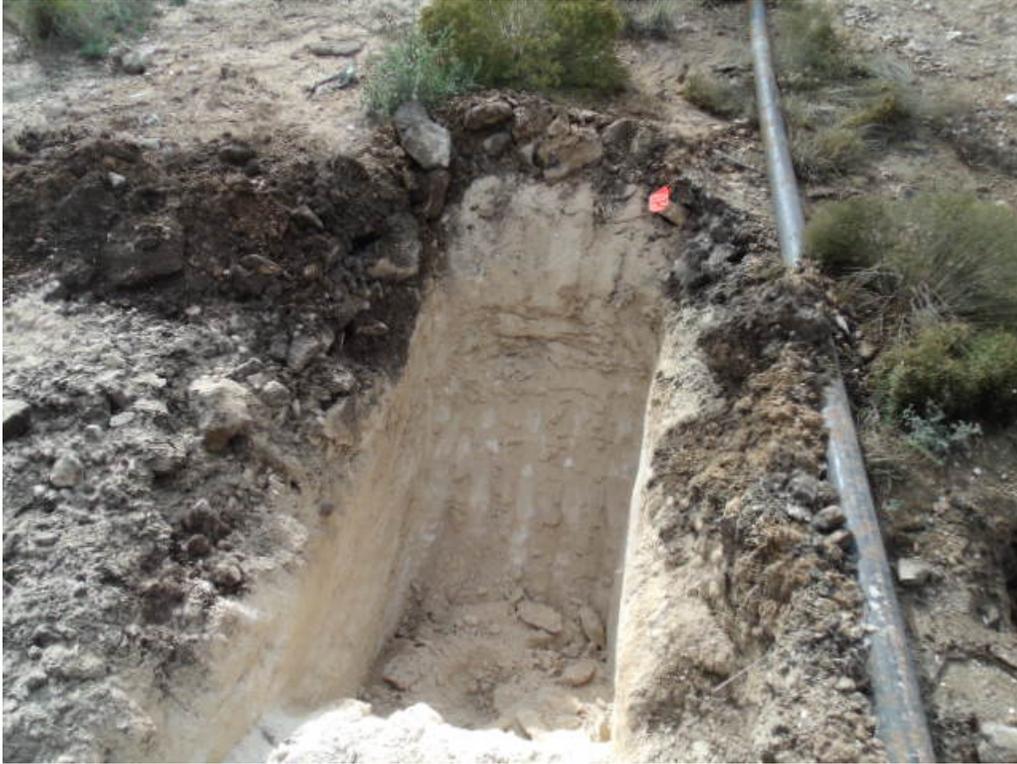
Photograph #1 – Sample point one at north end of release area

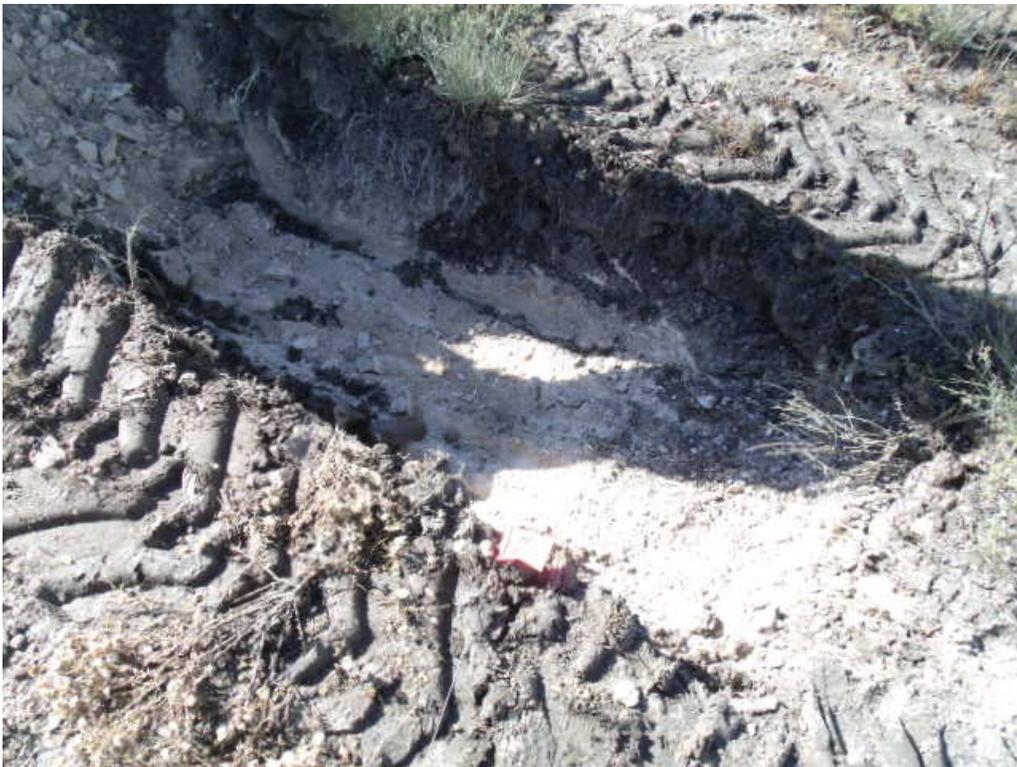
Photograph #2 – Sample point two at south end of release area

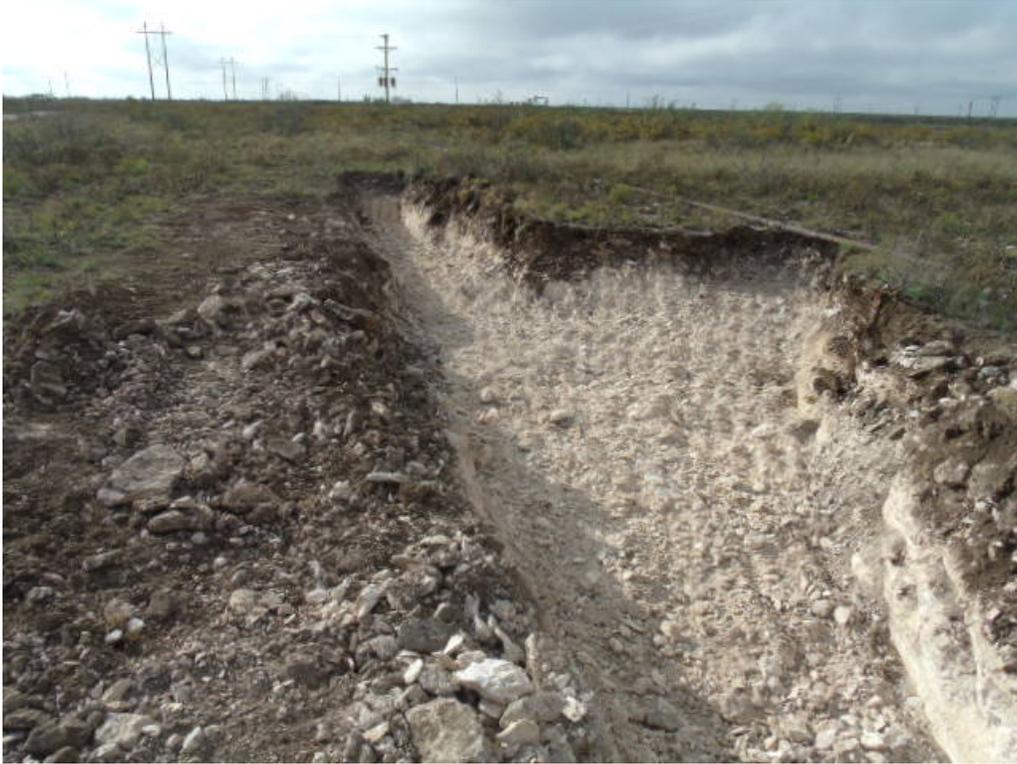
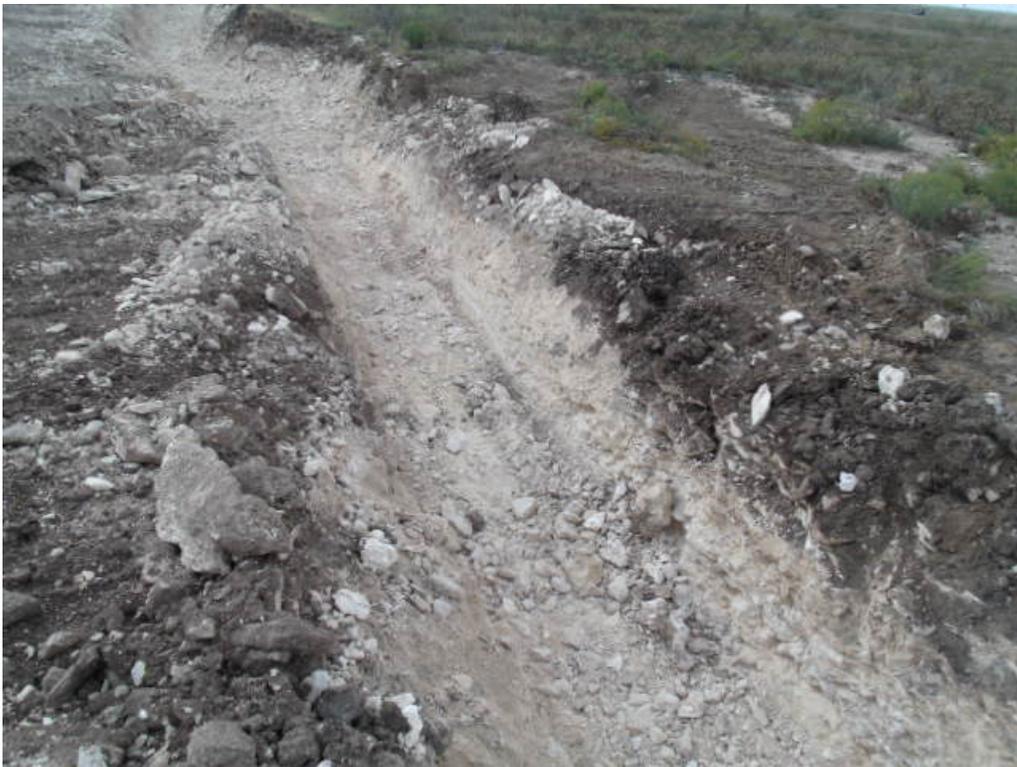
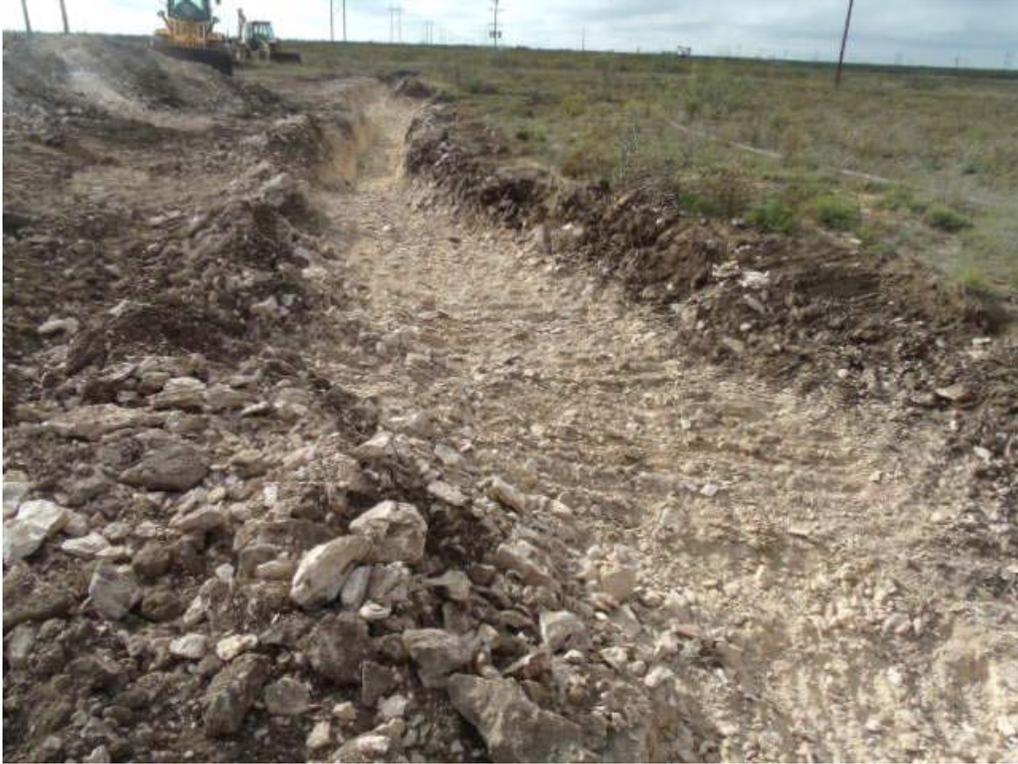
Photograph #3 – Excavated area

Photograph #4 – Excavated area

Photograph #5 – Excavated area

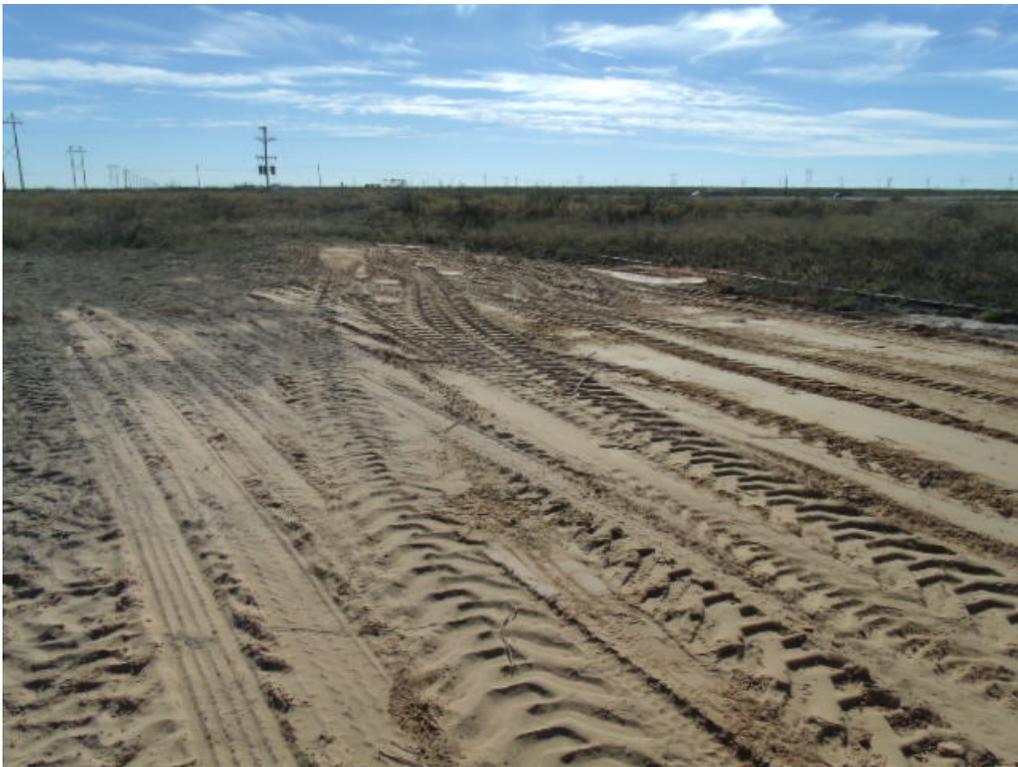
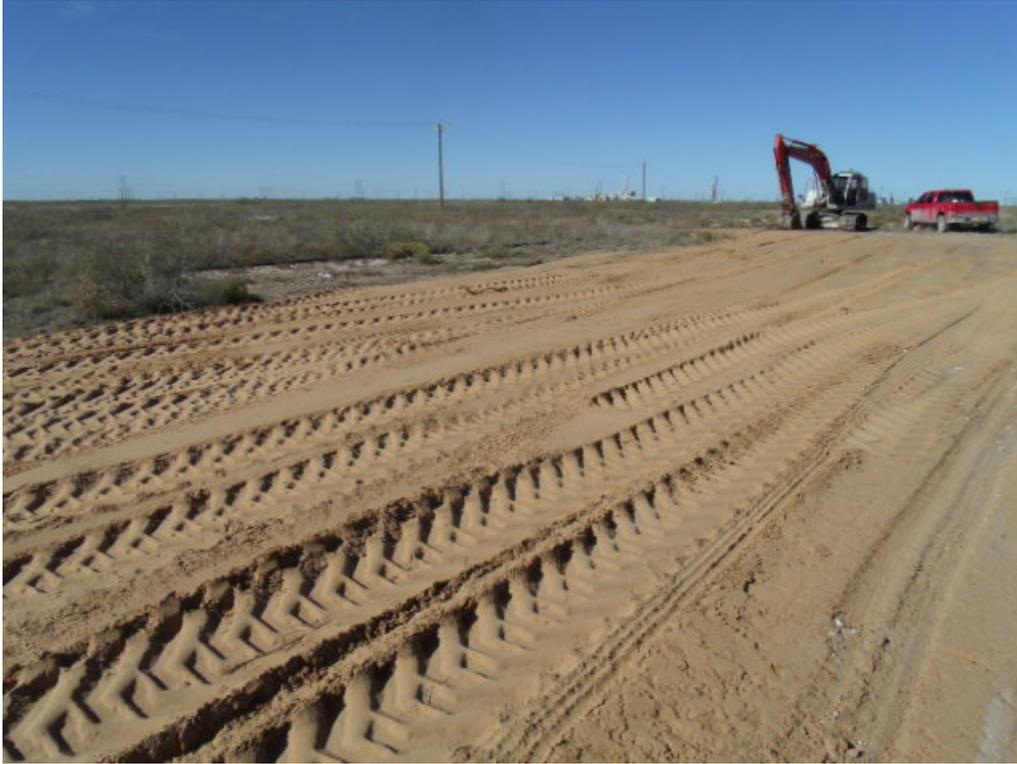
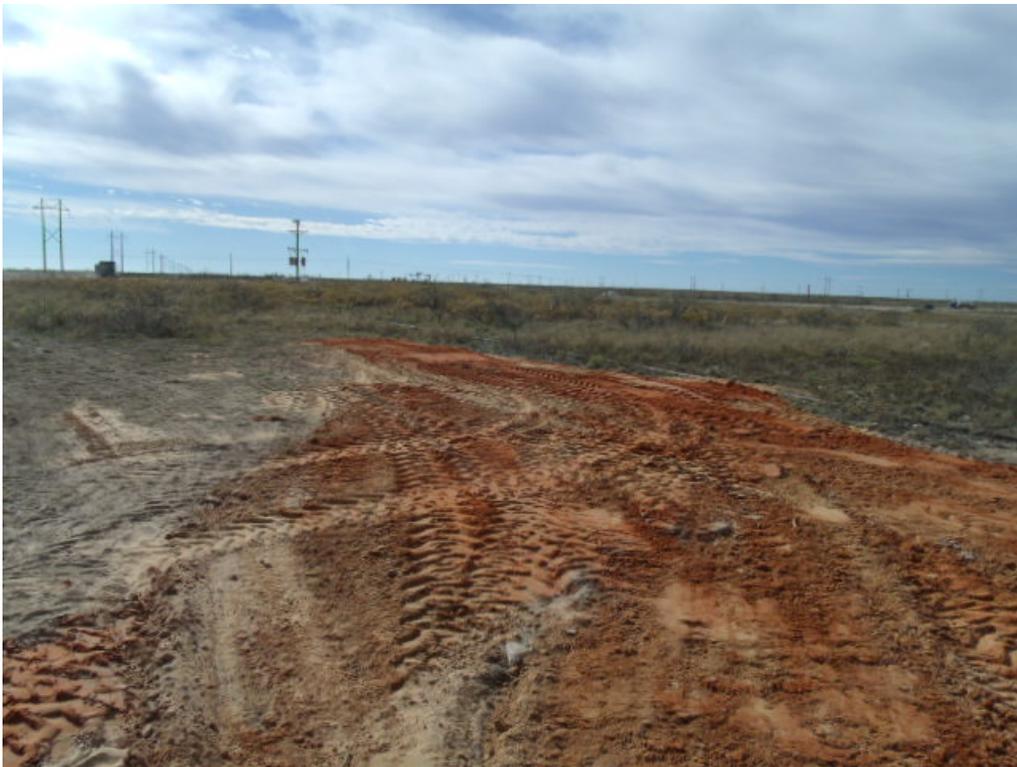
Photograph #6 – Backfilled

Photograph #7 – Backfilled

Photograph #8 – Backfilled

Based on laboratory analytical results indicating contaminant concentrations in the excavation were below NMOCD RRALs, the excavation has been backfilled with approximately 270 cubic yards of clean soil; soil was free of deleterious material or rocks or large clumps.

Backfilling continued until the entire excavation was closed. Upon completion of backfill activities, the entire disturbed area has been contoured to blend with existing pasture area, raked, seeded, and protected against wind/water erosion.

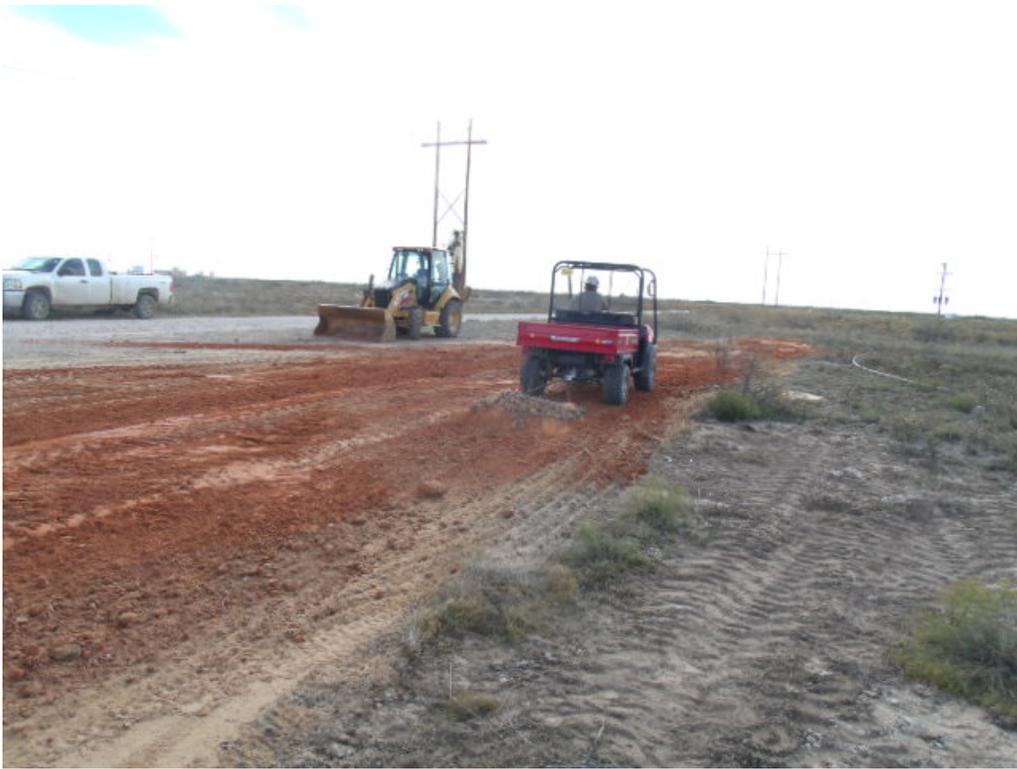
Photograph #9 – Raking

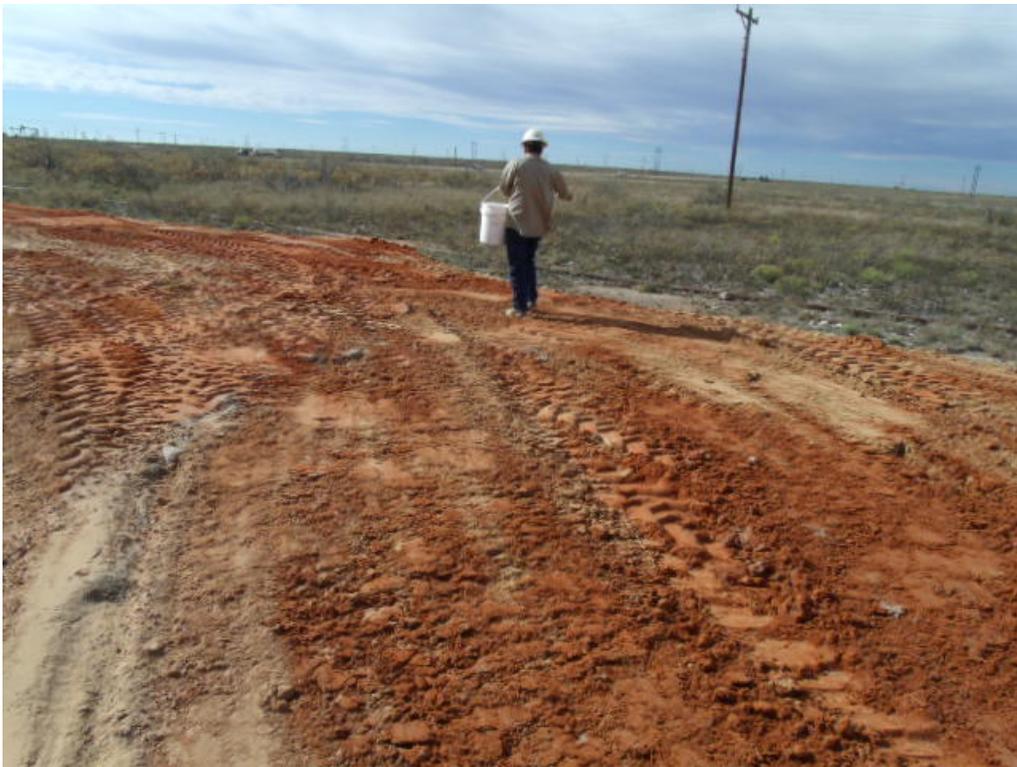
Photograph #10 – Seeding
