EVGSAU 3440-002
(1RP-3554)

Termination Request

**RE: Termination Request
ConocoPhillips EVGSAU #3440-002 (1RP-3554)
UL/L & K sec. 34 T17S R35E
API No. 30-025-0300800**

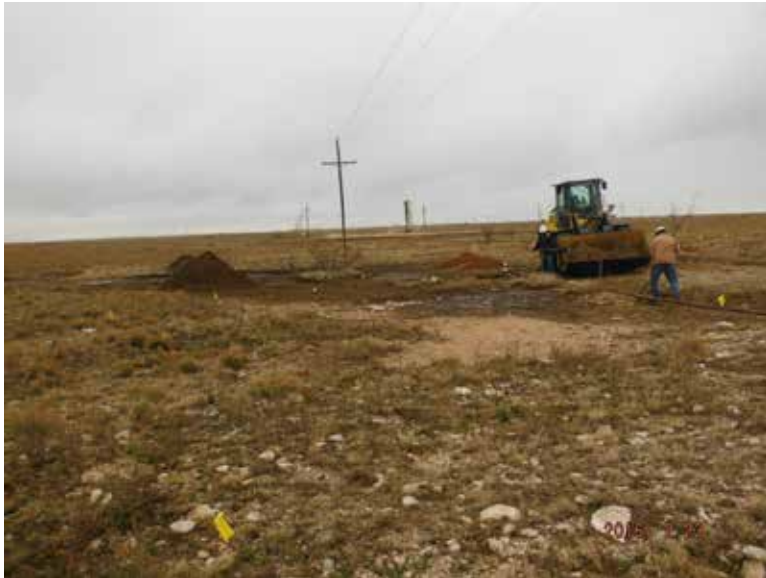
Initial release area, facing east

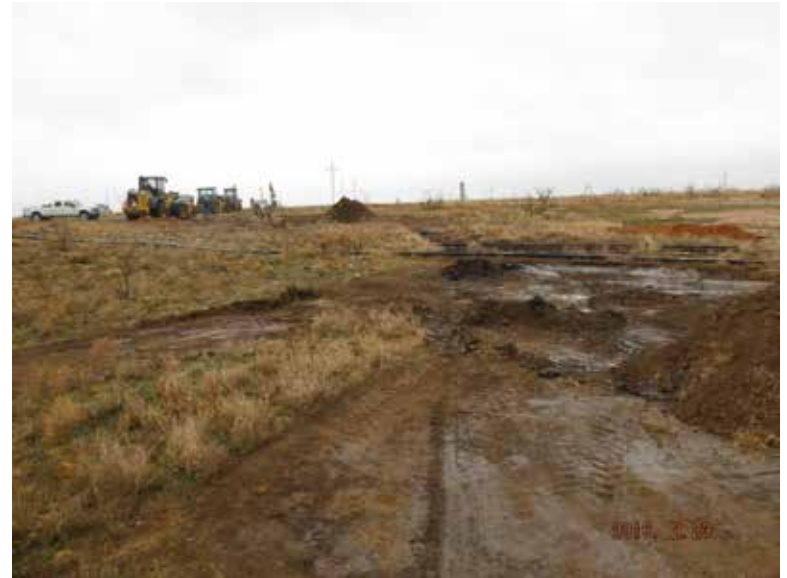
Initial release area, facing west

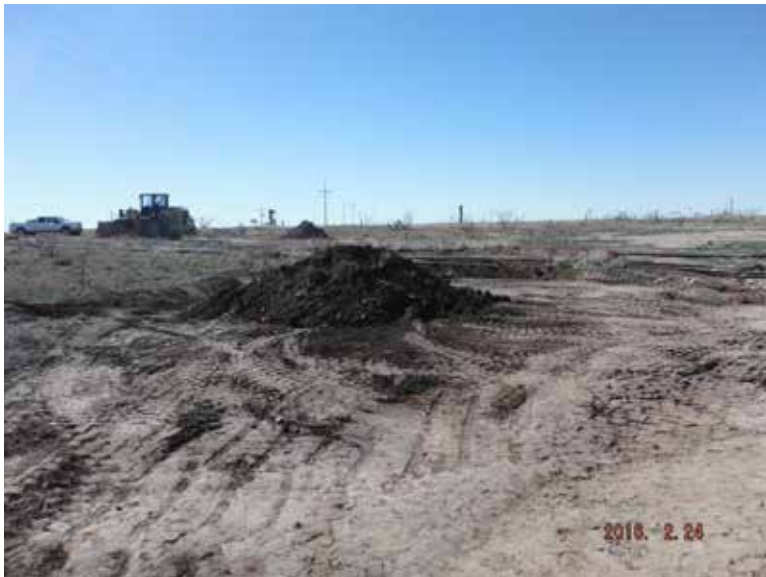
Excavated area, facing west

Basin personnel were on site to assess the release on January 18th, 2016. The release was mapped and photographed. The release was sampled at the surface and with depth. Representative samples were sent to a commercial laboratory for analysis. Laboratory analysis for points 1 and 2 returned chloride concentrations, Gasoline Range Organics (GRO) and Diesel Range Organics at non-detect levels at 6 in bgs. Point 3 returned chloride, GRO and DRO of non-detect at 2 ft bgs. Based on this assessment, the area around points 1 and 2 were scraped to a depth of 6 in bgs, and the area around point 3 was excavated to a depth of 2 ft bgs. Excavation work began on February 23rd, 2016.

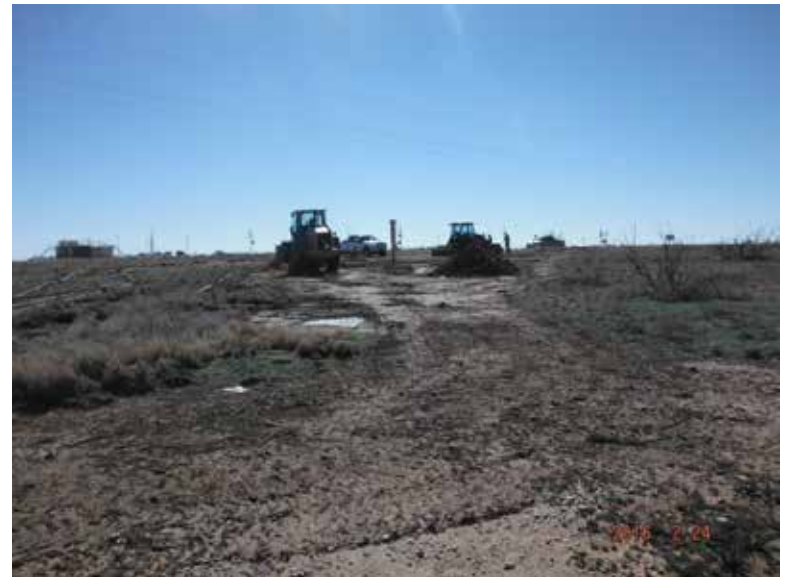
Excavated area, facing south

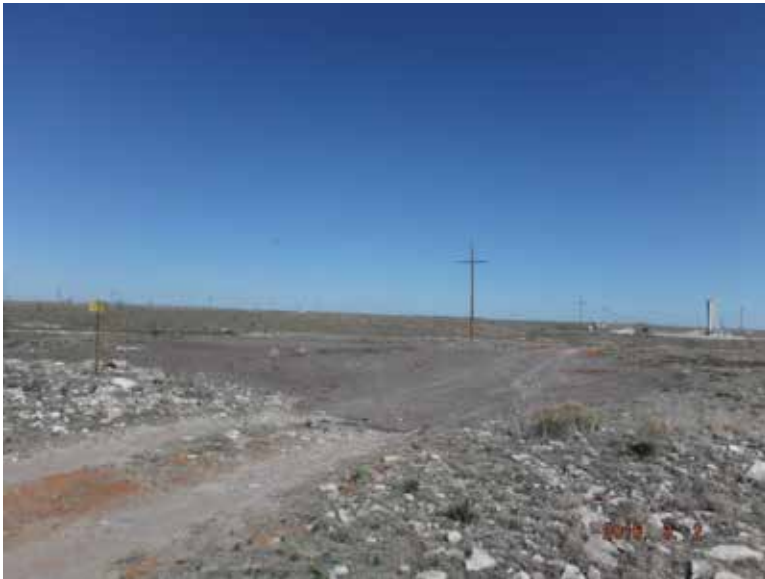
Backfilled site, facing west

On February 29th, 2016, permission was obtained to backfill the site. Backfilling operations began on March 2nd, 2016. The site was backfilled and the surface contoured to match the existing pasture. The site was seeded on March 3rd, 2016 with BLM #2 seed mixture.

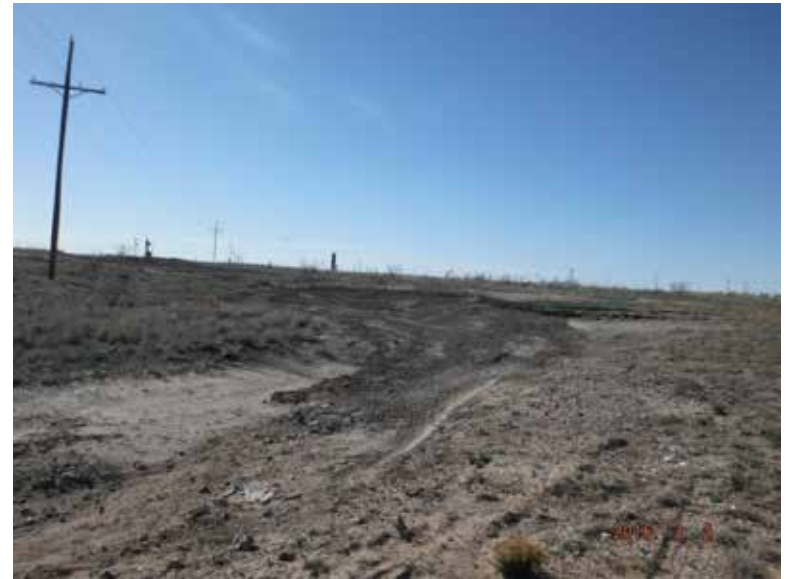
Backfilled site, facing west

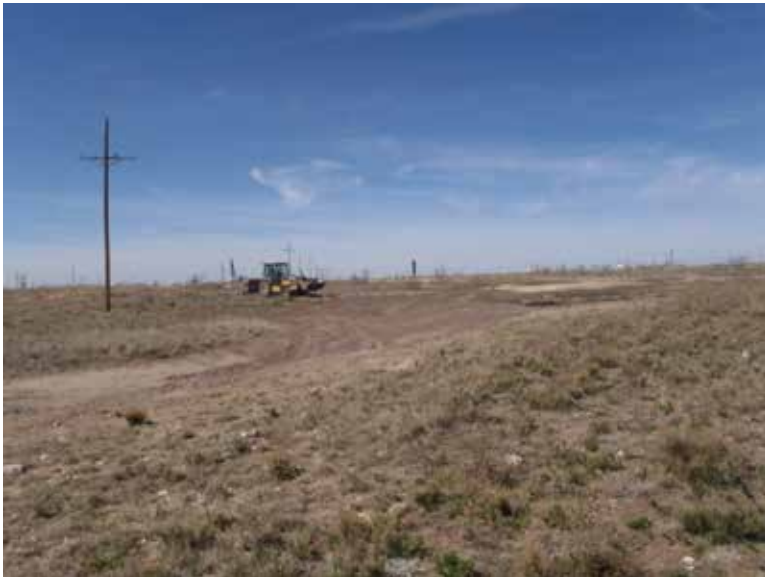
Seeding Site , facing east
