SEMU 180

(1RP-3500)

Termination Request

**RE: Termination Request
ConocoPhillips SEMU 180 (1RP-3500)
UL/L sec. 13 T20S R37E
API No. 30-025-39189**

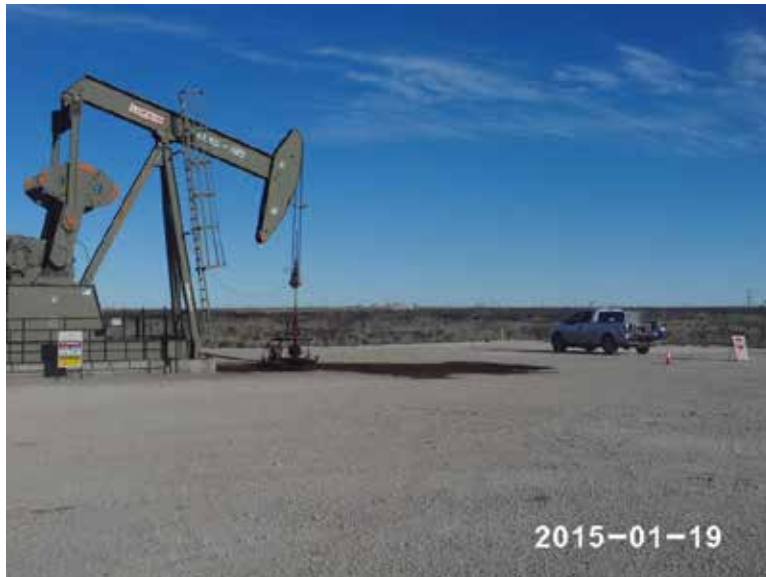
1/19/15

Initial release area, facing northwest

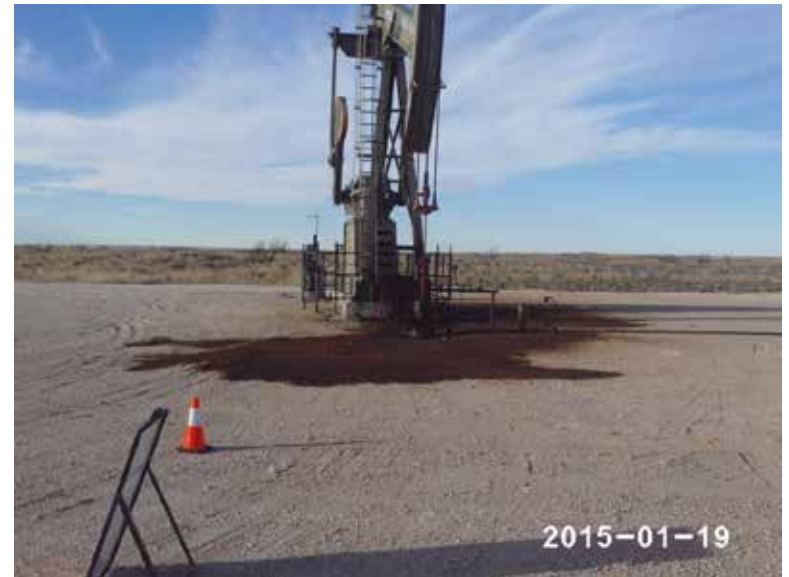
1/19/15

Initial release area, facing south

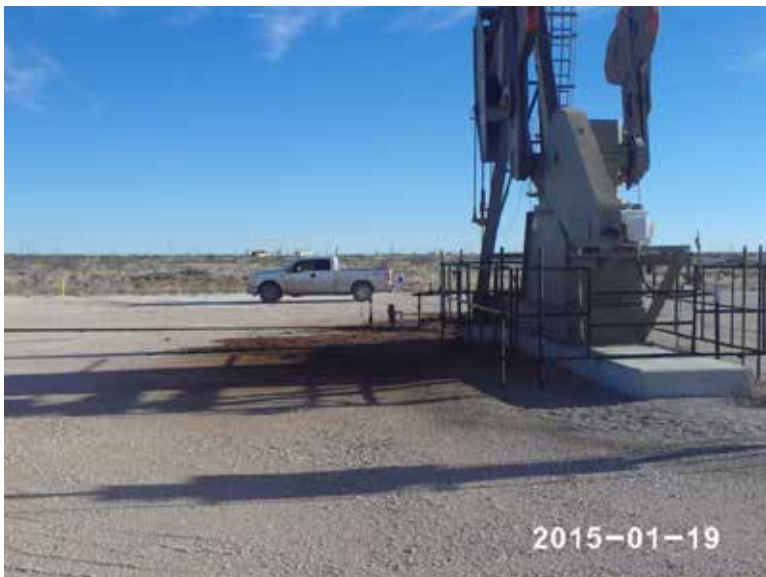
1/19/15

Initial release area, facing north

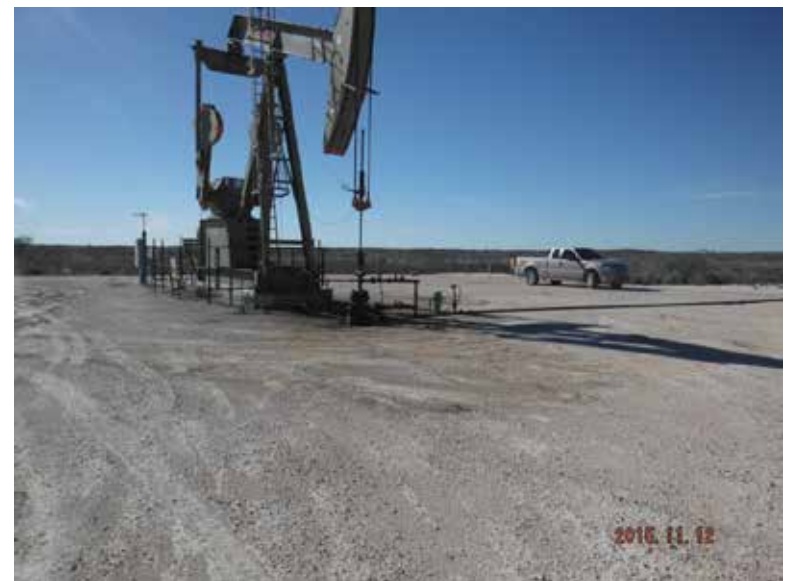
11/12/15

Initial Sampling Photo, Facing South

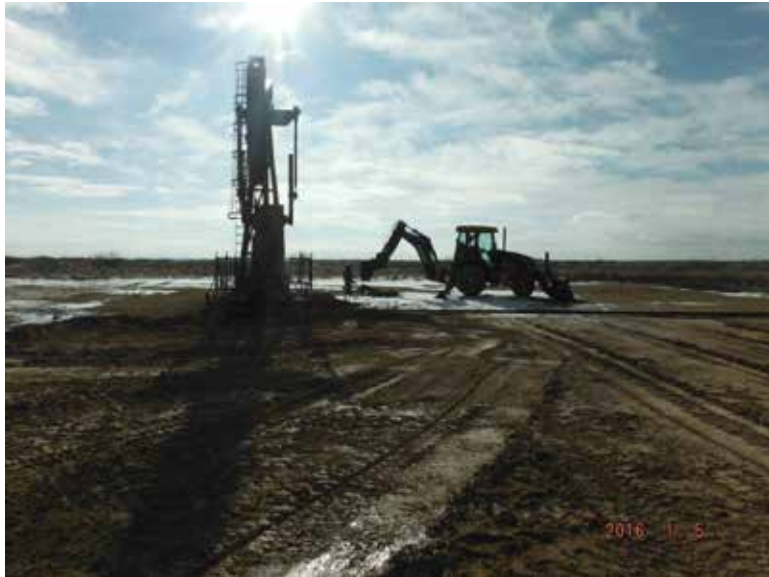
1/5/16

Excavating, Facing South West

CAP activities began January 5th, 2016 and the area around point 1 was excavated to a depth of one and one-half (1.5) feet bgs. A discreet sample was collected from the base of the scrape and taken to a commercial laboratory for analysis. The point 1 sample @ 1.5' returned a chloride result of <16 mg/kg, a GRO/DRO of <10 mg/kg and a BTEX of <0.3 mg/kg. The area around point 2 was scraped to a depth of one (1) foot, but field testing indicated that a sample would not achieve reading below regulatory standards. The area around point 2 was then scraped to a depth of one and one-half (1.5) feet bgs. A discreet sample was collected from the base of the scrape and taken to a commercial laboratory for analysis. The point 2 sample @ 1.5' returned a chloride result of <16 mg/kg, a GRO/DRO of <10 mg/kg and a BTEX of <0.3 mg/kg. Approximately 55 yards was exported to an NMOCD approved facility for disposal. On January 8th, 2016 a backfill request was sent to NMOCD and BLM and approved by both NMOCD and BLM the same day. Approximately 55 yards caliche was imported for backfill. A sample of the imported soil was collected and taken to a commercial laboratory for analysis. The imported sample returned a chloride result of 144 mg/kg. Site was backfilled with imported caliche and contoured to the surrounding area.

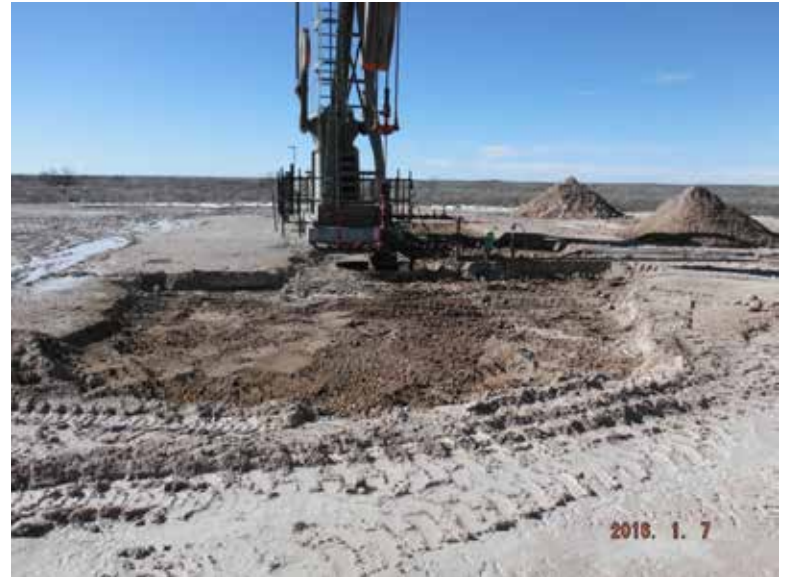
1/7/16

Excavation Photo, Facing South West

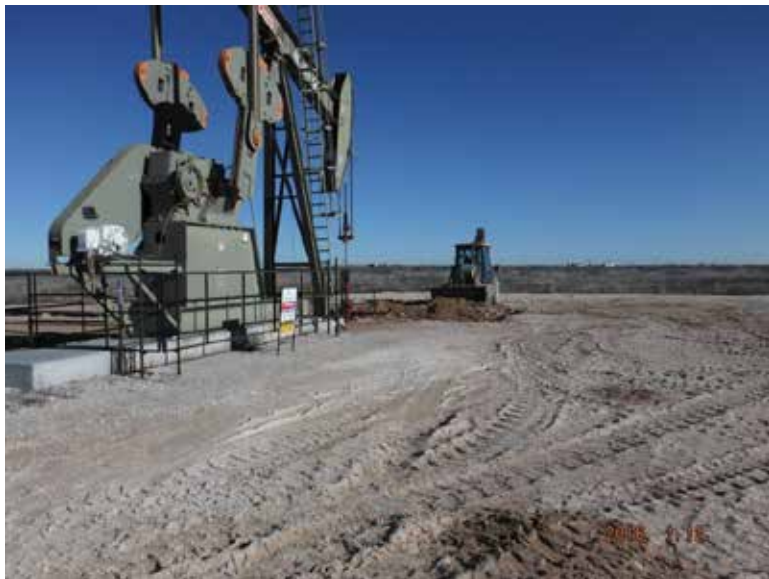
1/12/16

Backfilling Site, Facing North East

All excavated soils will be taken to a NMOCD approved facility for disposal. Clean caliche will be imported to the site to serve as backfill. A sample of the imported caliche will be taken to a commercial laboratory to confirm that the chloride reading is below regulatory standards. The scrape will be backfilled with the clean, imported caliche and contoured to the surrounding location.

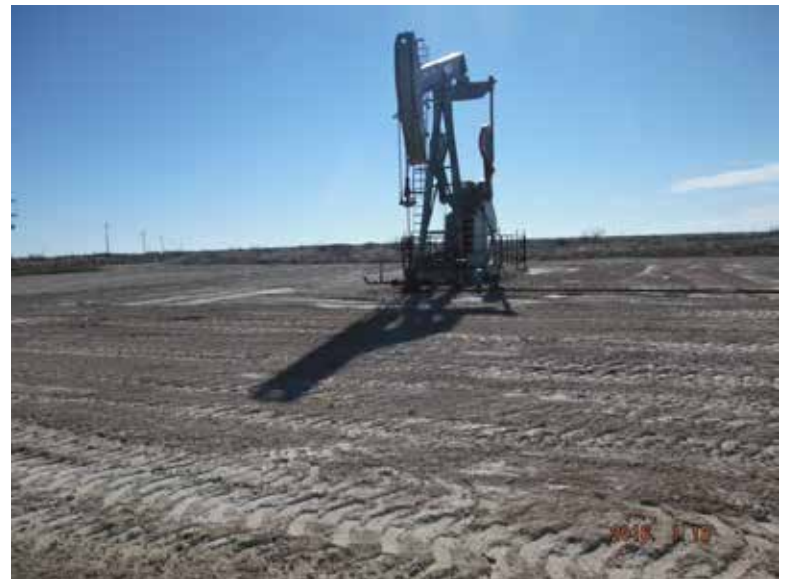
1/18/16

Final Photo, Facing South
