Closure Report

Site Name:	North Hobbs GSA Unit #141-32
Company:	Oxy Permian Ltd.
Legal Description:	U/L K, Section 32, T18S, R38E
County:	Lea County, NM
GPS Coordinates:	N 32.70128° W 103.17177°

Date of Release:	08/29/2015
Type of Release:	Produced water
Source of Release:	Stress/fatigue of 3" steel injection line
Volume of Release:	150 bbls
Volume Recovered:	145 bbls

Remediation Parameters:	Excavate the entire leak area to a depth of 6 inches. Backfill the site with clean soil.
Remediation Activities:	05/23/2016 to 05/27/2016

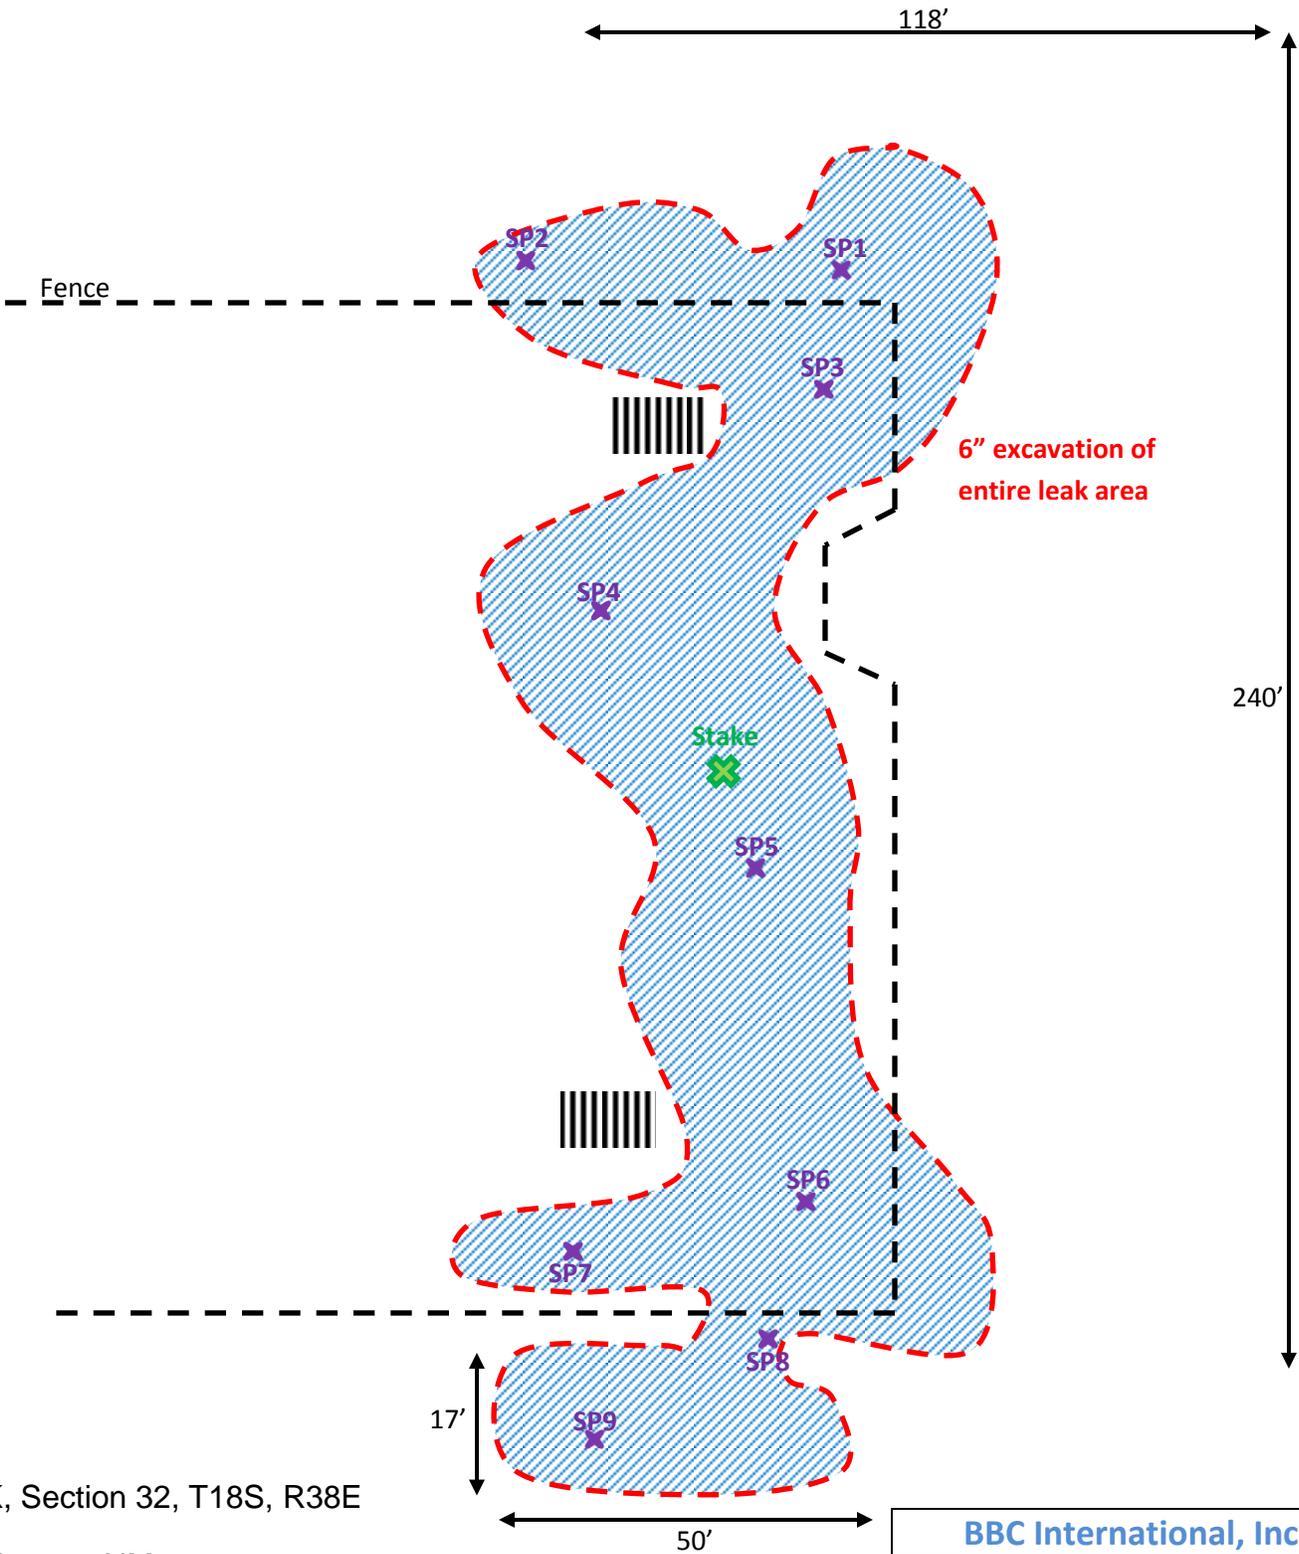
Oxy
North Hobbs GSA Unit #141-32

U/L K, Section 32, T18S, R38E

API#30-025-07523

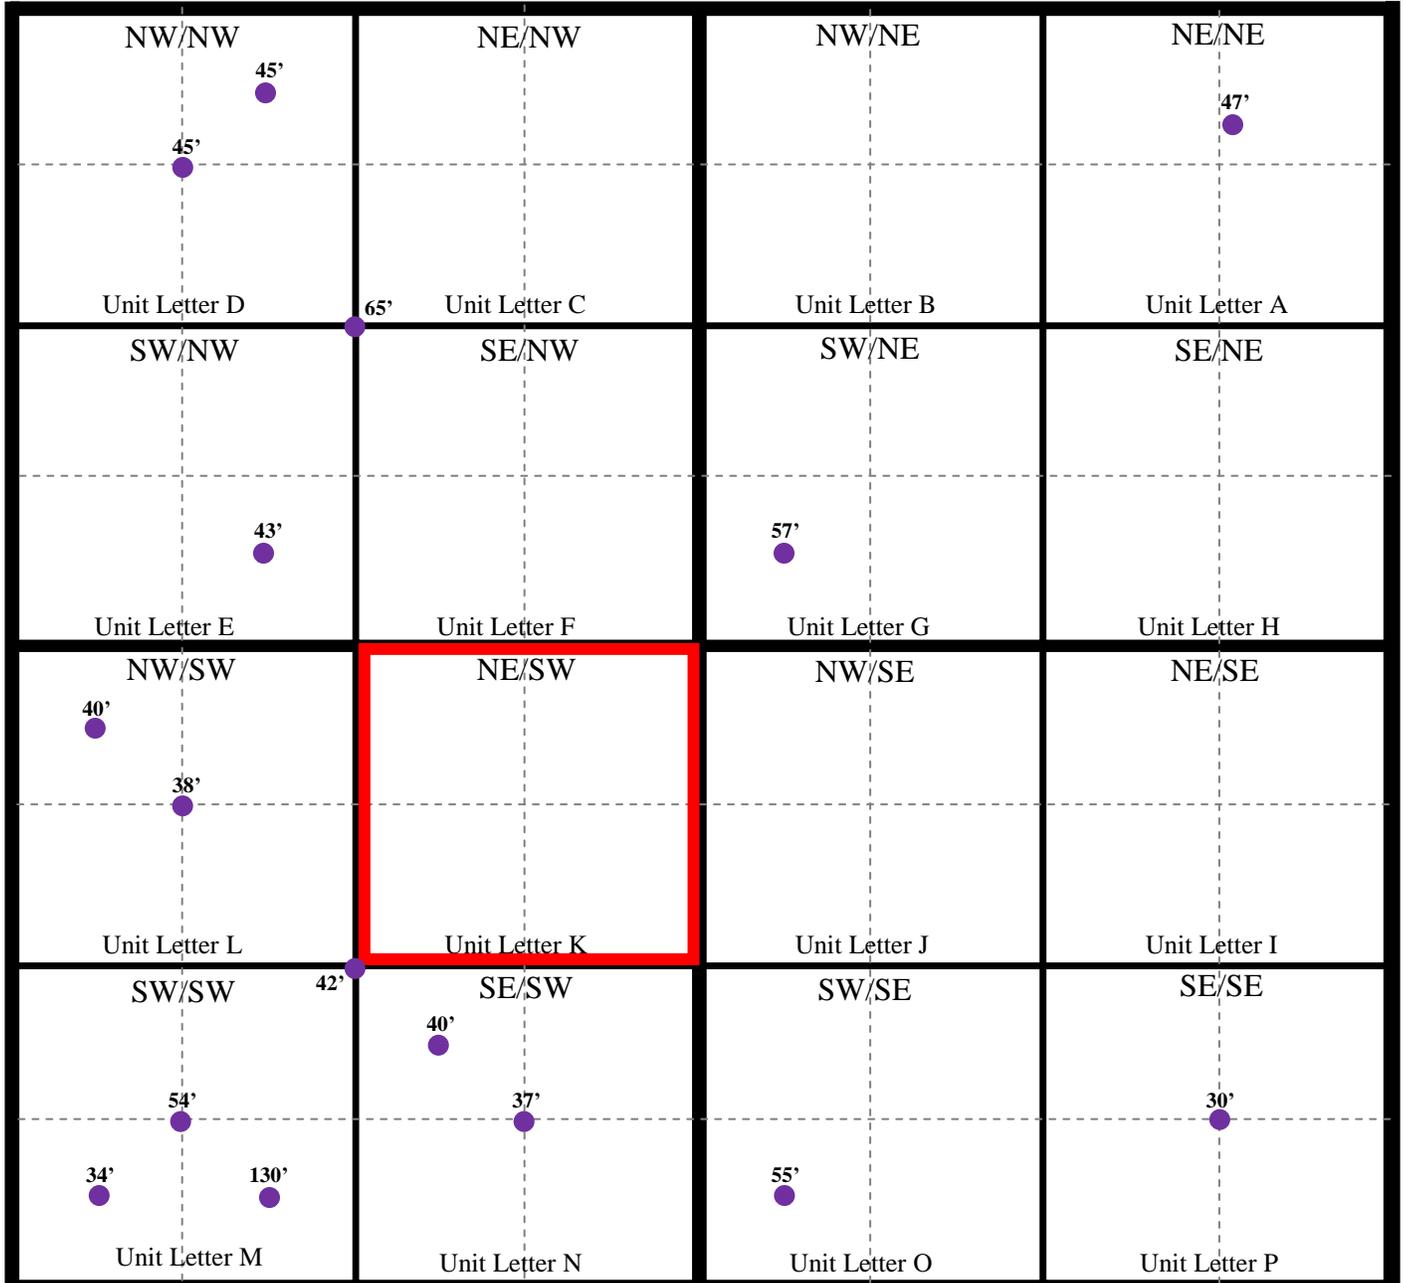
Trend Map 25'-50'

County: Lea Unit Letter: K Section: 32 Township: 18S Range: 38E
