RE: Targa-Fields

## REMEDIATION SUMMARY

**RE:** Townsend 16" Pipeline Remediation Summary, Lea County, New Mexico

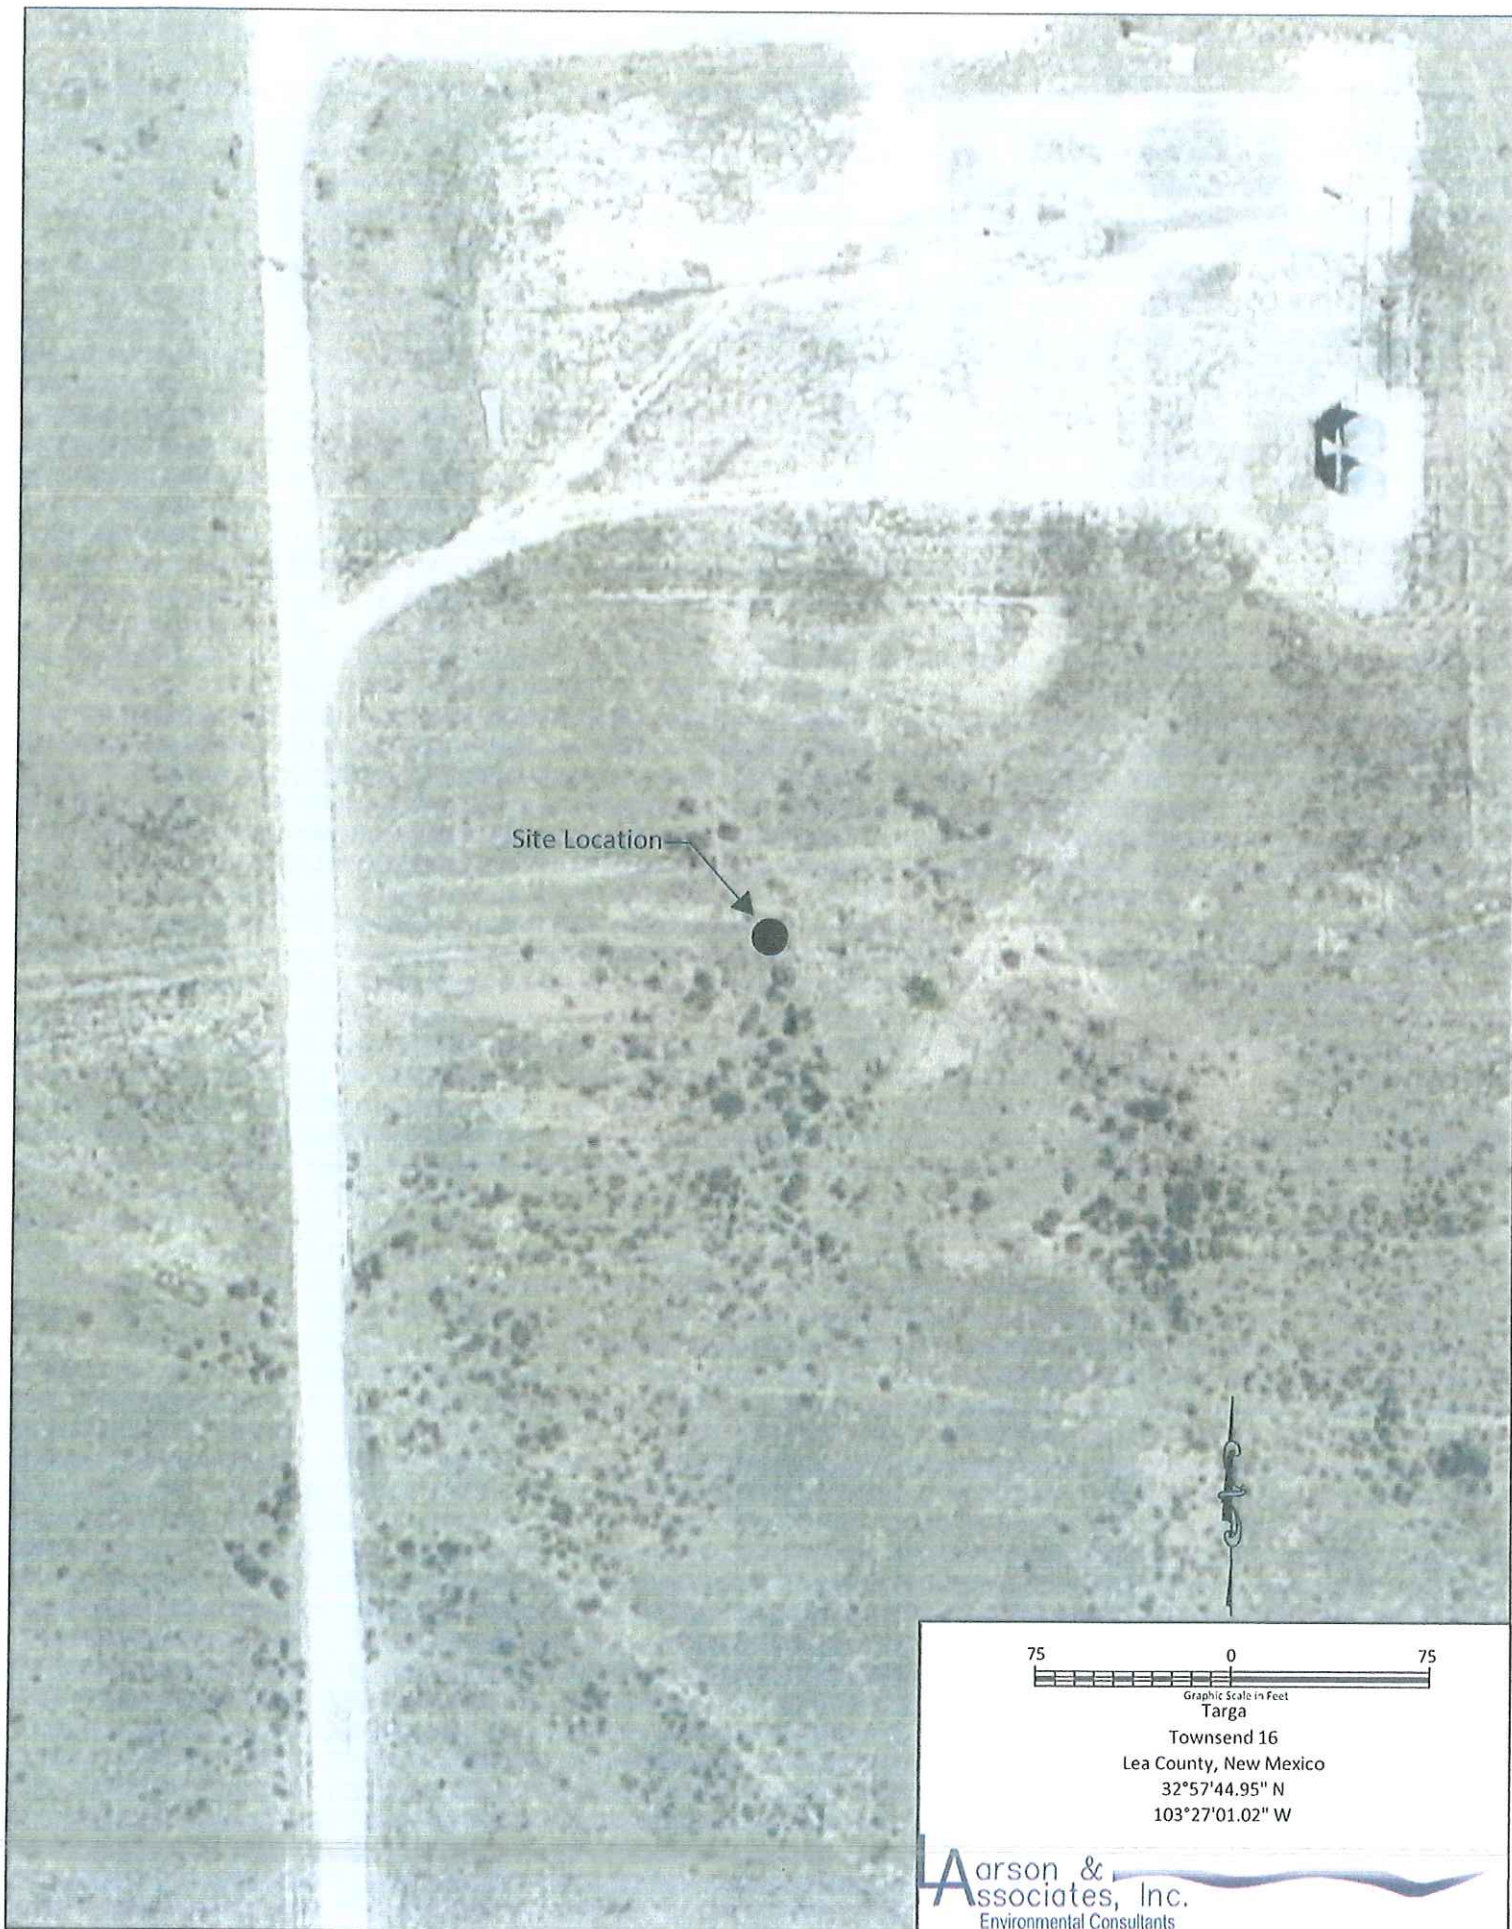
Figure 2 - Aerial Map

This summary is a supplement to a report dated August 27, 2015 and presents the investigation and remediation of a natural gas liquid (NGL) release from the Townsend 16" pipeline (Site). The legal description is Unit M (SW/4, SW/4) Section 3, Township 16 South and Range 35 East in Lea County, New Mexico. The Site is located about 4 miles west of Lovington, New Mexico. The release occurred in July 2015. The NGL covered an area measuring approximately 1,025 square feet. Watson Construction, Inc. (Watson) used a track hoe to excavate approximately 60 cubic yards of soil from around the pipeline to repair the leak. Soil was excavated to about 4 feet below ground surface (bgs) and piled adjacent to the south side of the excavation. Figure 1 presents a topographic map. Figure 2 presents an aerial map.

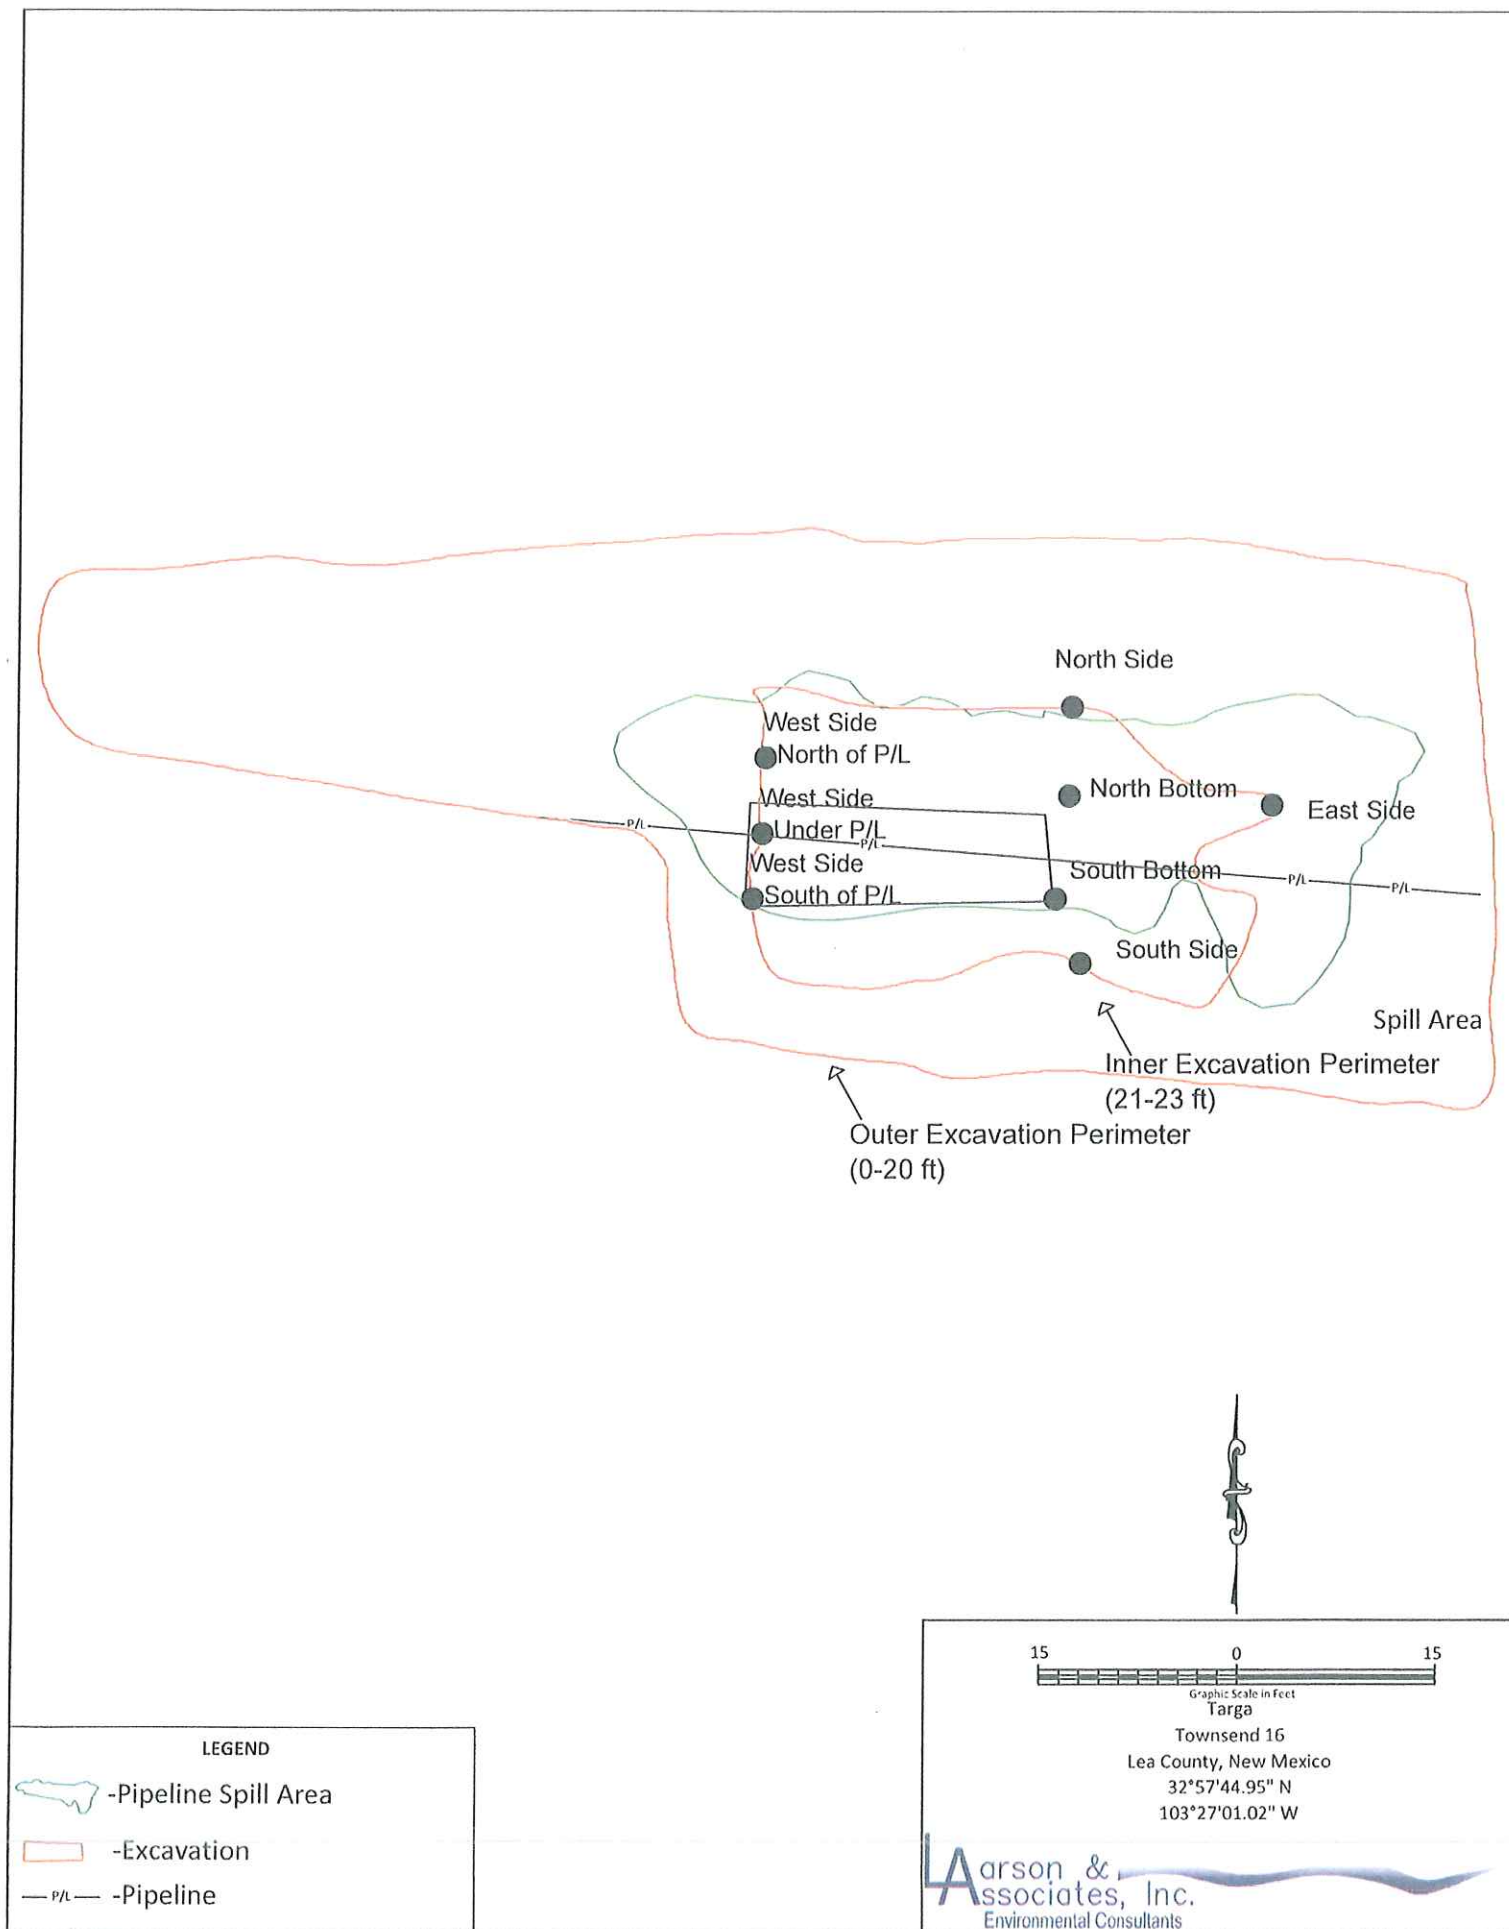
Figure 3 - Site Map

On August 3, 2015, LAI personnel supervised drilling five (5) borings (SB-1 through SB-5) between about 10 and 25 feet bgs. The laboratory reported concentrations of TPH above the RRAL to greater than 10 feet bgs at location SB-1 (HA-1). Table 1 presents the investigation analytical data summary. Figure 3 presents a site drawing.
