Re: New Mexico E-State NCT-1-007 Wellhead Release Soil Assessment and Delineation Activities Report

# **Soil Assessment and Delineation Activities Report**

New Mexico E State NCT-1 007  
Wellhead Release  
Lea County, New Mexico

6320 Rothway, Suite 100 Houston Texas USA  
089861 | Report No 1 | January 15, 2016

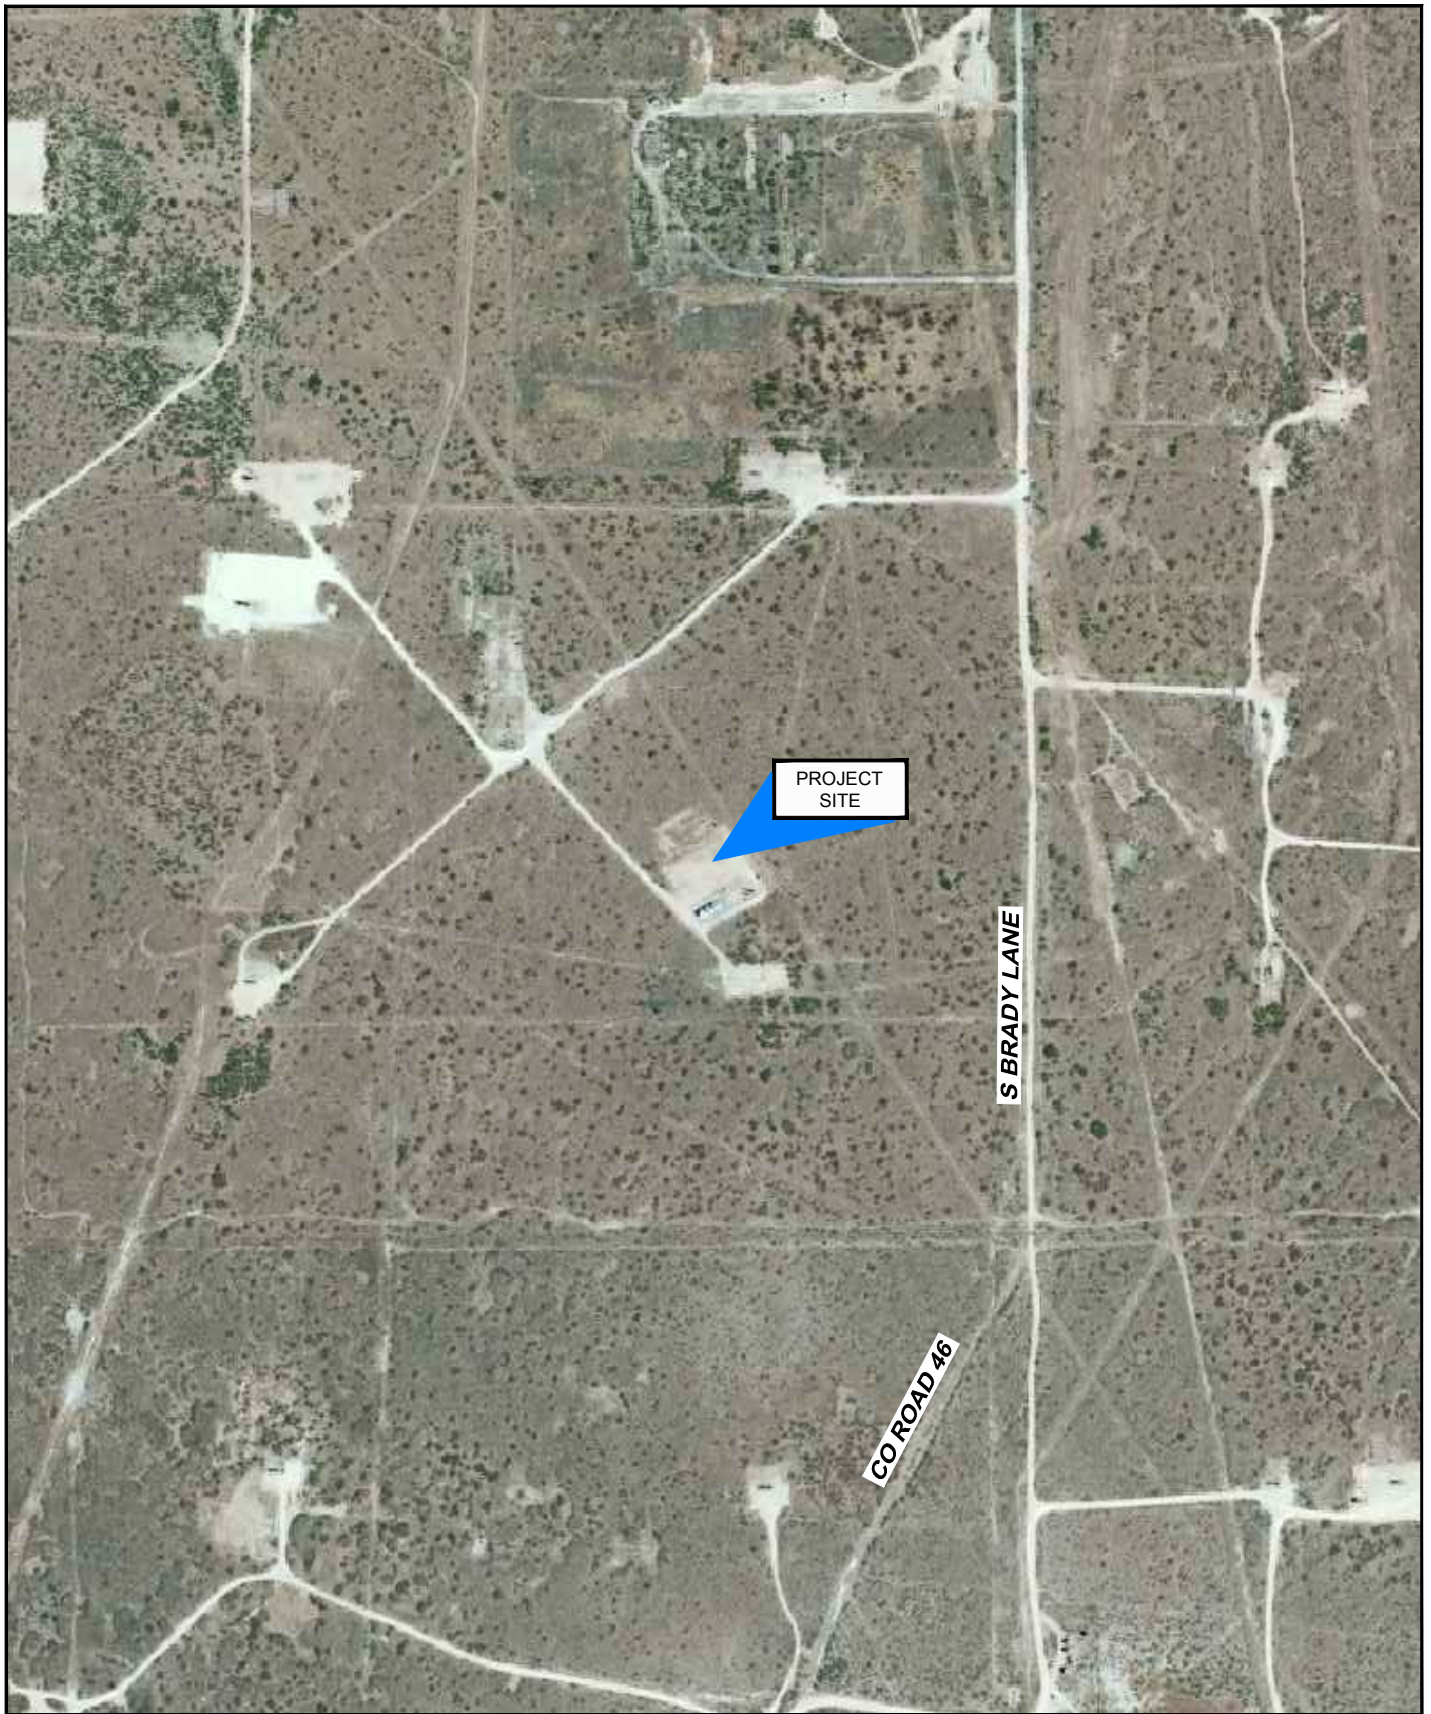
FIGURE 2

SITE AERIAL MAP

The Site is located in Unit N, Section 1, Township 20 South, Range 36 East, approximately 3.2 miles southwest of Monument, New Mexico, in eastern Lea County (Figure 1 and Figure 2).

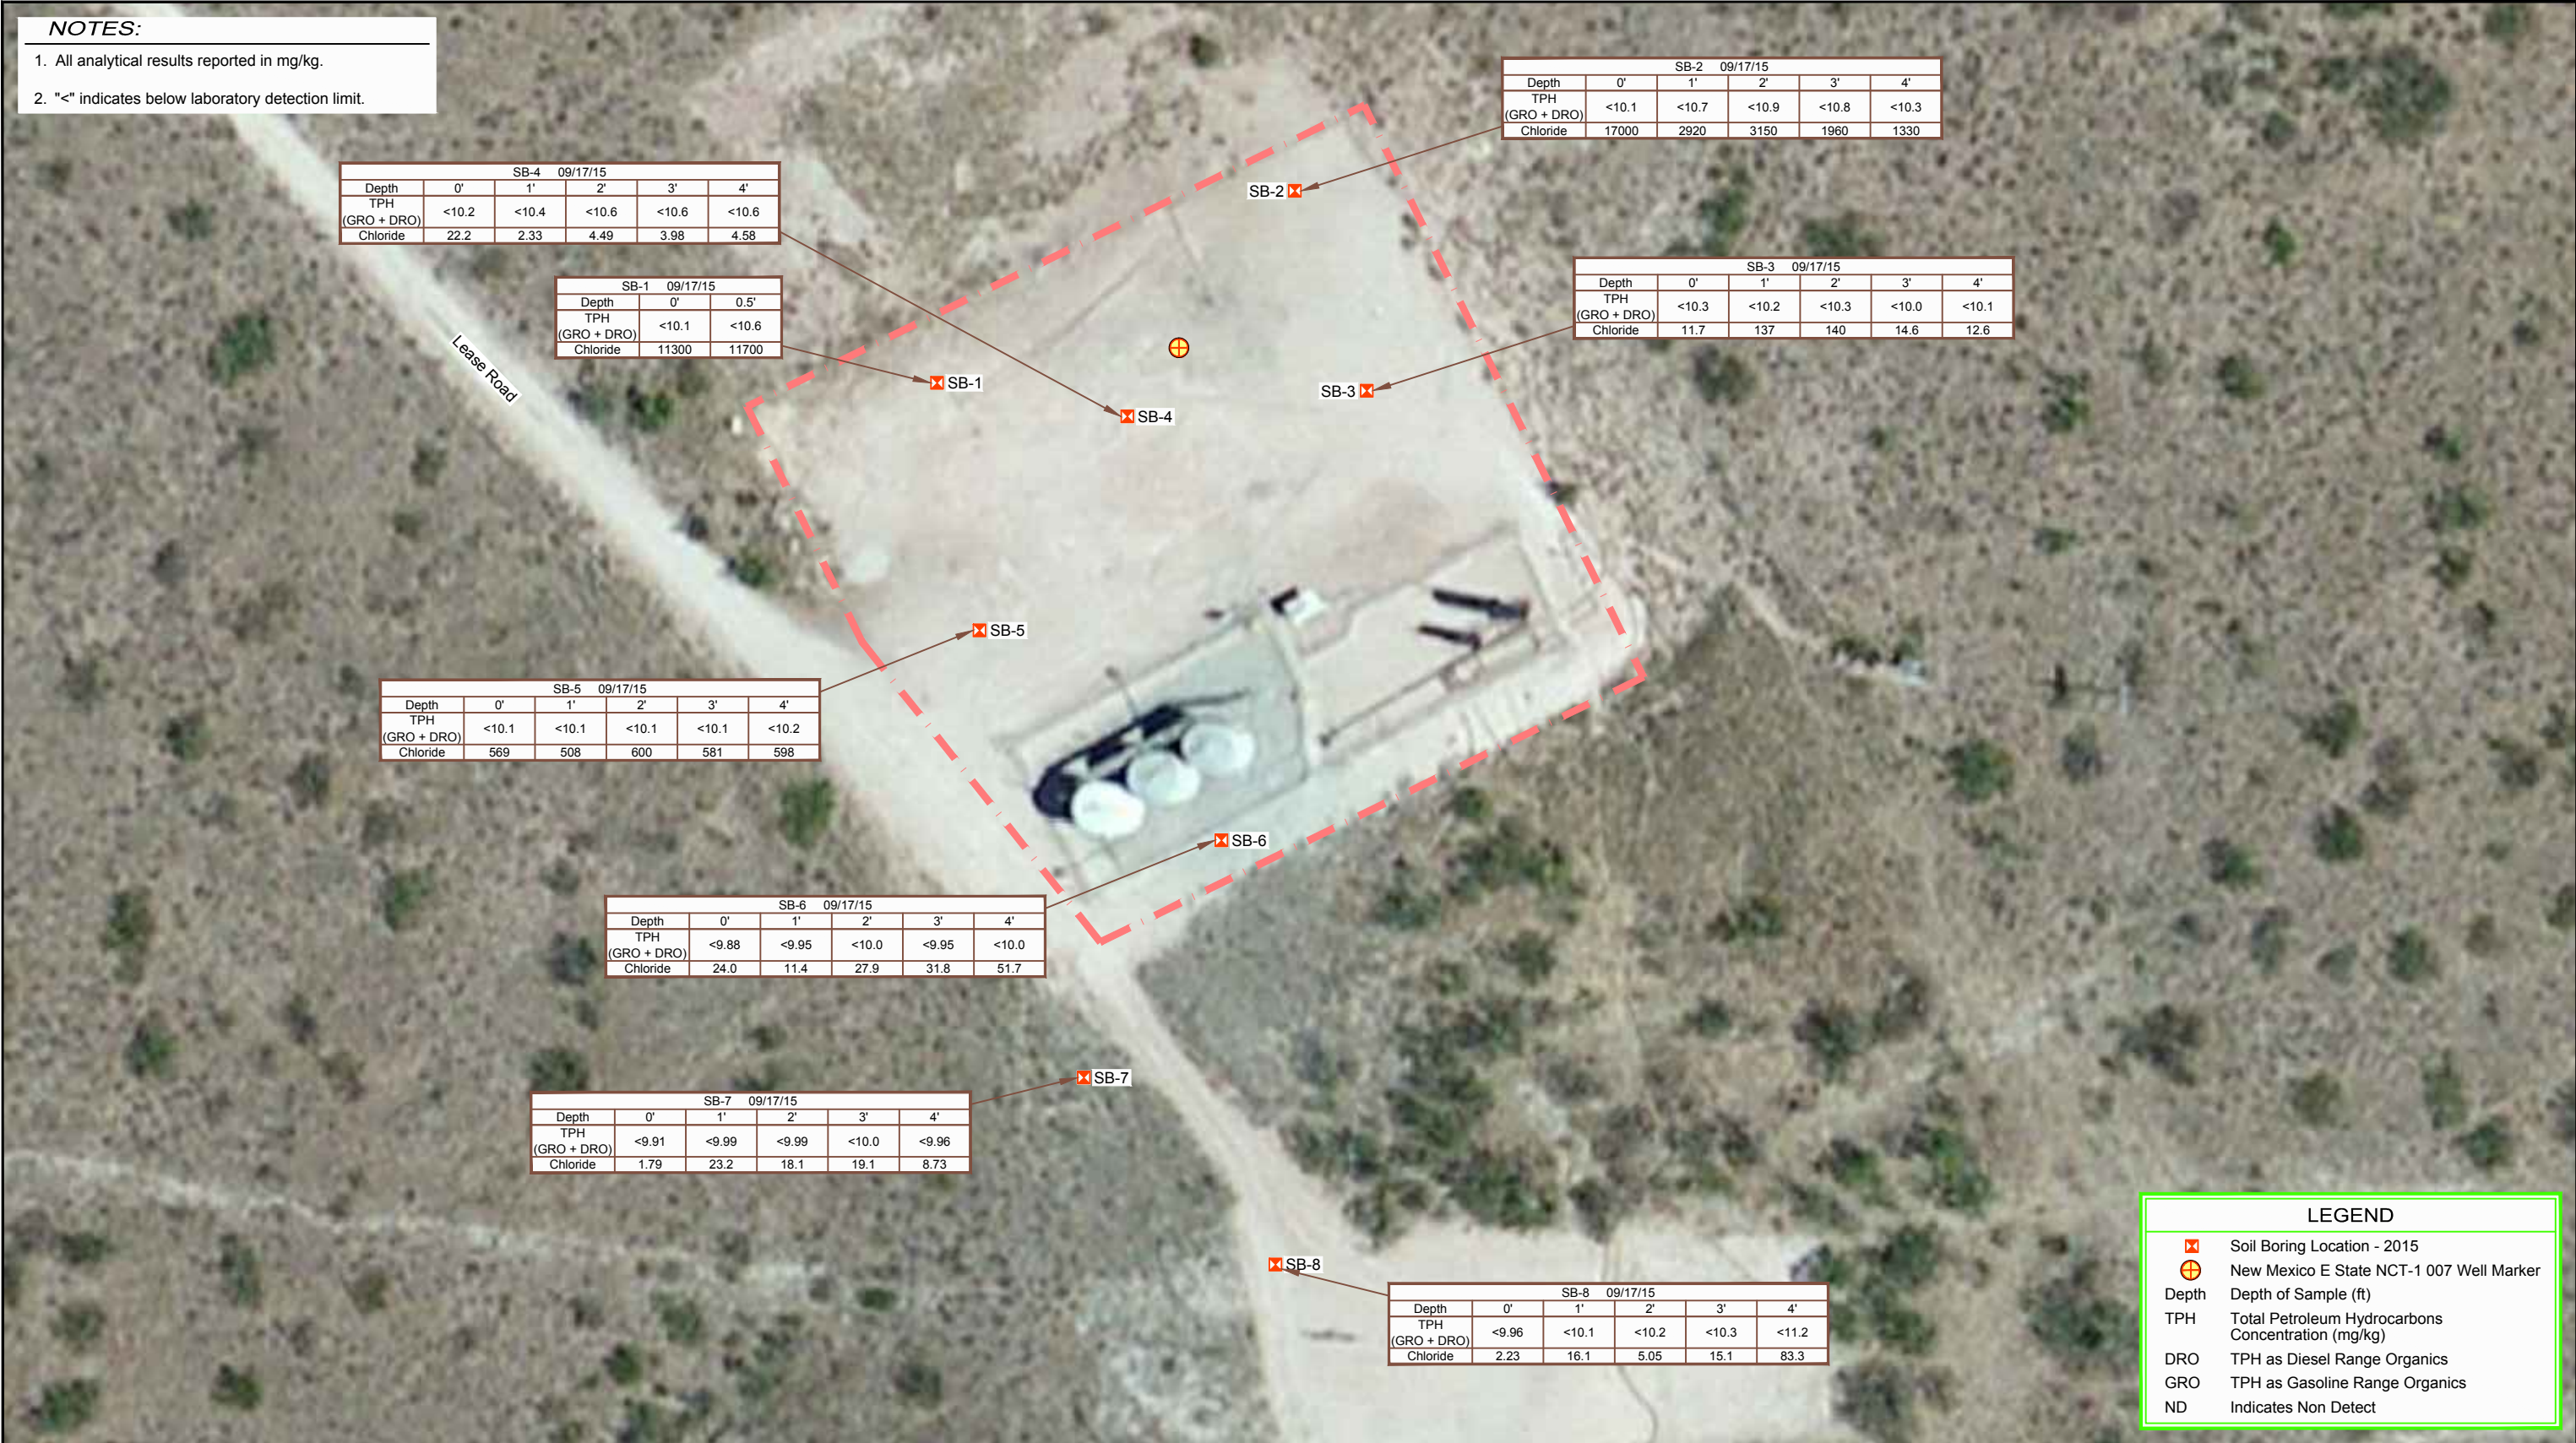
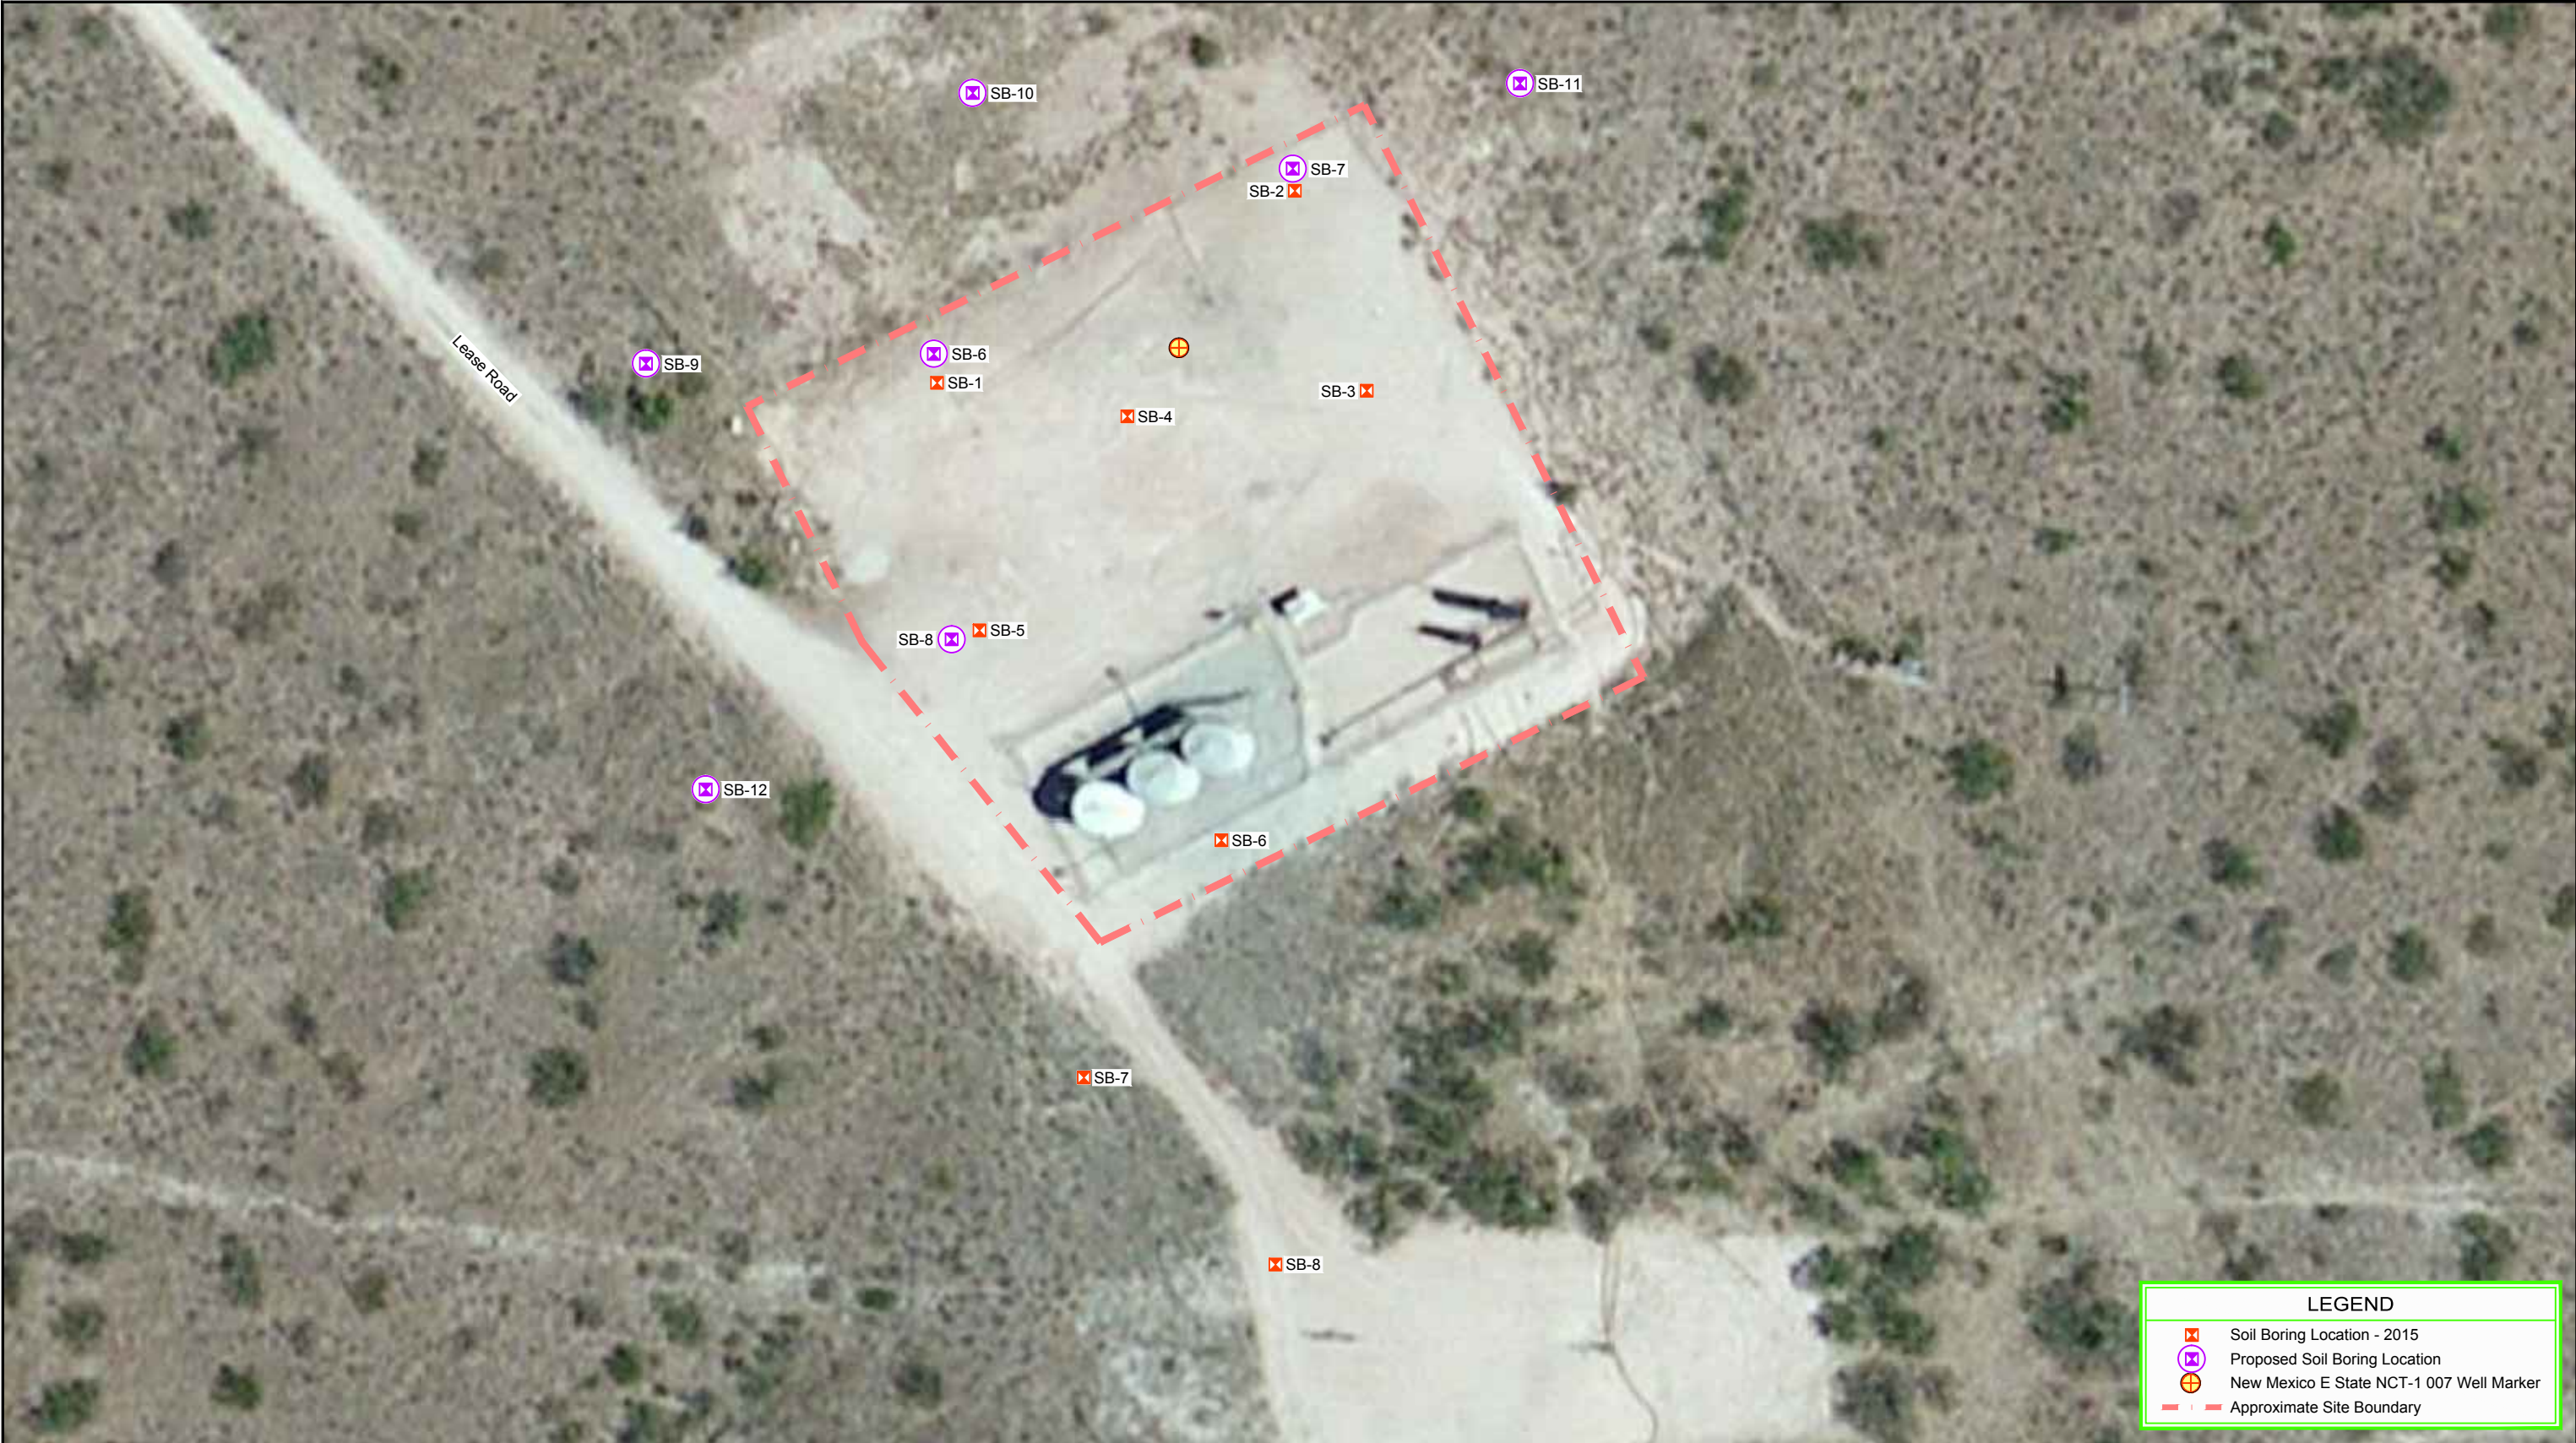
FIGURE 4

PROPOSED BORING LOCATION MAP

GHD proposes to advance seven additional soil borings in the northern and western portions of the Site (Figure 4). Field screening of soil cuttings for chlorides will be performed to guide drilling activities, and the terminal depth of each boring will be based on these field screening results. The following outlines basic project details that will be completed by GHD and GHD subcontractors:
