Remediation Summary and Closure Report
Vacuum Grayburg San Andres Unit #228
RP #3294

Unit I, Section 1, Township 18 South, Range34 East, Lea County, New Mexico

088200 | Report No 4| March 2016

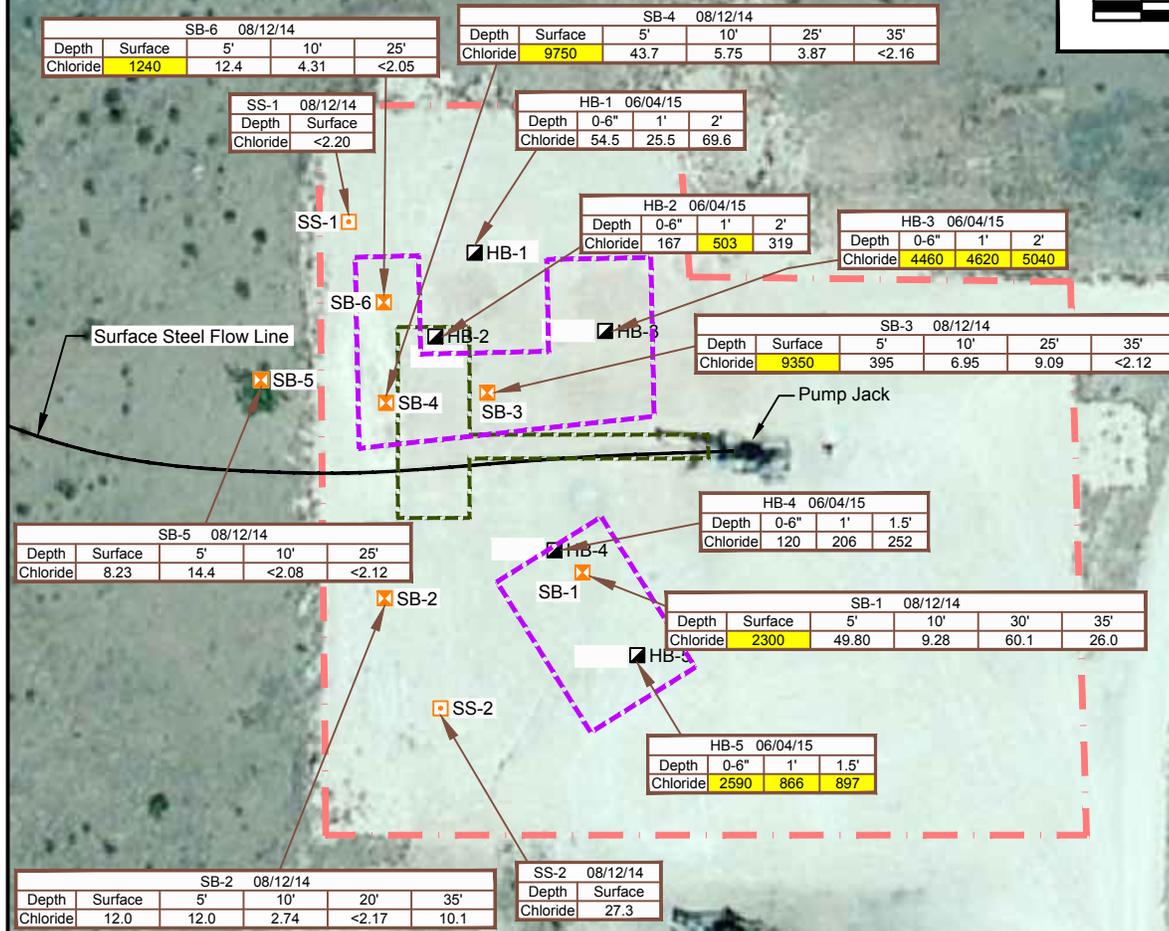
figure 3

SITE DETAILS AND ANALYTICAL RESULTS MAP - 2014 & 2015
VACUUM GRAYBURG SAN ANDRES UNIT #228
LEA COUNTY, NEW MEXICO
Chevron Environmental Management Company

Excavation limits were based upon the results of the August 2014 and June 2015 investigations. Following the completion of site preparation activities (i.e., utility clearance via One-call services and performance of a ground penetrating radar [GPR] survey), excavation activities commenced on December 1, 2015 and were completed on December 4, 2015. Two impacted areas (Southern and Northern excavation areas) were excavated until field screening utilizing Hach chloride test strips indicated soils were below the RRAL for chlorides along each sidewall and the bottoms of the excavations. Approximately 384 cy of soil was excavated from the two areas. The final limits of the two excavation areas are included on Figure 4, the Site Details and Analytical Results Map.

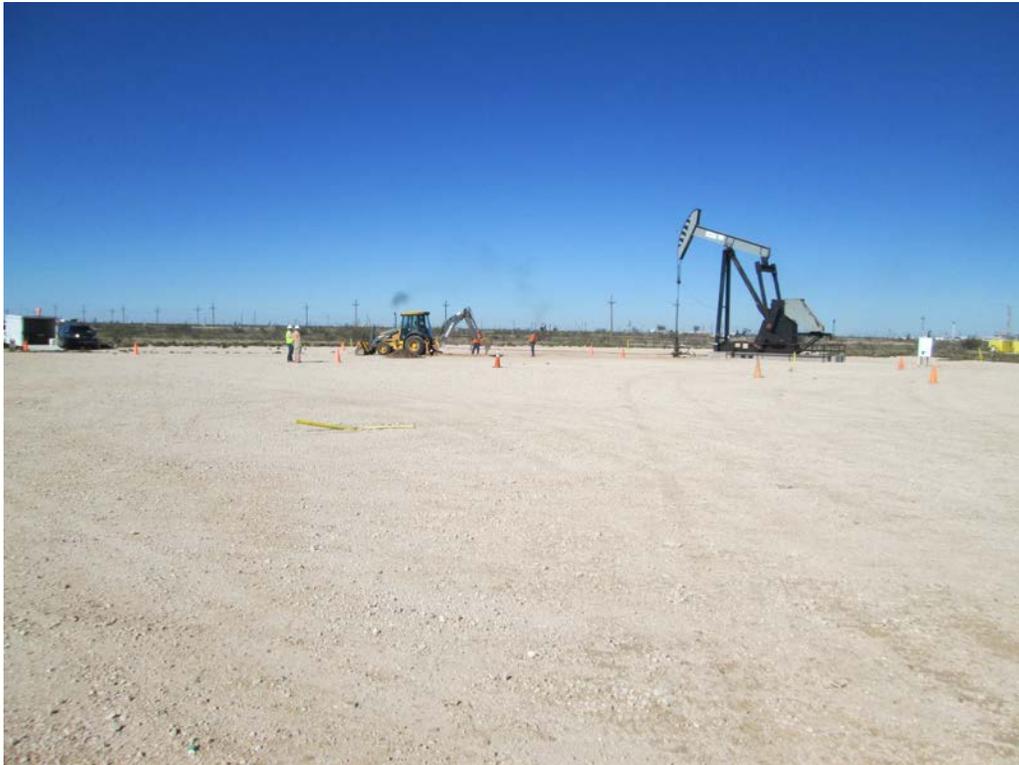
PHOTO 1: View of Site prior to excavation activities.

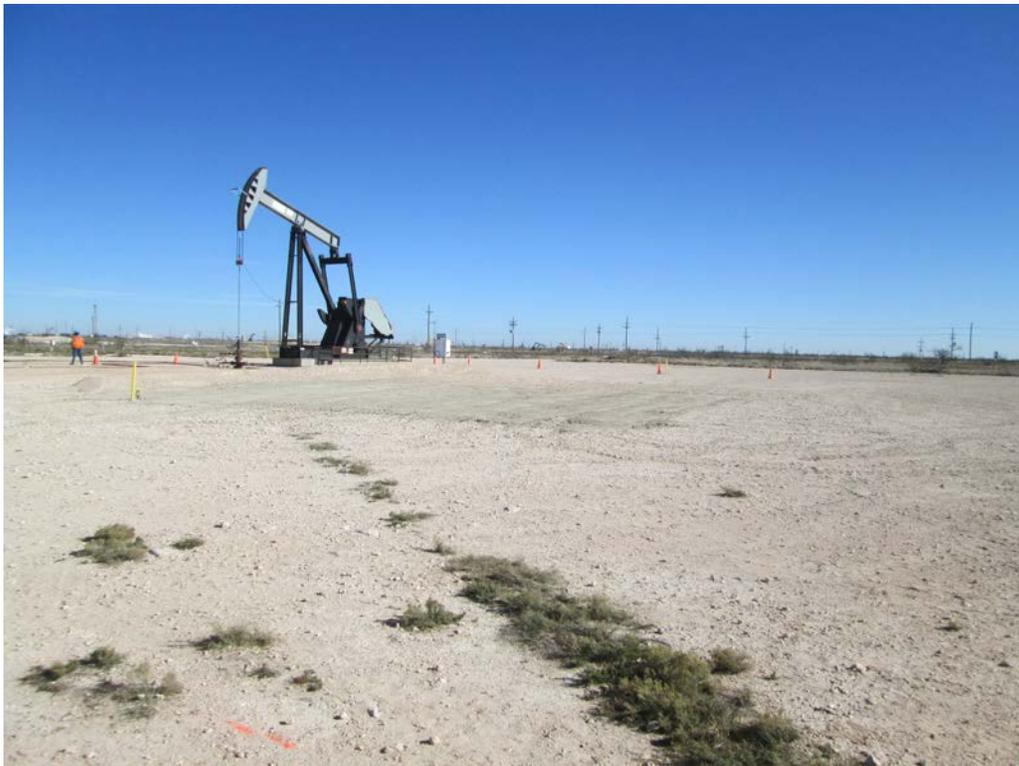
PHOTO 2: View of South Area following backfilling activities.

Approximately 396 cy of clean fill material was placed back into the excavations. An additional 40 cy of caliche material was delivered to the Site from a local source and used to backfill the remainder of the excavations. The backfilled material was compacted, and the Site was graded to match existing topography and slightly mounded to allow for settling. Attachment C includes photographic documentation of backfilling activities.

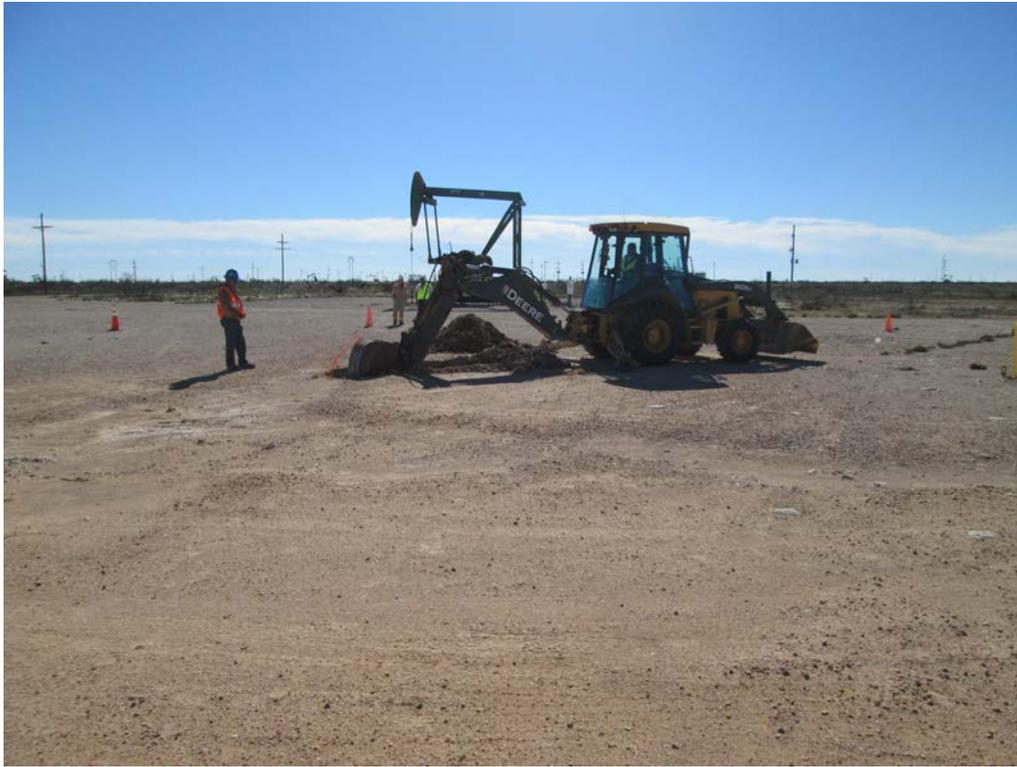
PHOTO 3: View of excavation activities within North Area.

Remediation activities were conducted on-site from December 1 through December 4, 2015. Field activities consisted of excavating approximately 384 cubic yards (cy) of affected soil from two areas located on the well pad. Approximately 384 cy of chloride-impacted soil was transported off-site for disposal at a Chevron-approved waste disposal facility. The remediation activities are further discussed in the following sections.

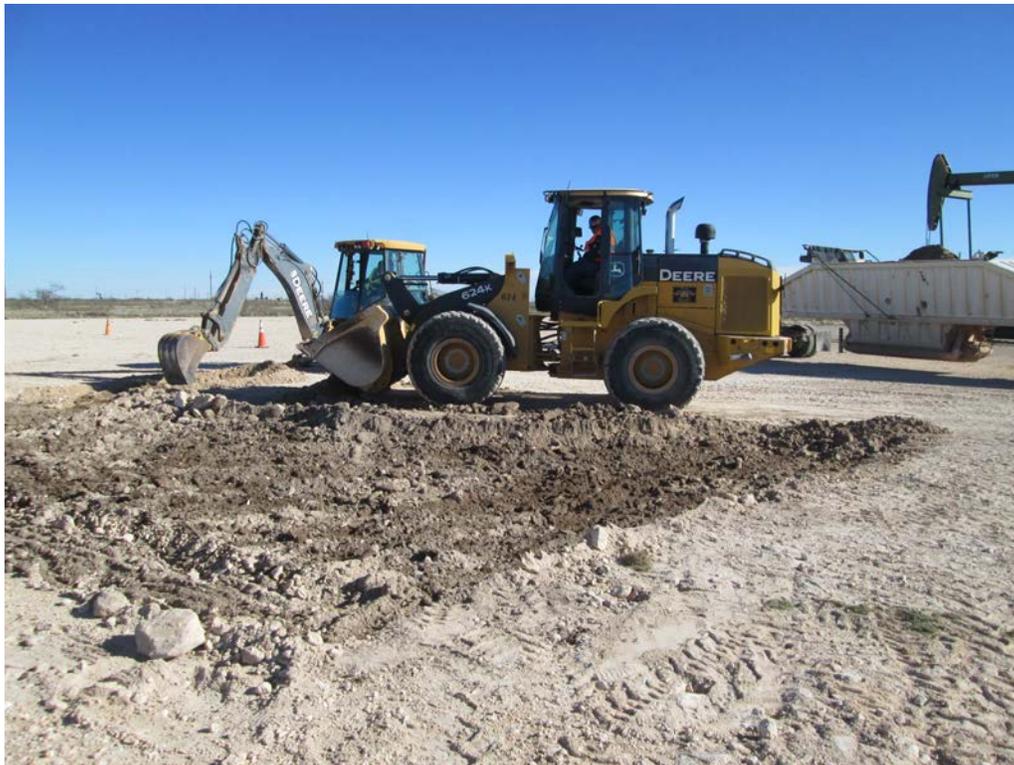
PHOTO 4: Additional view of North Area during excavation.

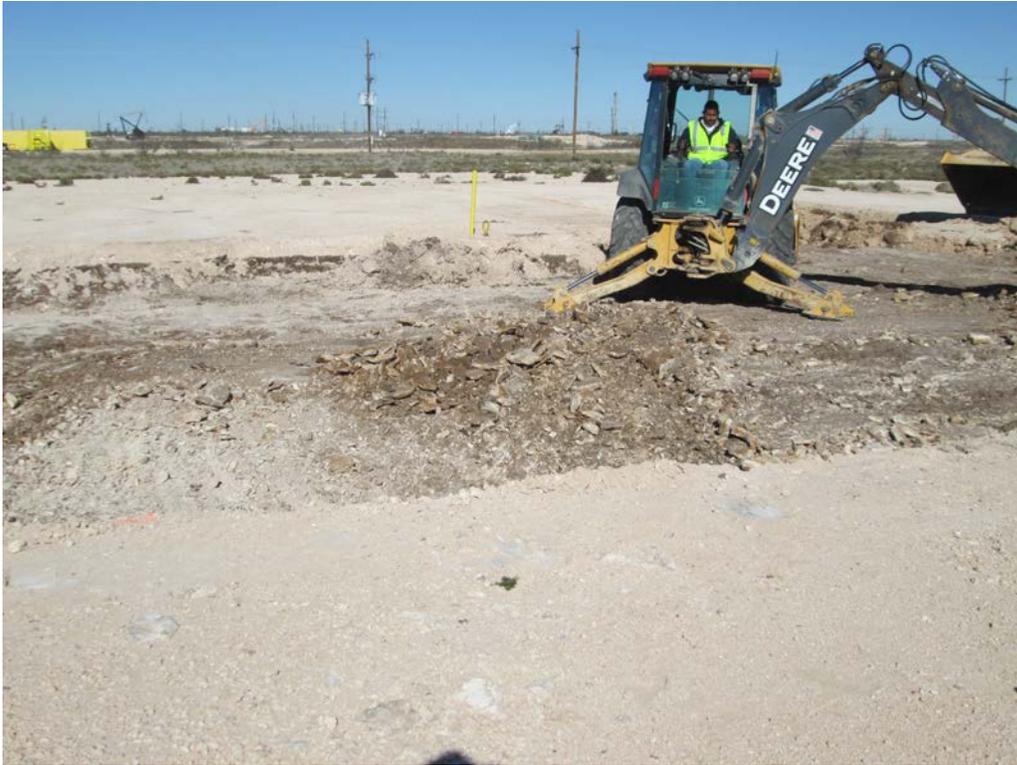
PHOTO 5: View of excavation activities for North Area.

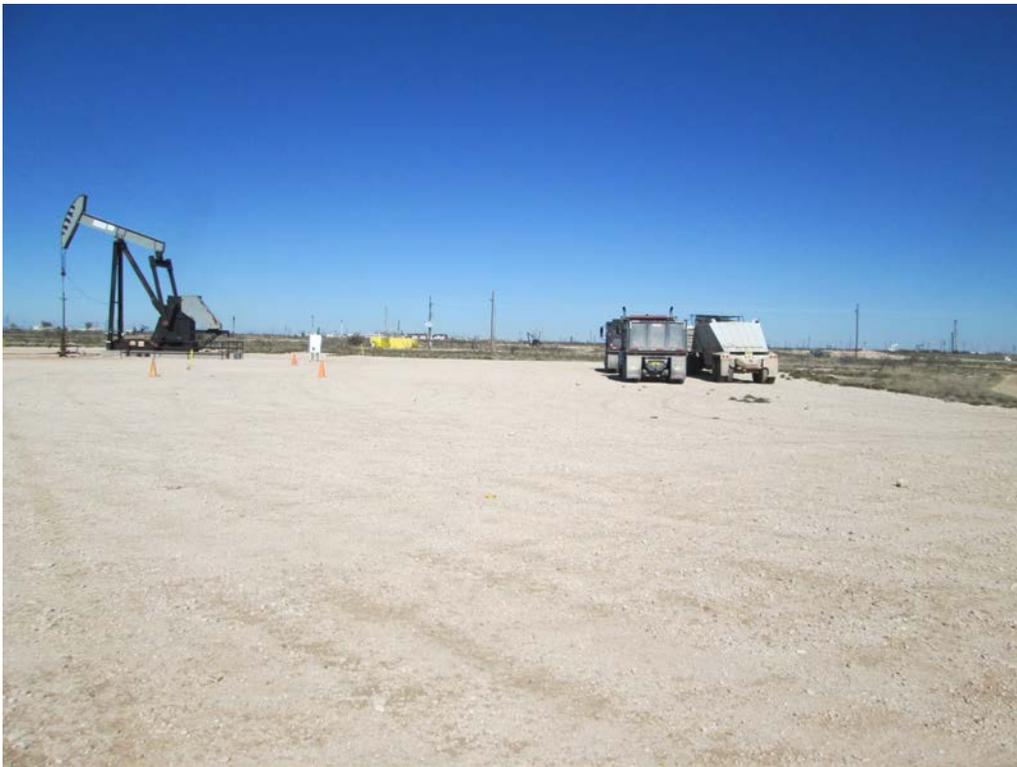
PHOTO 6: View of North Area following backfilling activities.
