Buck Federal CTB

Corrective Action Plan

**RE: Corrective Action Plan
ConocoPhillips Buck Federal CTB
NMLC 068281B**

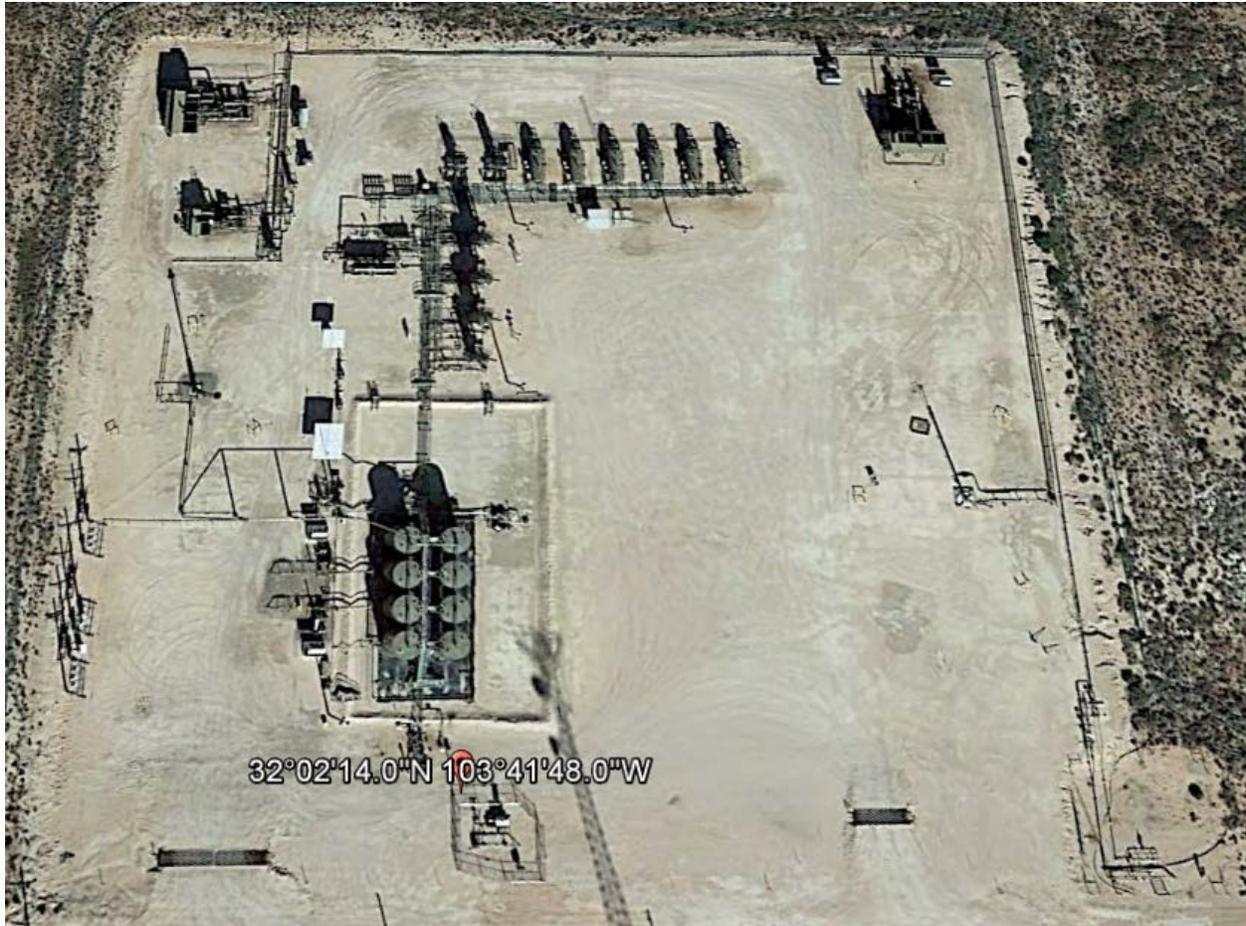
Figure 1 – Site Map

COP personnel were on site to visually assess the release on September 6th. The release was mapped and photographed (Appendix B). Based on the assessment, the release will be excavated down 6 inches bgs. Once the excavation is completed, discrete samples will be taken and field tested for chlorides and organic vapors. If the field data indicates that the individual samples will not achieve chloride, Gasoline Range Organics (GRO), Diesel Range Organics (DRO) and BTEX readings below regulatory standards, the excavation will be deepened until field testing indicates that all constituents from bottom discrete samples will return values below regulatory standards. Five discrete samples will be collected in total. Four surface samples will be collected just outside the berm on all four sides. The fifth sample will be from the center of the spill and will go down as deep as the spill penetrated. The samples will then be taken to a commercial laboratory to confirm that chloride, GRO, DRO and BTEX readings are below regulatory standards.

All excavated soils will be taken to a NMOCD approved facility for disposal. Clean soil will be imported to the site to serve as backfill and contoured to the surrounding location. Once these activities have been completed, a report will be sent to NMOCD requesting 'remediation termination' and site closure.

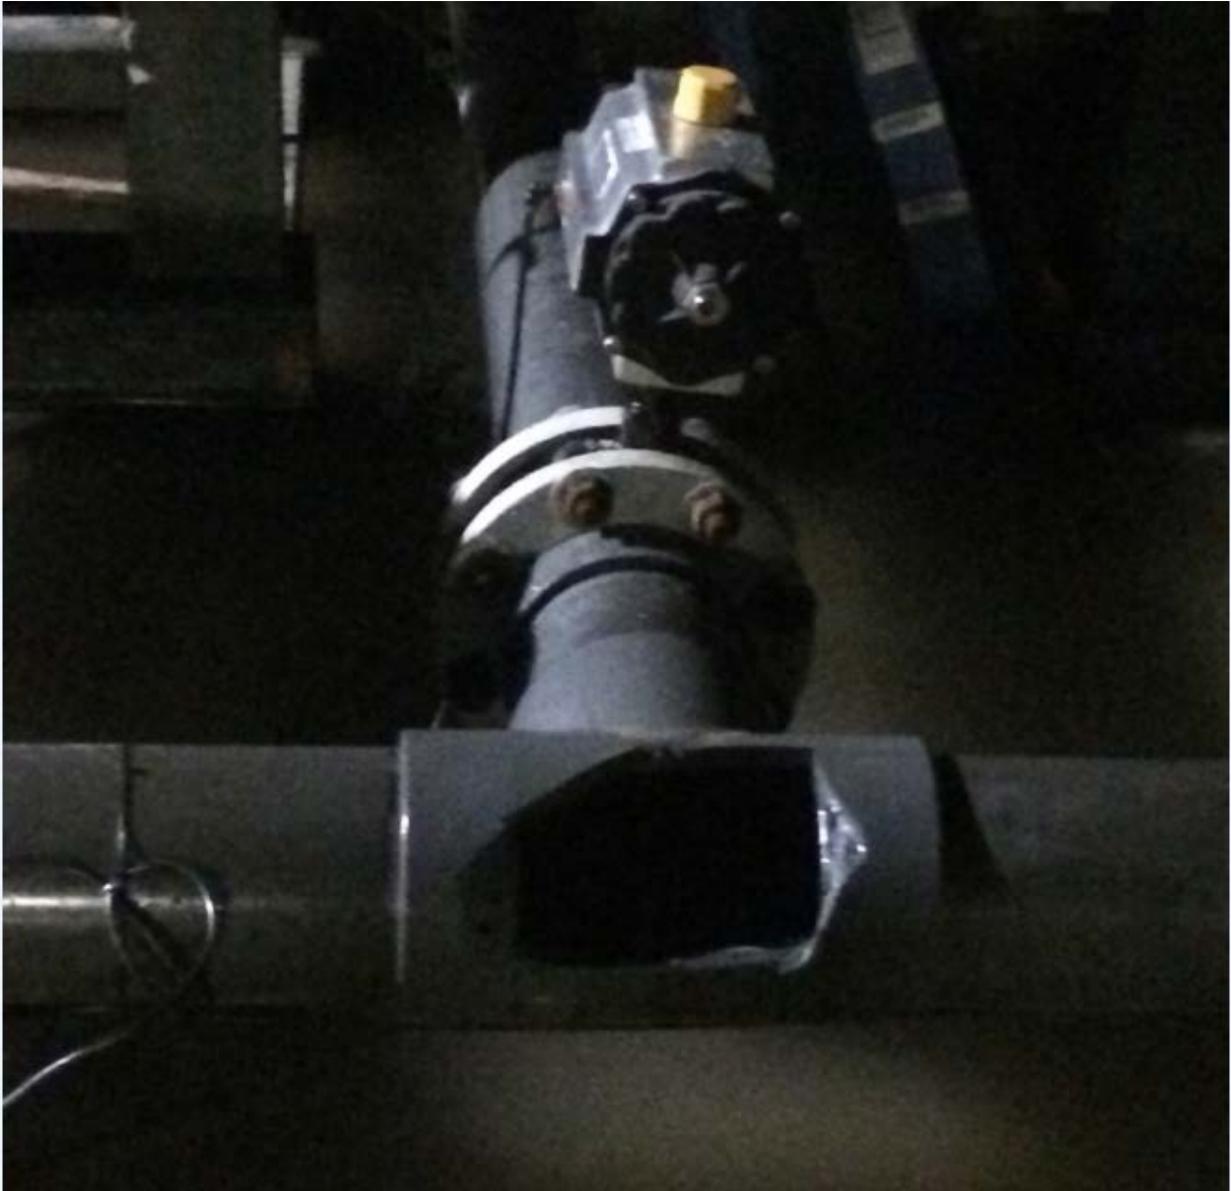
Appendix B – Photo Documentation

A 240 BBL Produced Water release occurred on the ConocoPhillips Buck Federal CTB located in Lea County, New Mexico: MSO was making his rounds when he noticed water inside the berm located around the oil and water tanks. When inspecting it more closely, the water was coming from a broken water line located on the filtration line near the filters. MSO shut down the water filtration pumps and closed the line that comes from tanks to the pump. MSO called to notify supervisor and had a water truck vacuum out the produced water from the berm.

View looking towards the South (9/6/2016)
