RE: Final Closure Report
XTO Energy – SDE 31 Tank Battery
UL-F, Section 31, Township 23 South, Range 32 East
Lea County, New Mexico
NMOCD Reference # 1RP-4398

The following *Final Closure Report* serves as a condensed update on closure activities for the above referenced Site.

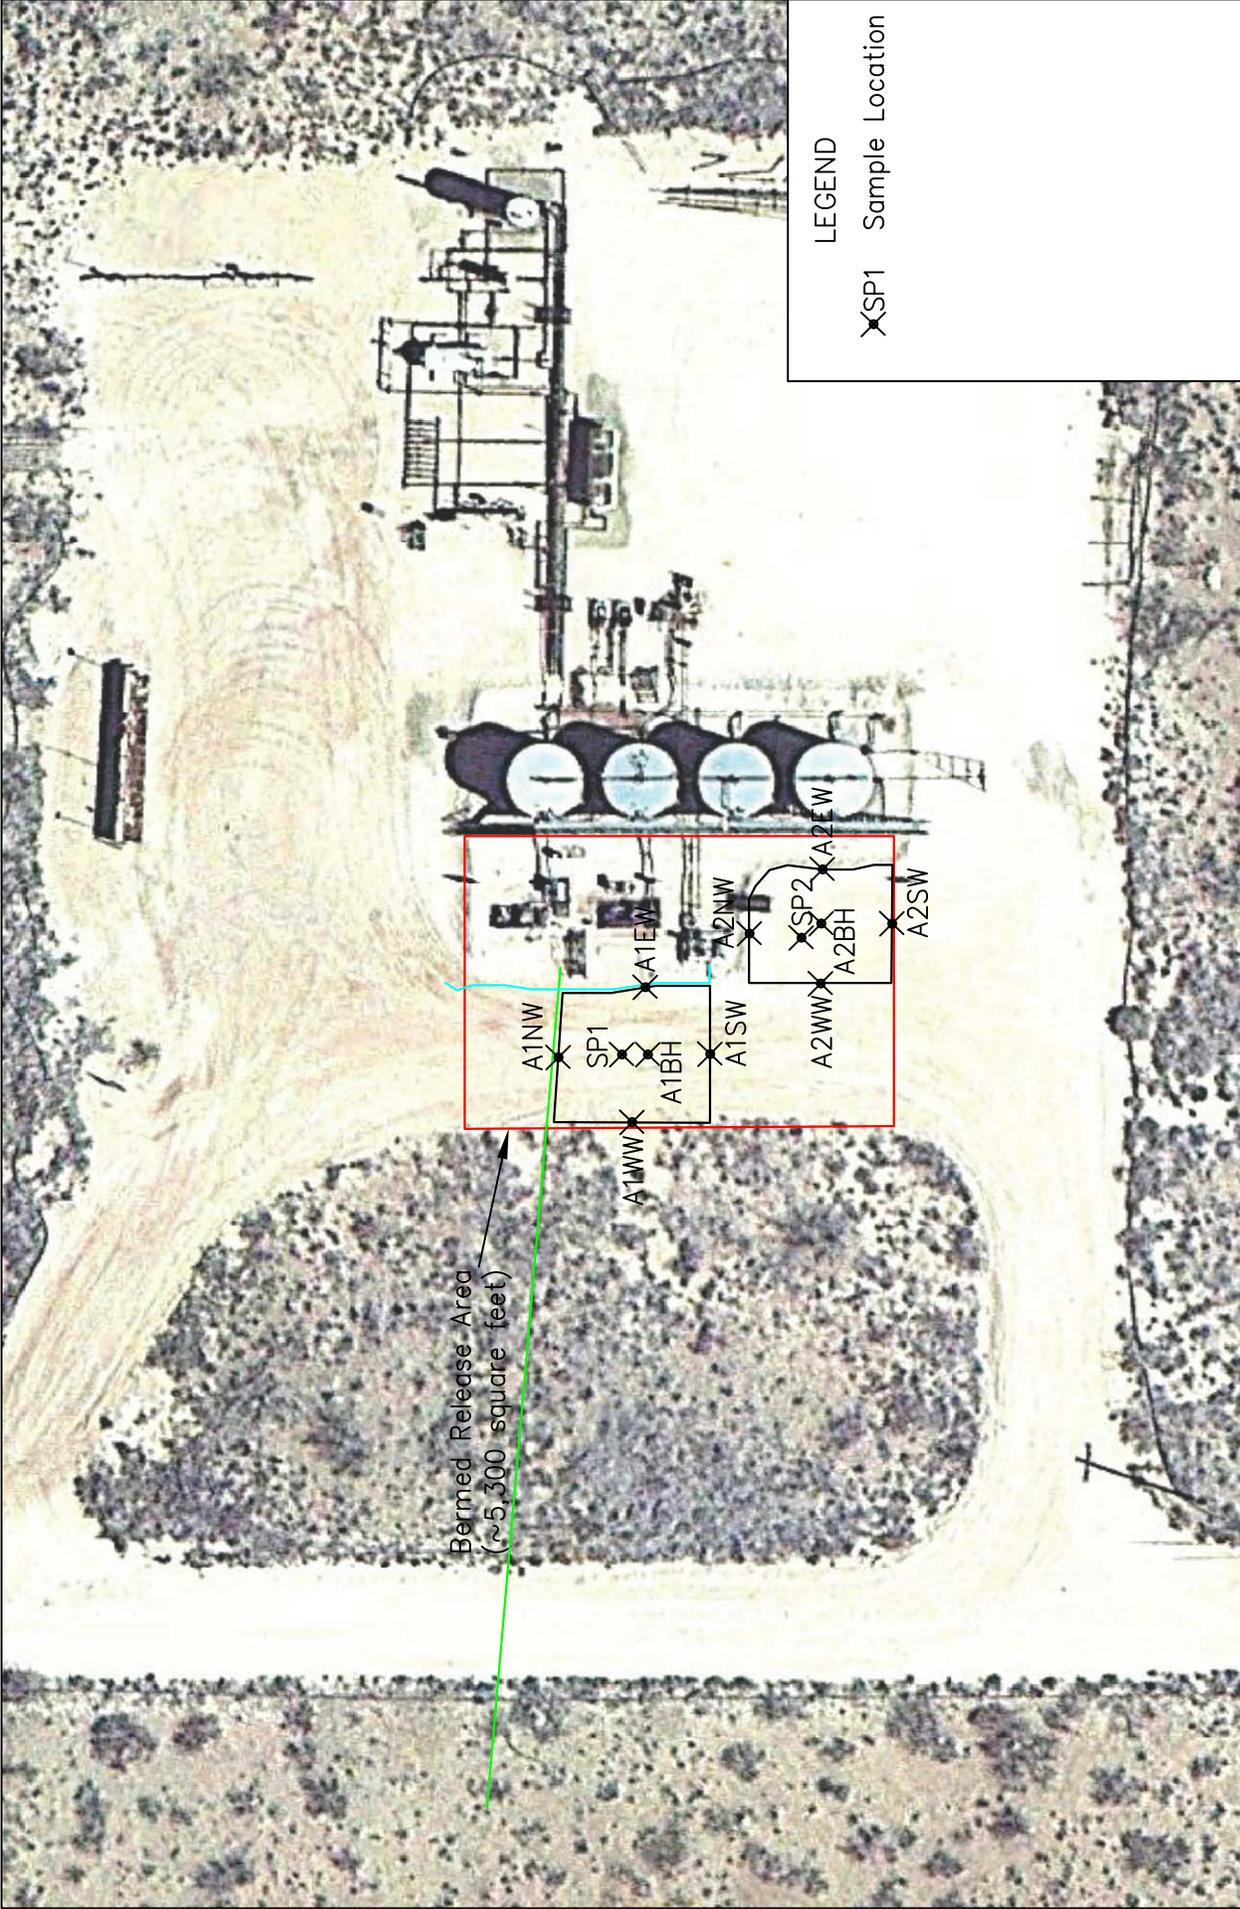
Figure 3
 Sample/Site Map
 XTO Energy
 SDE 31 Battery

EPI personnel mobilized on the site on August 12, 2016 to collect soil samples to determine the vertical extent of contamination. A total of ten (10) soil samples were collected from two (2) sample locations; SP1 and SP2. All samples were jarred, chilled and sent to Cardinal Labs for Chloride testing. Laboratory analytical results indicate Chloride concentrations in excess of NMOCD Recommended Remedial Action Levels (NMOCD RRALs) of 1,000 mg/Kg at SP1 to three (3) feet bgs and SP2 to two (2) feet bgs (reference Figure 3 and Table 2).

Bermed Release Area
 (~5,300 square feet)

The release area around SP1 was excavated approximately three (3) foot bgs; the release area around SP2 was excavated approximately two (2) feet bgs. Approximately 178 tons of contaminated material were excavated and transported to a state approved facility for disposal.

On November 16, 2016 soil samples were collected from the side walls and bottoms of the excavations. A total of ten (10) soil samples were collected from the excavations. All samples were jarred, chilled and sent to Cardinal Labs for Chloride testing. Laboratory analytical results indicate Chloride concentrations in excess of NMOCD RRALs of 1,000 mg/Kg in the A1NW, A1EW, A2NW, and A2EW samples (reference Figure 3 and Table 2). The process equipment to the east and process lines to the north prevent further excavation.

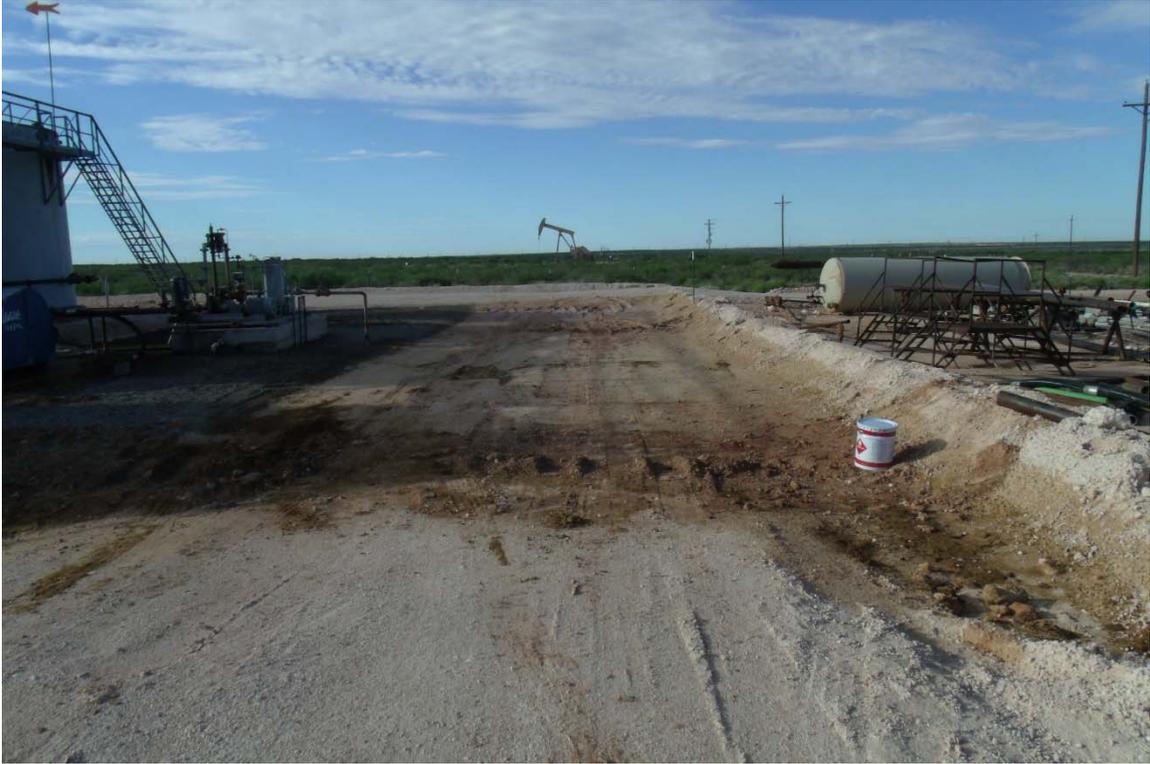
Photograph #1 – Release area

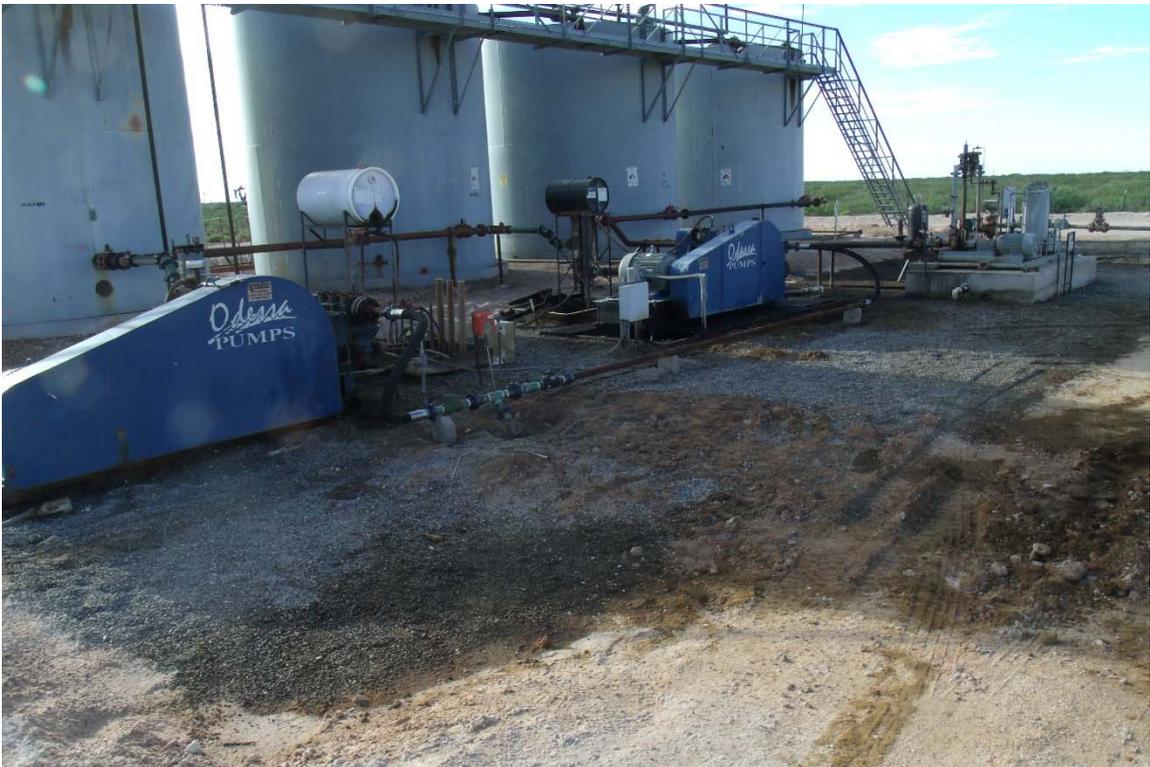
Photograph #2 – Release area

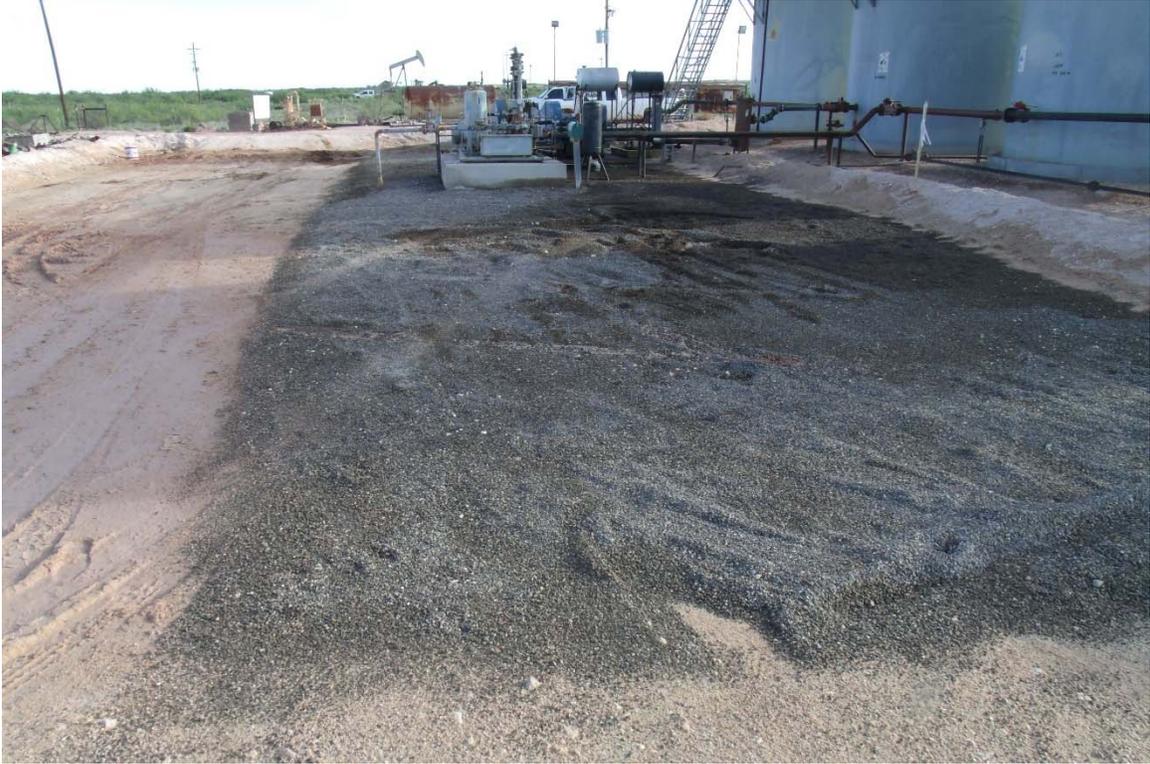
Photograph #3 – Release area

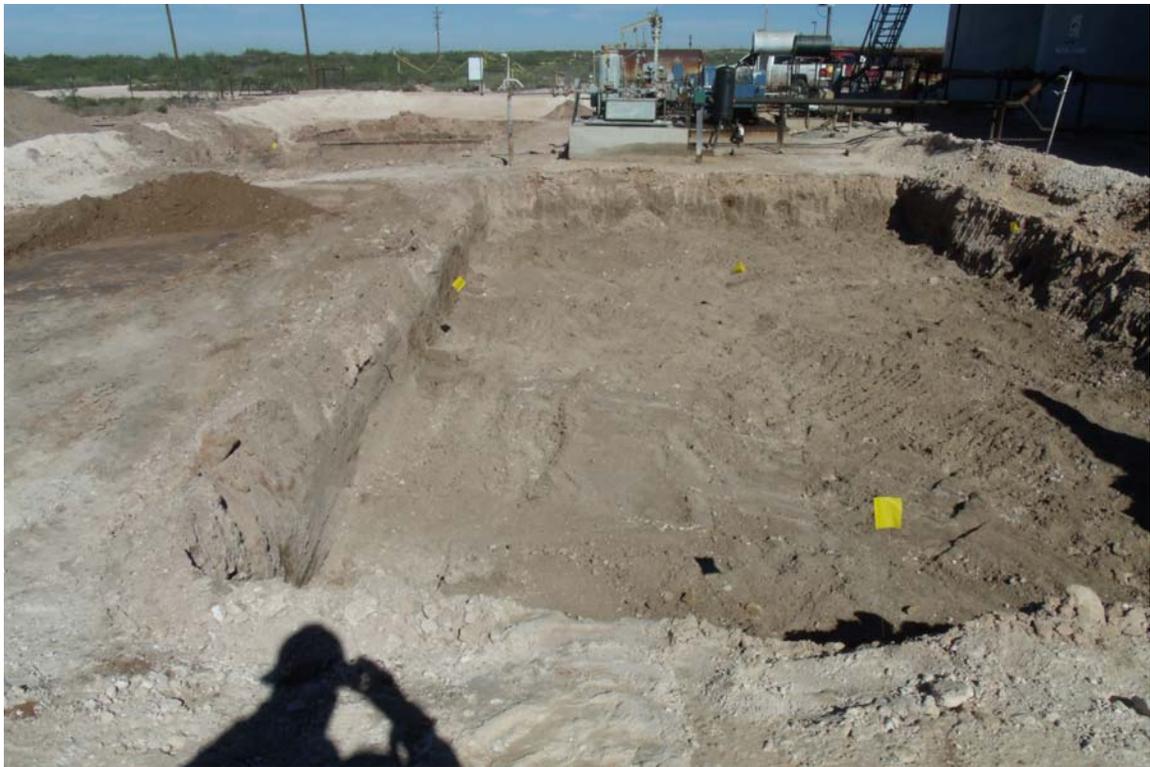
Photograph #4 – Excavations

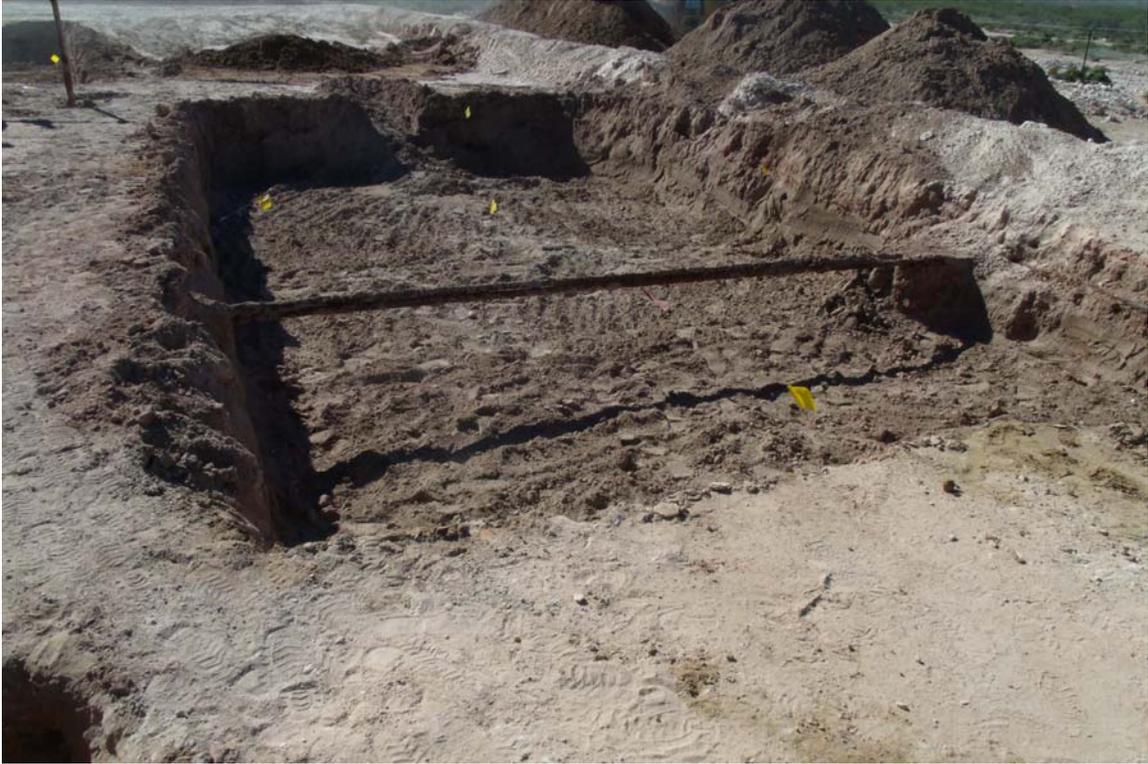
Photograph #5 – Excavation A1

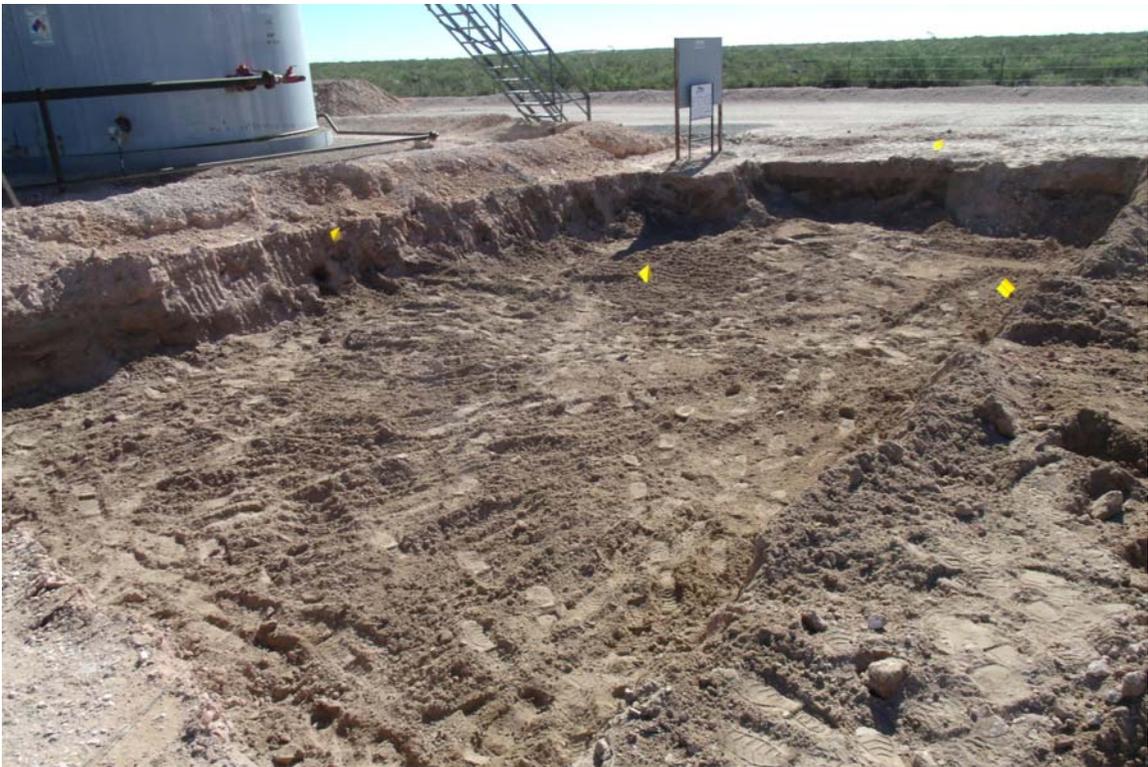
Photograph #6 – Excavation A2

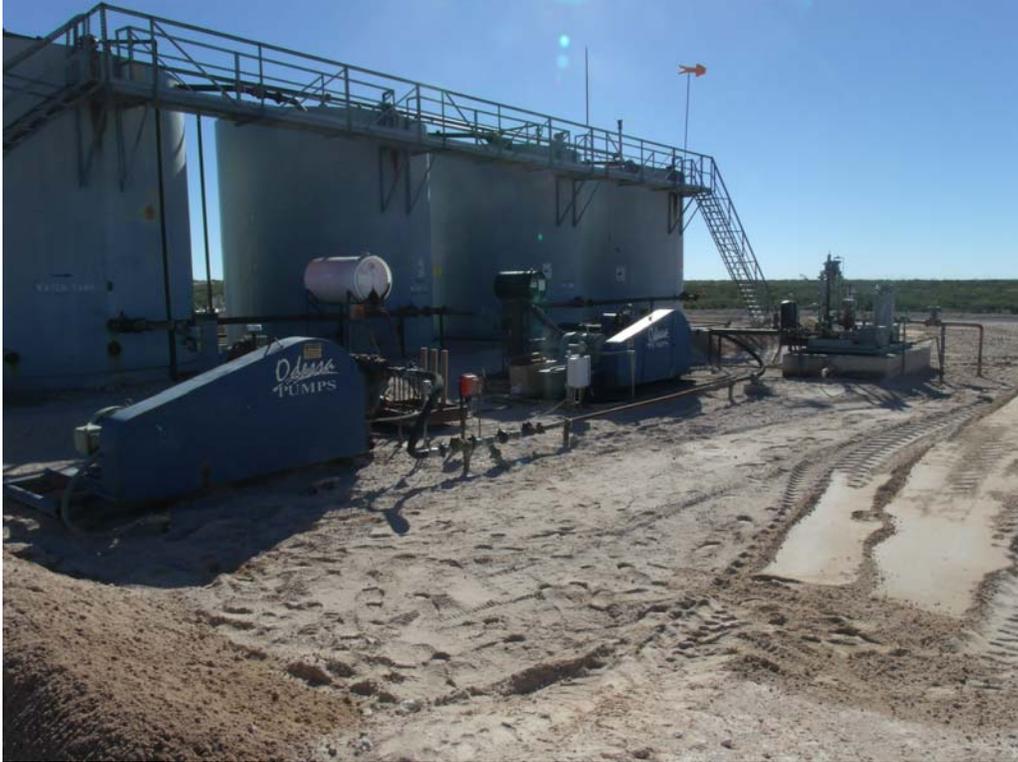
Photograph #7 – Backfilled

Based on laboratory analytical results and with NMOCD and BLM approval, the excavations have been backfilled with approximately 178 tons of clean soil; soil was free of deleterious material or rocks or large clumps.

Backfilling continued until the entire excavation was closed. Upon completion of backfill activities, the entire disturbed area was contoured to blend with existing pad area and protected against wind/water erosion.

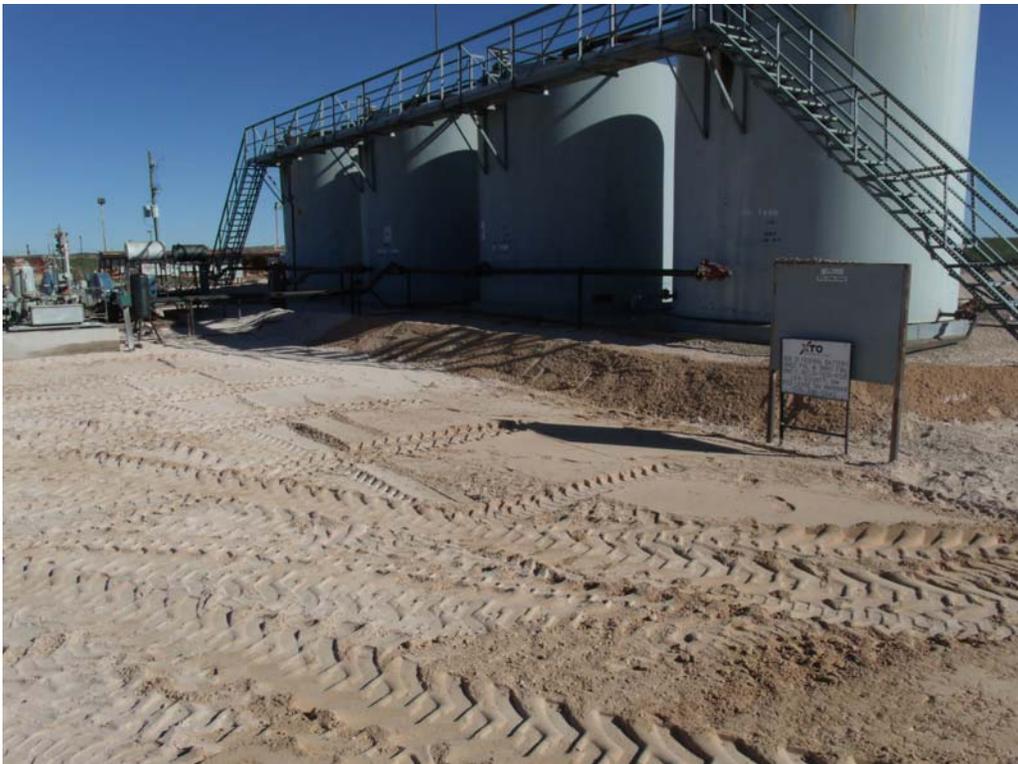
Photograph #8 – Backfilled
