RE: Corrective Action

Rice Operating Company – Justis SWD System

Justis K-36 AD (1RP-4248): UL/K, Sec. 36, T25S, R37E

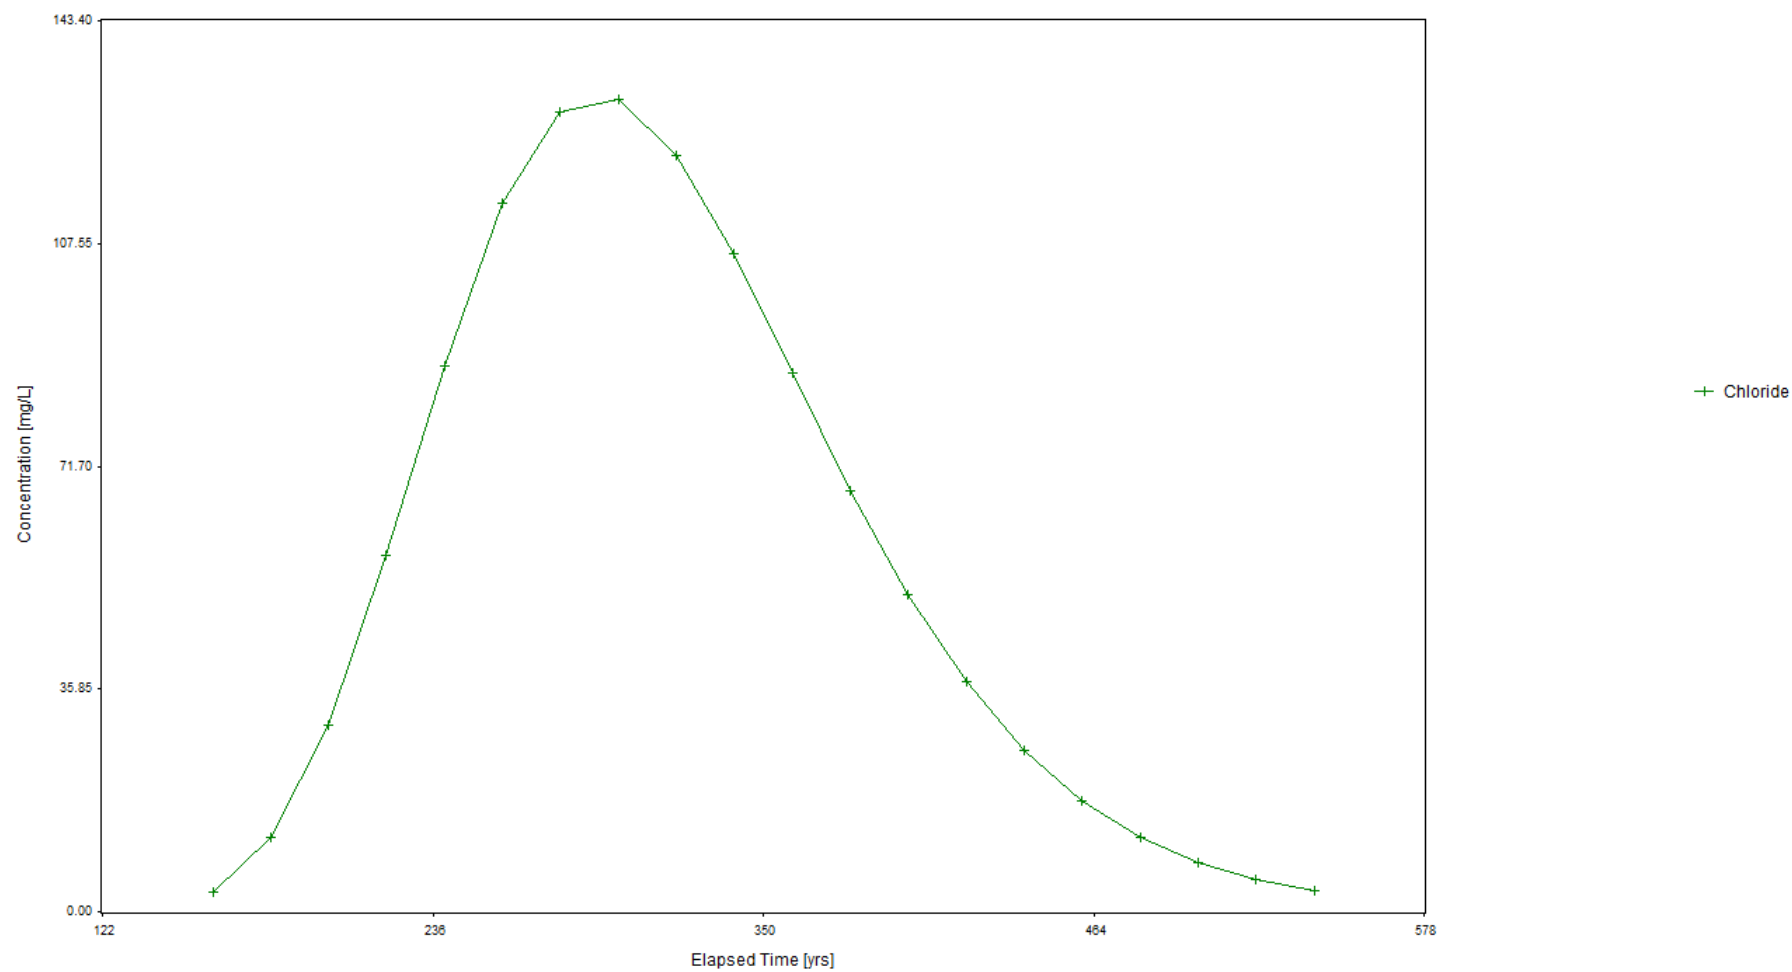
Chloride Concentration At The Receptor Well
Rice Justis K-36 AD

MAXIMUM WELL CONCENTRATION IS 132.2 AT 0.295E+03 YEARS

To determine if residual chloride in the vadose zone pose a threat to groundwater quality, BEST ran the U.S. Environmental Protection Agency Exposure Assessment Multimedia Model (MULTIMED Version 1.5, 2005). The model prediction concludes that the peak concentration of chloride in groundwater contributed by the vadose zone soils would be approximately 132 mg/L in 295 years with the installation of the 20-mil reinforced liner. The multimed output file and graph are attached.
