**Texland Petroleum
Lea YL State #2
Sec. 2-T17S-R37E, Lea Co., NM
Affected Surface Area – 6,110 sq. ft. / .14 acre
GPS Coordinates: N32.86800 W103.22282**

Proposed Corrective Action Plan

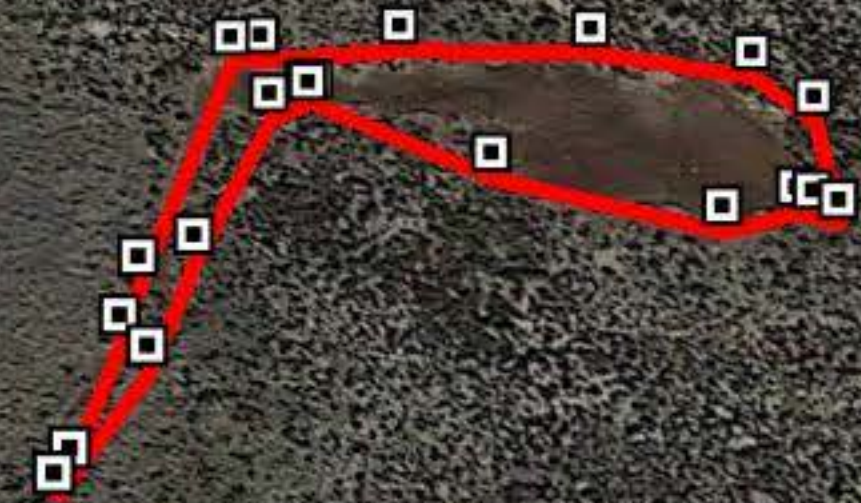
Texland Petroleum
Lea YL State #2
Oil & Produced Water Spill
Affected Area - 6,110 sq. ft. / .14 acre
GPS Coordinates: N32.86800
W103.22282

Based on a previous conversation between Texland Petroleum and Mr. Tomas Oberding of the New Mexico Oil Conservation Division, the corrective action plan for this release will consist of excavating, removing, and disposing the contaminated soils at an off-site permitted facility. BCC, Inc. will delineate this release both vertically and horizontally by on-site field testing of the soil as the excavation is carried out. Field testing will include both chloride and TPH analysis. Excavation and removal will continue until field testing analysis reveals that the remaining soils are below the required contaminant specific levels, or to a depth of 4 feet bgs. Soil samples will be pulled at the base of the excavation and laboratory analyzed to confirm all TPH, BTEX, and chloride levels are satisfactory before any backfilling occurs. If excavation is required down to the 4 foot bgs depth, a plastic liner will be placed throughout the excavated areas and clean soil will be backfilled and contoured to provide drainage away from the site. All affected areas will be revegetated with an approved native grass seed blend.
