## **Final Closure Report**

**Vanguard  
Nowata AGR State #1  
Lea County, New Mexico  
Unit Letter "P", Section 9, Township 18 South, Range 35 East  
Latitude 32.7573739 North, Longitude 103.4571457 West  
NMOCD Reference #1RP-3901**

**April 2017**

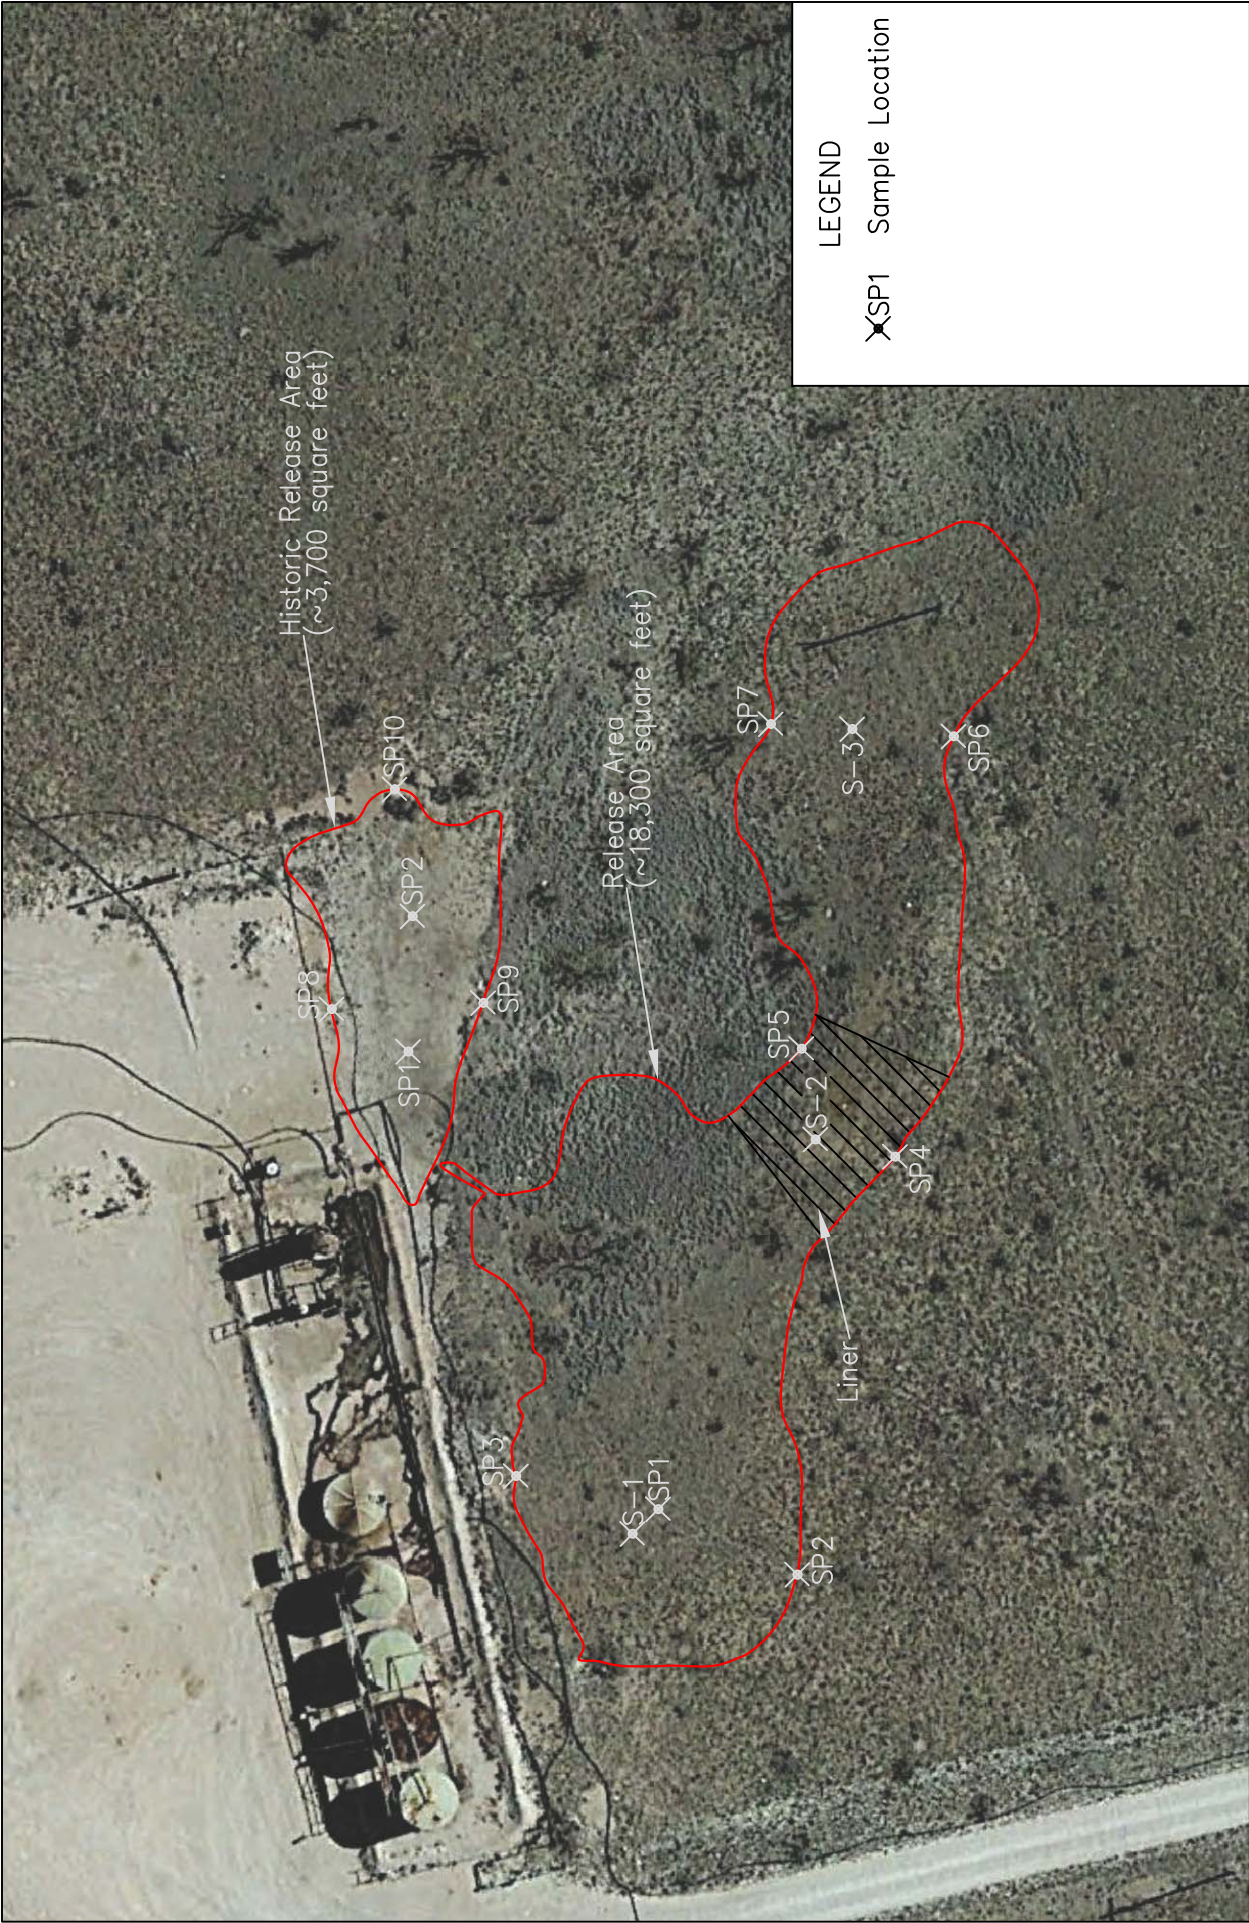
Figure 3 Site/Sample Map Vanguard Nowata AGR State #1	Lea County, New Mexico SE 1/4 of SE 1/4, Sec. 9, T18S, R35E N 32° 45' 26.42" W 103° 27' 25.82" Elevation: 3,932 feet amsl	DWG By: D Dominguez January 2017	REVISED:	 
		0 50 100	SHEET 1 of 1	
		  Feet

On May 31, 2016 EPI personnel mobilized on site to collect soil samples to determine the vertical extent of contamination at the historic release area. A total of seven soil samples were collected from two sample locations; SP1 – SP2. All seven soil samples were field tested for organic vapors and chlorides. Field testing indicates elevated readings for organic vapors and chlorides between surface and two to three feet bgs. Two representative soil samples were sent to Cardinal Labs in Hobbs, New Mexico, for testing. Laboratory analytical results indicate Benzene, BTEX, TPH, and Chloride concentrations are below NMOCD RRALs at sample location TD (reference *Figure 3* and *Table 2*).

On December 8, 2016 EPI personnel were on site to collect soil samples from the side walls of the excavation. A total of ten soil samples were collected from nine side wall sample locations, with one confirmation sample collected from the excavation floor at the area of sample S-1. All ten samples were sent to Cardinal labs for Chloride testing. Laboratory analytical results indicate that eight of the ten the side wall samples were below NMOCD RRALs, while two side wall samples, SP7 and SP9 were above NMOCD RRALs for Chloride (reference *Figure 3* and *Table 2*). These two areas were excavated and then resampled on December 20, 2016; both samples were sent to the lab for Chloride testing. Laboratory analytical data indicates Chloride concentrations are below NMOCD RRALs for Chloride (reference *Figure 3* and *Table 2*).

Based on Talon LPE proposal, field testing, laboratory analytical data, and NMOCD approval, EPI excavated the release area around S-1 to four feet bgs, S-2 to four feet bgs, S-3 to two and half feet bgs, and the historic release area to three feet bgs. Approximately 1,176 cubic yards of contaminated soil were hauled to state approved facility for disposal. A 20-mil poly-ethylene liner was installed over the area of S-2, and the excavation was then backfilled with approximately 1,176 cubic yards of clean soil.

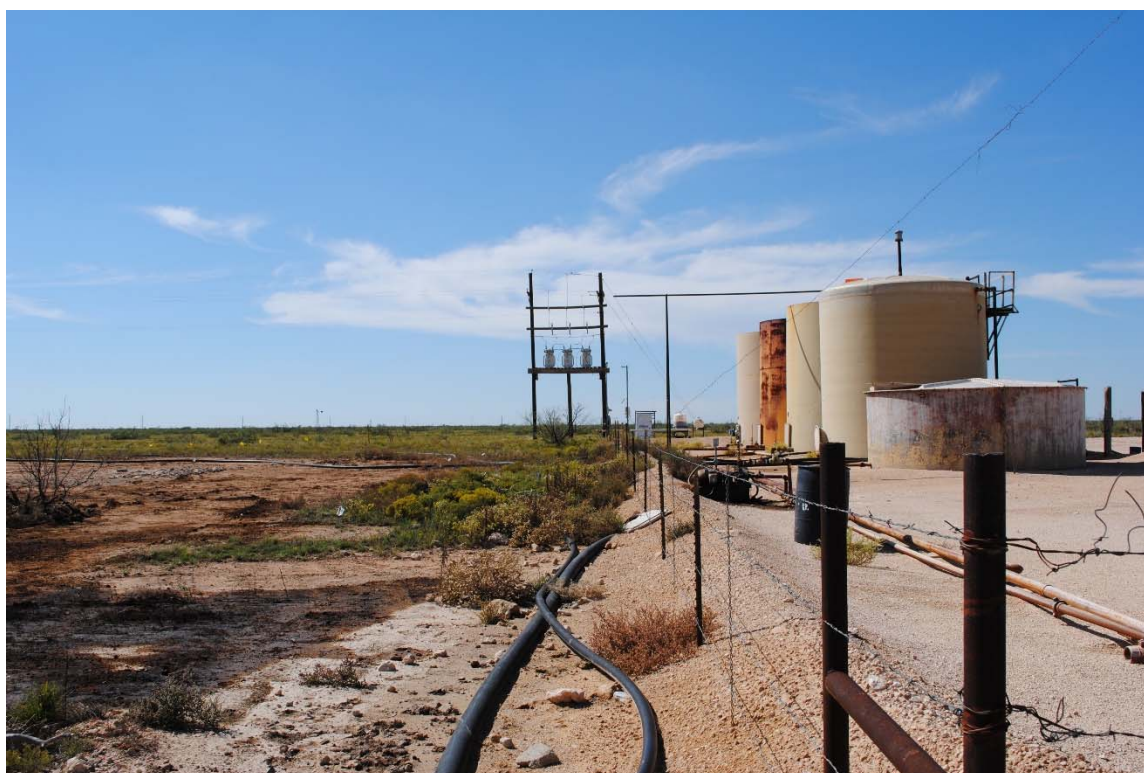
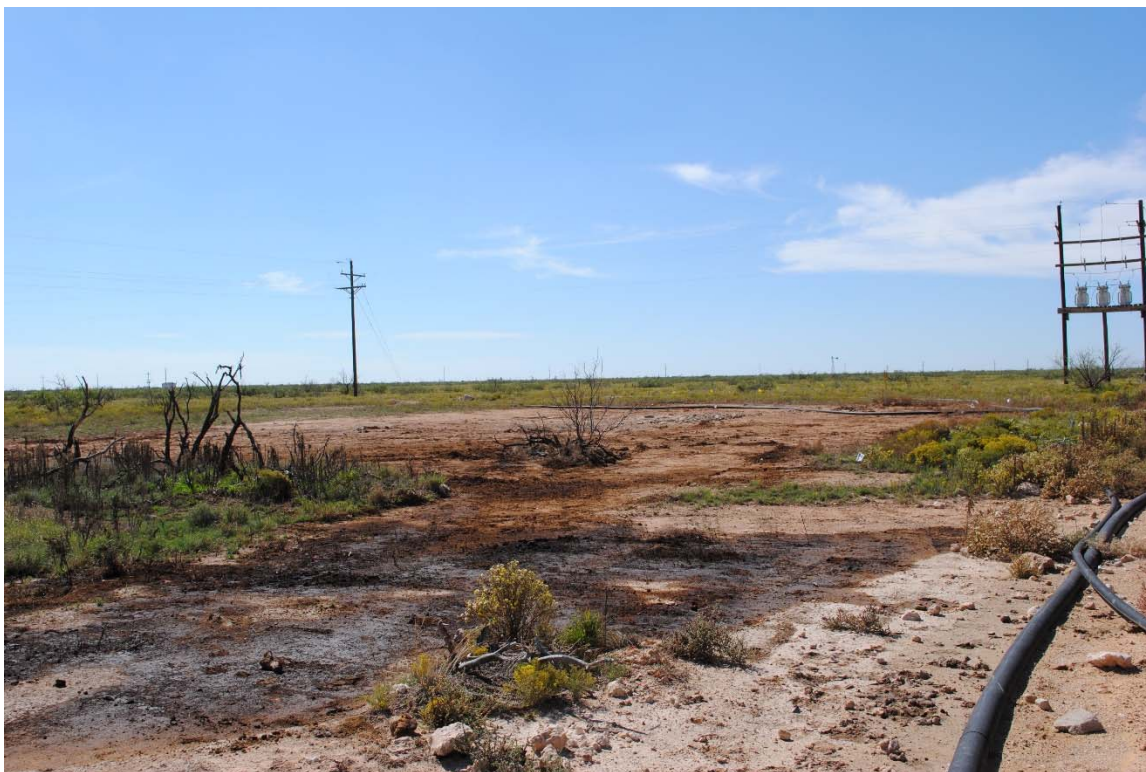
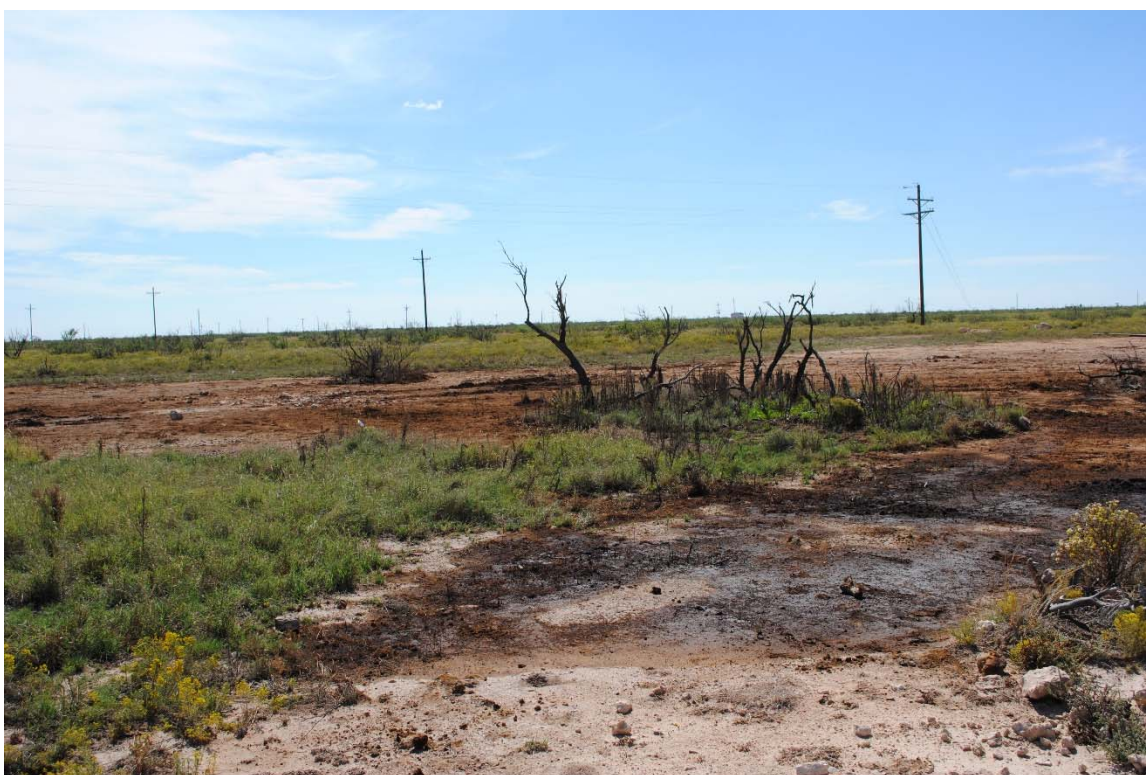
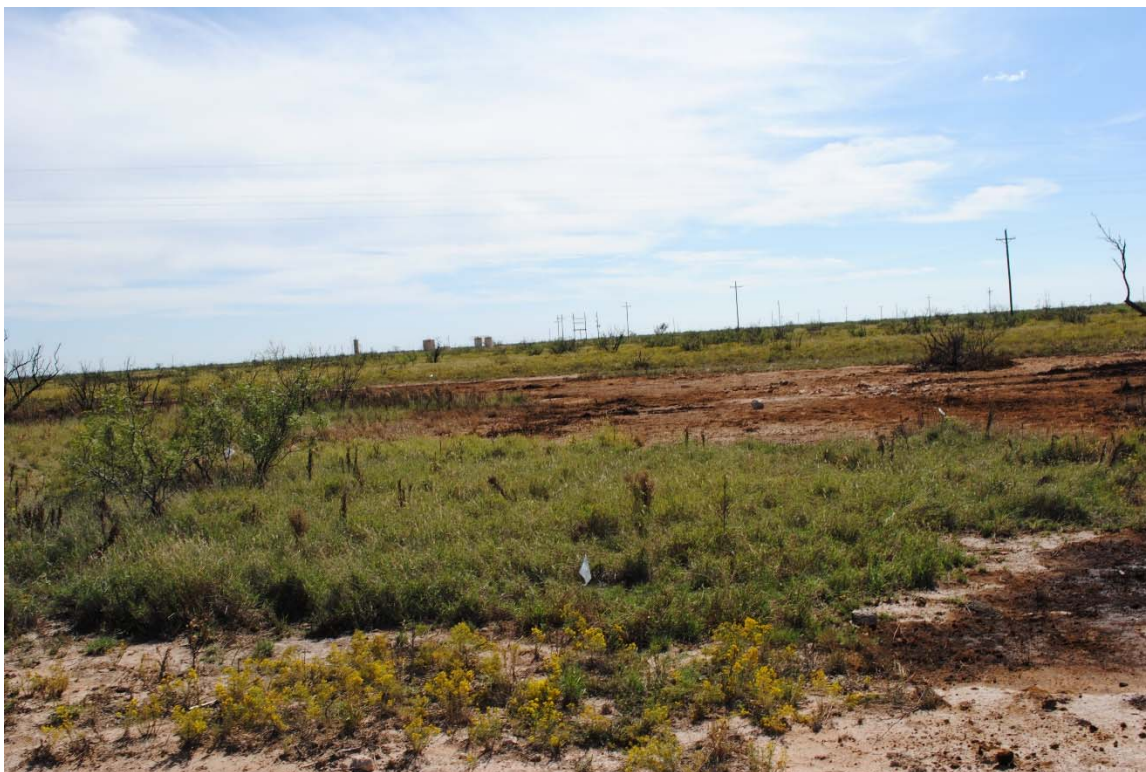
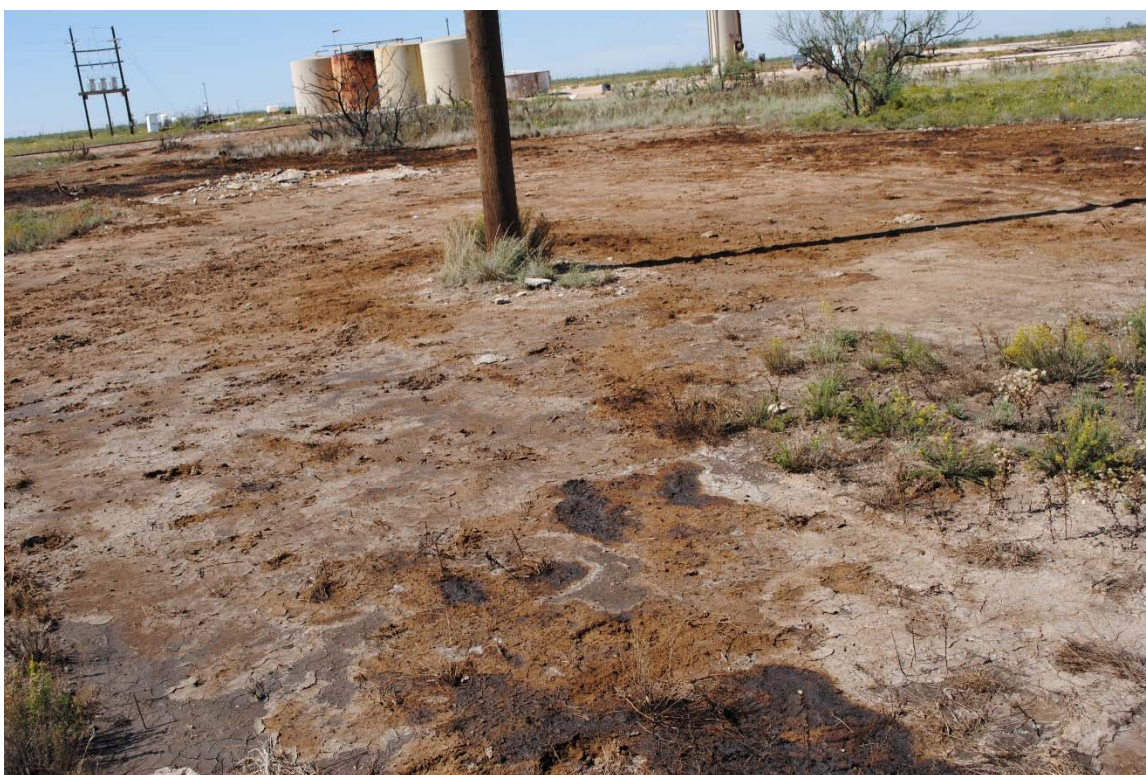
Photograph #2- Looking across release area

Photograph #3- Looking across release area

Photograph #4- Looking across release area

Photograph #5- Looking across release area

Photograph #6- Looking across release area

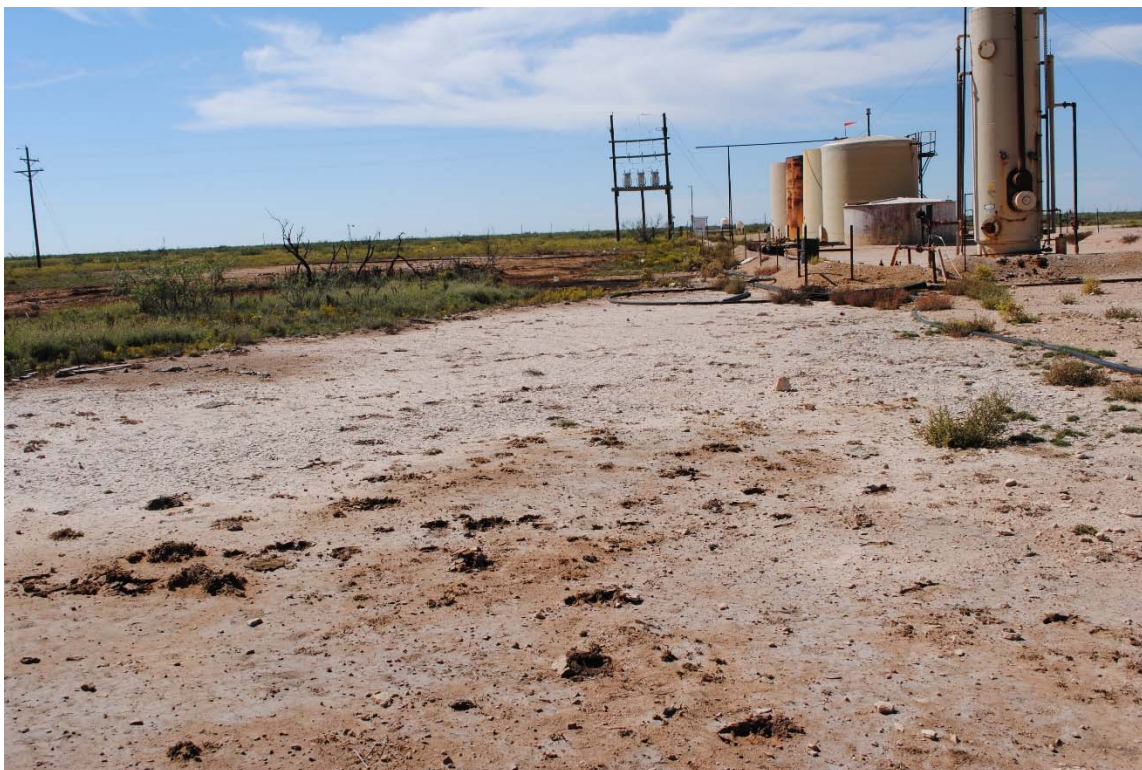
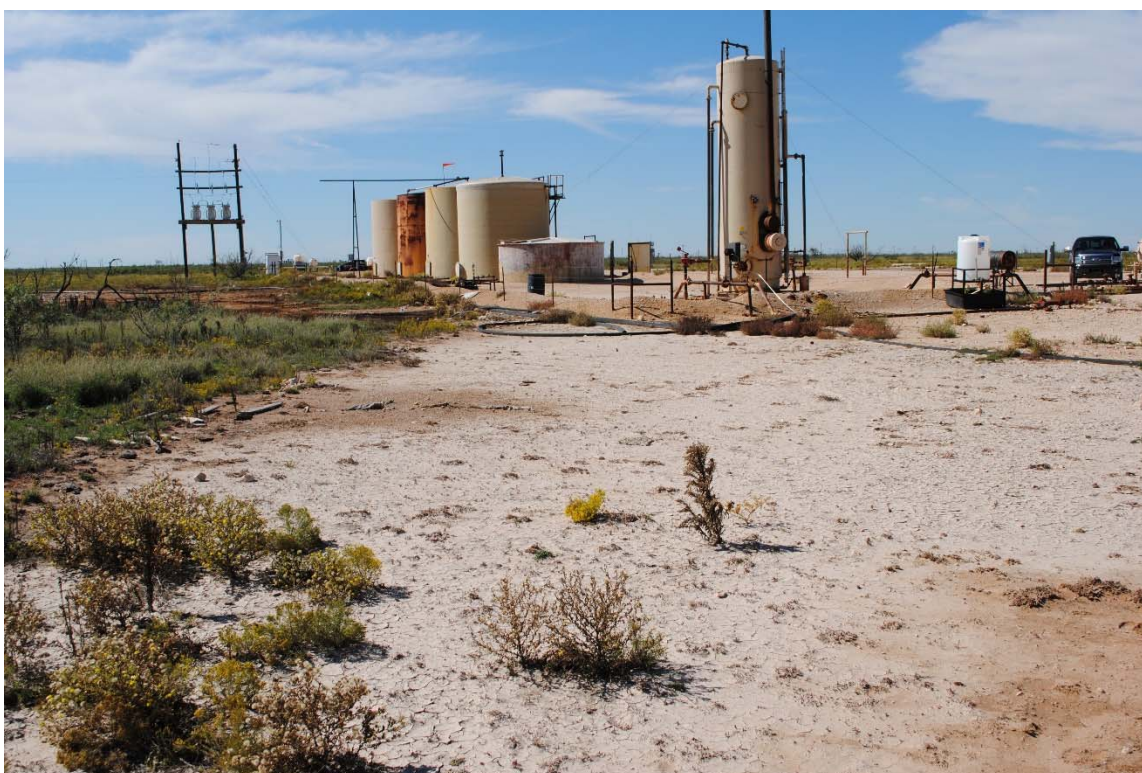
Photograph #7 – Looking across historic release area

Photograph #8 – Looking across historic release area

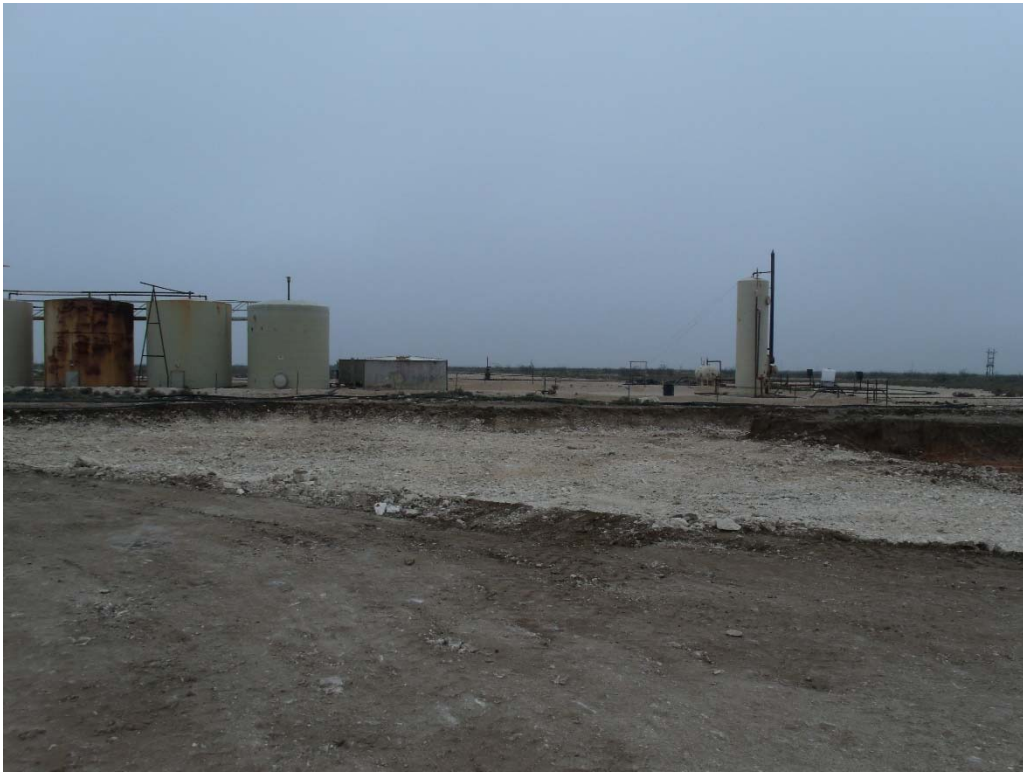
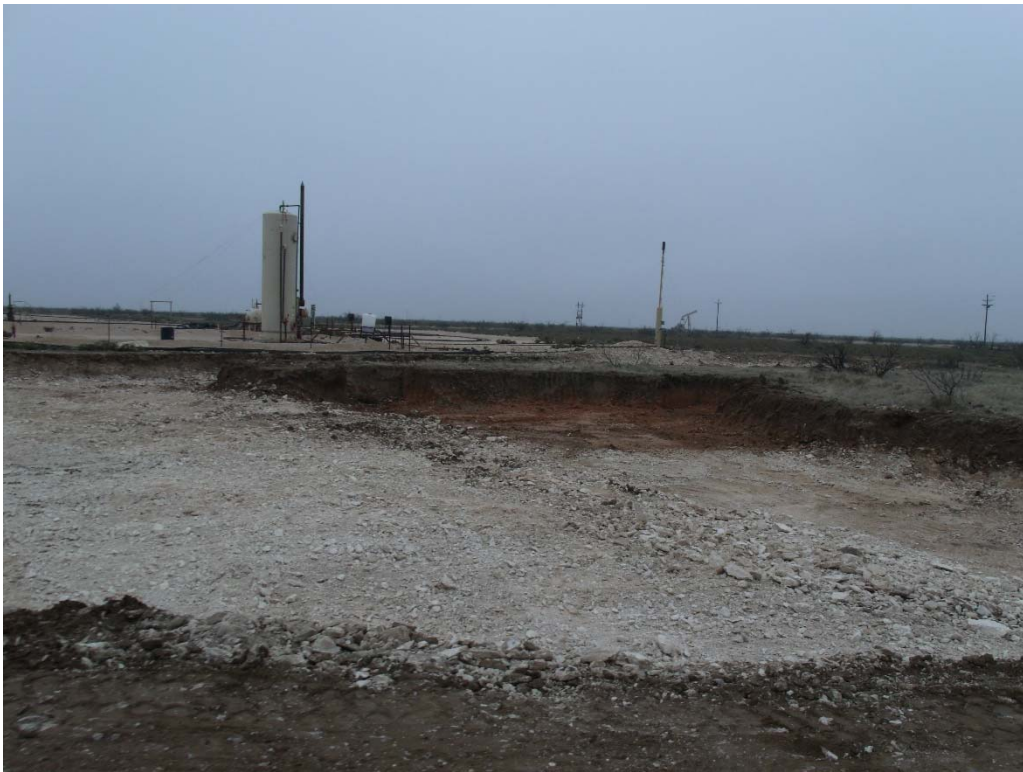
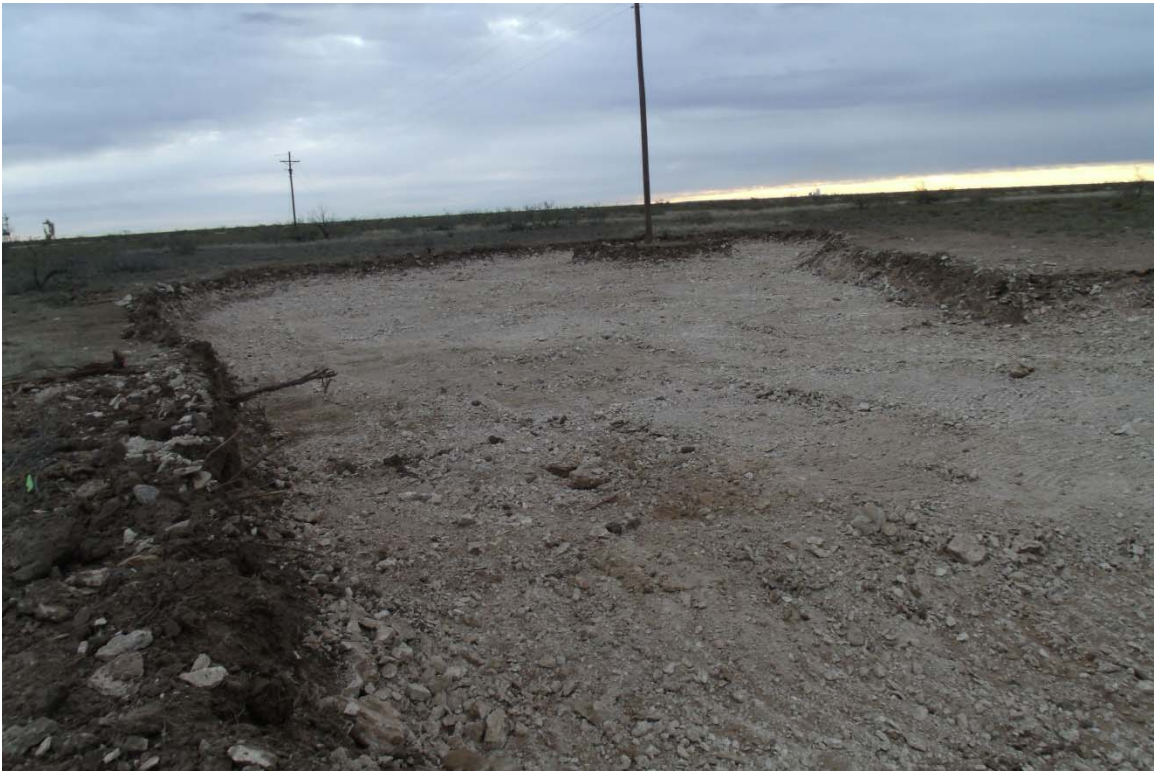
Photograph #9- Looking across excavation

Photograph #10- Looking across excavation

Photograph #11- Looking across excavation

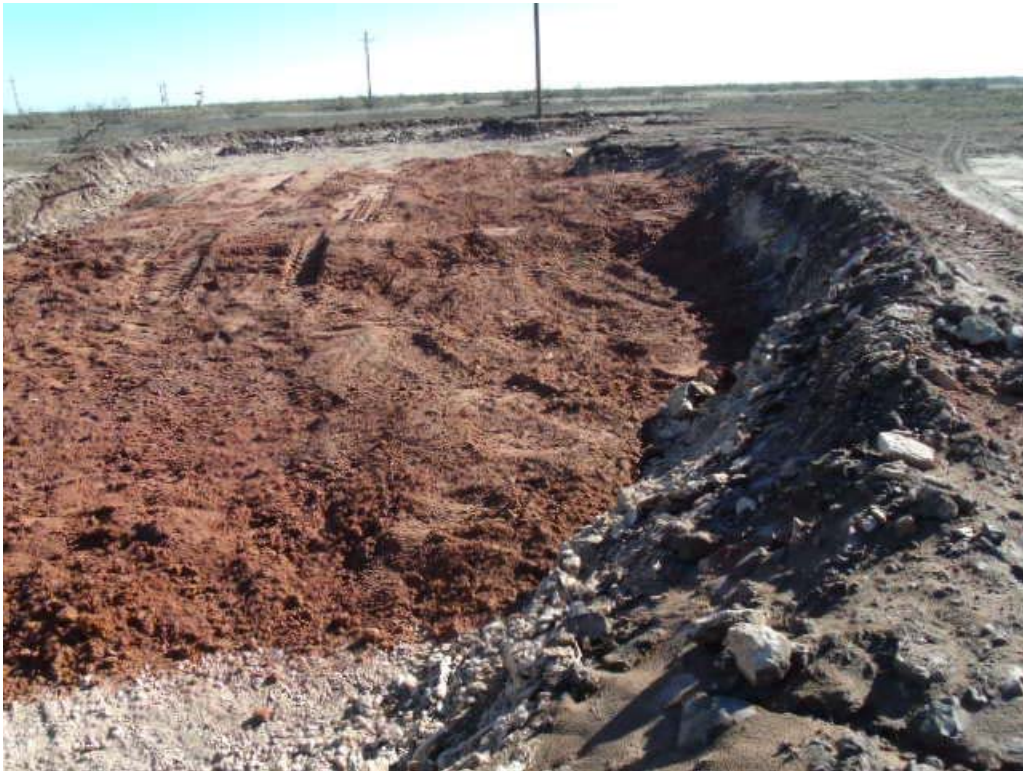
Photograph #12- Looking across excavation with padding for liner

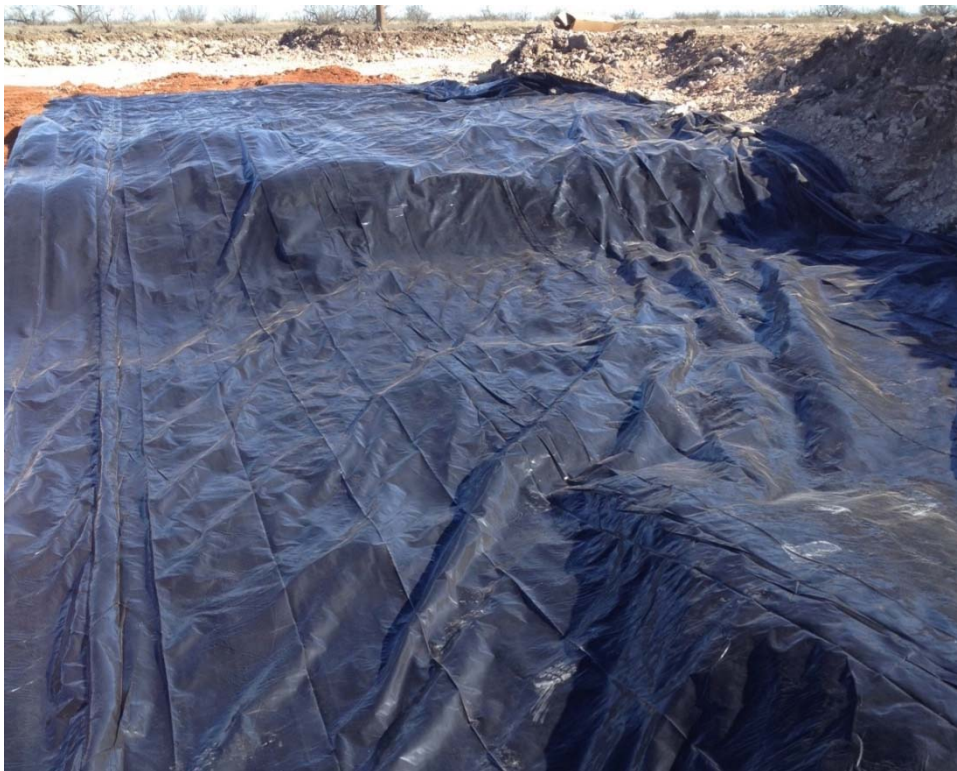
Photograph #13 – Looking across excavation with liner installed

Photograph #14 – Looking across excavation with liner installed

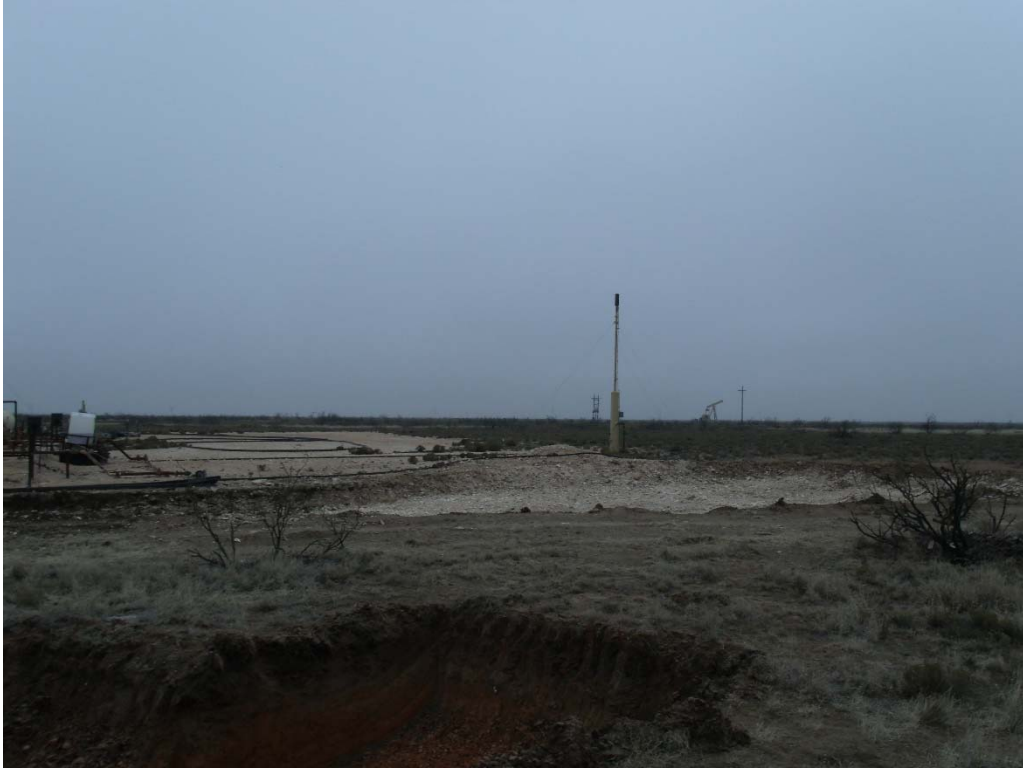
Photograph #15- Looking across historical release area excavation

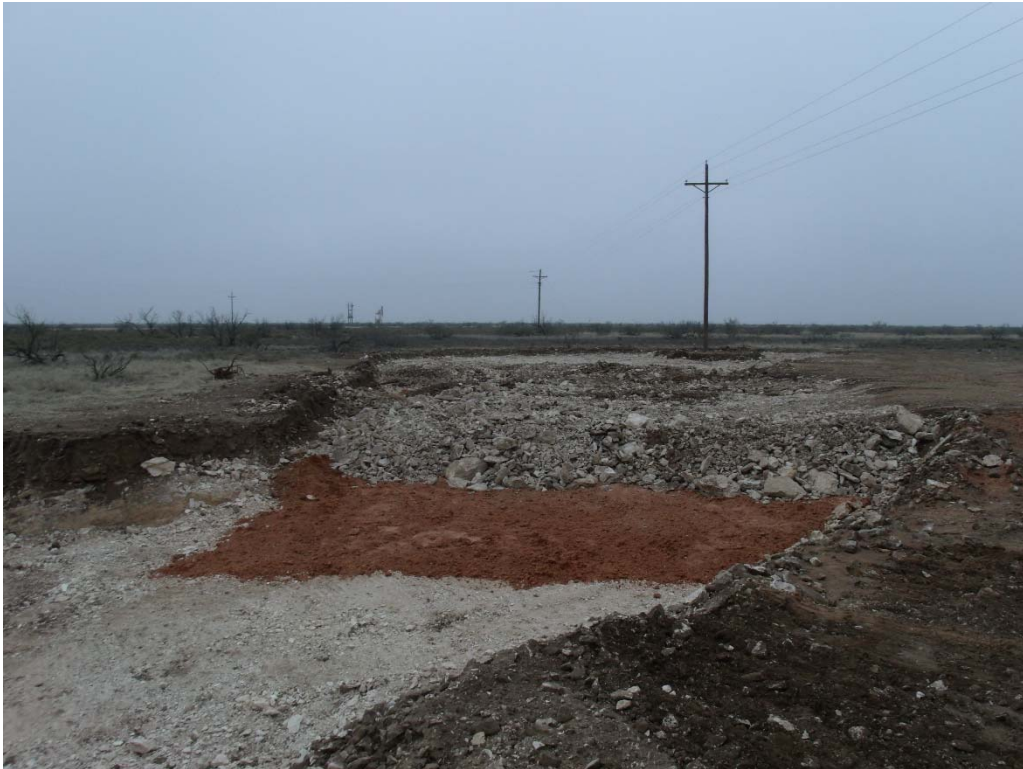
Photograph #16- Padding layer atop liner and backfilling begins

Caliche and top soil were free of deleterious material or rocks or large clumps. Backfilling continued until the excavation was closed. Upon completion of backfill activities, the disturbed area was contoured to blend with existing pasture area and protected against wind/water erosion. The entire disturbed area will also be seeded and watered.

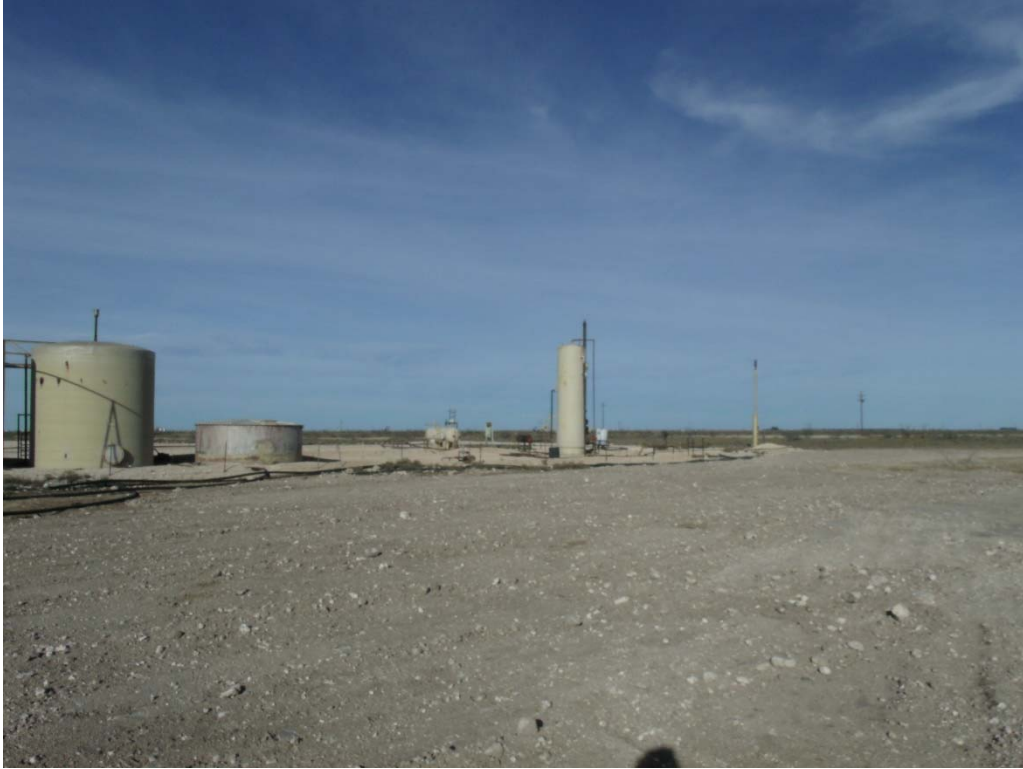
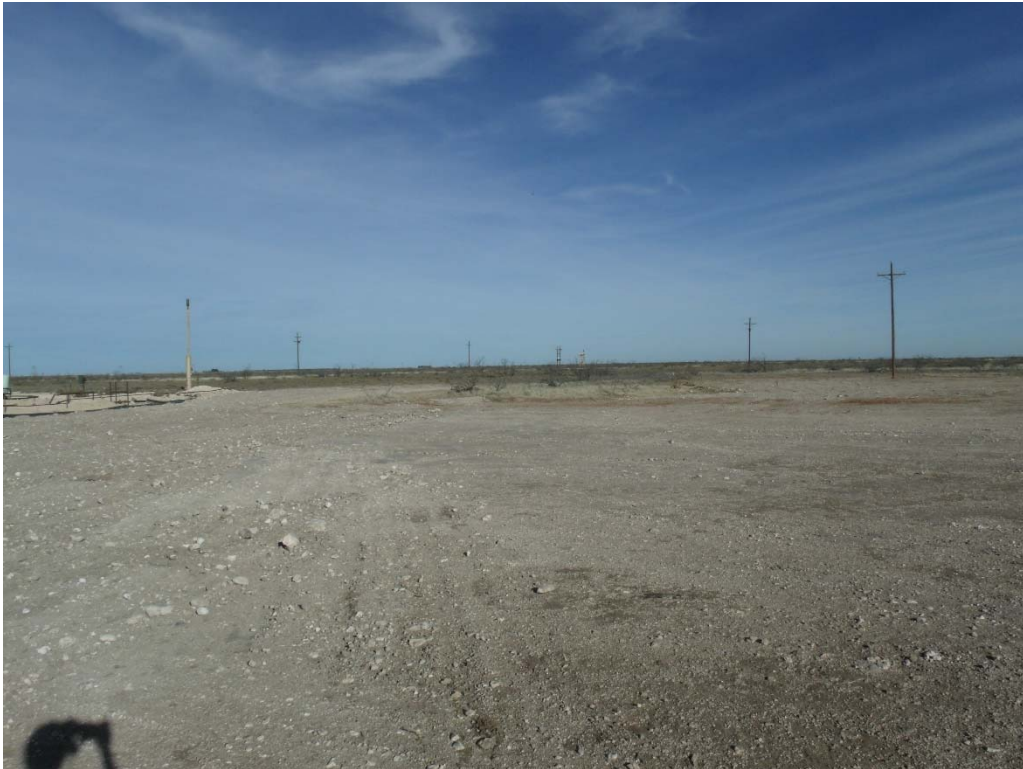
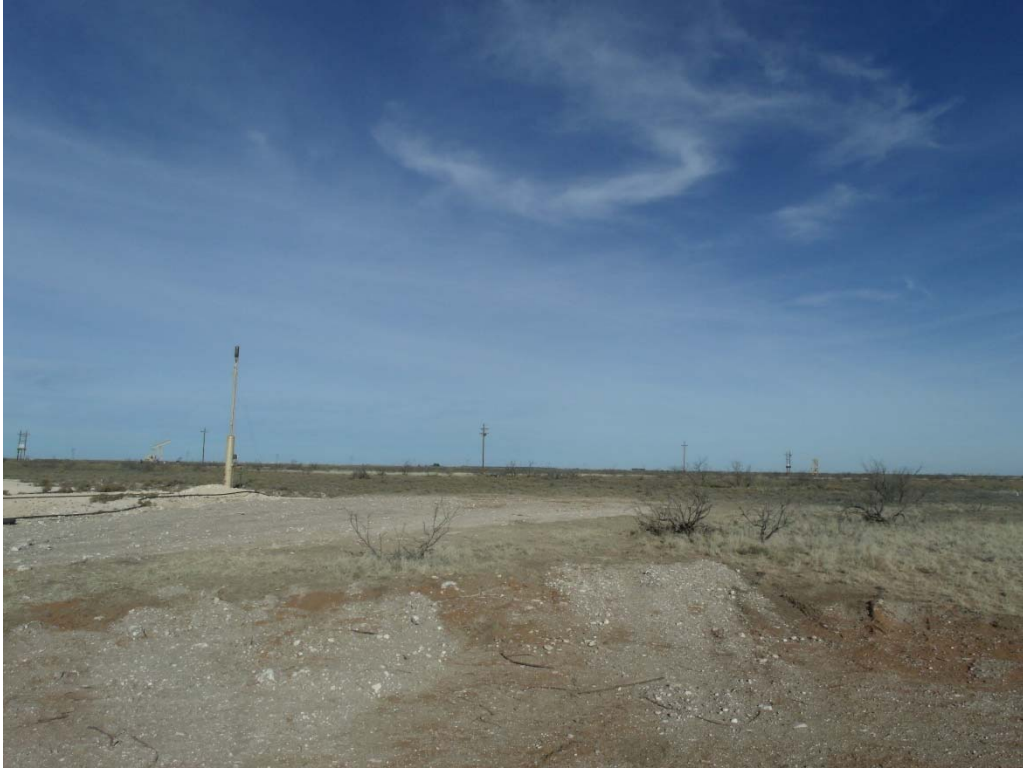
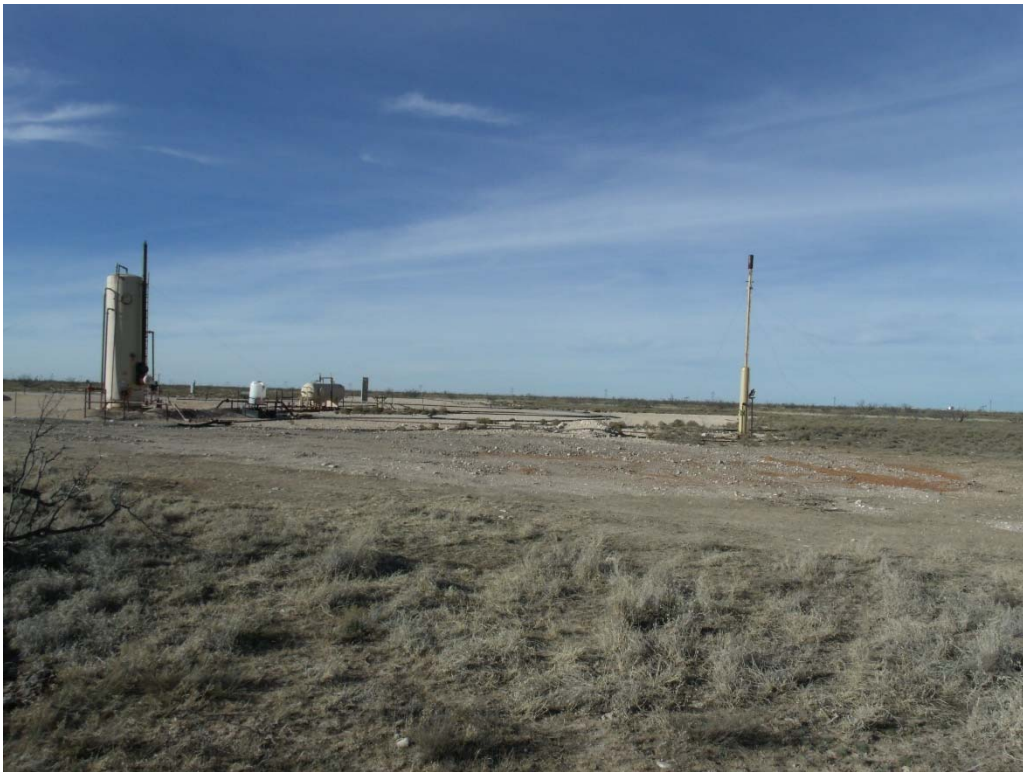
Photograph #17- Backfilled

Photograph #18- Backfilled

Photograph #19 – Backfilled

Photograph #20 – Backfilled
