Final Closure Report

**Vanguard Operating, LLC
Hill Tank Battery
Lea County, New Mexico
Unit Letter "B", Section 4, Township 21 South, Range 37 East
Latitude 32.513168 North, Longitude 103.165092 West
NMOCD Reference #1RP-4450**

May 2017

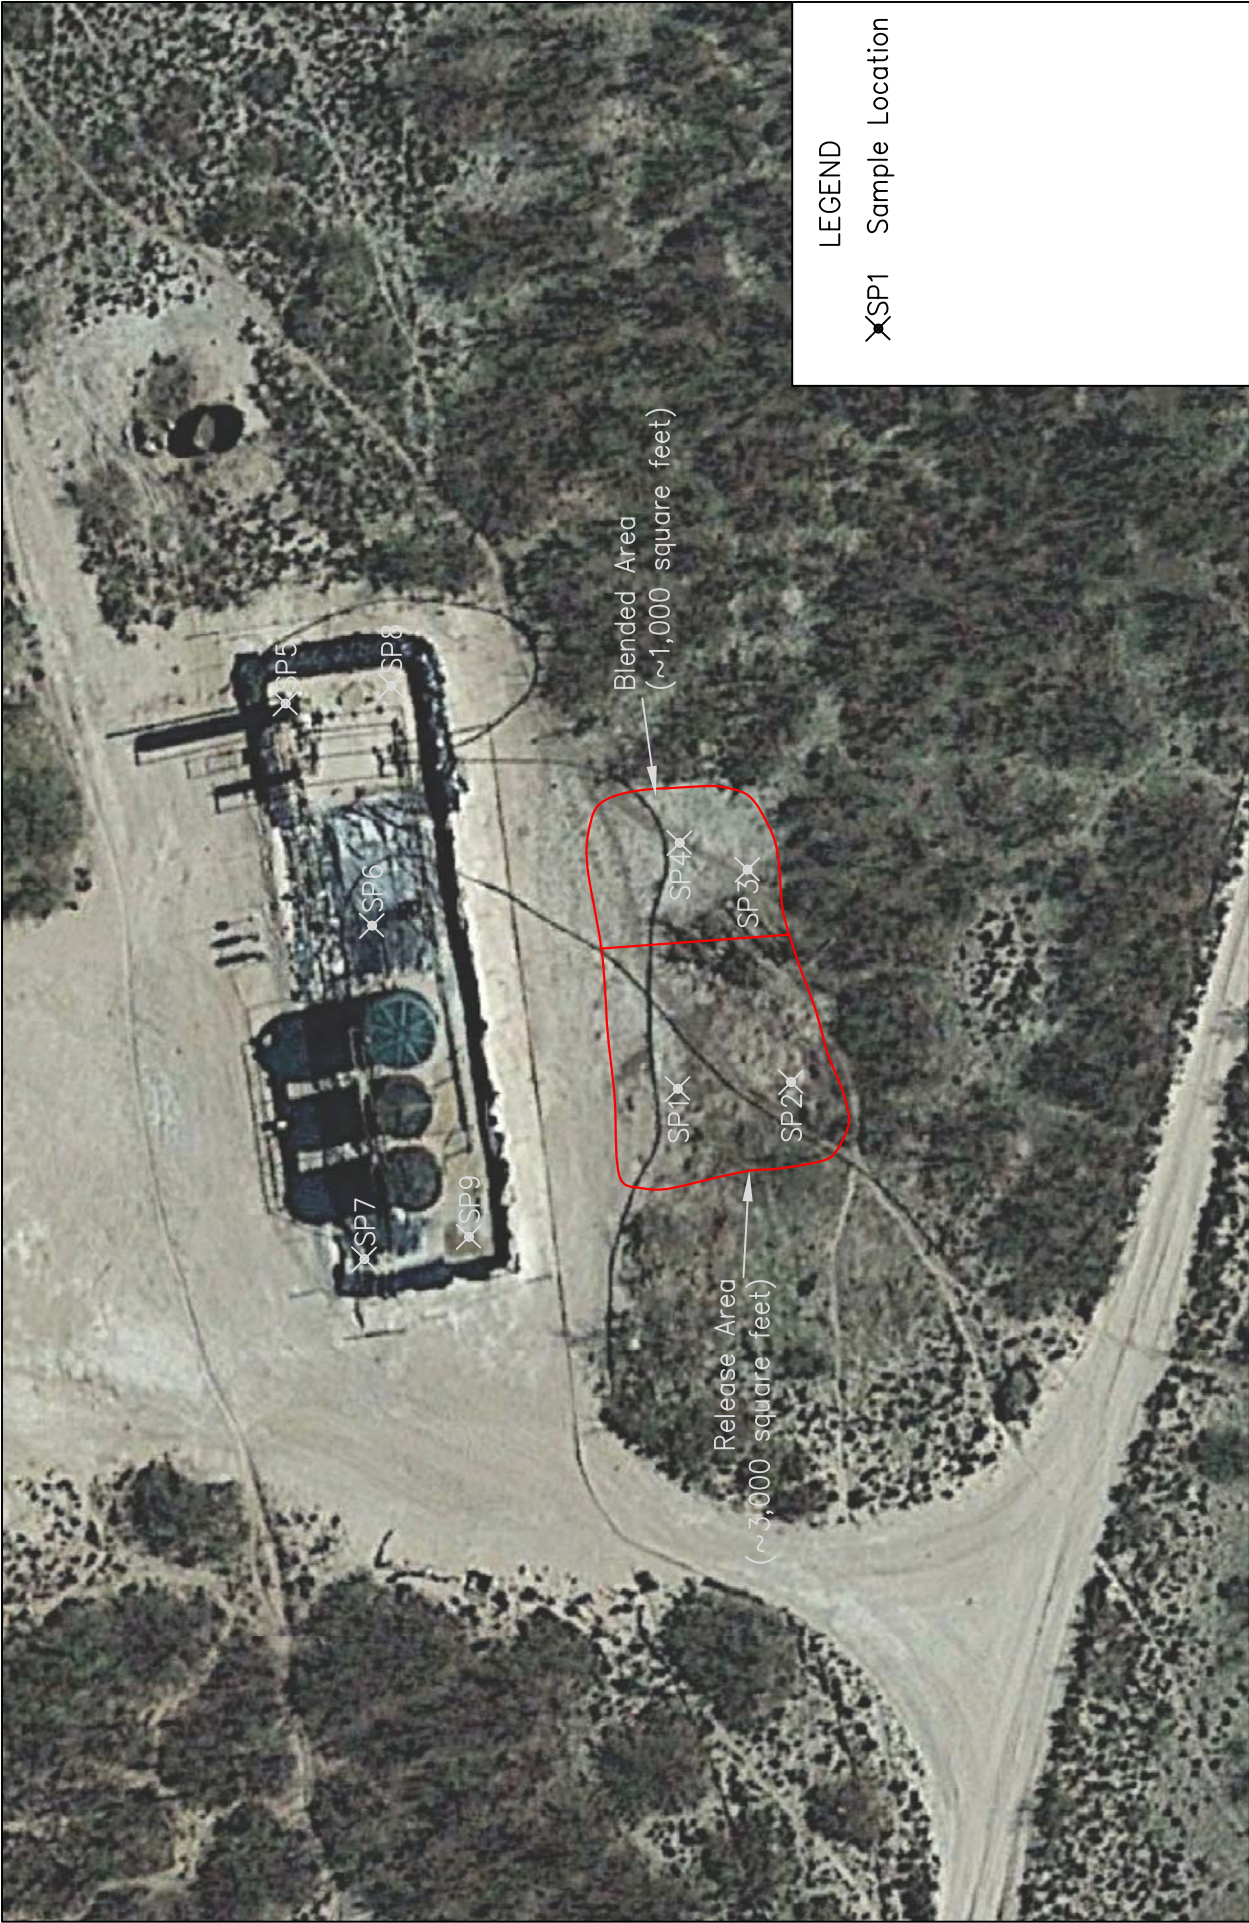
locations; SP1 – SP4. Four representative samples, one from each sample point, were sent to Cardinal Labs for chloride testing. Laboratory analytical results indicate the release area is void of Chloride concentrations in excess of NMOCD RRALs (reference *Figure 3* and *Table 2*).

Field testing of the surface sample from SP4 indicated elevated chlorides above NMOCD RRALs. In lieu of excavation the area was dug up, blended, resampled, and backfilled. The composite sample collected was sent to Cardinal Labs for chloride testing. Laboratory analytical results indicate the area to be void of Chloride concentrations in excess of NMOCD RRALs (reference *Figure 3* and *Table 2*).

On February 7, 2017 EPI personnel were on site to collect soil samples from within the lined containment area. A total of five soil samples were collected from five sample locations, SP5 – SP9. All five samples were sent to Cardinal labs for testing. Laboratory analytical results indicate the lined containment area to be void of contaminant concentrations in excess of NMOCD RRALs (reference *Figure 3* and *Table 2*).

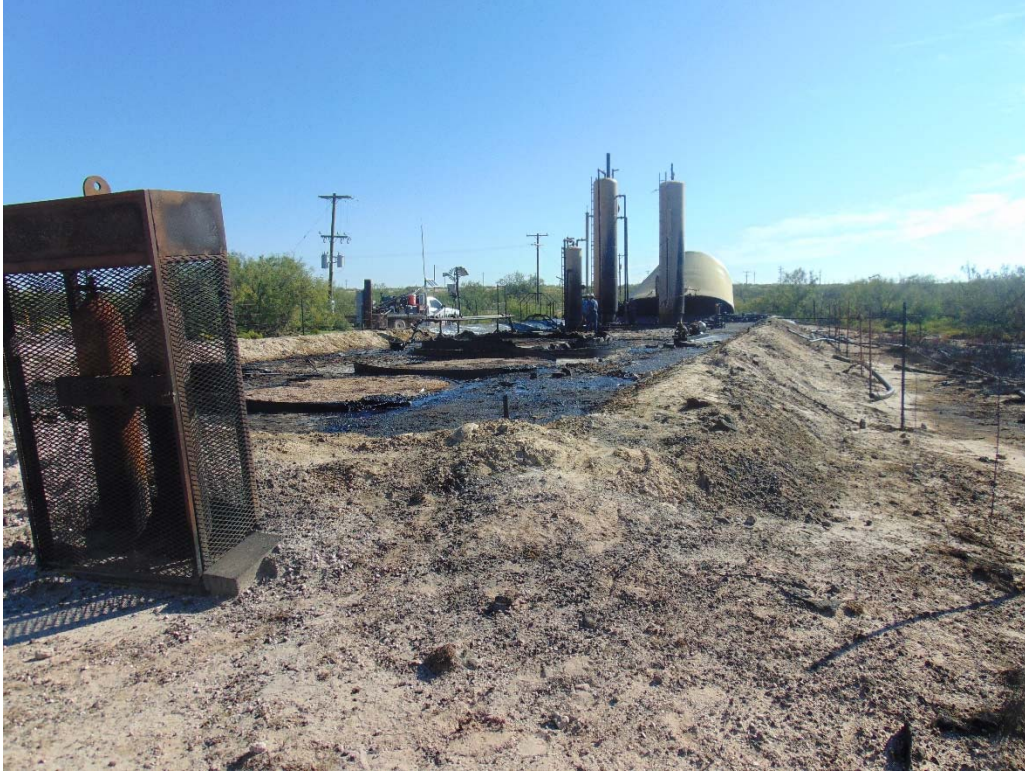
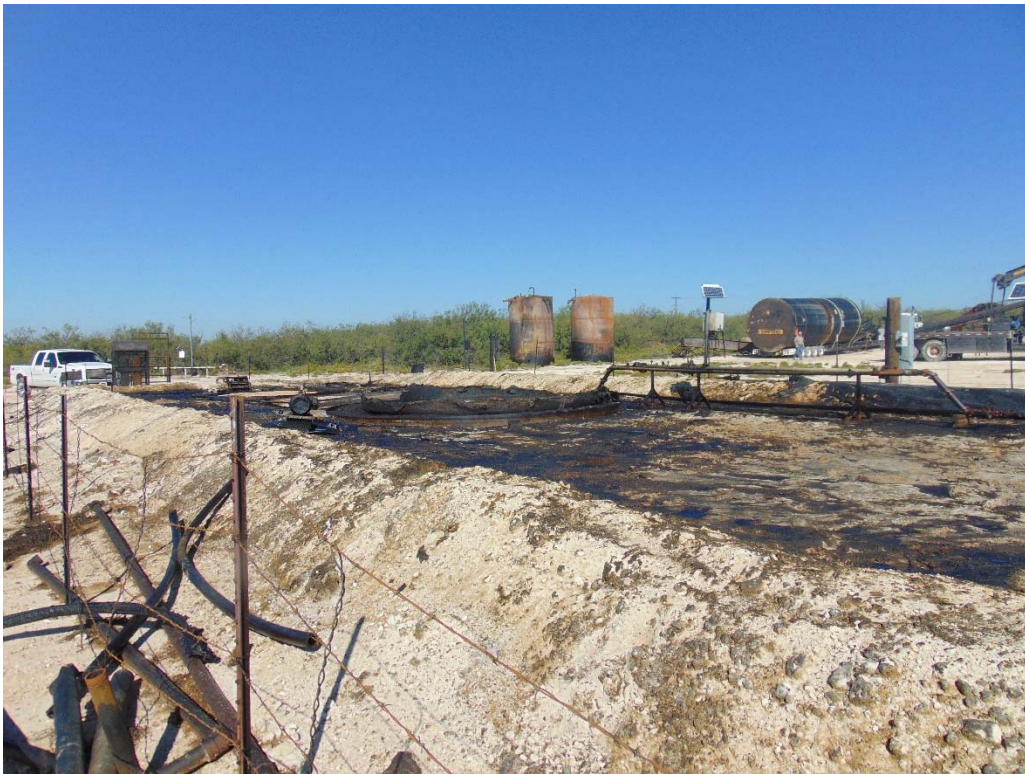
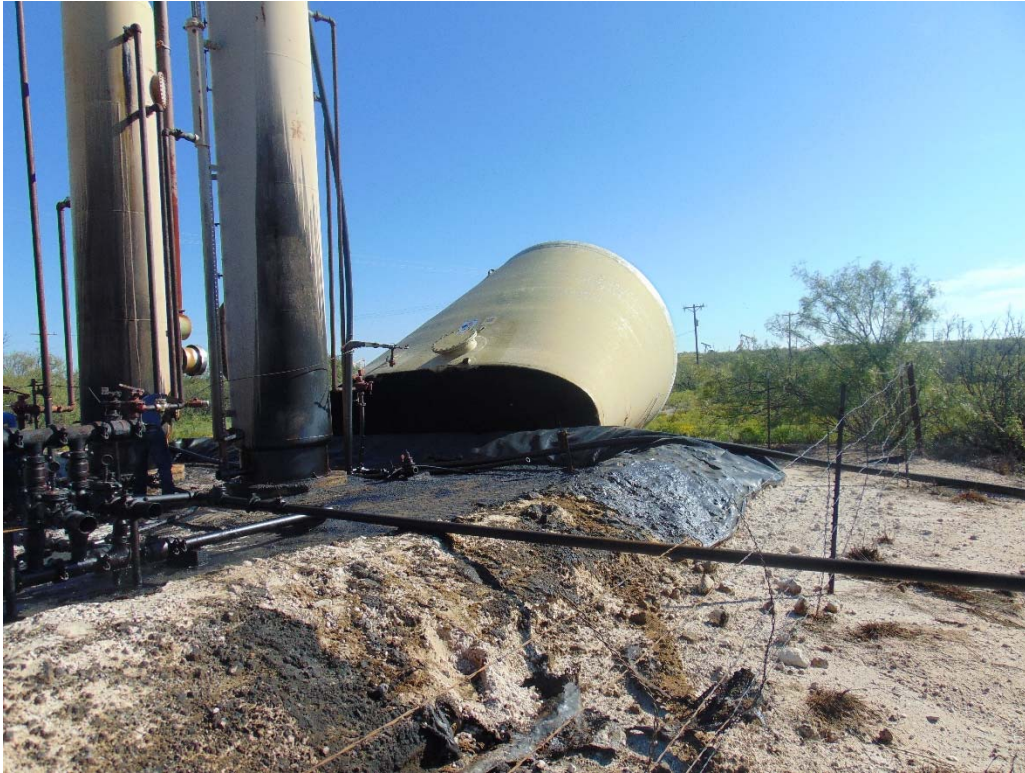
Photograph #1 – Tank battery struck by lightning

Photograph #2 – Tank battery struck by lightning

Photograph #3 – Tank battery struck by lightning

Lightning struck tank causing a fire which damaged all the tanks on site. Produced water and oil remained inside of the lined containment. Wells were shut in until weather permits repairs.

Damage was to tank and equipment inside of containment. Tanks will be removed and replaced. Any contaminated soil above the liner will be remediated and the liner replaced if damaged.

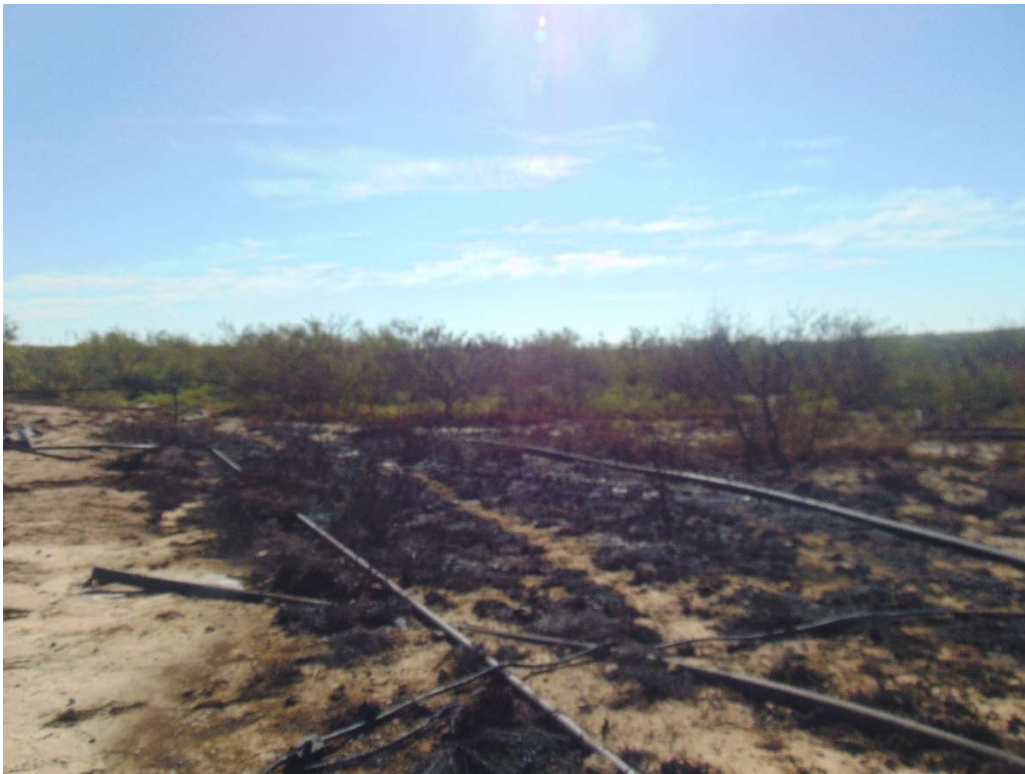
The fluid stayed within the tank battery containment. The area to the south of the tank battery covered an area approximately 81 x 41 feet. The area consists of approximately two feet of sandy topsoil atop a hard caliche layer.

Photograph #4 – Looking across release area

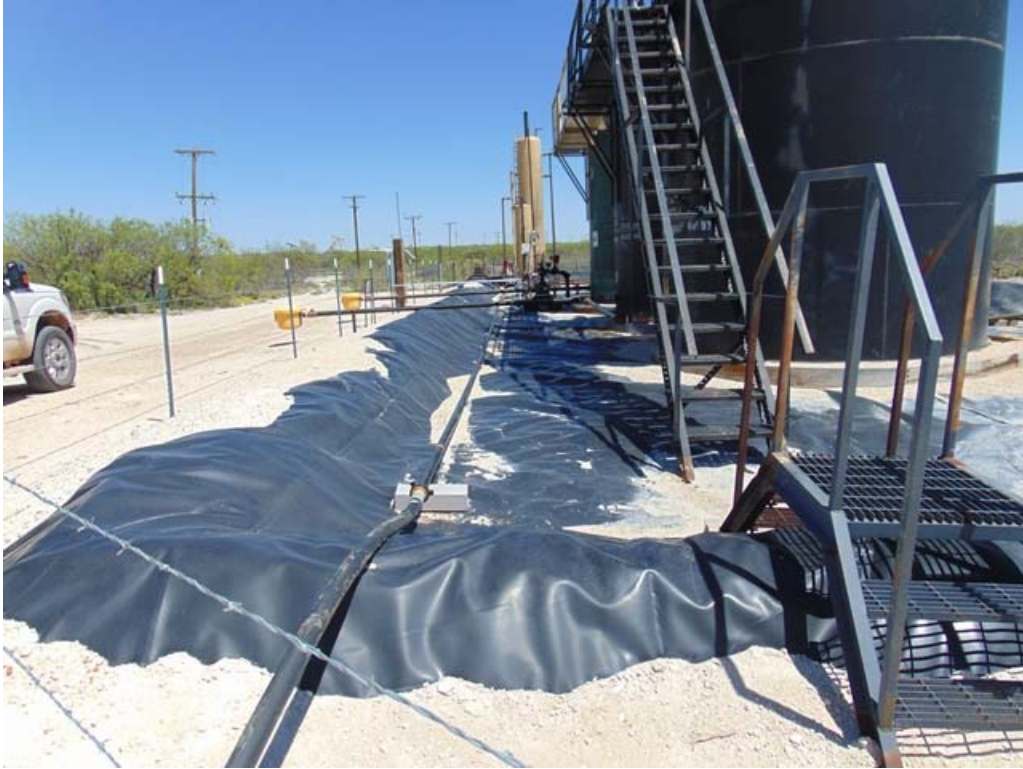
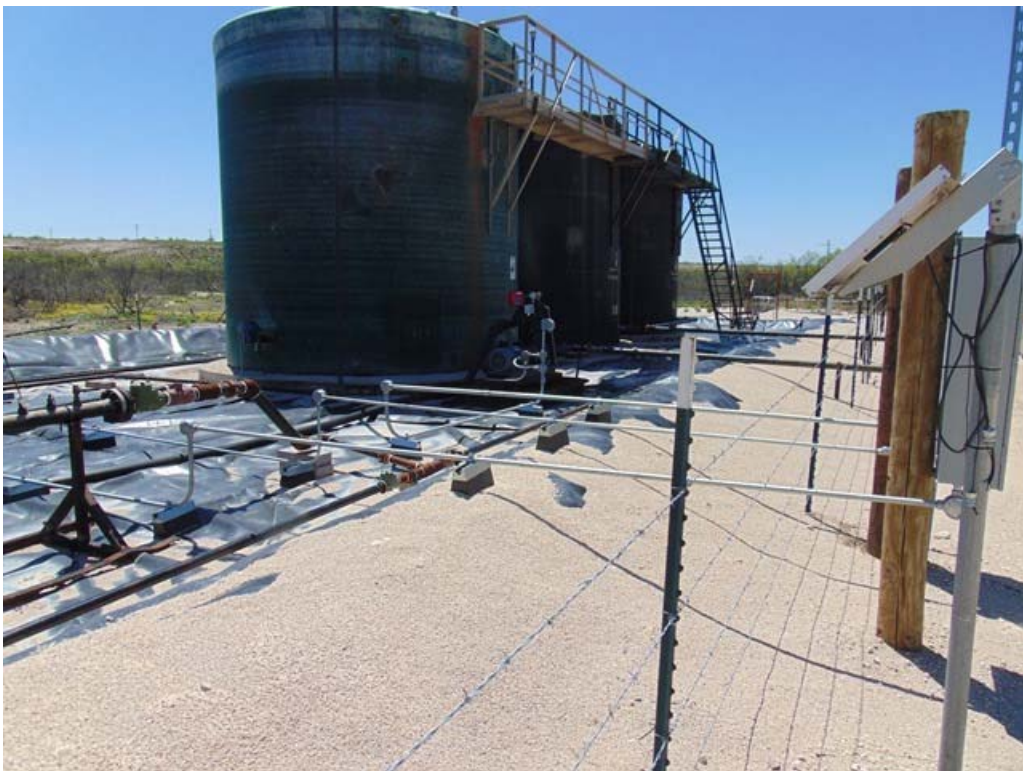
Photograph #5 – Rebuilt tank battery with new liner

Photograph #6 – Rebuilt tank battery with new liner

The entire tank battery was rebuilt and liner replaced. Collier Backhoe Service worked in conjunction with Balderama to remove the contaminated soil and process equipment. The contaminated soil was scrapped up and the berms were removed. All contaminated soil was hauled to a state approved disposal facility. Clean caliche was hauled in, the berms were replaced, a new liner installed, and the tank battery was rebuilt (reference *Attachment IV* and *NMOCD website*).

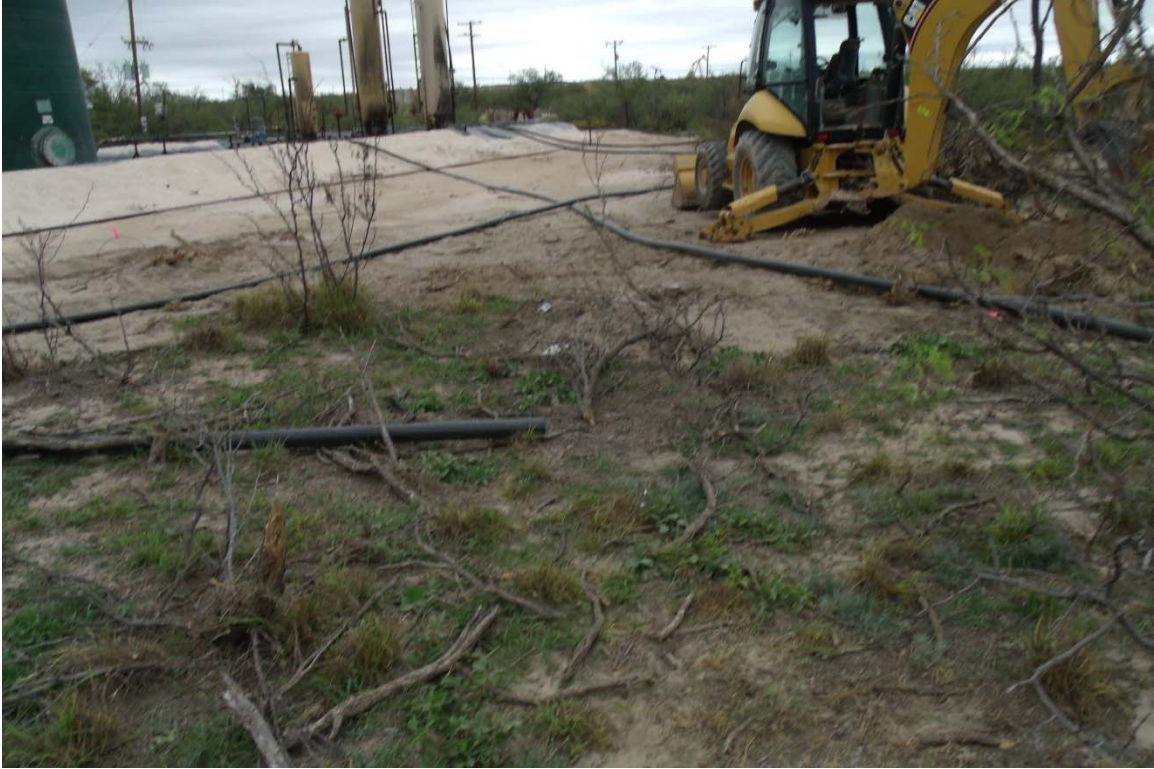
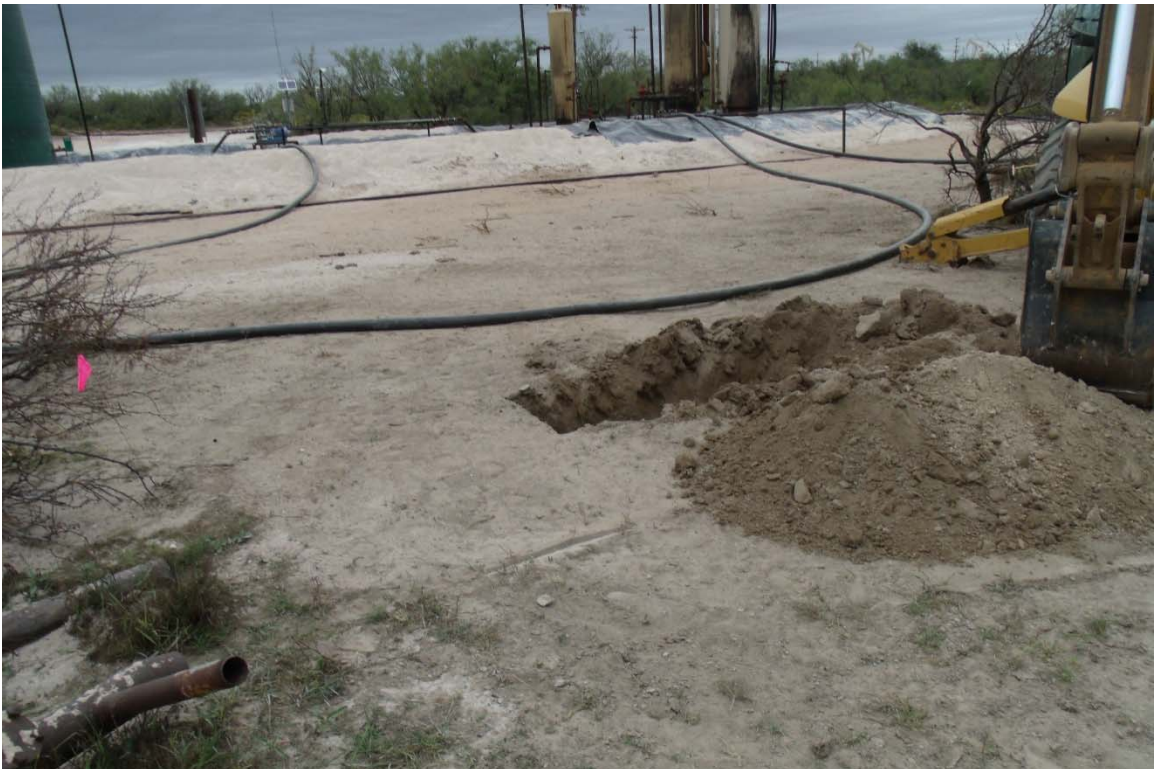
Photograph #7 – Sampling the area south of the battery

Photograph #8 – Sampling the area south of the battery

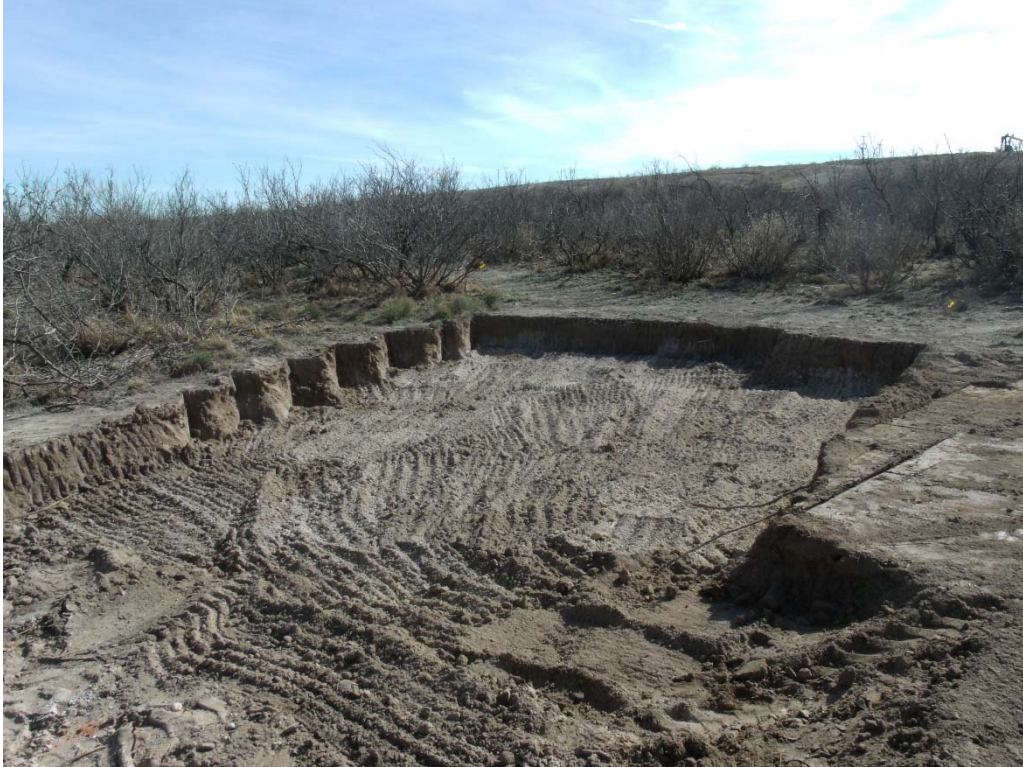
Photograph #9- Looking across excavation around SP4

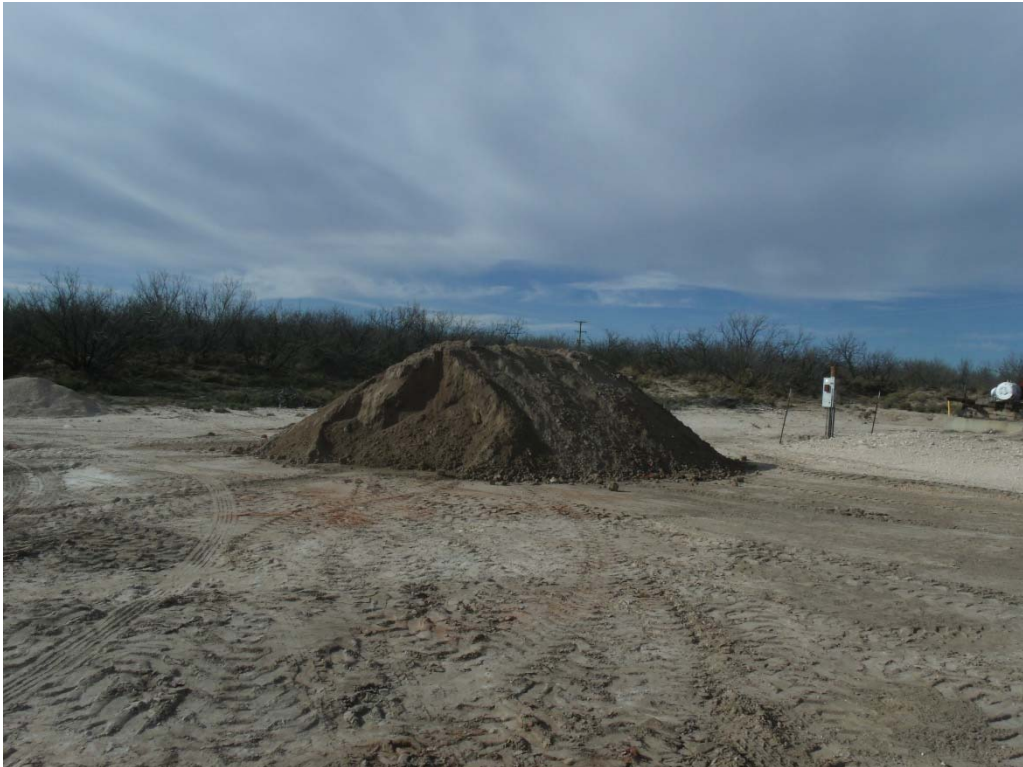
Photograph #10- Blending the soil around SP4

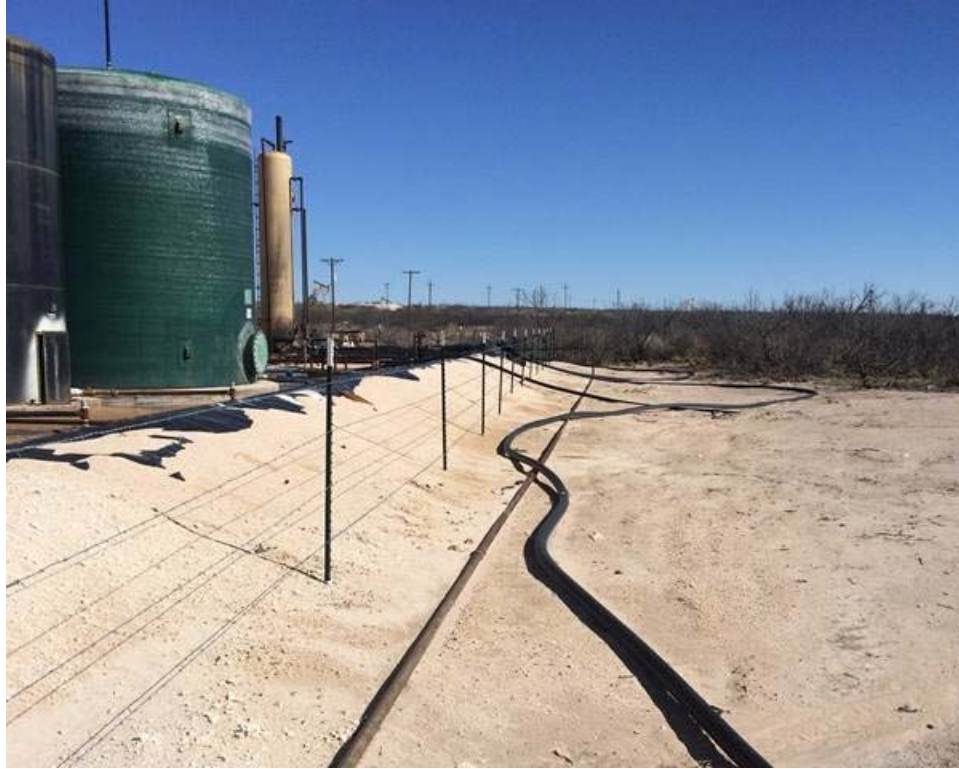
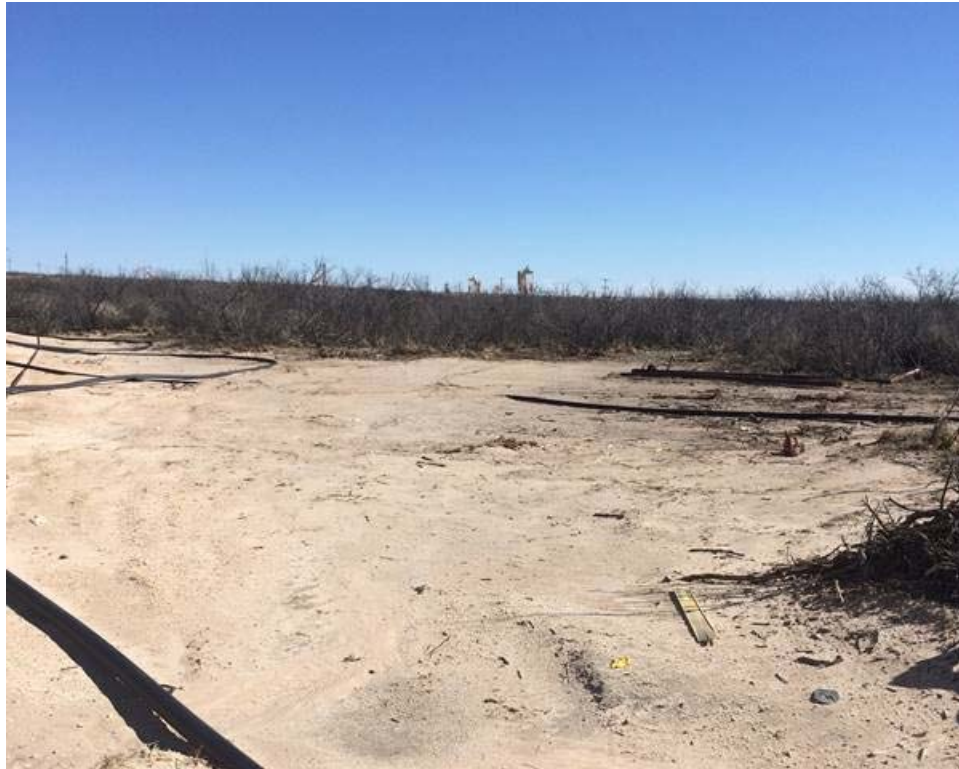
Photograph #11- Blended soil backfilled

Photograph #12- Blended soil backfilled

Upon completion of backfill activities, the disturbed area was contoured to blend with existing pasture area and protected against wind/water erosion.
