### **Site Closure Report**

Cimarex Penzoid 36 #1

Talon Project #700348.345.01

RP #4343

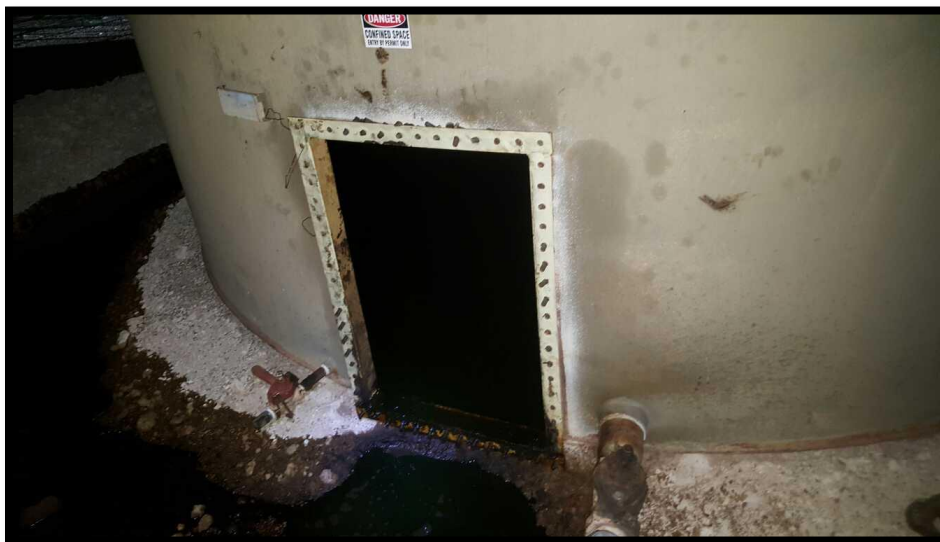
### **Photograph No. 1**

**Description:**  
Source of crude oil  
release and flowpath.

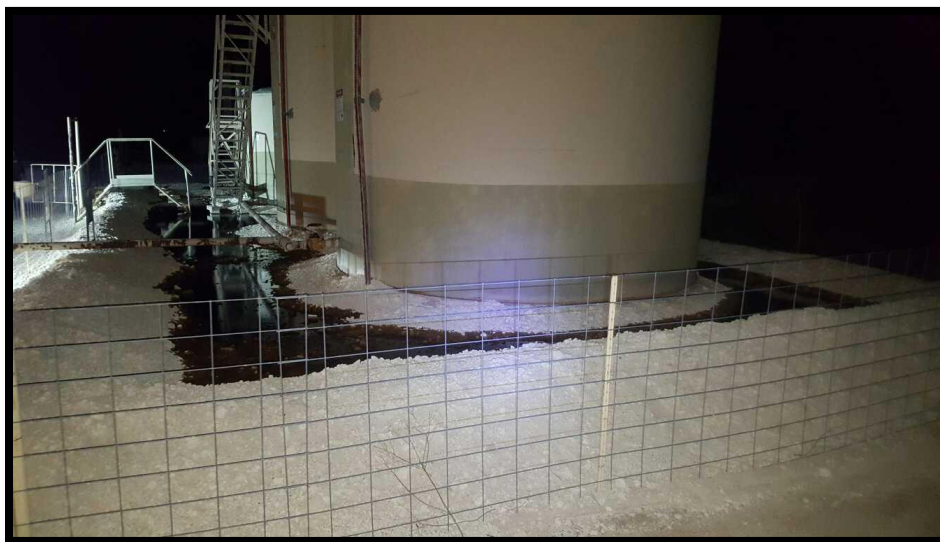
### **Photograph No. 2**

**Description:**  
Crude oil flowpath  
inside tank battery berm

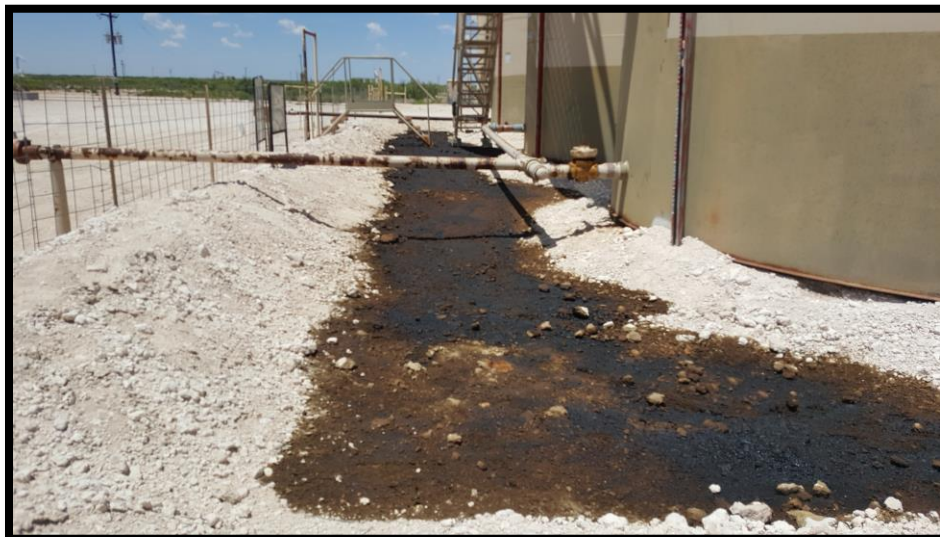
### **Photograph No. 3**

**Description:**  
Crude oil flow path  
following vacuum truck  
activities.

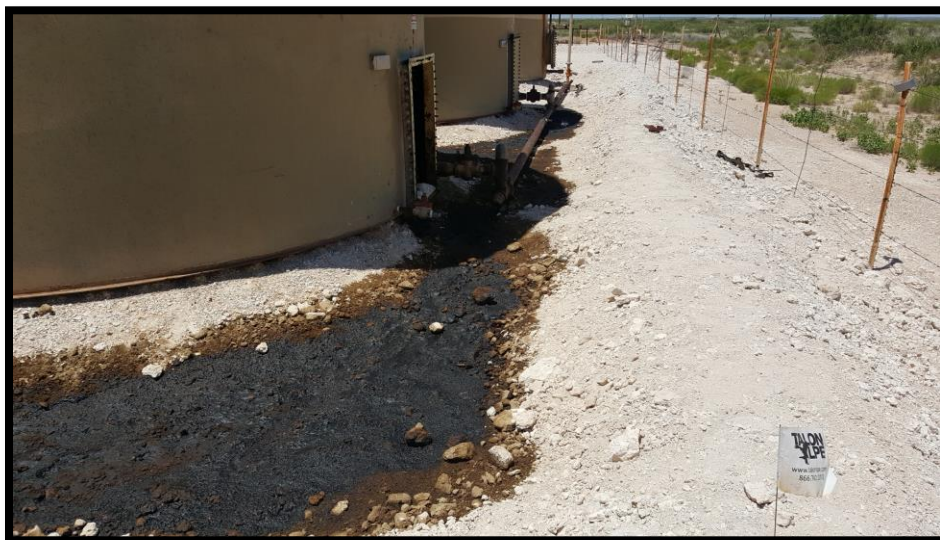
### **Photograph No. 4**

**Description:**  
Crude oil flow path  
following vacuum truck  
activities.

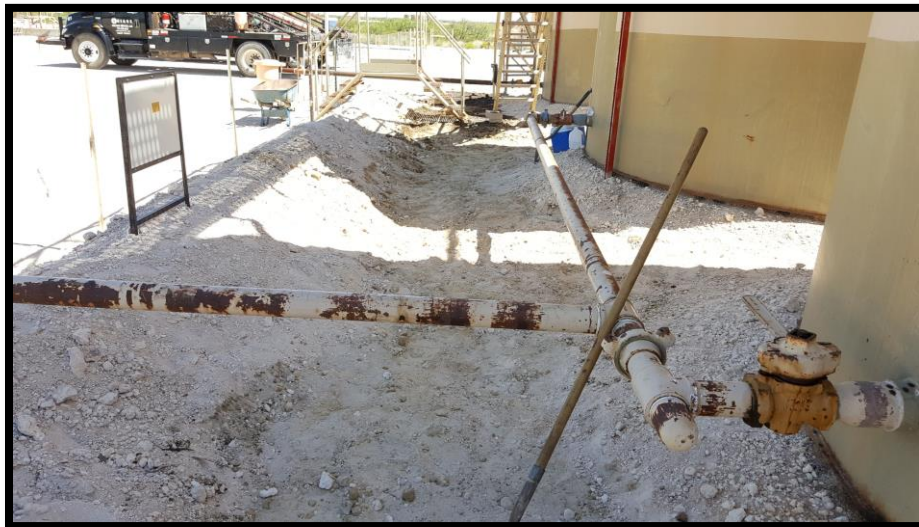
### **Photograph No. 5**

**Description:**  
Impacted area  
following excavation  
activities.

The final excavation limits measured approximately 250 square feet. Vertical depth was determined to be approximately six (6) inches bgs. Photographic Documentation of excavation activities is presented in Appendix C. Copies of the Waste Manifests is presented in Appendix F.

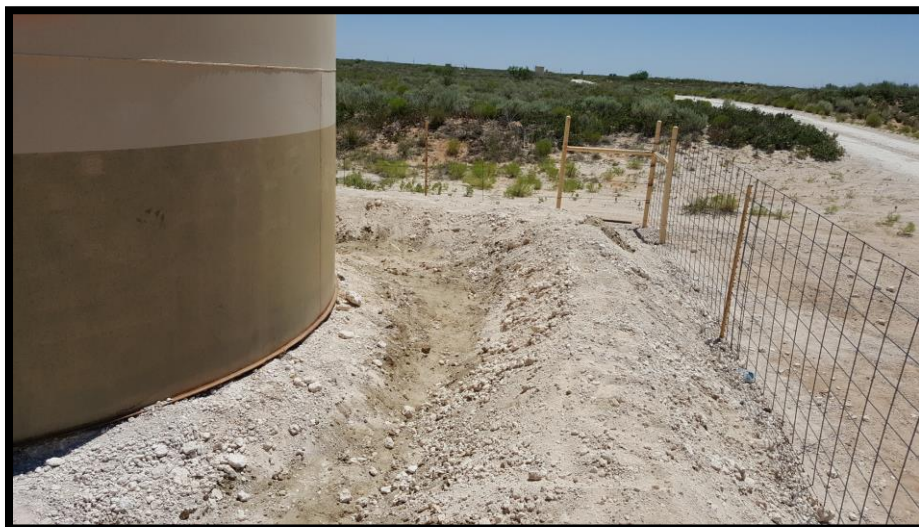
### **Photograph No. 6**

**Description:**  
Impacted area  
following excavation  
activities.

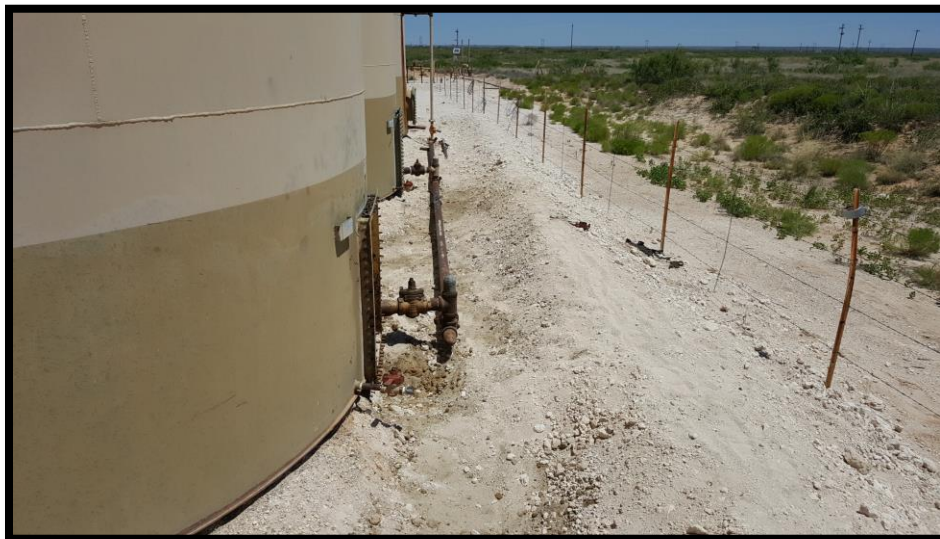
### **Photograph No. 7**

**Description:**  
Impacted area following  
excavation activities.

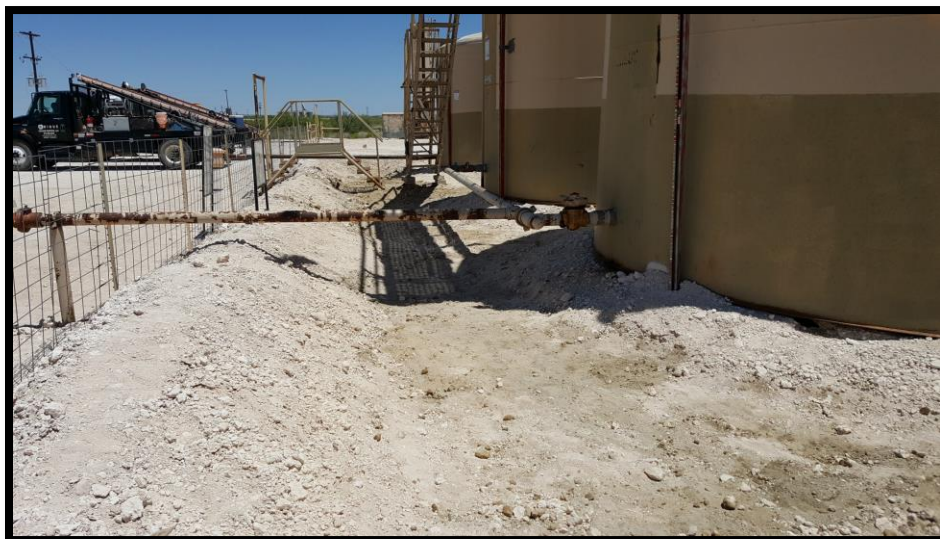
### **Photograph No. 8**

**Description:**  
Release site following  
backfilling activities.

On August 4, 2016, the excavated area was backfilled and graded to match pre-release conditions. Fresh soil procured from Ramirez and Son in Hobbs, New Mexico was utilized as backfill material. Backfill activities were completed by utilizing hand tools.
